**WASHINGTON PHASE II FISH  
DIVERSION SCREEN EVALUATIONS IN  
THE YAKIMA RIVER BASIN, 1998**

Annual Report 1998

DOE/BP-62611-15

# **Washington Phase II Fish Diversion Screen Evaluations in the Yakima River Basin, 1998**

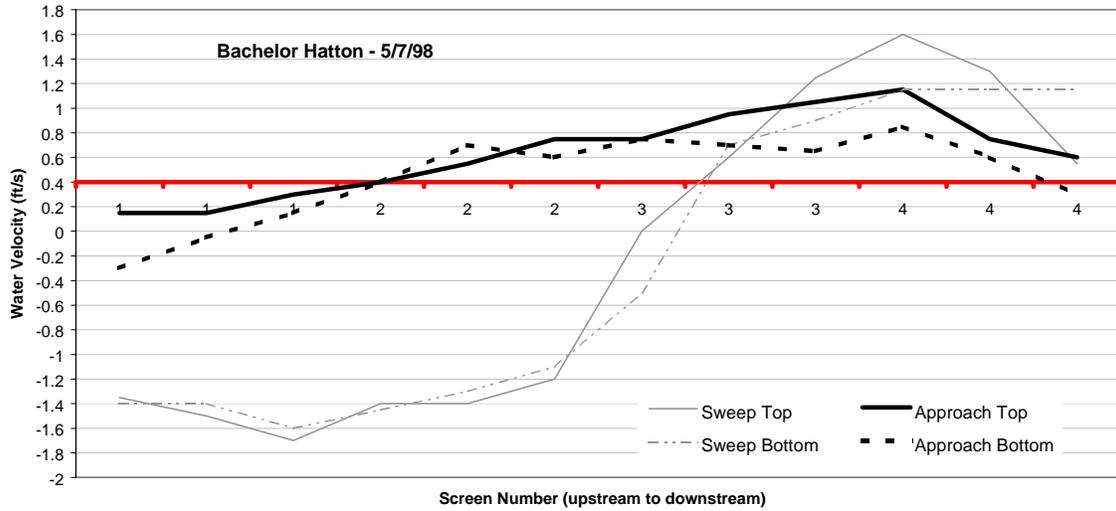
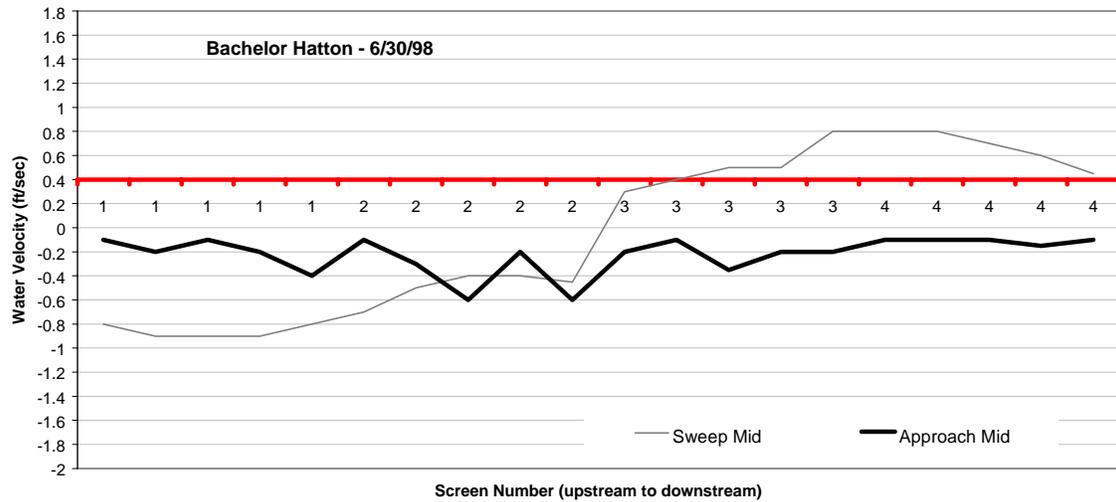
High water and poor hydraulic conditions created a large eddy in the forebay that produced negative sweep and approach velocities in front of the two upstream screens (Figure 5 and Figure 6). The eddy was due, in part, to the imbalance of the headgate structure openings, as shown in Figure 7. The gate on the left allowed a greater amount of water into the forebay than the gate on the right. As this water entered the forebay, it hugged the wall farthest from the screens until it reached the bypass area. The water then turned in toward the screens and flowed upstream, creating the negative velocity patterns (Figure 8).

During May, approach velocities increased from upstream to downstream and exceeded 0.4 fps in front of the two screens nearest the bypass, and a 4.5-in. headloss was observed between the forebay and aftbay. In June, all approach velocities were negative, suggesting that little or no water passed into the irrigation canal. Overall, 50% of the recorded approach velocities at this site were zero or negative and 34% were greater than 0.4 fps. Thus, just 16% of the approach velocities fell between 0 and 0.4 fps.

Figure 5. Water velocities at Bachelor Hatton, 5/7/98.

Figure 6. Water velocities at Bachelor Hatton, 6/30/98.

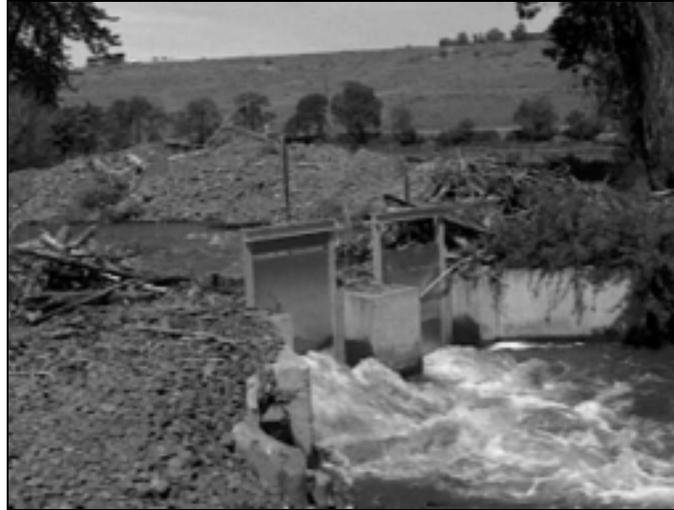
Figure 7. Unbalanced headgate openings at Bachelor Hatton, May 7, 1998.

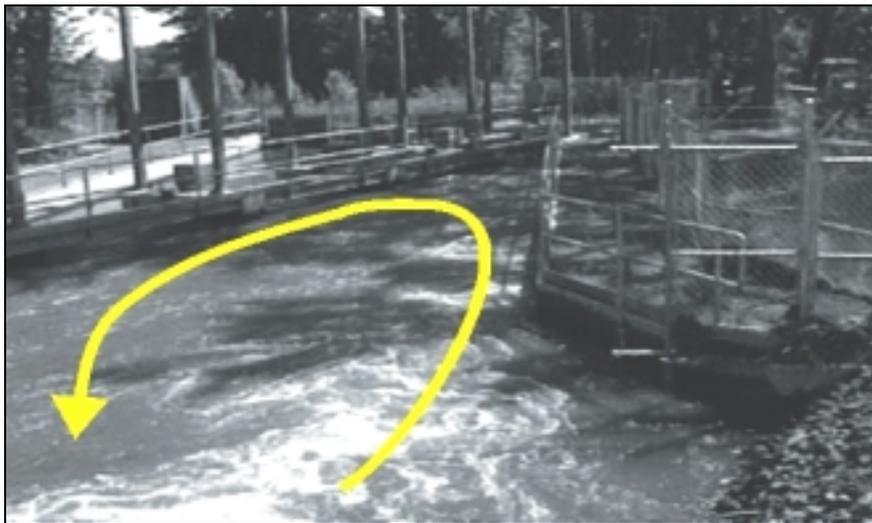
Figure 8. Circular flow pattern at Bachelor Hatton, May 7, 1998.

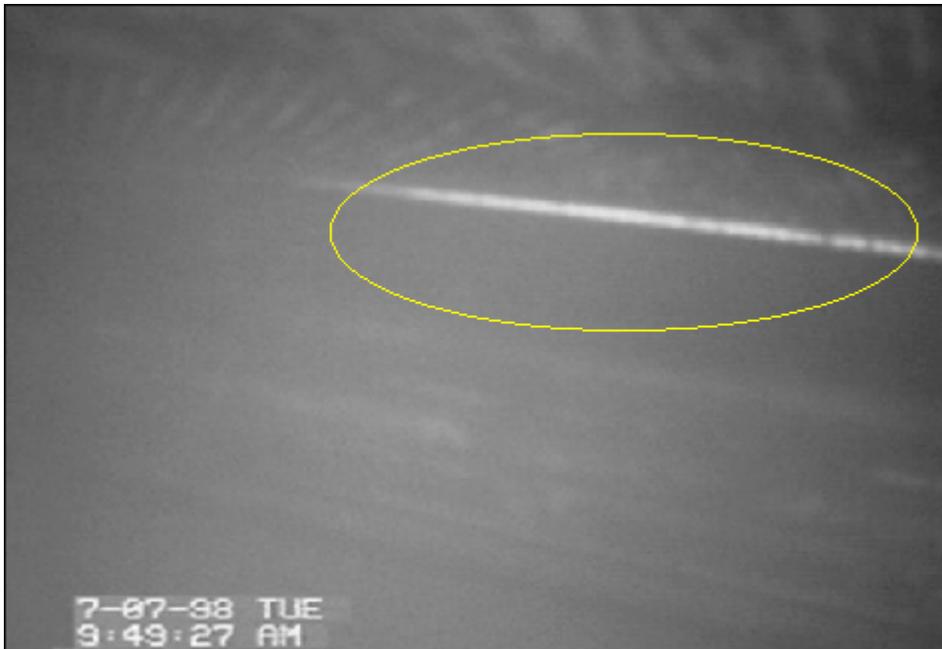
There were a few concerns regarding screen condition. In July, a small gap was noticed between the bottom seal and Screen 1 (upstream of the middle of the screen, Figure 17). Also, small oil slicks were observed in the water behind Screen 2. Otherwise, the screens were in good shape. They were brown with algae and diatoms, but the openings were not blocked, and the drums turned evenly. With the exception of the gap at Screen 1, the seals were in good condition.

Figure 17. Gap (in yellow ellipse) observed under Screen 1 (upstream) at the Kelly Lowry screen facility, on July 7, 1998.

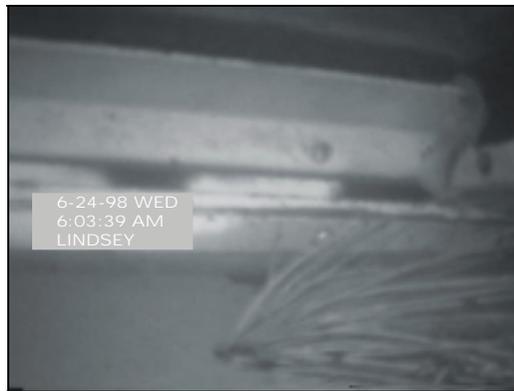
Some streaking from uneven contact between the screen and bottom seal was observed in September. Video also recorded small amounts of light passing between the bottom seal and screen near the upstream end, indicating the presence of a small gap. There were several places where caulking was missing along the bottom where small fish could try to hide (Figure 21). Many dace were observed inside the drum screen in September. The side seals were in good condition and the screen always rotated evenly.

Figure 21. Missing caulking sealant at Lindsey, 6/24/98.

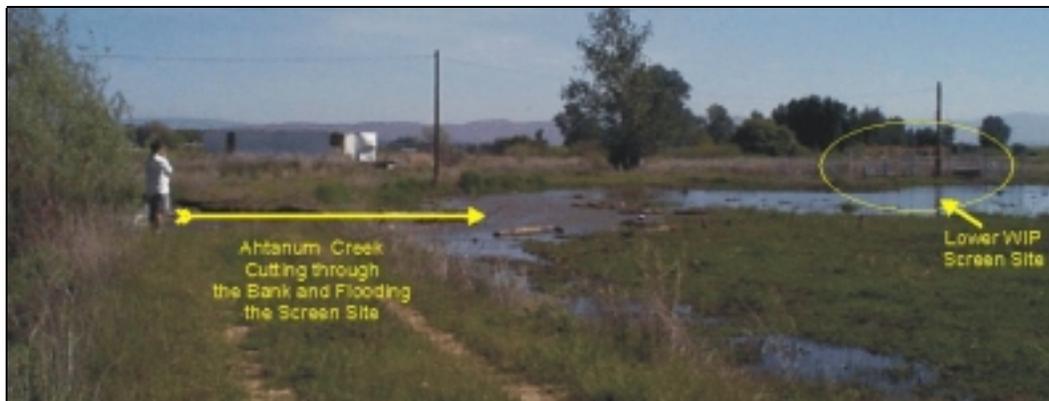
Lower WIP was visited 5/7/98 and 7/6/98. No velocity measurements or video were recorded in May because of flood conditions. Ahtanum Creek cut through the bank upstream of the screen site and water flowed directly from the creek into the irrigation ditch behind the screen (Figure 22). In July, flooding had subsided, but because most of the creek was diverted upstream at the WIP Upper site, little water entered Lower WIP.

Figure 22. Flooding at Lower WIP, 5/7/98.

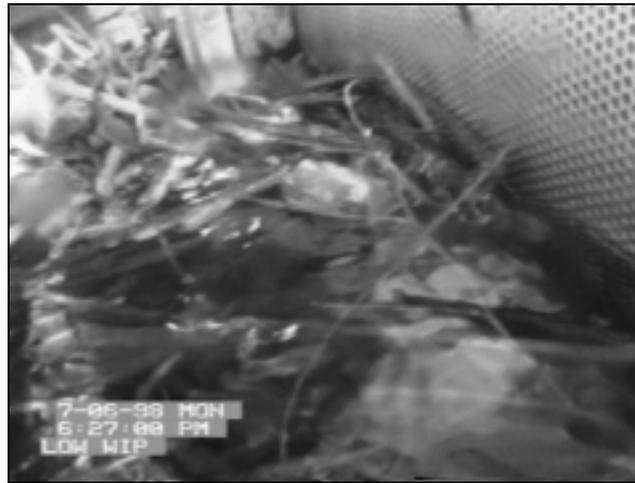
During July, the screens were operating and turned evenly despite the tremendous amount of sediment (>10 in. above the sill). There were only 2-5 in. of water above the sediment. The side seals visible above the silt appeared to be in good condition. Besides the sediment problem, the forebay was also filled with woody debris (Figure 23). Clearly, this site needed to be dredged. A number of small, non-salmonid fish were observed in front of the downstream screen.

Figure 23. Woody debris in the forebay at Lower WIP, 7/6/98.

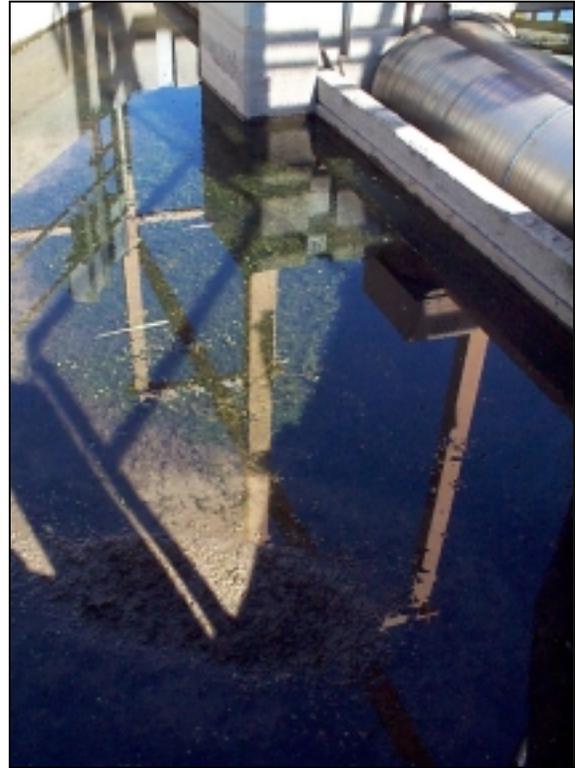
sediments practically blocked the entrance to the canal, though most of the sediments and plant growth were behind the screens and were deep enough to form an “island” (Figure 31). Only one inch had accumulated on top of the sill in front the screens.

Figure 31. Island of sediment formed behind the Taylor Screens, 9/21/98.

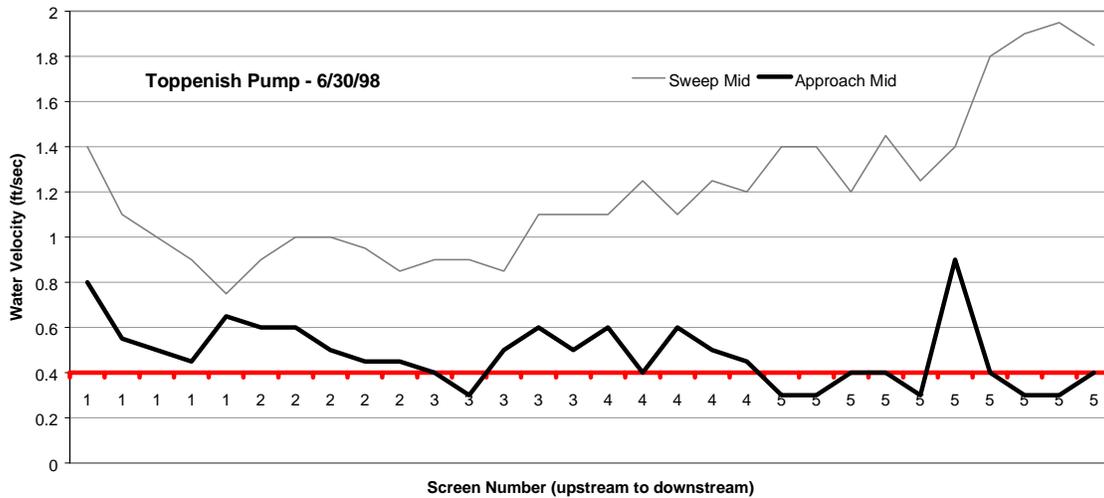
This site had an average approach velocity of 0.48 fps, exceeding NMFS criteria for 60% of the recorded velocities (Figure 32). Screen submergence was approximately 78%.

Figure 32. Water Velocities at Toppenish Pump, 6/30/98.

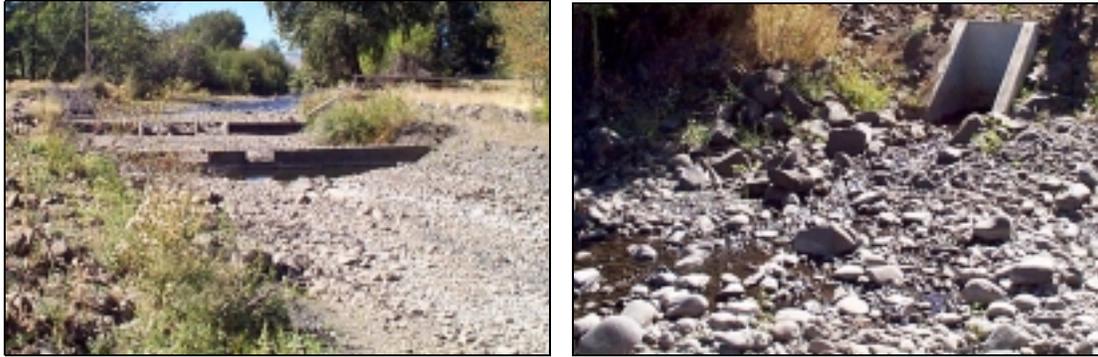
Adequate water was bypassed in May and June, but the bypass was blocked in September since all water in Ahtanum Creek was diverted to the irrigation canal (Figure 36). Water was slightly backed up in the forebay during the May evaluation because of the high water, but flow conditions were generally good. Outfall conditions at the terminus of the bypass pipe were good for fish passage in May and June.

Figure 36. Dry Ahtanum Creek bed (left) and bypass outfall area (right) when water was fully diverted at the WIP upper site, 9/14/98.

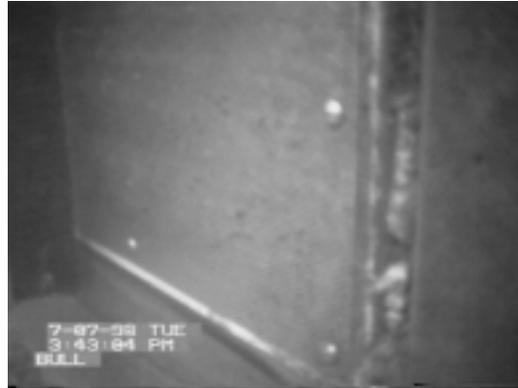
The screens and seals were generally in good condition. A small amount of loose caulking was observed along the bottom and side of the third metal panel (near the bypass; Figure 39

Figure 39. Loose caulking on flat plate screen at Bull ditch diversion on 7/7/98.

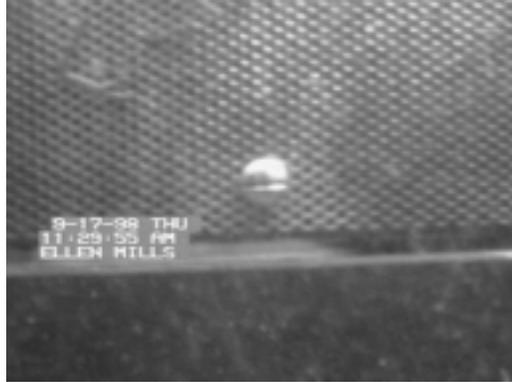
The screens were in good condition, but much of the seal caulking under water had come loose or was missing (Figure 43).

Figure 43. Loose/missing caulking on screen seal at the Ellensburg Mill diversion, 9/17/98.

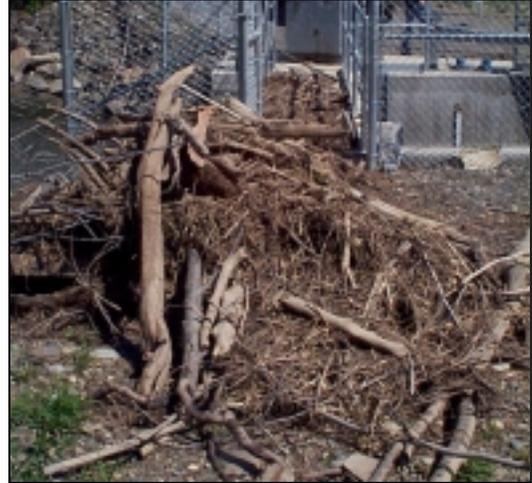
Figure 44. Debris removed from the trash rack at Ellensburg Mill, 5/13/98.

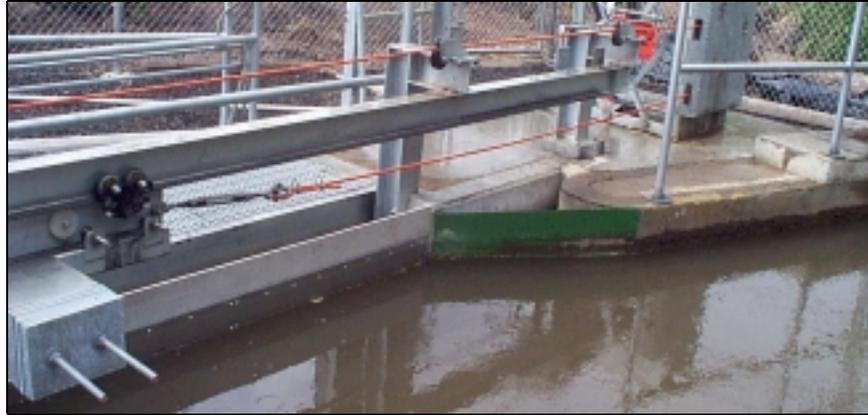
Figure 45. New metal plate attached above the screen and 100% submergence mark on the green metal corner piece, 5/11/98.

Improvements to the site in 1998 included a new 6 in.-tall metal extension above the screen to keep it from overtopping and a 100% submergence mark (Figure 45).

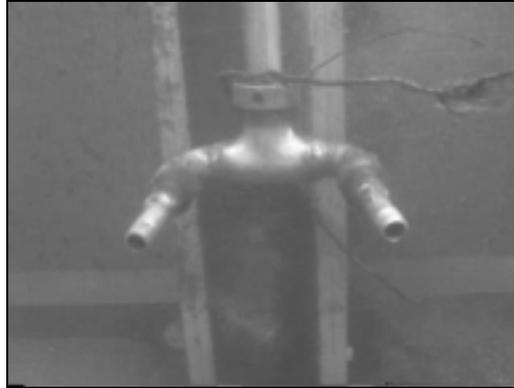
Figure 46. Device used to move silt away from the screen at Naches Selah, 6/24/98.

Improvements to the site in 1998 included a new mechanism for clearing silt from in front of the screens. The device consisted of an air hose attached to a pipe that extended to the bottom of the screen and split into two nozzles (Figure 46). The pipe was attached to the cleaning brush so it could move back and forth over the length of the screen.

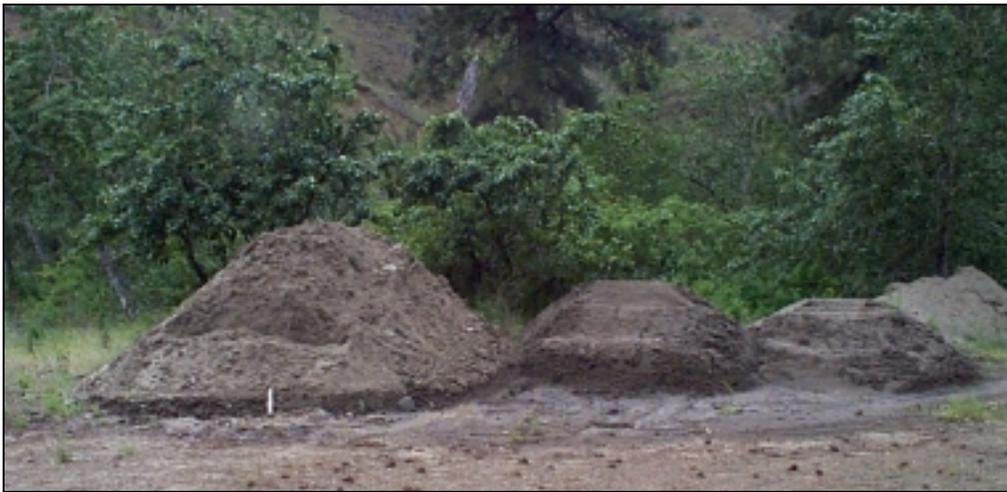
Sedimentation was excessive at Naches Selah. Although we always evaluated the site immediately after silt had been removed, there was evidence that a large amount of silt had been recently removed (Figure 50). In May, maintenance crews removed sediment approximately 3 ft deep adjacent to the screens and sediment approximately 4 ft at the forebay entrance just one day prior to our evaluation. The sediment had been so deep, cleaning brushes were unable to move through it. Lesser amounts of sediment and debris were observed in June, although a small log had entered the forebay, and some leafy debris had accumulated on the screen in between brush operation cycles. In September, we evaluated the site within a week of sediment removal from the forebay. We observed only small amounts of sandy silt and small gravel in front of the screens. An artifact of manual sediment removal appears to be an increase in sediment depth between the screen and the louvers, often as deep as 10 in.

Figure 50. Piles of sediment removed from the forebay at Naches Selah, 5/12/98.

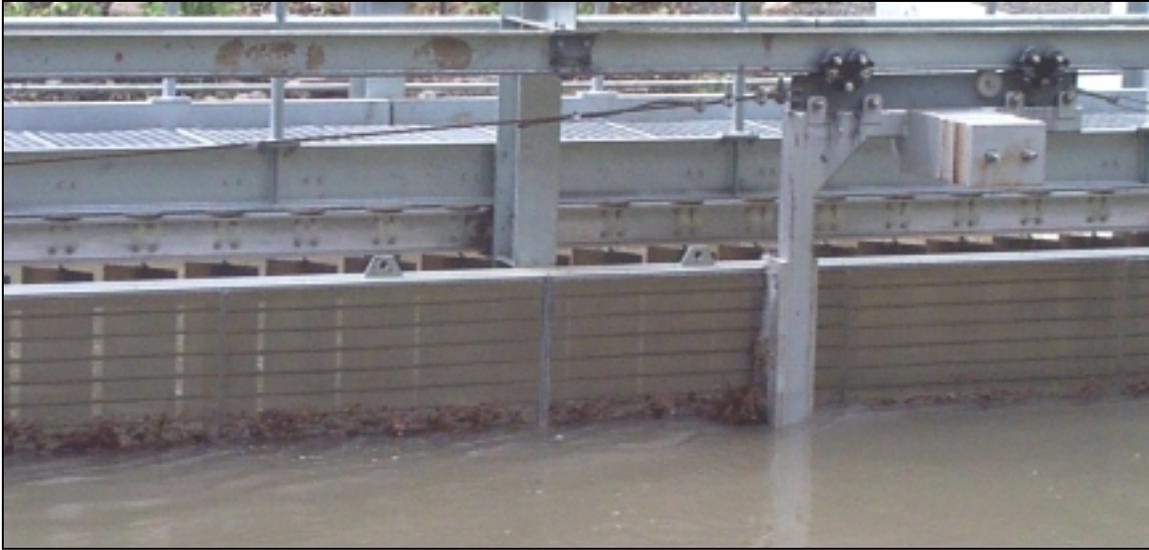
Figure 57. Leafy material accumulating on the Yakima Tieton screen, 5/12/98.

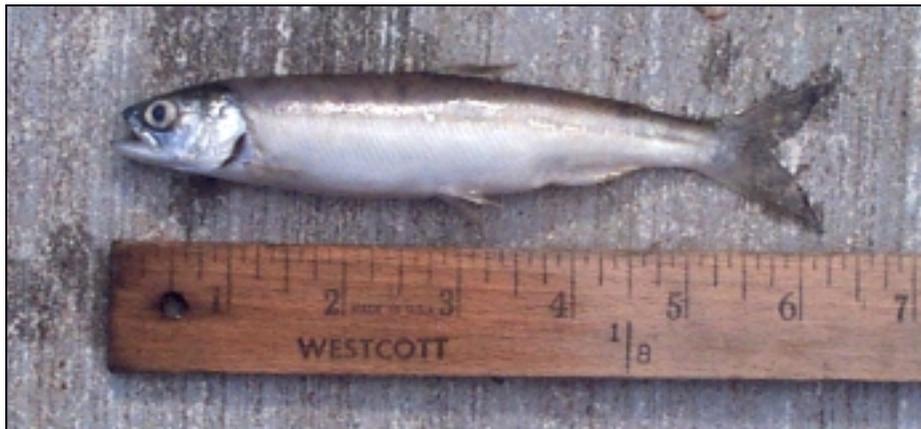
Figure 58. Kokanee retrieved from the bypass at Yakima Tieton, 5/12/98.
