CAMAS CREEK (MEYERS COVE)  
ANADROMOUS SPECIES HABITAT IMPROVEMENT PLAN

Final Report

Bruce May, Forest Fisheries Biologist  
and  
Robert W. Rose, Fisheries Technician  
USDA Forest Service  
Salmon National Forest  
Salmon, ID 83467

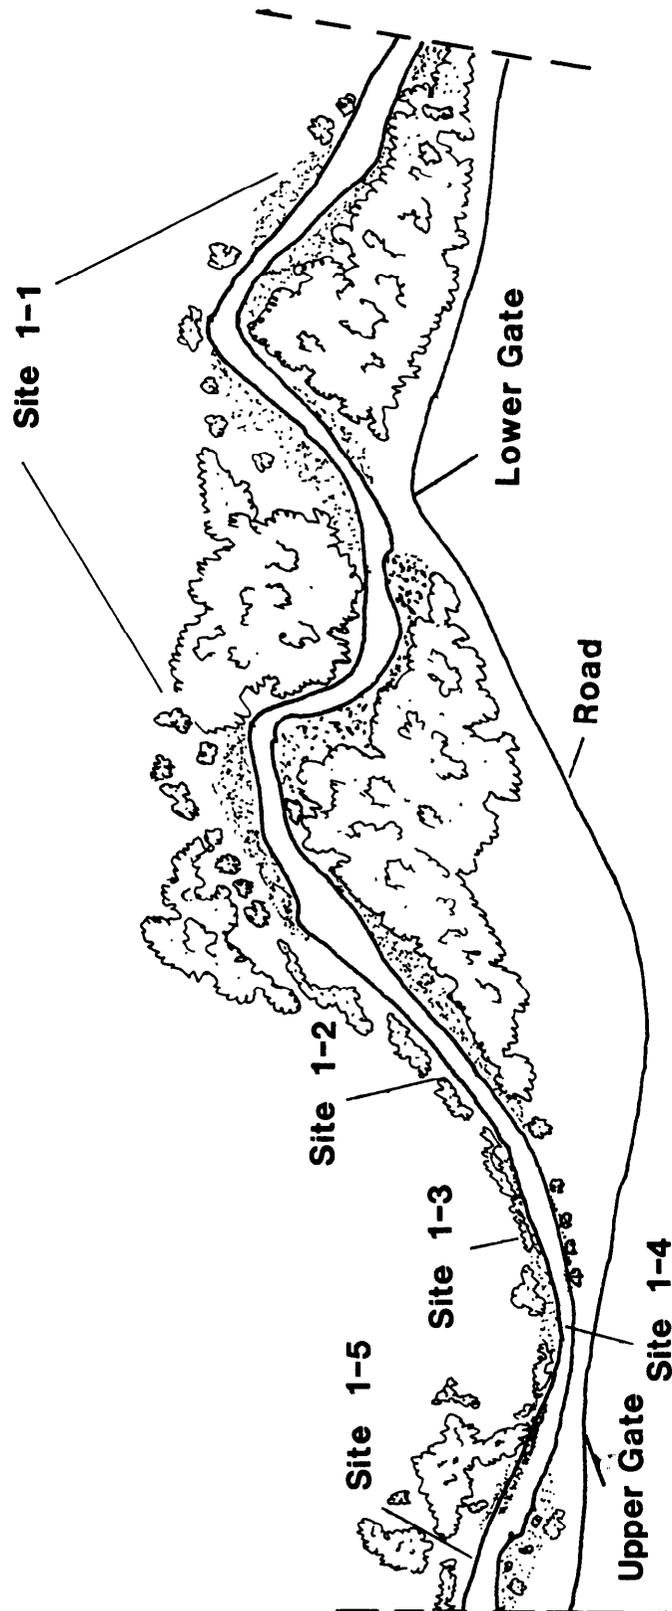
Figure 3. Location of major instability identified in the lower reach of Camas Creek in Meyers Cove area.

The lower reach on Camas Creek comprised approximately 3,437 feet of stream channel. This reach originated in the area near a lower gate and proceeded upstream to a point just above an upper gate (Fig. 3). The lower portion (site 1-1) of this reach was characterized by relatively heavy willow and cottonwood stands. Channel conditions reflected the influence of high bedload movement from past runoff periods. Point bars and channel bars predominated through the 2,417 feet of this lower section of the reach. Above this section there were four sites with obvious streambank cutting and/or sloughing attributable to stream energies and land management influences (Table 2). Livestock influences were most noticeable on the right banks in areas where willow and grass species were the dominant vegetation.

Table 2. Camas Creek lower reach stream channel condition and riparian zone **inventory**. Bank location is referenced facing upstream. Reach length was approximately 3,437 feet.

Site	Location	Length (ft)	Height (ft)	Comments
1-1	<b>Extreme lower portion of reach - both banks</b>	<b>2,417</b>	<b>--</b>	point and channel bars predominate; riparian vegetation composed of willow, cottonwood with various grasses and forbs; livestock conflicts light to moderate in nature; low bank with minimal cutting
1-2	<b>Right bank</b>	<b>10</b>	<b>2-3</b>	small bank rock with sod vegetative cover, cutting likely being influenced by livestock use and past agriculture activity on adjacent meadow .
1-3	Right bank	6	3	conditions similar to section 1-2
1-4	Left bank	180	2-10	gravel bar with adjacent channel bank having small bank materials; limited vegetation on channel bank; would be influenced during high water
1-5	Right bank	492	--	This section reflects the influence of post cutting; present conditions have interspersed areas of cutting and gravel bars.

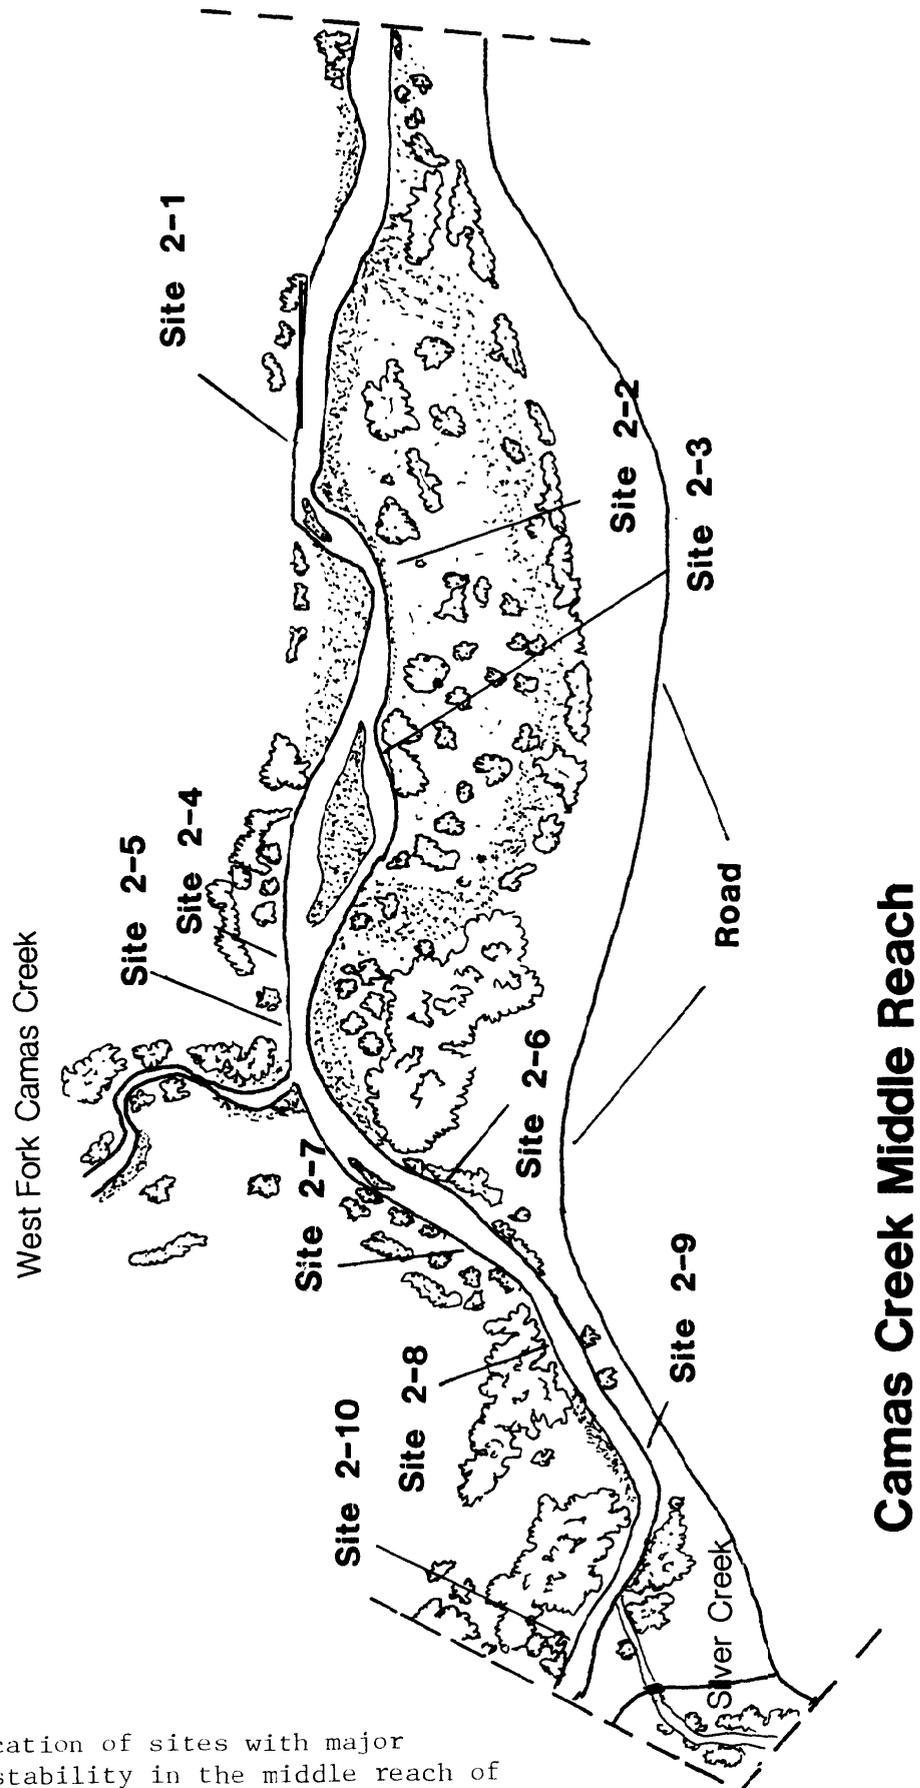
Figure 4. Location of sites with major instability in the middle reach of Camas Creek, Meyers Cove area.

The middle reach inventoried on Camas Creek was approximately 2,790 feet in length (Fig. 4). This area included the junctions of both Silver Creek and the West Fork of **Camas** Creek with main Camas Creek and contained a large remnant meander of the main drainage. Several channel and point bars were observed and channel conditions reflected the influence of runoff from the West Fork. Revegetation of the old meander was proceeding at a very slow rate; livestock use and limited soil were primarily responsible for the slow recovery. Older cottonwoods dominated as the larger woody riparian vegetation and younger cottonwoods were noticeably absent. Channel conditions reflected the influence of runoff conditions and livestock use of the streamside areas (Table 3). A portion of the stream side area from sites 2-5 through 2-10 had been fenced to exclude cattle use and provide protection to riparian vegetation and streambanks.

Table 3. Camas Creek middle reach stream channel and riparian zone inventory. Reach length was approximately 2,792 feet. Bank location referenced facing upstream.

Site	Location	Length (ft)	Height (ft)	Comments
2-1	Right bank	190	2-3	streambank with cutting and sloughing; small bank materials; vegetation primarily bluegrass and forbs. Very limited amount of larger woody riparian vegetation; livestock influence evident.
2-2	Left bank	120	2-3	braided channel site; primarily a juvenile rearing area with low stream energies; old cutting that is naturally healing
2-3	Left bank	75	1	located just upstream of 2-2 on the braided side channel; old cutting evident that is naturally healing
2-4	Right bank	100	4	section of bank with cutting and sloughing evident; smaller bank rock materials present; vegetation dominated by occasional willow and other smaller materials
2-5	Right bank	27	6	just upstream of 2-4 and with similar streambank conditions; a fence has been installed to provide protection of this site.
2-6	Left bank	126	2-4	section of bank located on an outside bend; cutting is evident but site is stabilizing as a result of large bank materials and large cottonwood root masses; presently protected by fence

2-7	Right bank	--	--	minor area of sloughing and cutting; small forbs and a minor amount of willow provide some bank protection; presently protected by fence
2-8	Right bank	--	--	section with gravel bar with developing streambank; sparsely vegetated and with small to moderate bank rock materials; presently protected by fence

Site Location	Length (ft)	Height (ft)	Comments
2-9 Left bank	70	3	unstable streambank area associated with large pool with back eddy currents; old beaver activity on opposite bank may have been responsible for directing flows and causing instability; presently protected by fence
2-10 Right bank	180	2-5	This site has substantial length of bank that is unstable and exposed to stream energies at high flows; at low flows gravel bar is exposed; opposite bank has substantial amount of debris; also Silver Creek enters immediately downstream; presently protected by fence

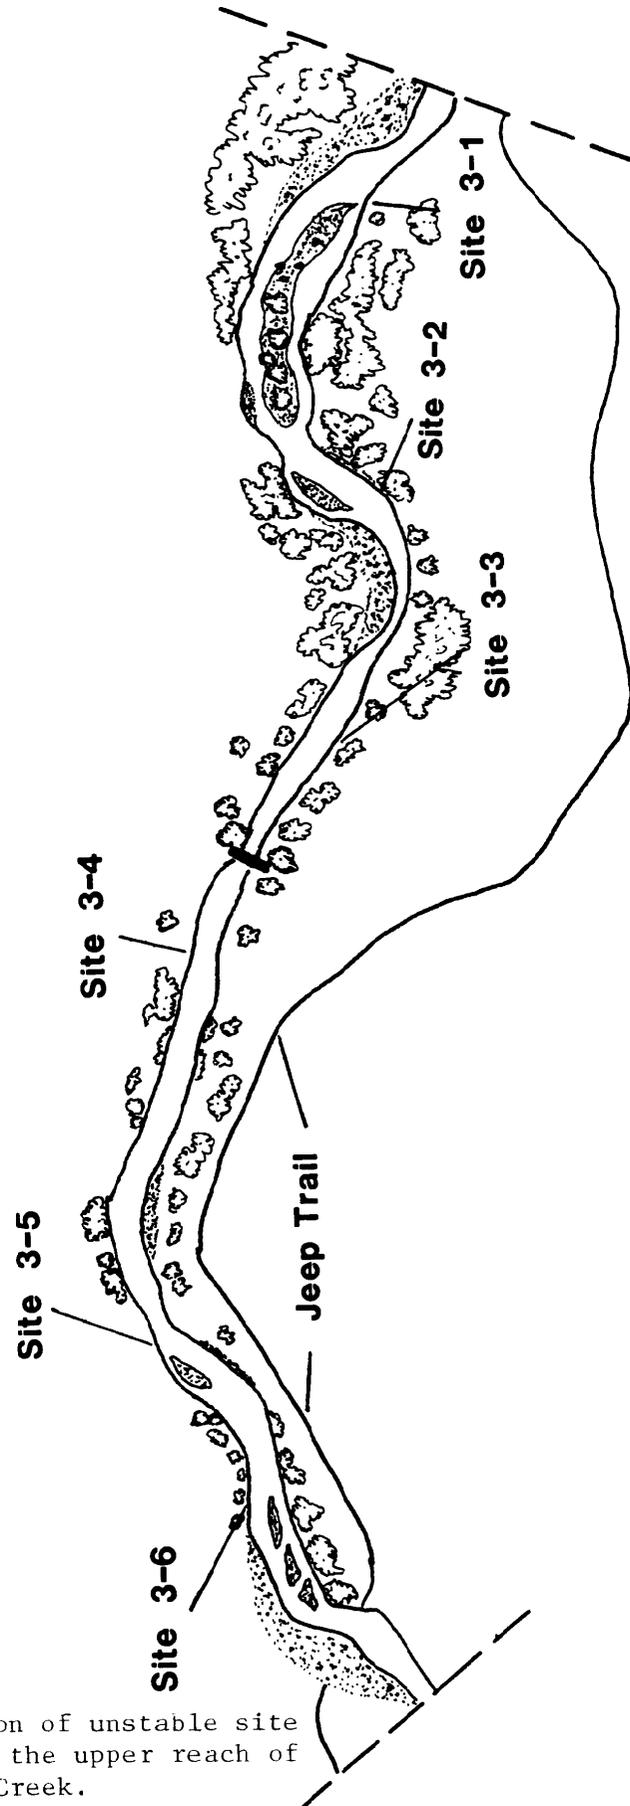
Figure Location of unstable site within the upper reach of Camas Creek.

The upper reach on **Camas** Creek in the Meyers Cove area (Fig. 5) extended from just above the confluence of Silver Creek upstream to a point where the jeep trail crossed Camas Creek. The length of this reach was approximately 2,792 feet and the stream channel was characterized by braided sections, wide shallow sections, and an area where the channel had divided forming a vegetated island. The immediate streamside zone is presently protected by a fence installed during 1984 and 1985. This reach of stream also has an old bridge designed to convey animals and equipment across Camas Creek during periods of high water. At present the bridge structure is in a state of disrepair and

will have to be removed. General stream side and channel conditions reflected heavy livestock use and the influence of high runoff stream energies (Table 4).

Table 4, Camas Creek upper reach stream channel and riparian zone inventory. Reach length was approximately 2,792 feet. Bank location referenced facing upstream.

Site	Location	Length (ft)	Height (ft)	Comments
3-1	Left bank	180	4	This area is below a diversion in the channel which forms a vegetated island; this site is an outside bend with active cutting and sloughing; stream bank materials are small and streamside vegetation is primarily sod forming grasses.
3-2	Left bank	75		This site is at a watering area associated with a corral area; the stream has recently uprooted several willows; there is silt being deposited in the slower water areas immediately below.
3-3	Right bank	95	4	active stream cutting below bridge; area has some vegetation in the form of willow and alder which may provide revetment in time.
3-4	Left bank	210	2-4	major section with active cutting; this is just above present bridge and the instability is threatening the bridge; larger bank rock materials
3-5	Right bank	48	2	small section of bank with intermittent sections of bank cutting; there is also some sloughing that has occurred

3-6	Right bank	46	5	This site has a section of bank that is cutting as a result of flows being deflected off of several channel bars; at present several large willows are providing some protection.

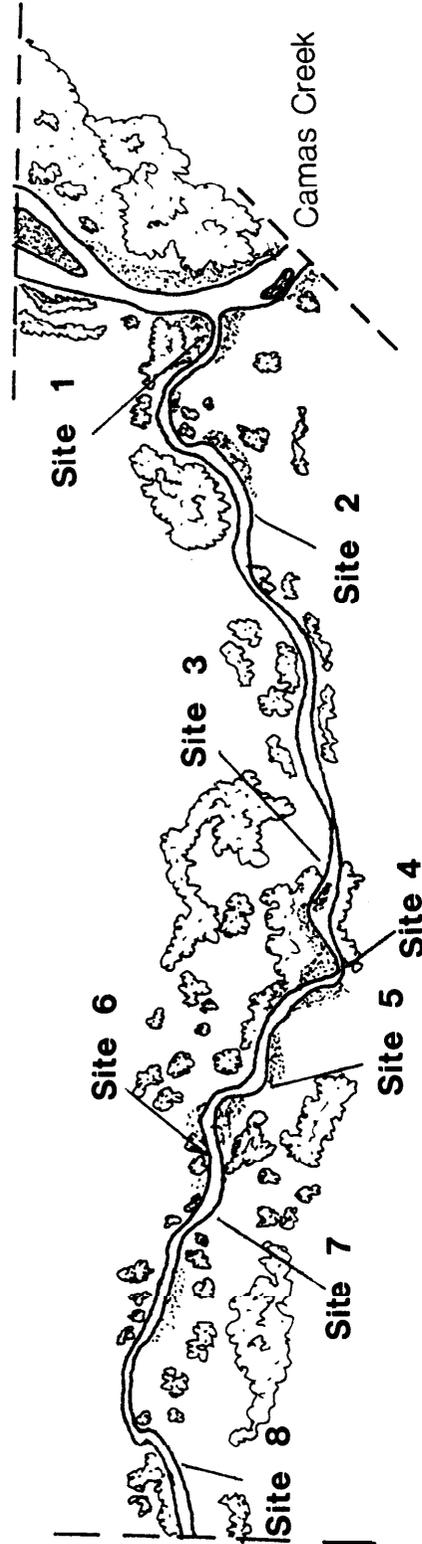
Figure 6. Lower reach of the West Fork Camas Creek with unstable sites.

The West Fork was a major tributary that flowed into Camas Creek in Meyers Cove area. To aid in the inventory process, this stream was divided into two reaches; the lower being 2,900 feet in length (Fig. 6), and the upper reach extending an equal distance upstream (Fig. 7). Within these two reaches, 19 separate sites having unstable bank conditions were identified (Table 5). These areas of instability were basically similar to those encountered in Camas Creek, with the exception that channel conditions **along** the West Fork showed the influence of channel scour to a much greater degree. The high intensity runoff event of the early 1970's forced the West Fork channel into a condition of disequilibrium. The resulting condition was typified by areas of channel bank cutting and gravel aggregation. Riparian vegetation recovery has been retarded to a degree as a result of heavy livestock use. Present vegetative condition and abundance along the West Fork has been insufficient to provide adequate natural revetment of the stream channel. The cover component of **the** habitat in the West Fork was also being impacted by the lack of adequate riparian **vegetation**.

Table 5. West Fork Camas Creek stream channel and riparian zone inventory. Each reach was approximately 2,900 feet in length with the total inventoried area being 5,000 feet. Bank location referenced facing upstream.

Site Location	Length	Height	Comments
Lower Reach			
1-1 Mouth of the West Fork	204	9	left bank at mouth with substantial cutting; gravel deposition evident and resulting in 2-3 braided channels; bank materials generally small and easily eroded; limited riparian vegetation
1-2 Left bank	264	4-7	major unstable bank area on stream bend; area of cut is vertical in nature
1-3 Right bank	120	--	This site has an area of old channel cutting; recovery is in process and the bank is being influenced by a channel bar that is diverting the stream flow.
1-4 Left bank	27	10	cutting streambank at an approximate 45° angle; limited revetment being provided by old cottonwoods
1-5 Left bank	44	3	unstable area that is in the process of recovery; large fallen cottonwood is parallel to channel and is providing protection from livestock
1-6 Right bank	67	4	Bank is primarily gravel with very little vegetation.
1-7 Left bank	84	5	Banks are nearly vertical with minimal vegetation; stream is flow along toe of canyon slope.

1-8 Left bank	200	--	area of old cutting; stream flow is being diverted away from channel bank by gravel bar; area is slowly recovering.
1-9 Right bank	21	6	45° cut slope; channel braids through this area; some bedrock is present.
Left bank	58	--

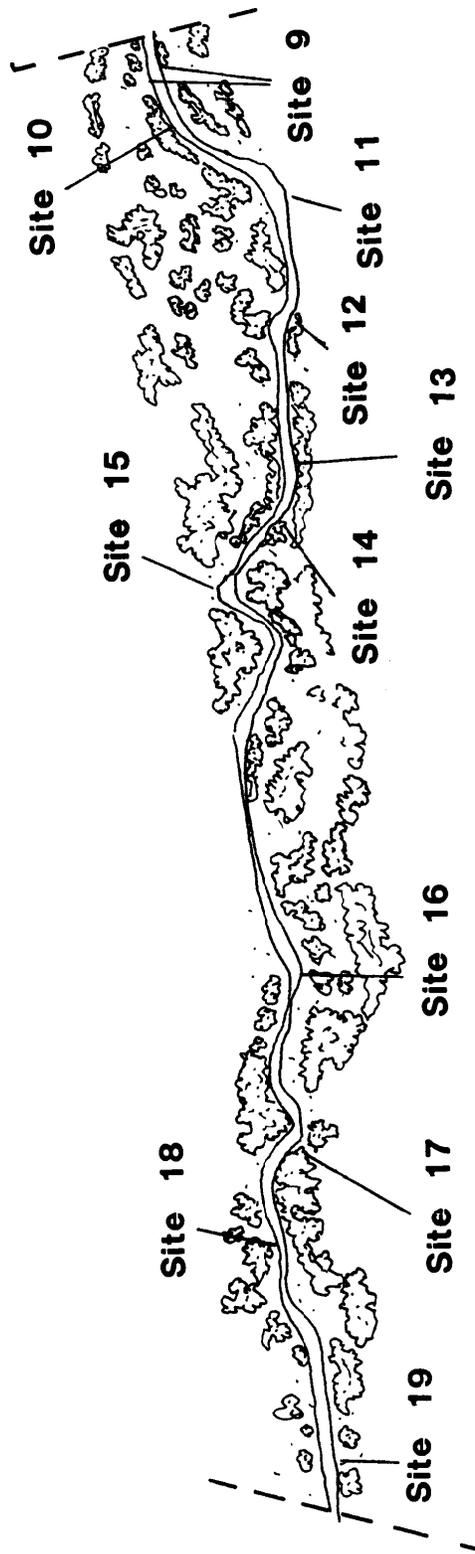
Figure The upper inventoried reach of the West Fork of Camas Creek with 11 sites identified as unstable.

Site Location	Length (ft)		Height (ft)	Comments
1-10 Right bank	155	4-6		This site is comprised of both past and present cutting.
1-11 Left bank	12	5		This site is just upstream of 1-10 in a relatively straight section of stream; has been influenced by livestock crossing.
1-12 Left bank	18	--		Livestock and vehicle crossing area; very gentle slopes
1-13 Left bank	210	up to 25		significant section of unstable bank; 45-60° slope
1-14 Left bank	56	--		unstable site with much livestock use
1-15 Right bank	23	2-4		heavy livestock use area; much woody debris evident as a result of past beaver activity
1-16 Left bank	108	3		area of old channel cutting; bank is presently isolated away from stream flow; recovery taking place
1-17 Left bank	400-500	7		area of old channel cutting; only a portion of flow is influencing this area; some stability is returning
1-18 Right bank	300-500	5-7		site has isolated channel section that was cutting; recovery in progress; bedrock channel control evident

1-19 Right bank	8	8		small section with active cutting

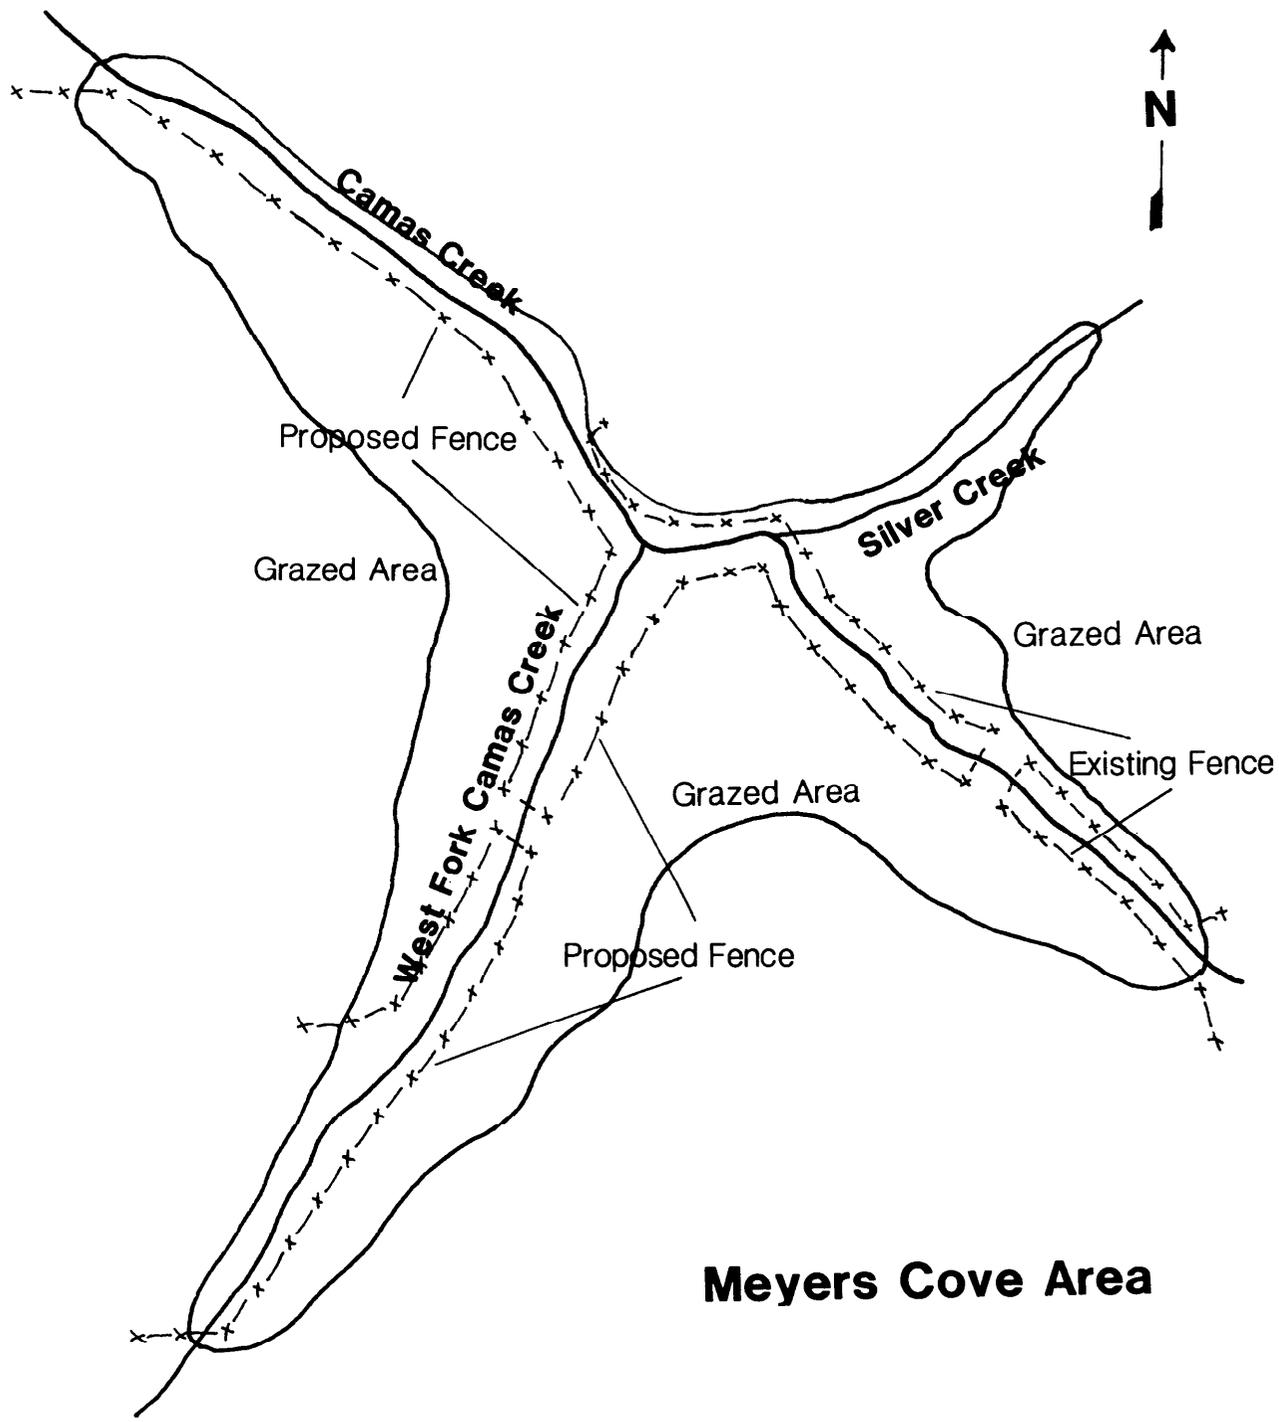
Figure 8. Proposed and existing fencing in the Meyers Cove area needed to coordinate grazing use and protect riparian resources.

Enhancement Activity 1 -- Isolate riparian/streamside zone from grazing areas by fencing (Fig. 8). This option would allow vegetation to become established in greater abundance. Direct bank disturbance would also be eliminated and habitat conditions would improve. It is anticipated that additional abundance of vegetation within the streamside zone would serve to lessen sediment delivery to the stream. cost estimates include materials, labor and administration.
