Natural Propagation and Habitat Improvement

Volume II - Idaho

Annual and Final Reports, 1985

LOCHSA RIVER TRIBUTARIES ENHANCEMENT PROPOSAL

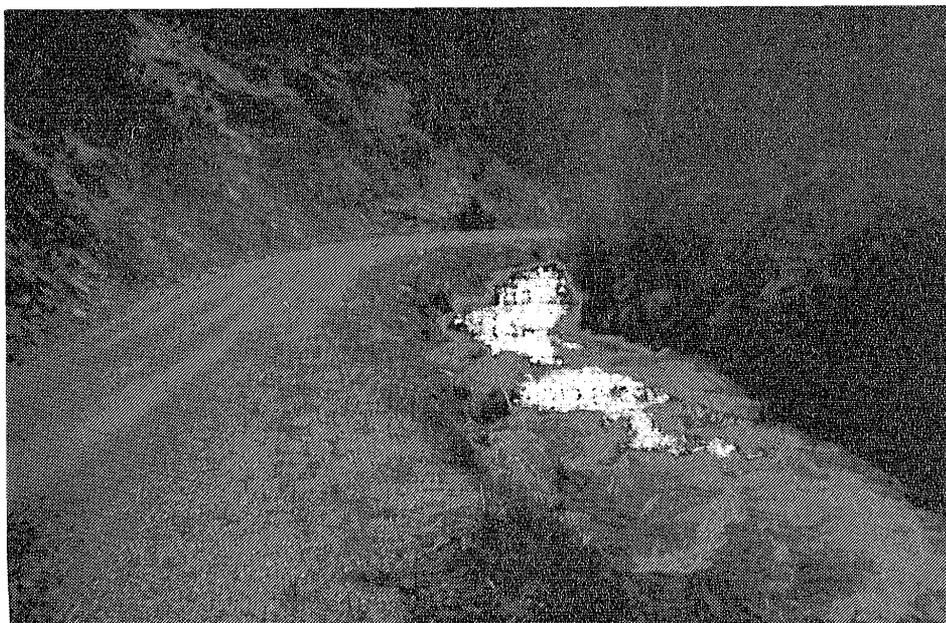
streams. The roads encroach upon Squaw and Doe Creeks, respectively, in many areas (Fig. 3). On Squaw Creek several road crossings have occurred in the past with very little regard to stream habitat (Murphy and Metsker 1962). A similar scenario exists in the Papoose Creek drainage. Logging has been occurring in this basin since the early 1950's. Forest Service Road 568 encroaches upon the stream in several areas and causes streambank failure or completely eliminates the riparian zone between the stream and road. Road encroachment and its impacts are not as extensive along the mainstem of Papoose Creek in comparison to the road encroachment along Doe and Squaw Creeks. However, the East Fork of Papoose Creek has severe and extensive road encroachment.

Figure 3. Road encroachment.

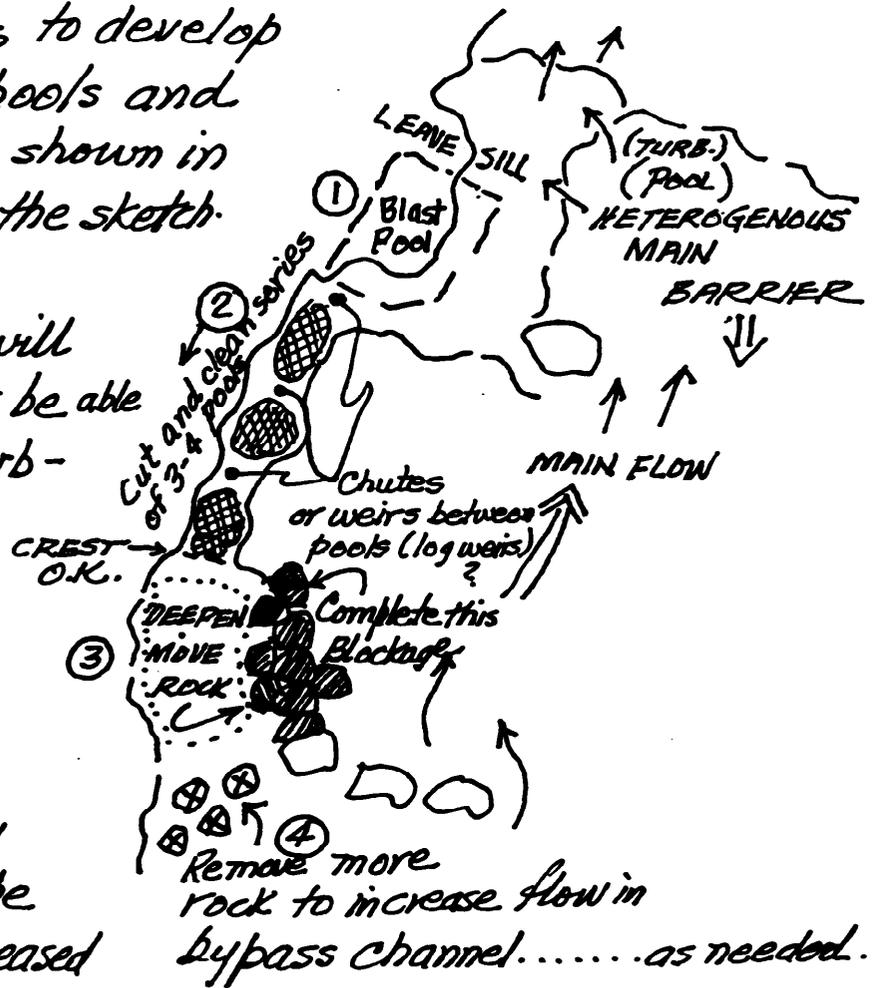
PLAN VIEW OF QUARTZ CREEK BARRIER No. 3

The kokanee will probably not be able to hold in the turbulent pool on the first level of the main barrier, and will fall off into the newly cut pool on the left. The increased flow down the new passage channel

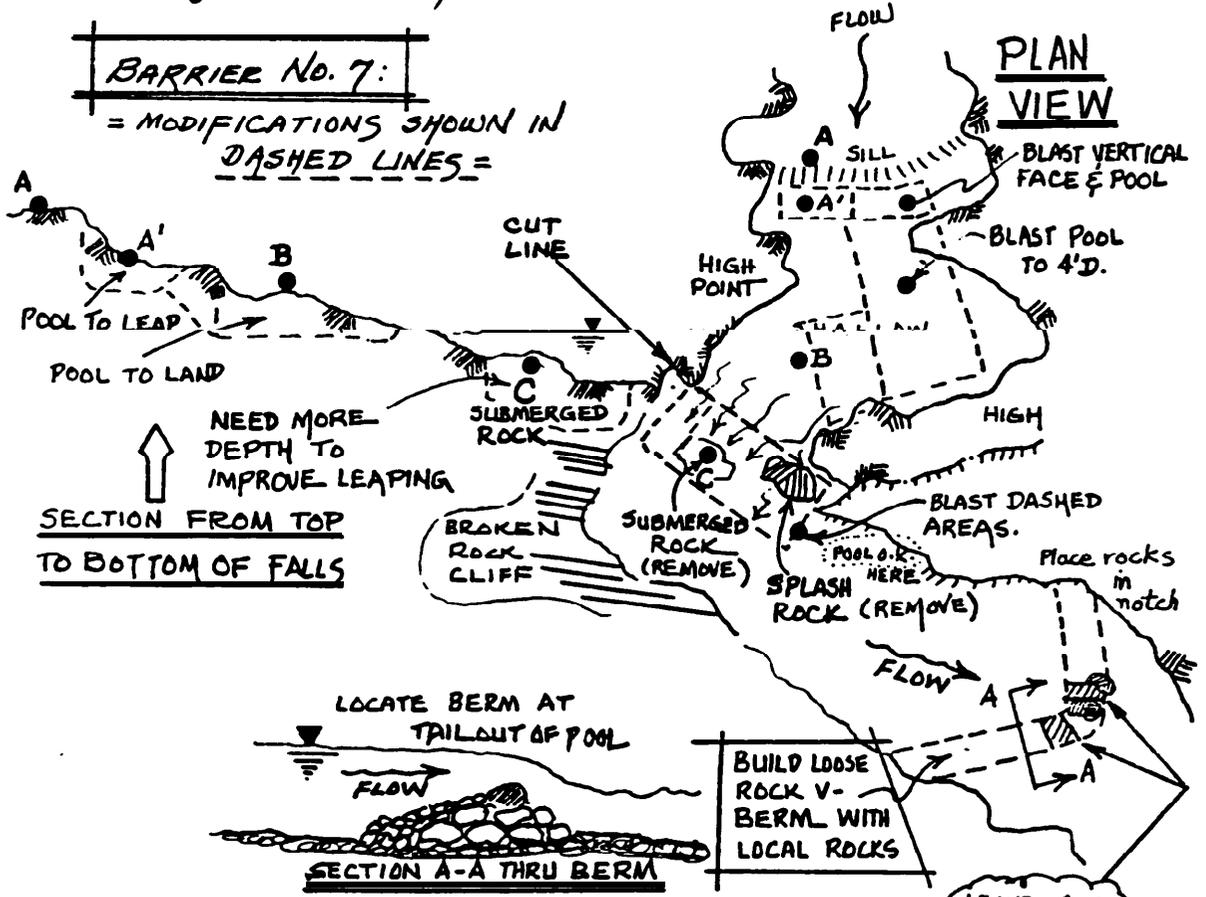
A summary analysis of each of the barriers visited is presented with a plan view sketch and sectional views(s) showing areas which should be excavated or modified in order to assist Chinook past these barriers during lower flow periods.

Beginning at the downstream end of the pool, the following modifications should be made to improve passage conditions at Barrier No. 7:
