1991 Annual Report

North Fork John Day Anadmmamus Fish Habitat Enhancement

Funded By:  
Bonneville Power Administration  
Division of Fish and Wildlife  
Contract No. DE-A179-84BP16725  
Project Number 84-8

January 1992

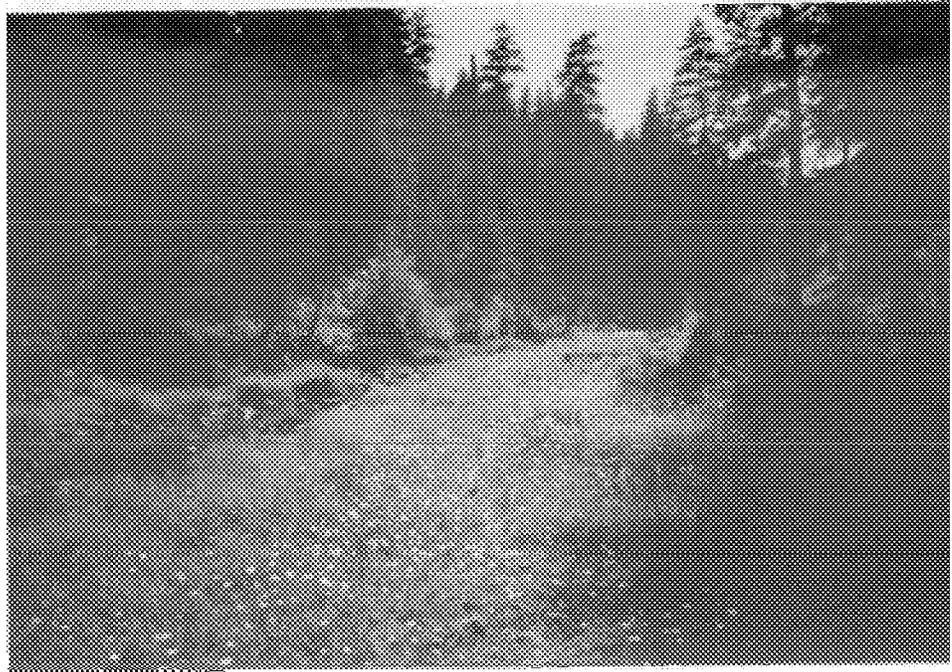
Preconstruction view of a riffle in Big Wall Creek, Note the absence of adequate pools, woody material, and instream boulders.

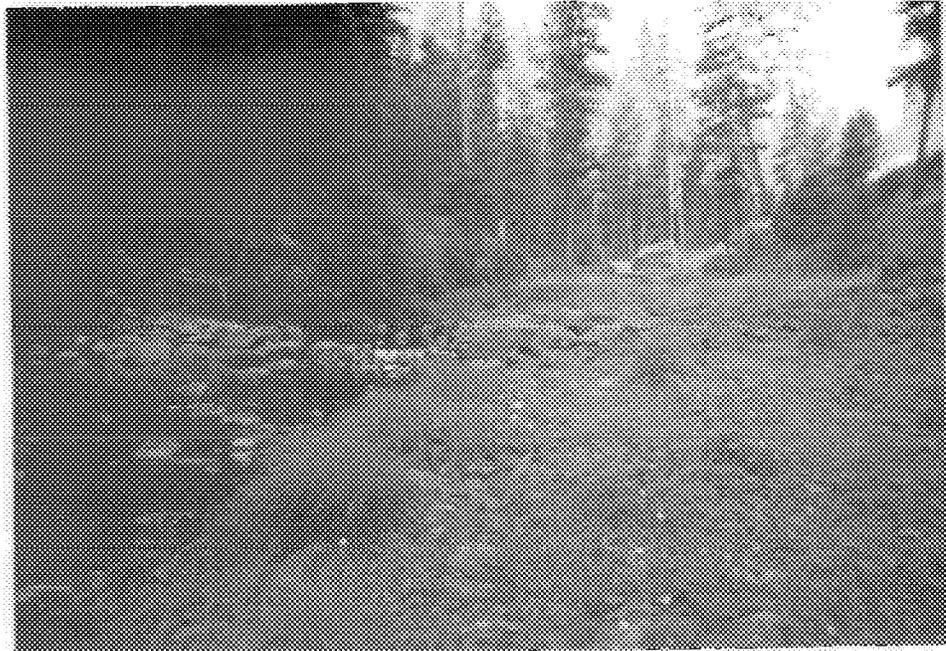
**A post construction view of the previous stream** segment. A pool-creating log weir with rock wings has been constructed. Note the addition of a rootwad for hiding cover.

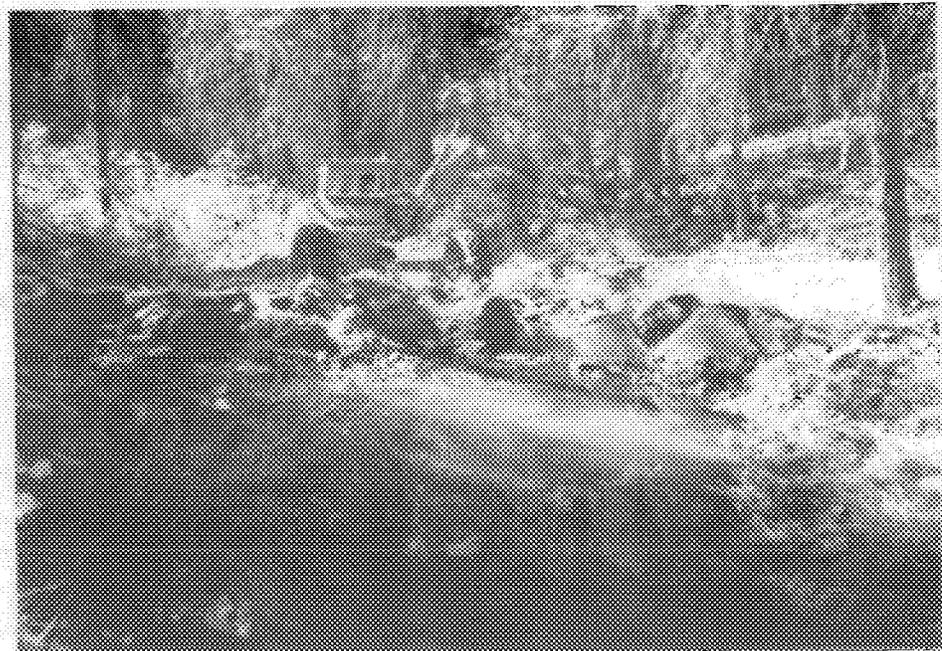
The spider excavator maintaining a rock weir on Wilson Creek. The weir failed to function as designed and was reconstructed to enhance its ability to maintain pool depth. A rootwad was also added to this pool.

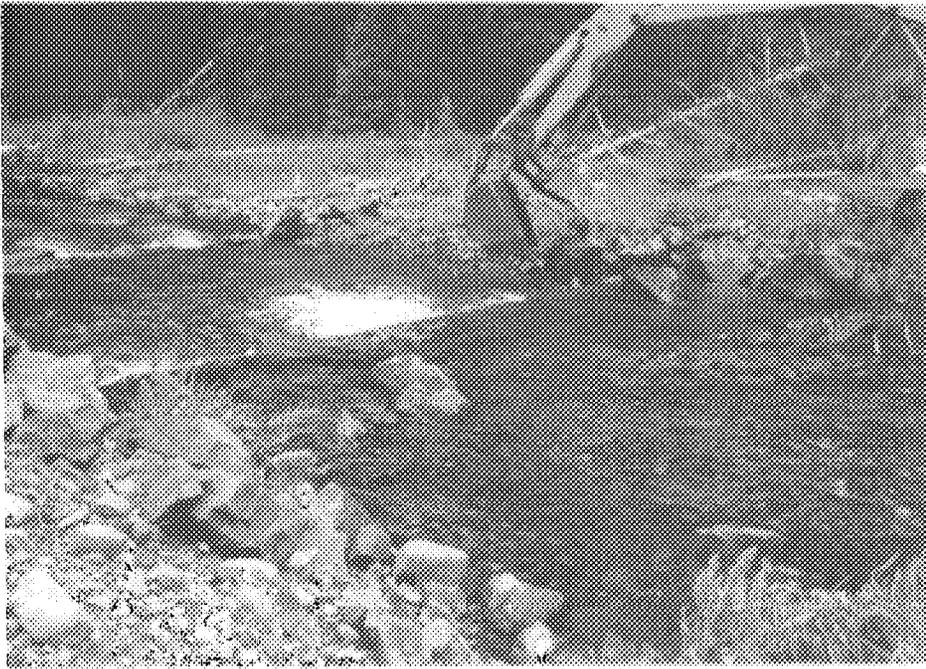
Excavator starting to rework weir on Clear Creek.  
Note the lack of cover and shade.

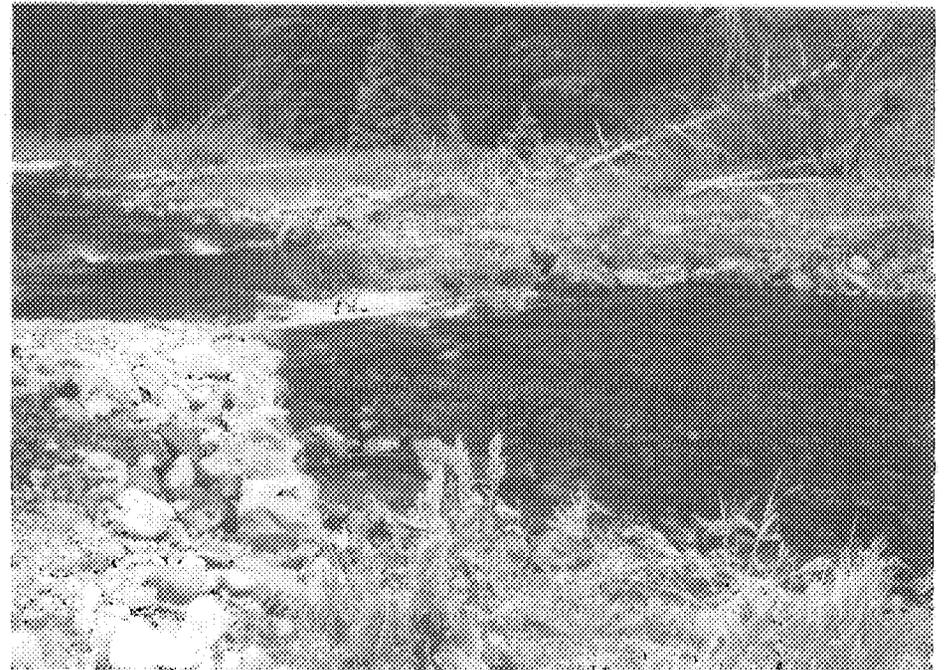
Completed weir with wings built onto it to keep pools dug during high flow. Woody material was added to the pool to provide hiding cover for salmon and steelhead.
