EVALUATION OF JUVENILE SALMONID BYPASS FACILITIES  
AND PASSAGE AT WATER DIVERSIONS ON THE LOWER  
UMATILLA RIVER

**Oregon Department of Fish and Wildlife**

**Project Number 89-24-01**  
**Contract Number DE-BI79-89BPO 1385**

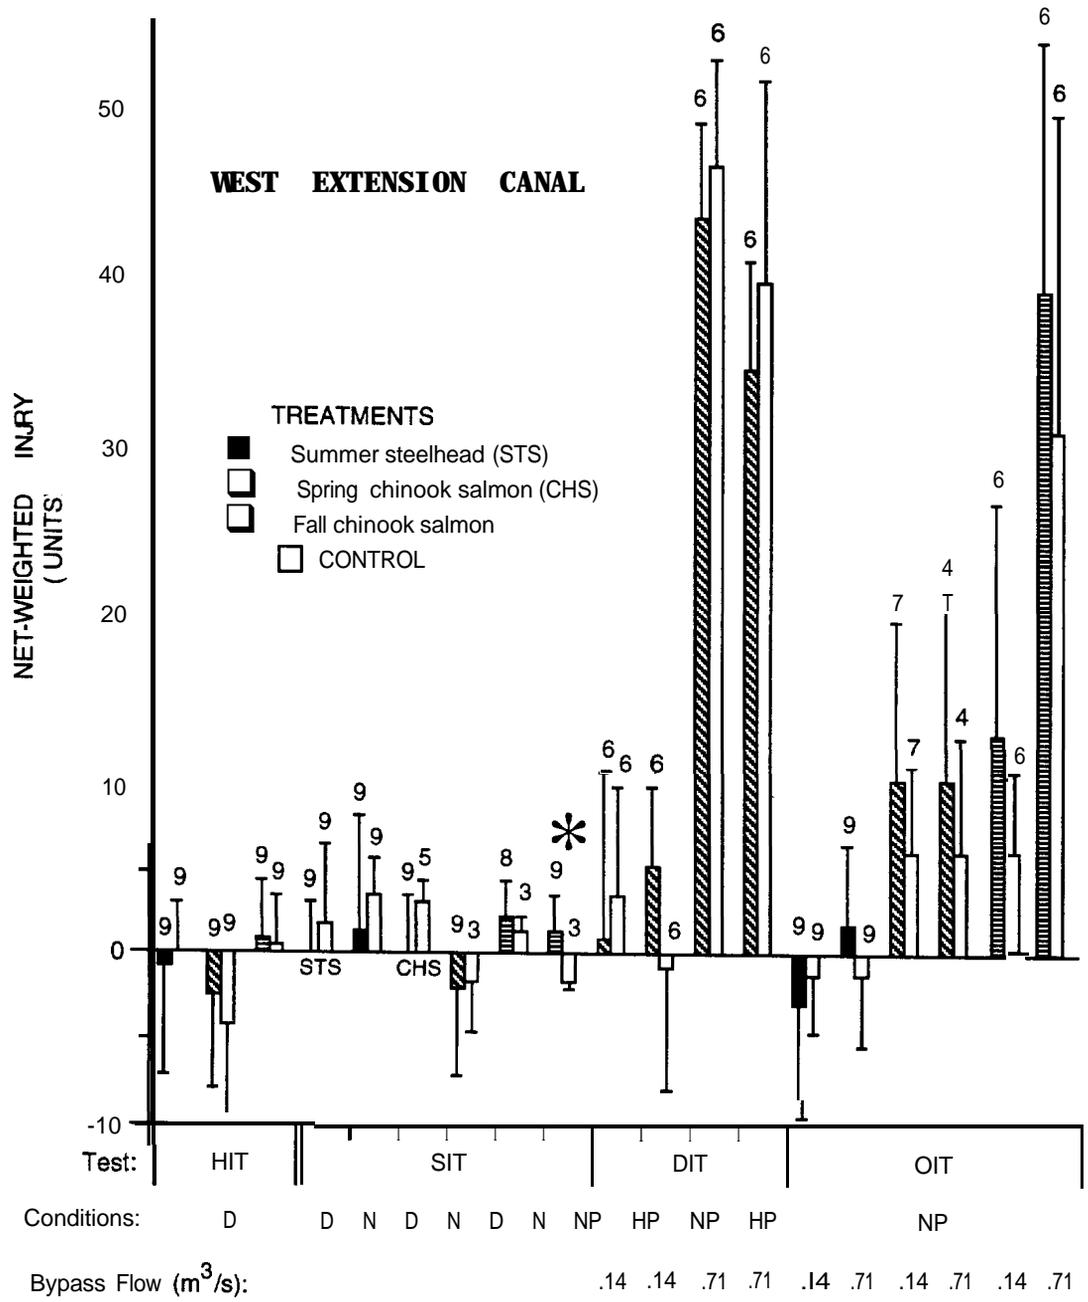
Outfall and downwell injury tests at West Extension Canal were less precise than tests conducted in upper bypasses (Figures 7 and 8). The mean minimum difference in treatment and control injury required for significance ( $\alpha = 0.10$ ) in outfall and downwell injury tests was 8.1 NWI units compared with a mean of 3.0 NWI units for tests conducted in upper bypasses. Even with this constraint, results were nearly significant in outfall injury tests conducted with subyearling fall chinook salmon at a bypass flow of  $0.14 \text{ m}^3/\text{s}$  ( $P = 0.16$ ) and  $0.71 \text{ m}^3/\text{s}$  ( $P = 0.12$ ), in outfall injury tests conducted with spring chinook salmon at a bypass flow of  $0.14 \text{ m}^3/\text{s}$  ( $P = 0.19$ ), and in the high-pool downwell injury test conducted with spring chinook salmon at a bypass flow of  $0.14 \text{ m}^3/\text{s}$  ( $P = 0.14$ ). Probabilities ( $P$ ) were greater than 0.62 in all other outfall and downwell injury tests. Injuries were most severe to fall chinook salmon in outfall injury tests; treatment injury was greater than control injury by 1.3% in full descaling and 12.0% in mortality at a  $0.71\text{-m}^3/\text{s}$  bypass flow and by 9.4% in full descaling and 2.6% in mortality at a  $0.14\text{-m}^3/\text{s}$  bypass flow. For spring chinook salmon, treatment injury was greater than

**Figure 7. Mean net-weighted injury incurred by treatment (filled bars) and control (open bars) fish in varying segments of the bypass facility at West Extension Canal, Umatilla River, Oregon. Sample sizes and significant comparisons (\*) are shown above SD error bars. Tests, relevant test conditions, and bypass flows are shown below the graph (HIT = headgate injury test, SIT = screen injury test, DIT = downwell injury test, OIT = outfall injury test, D = day release, N = night release, NP = normal downwell pool depth, HP = high downwell pool depth).**

control injury by 9.0% partial descaling and 0.4% full descaling in the outfall injury test at a 0.14-m<sup>3</sup>/s bypass flow and 16.3% partial descaling in the high-pool downwell injury test at a 0.14-m<sup>3</sup>/s bypass flow.

Poor precision in outfall and downwell injury tests at West Extension Canal was a probable result of variable injury rates associated with inconsistent trap placement among replicates. Even though outfall and downwell injury tests were not statistically significant, test results suggest some fish are injured in the lower bypass. Injury was consistently higher for treatment fish than control fish in outfall injury tests with spring chinook and subyearling fall chinook salmon. Injuries to spring chinook salmon in the

lower bypass were not severe (partial descaling). However, injuries to subyearling fall chinook salmon in the outfall injury test (descaling and mortality) were the most severe of any of the bypass injury test results. Weaker swimming ability of subyearling fall chinook salmon was the most probable reason injuries were severe. In addition, fall chinook salmon were more prone to injury when bypass flow was high (0.71 m/s). Reduction of flow through the lower bypass when fall chinook salmon are present (late-May and June) should be considered to reduce potential injury. Non-standard operations with a high downwell pool depth did not provide additional protection from injury.

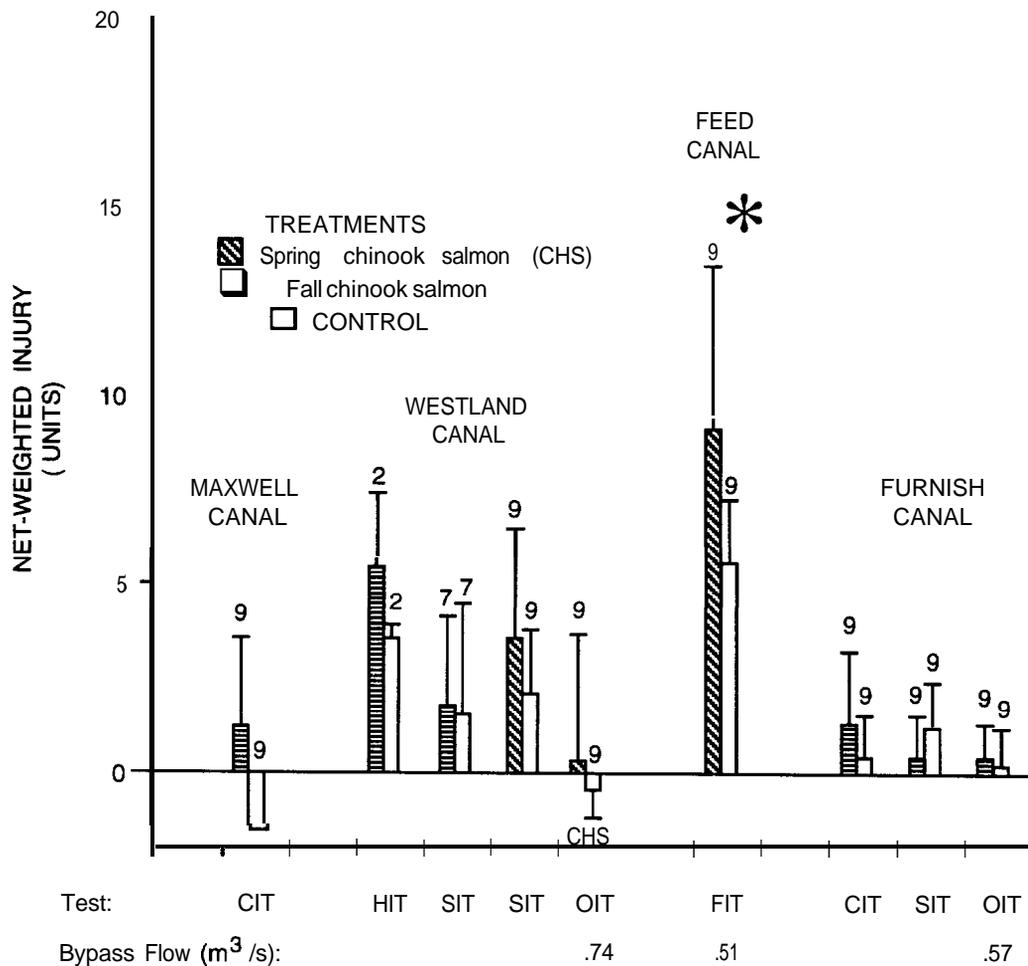
**Figure 8. Mean net-weighted injury incurred by treatment (filled bars) and control (open bars) fish in varying segments of the bypass facilities at Maxwell, Westland, Feed, and Furnish canals, Umatilla River, Oregon. Sample sizes and significant comparisons (\*) are shown above SD error bars. Tests, relevant test conditions, and bypass flows are shown below the graph (CIT = canal injury test, HIT = headgate injury test, SIT = screen injury test, OIT = outfall injury test, FIT = facility injury test).**

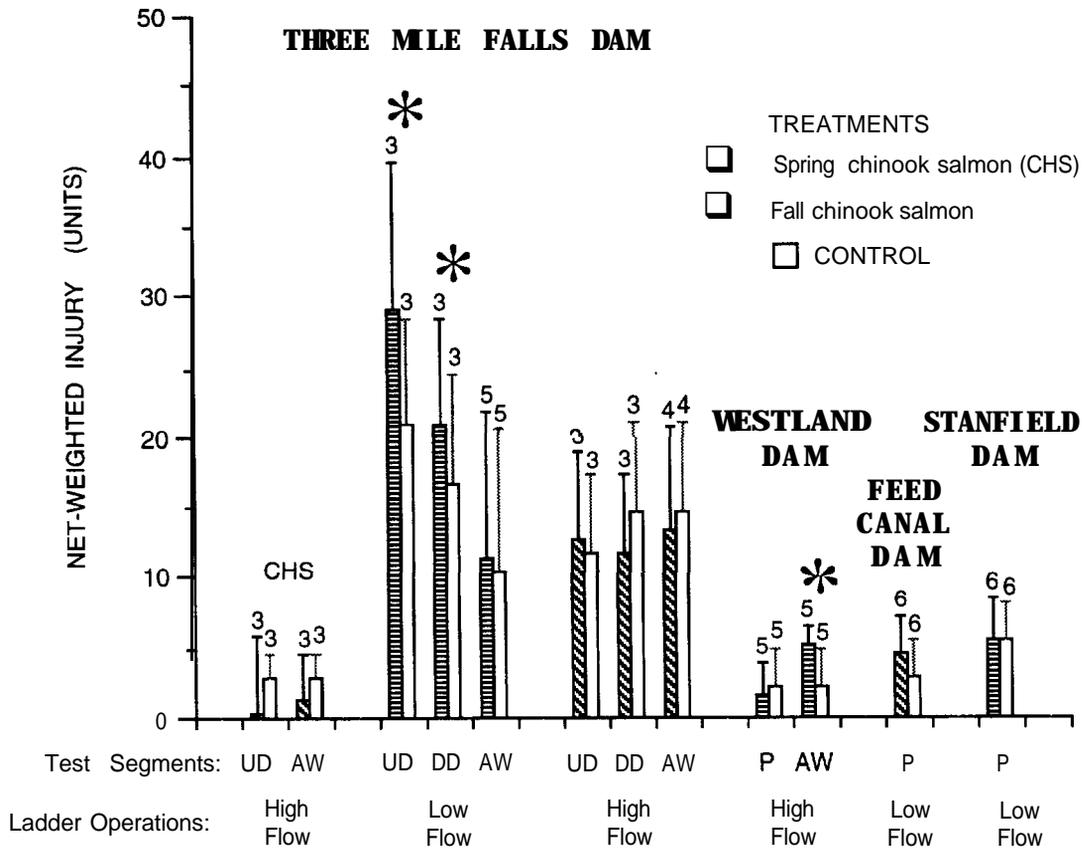
Subyearling fall chinook salmon passing through the auxiliary water system of the fish ladder at Westland Dam received significant injury ( $P = 0.05$ ), whereas fish moving through the passage section did not ( $P = 0.50$ ; Figure 9). Treatment fish in the auxiliary water system incurred greater low partial descaling (7.6%), moderate partial descaling (3.1%), and full descaling (1.4%) than control fish.

Injury was not significant for test fish passing through fish ladders at Feed Canal Dam ( $P = 0.13$ ) or Stanfield Dam ( $P = 0.40$ ; Figure 9). Treatment injury was greater than control injury at Feed Canal Dam by 4.0% in moderate partial descaling and 0.5% in full descaling. At Stanfield Dam treatment injury was greater than control injury by 0.4% low partial descaling, 1.7% moderate partial descaling, and 0.6% full descaling.

**Figure 9. Mean net-weighted injury incurred by treatment (filled bars) and control (open bars) fish in varying segments of fish ladders at Three Mile Falls, Westland, Feed Canal, and Stanfield dams, Umatilla River, Oregon. Sample sizes and significant comparisons (\*) are shown above SD error bars. Tests segments and ladder operations are shown below the graph (UD = upstream of diffusers, AW = auxiliary water system, DD = downstream of diffusers, P = passage section).**

Midchannel diffusers were the most probable cause of injury to juvenile salmonids in fish ladders on the lower Umatilla River. Juvenile salmonids moved safely through the unobstructed passage sections of fish ladders at Westland, Feed, and Stanfield dams. In contrast, injuries were most severe to subyearling fall chinook salmon in the passage section of the ladder at Three Mile Falls Dam. The passage section of this ladder has two sets of midchannel diffusers. Two-thirds of the descaling detected in the passage side of the ladder was associated with diffusers.

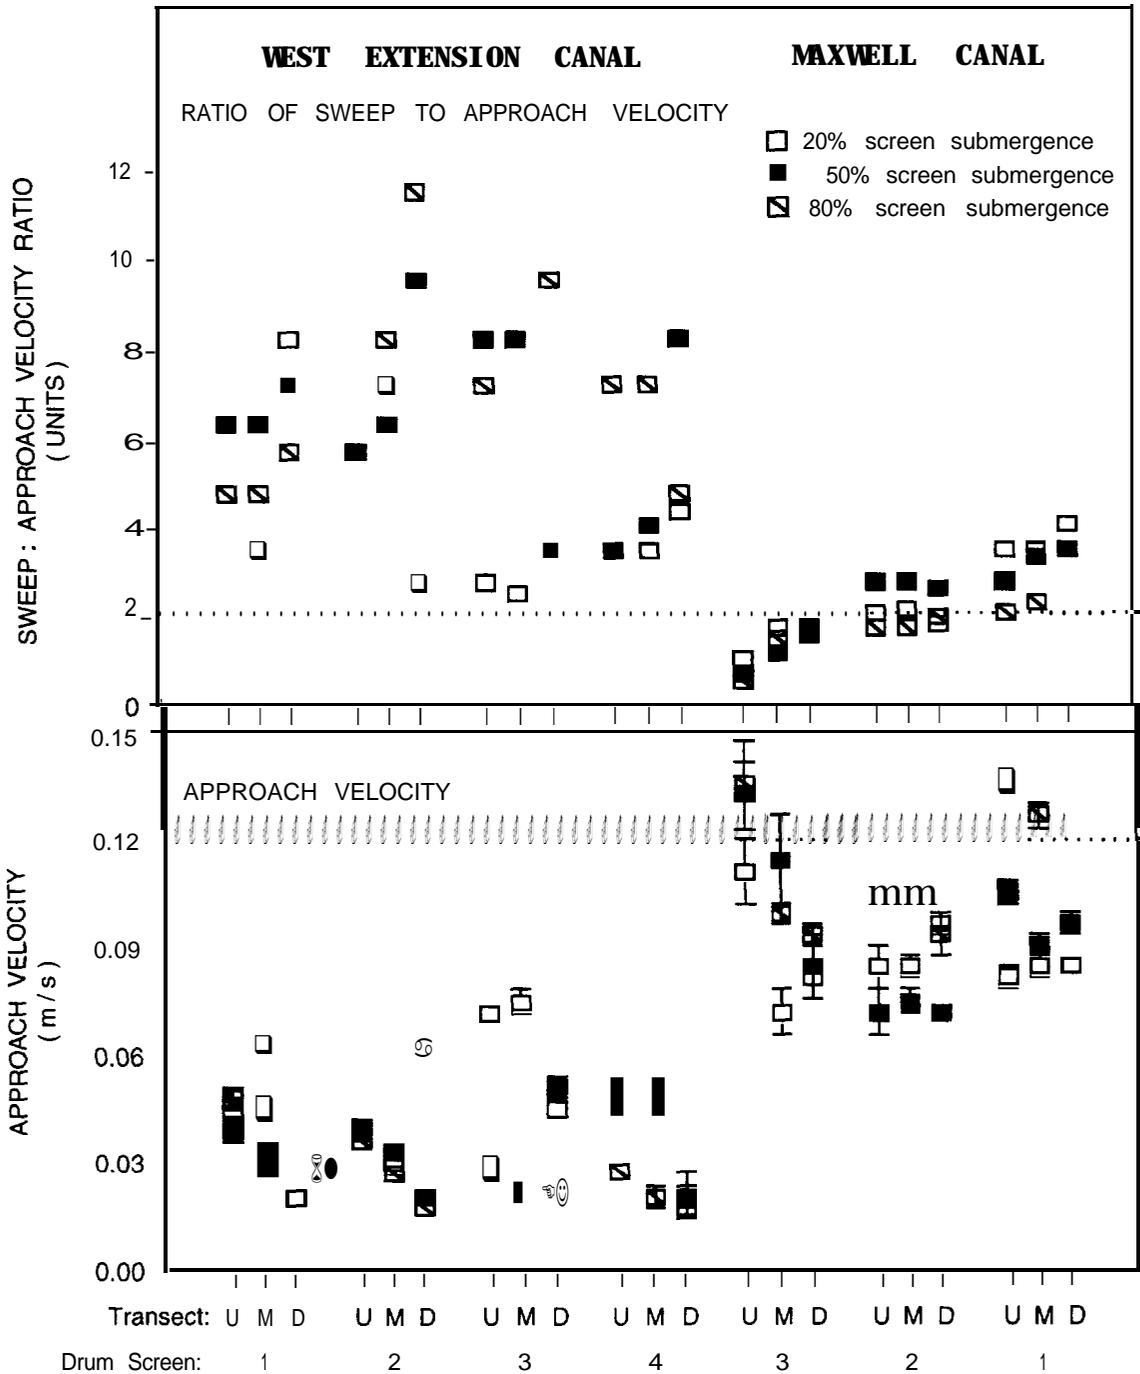
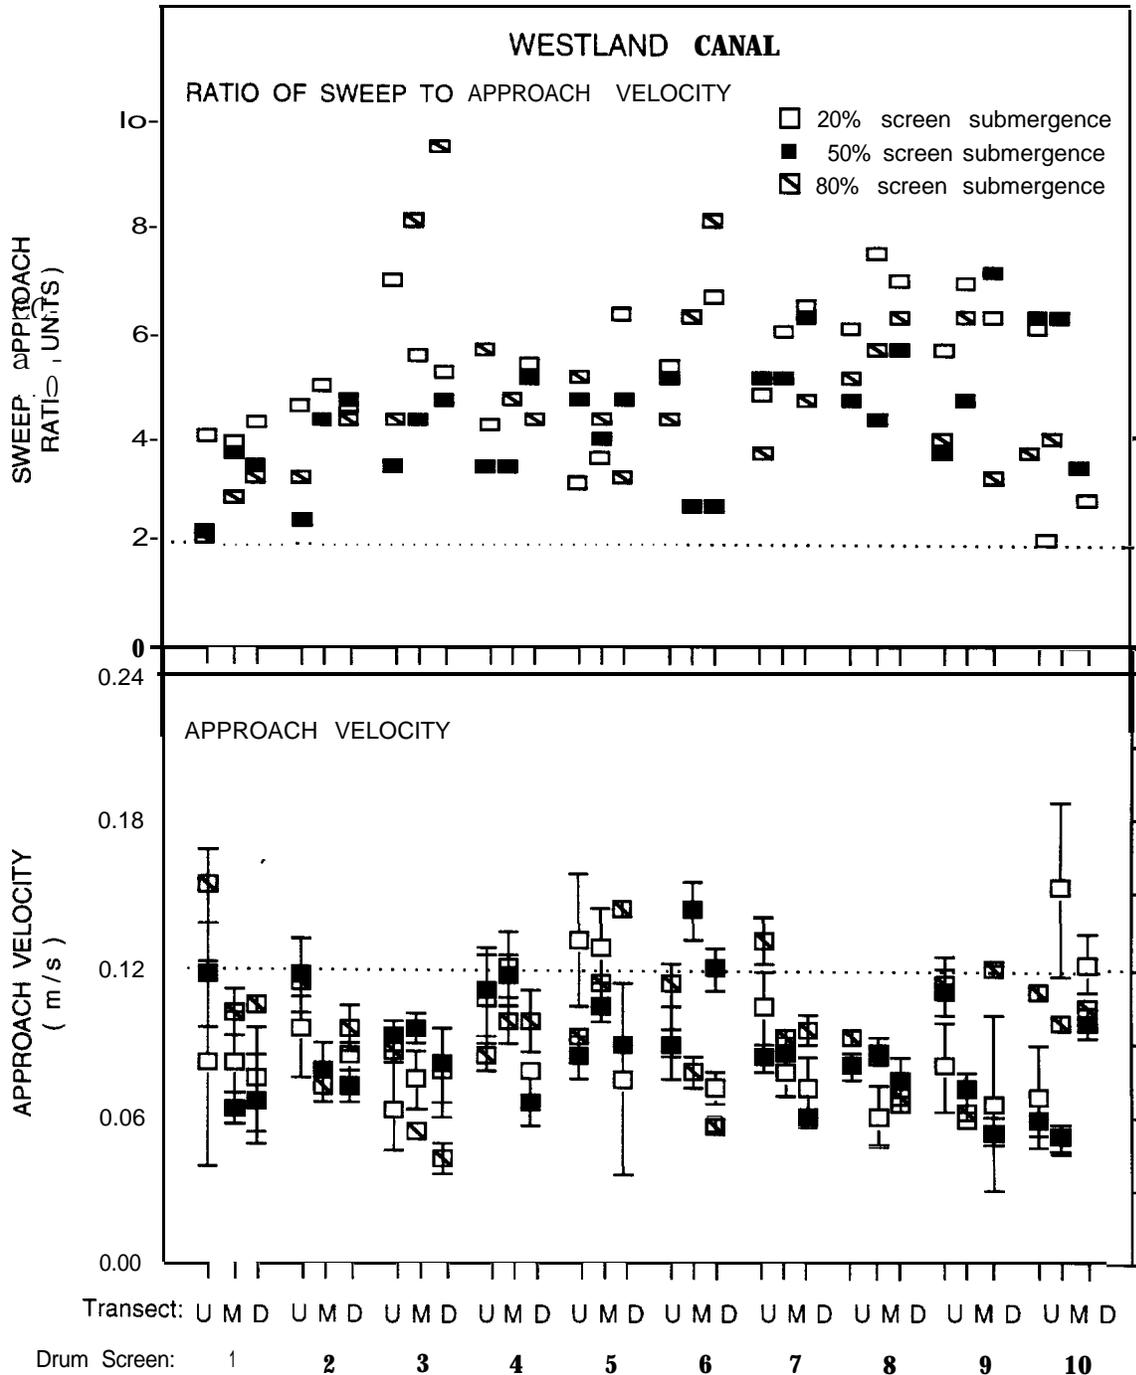
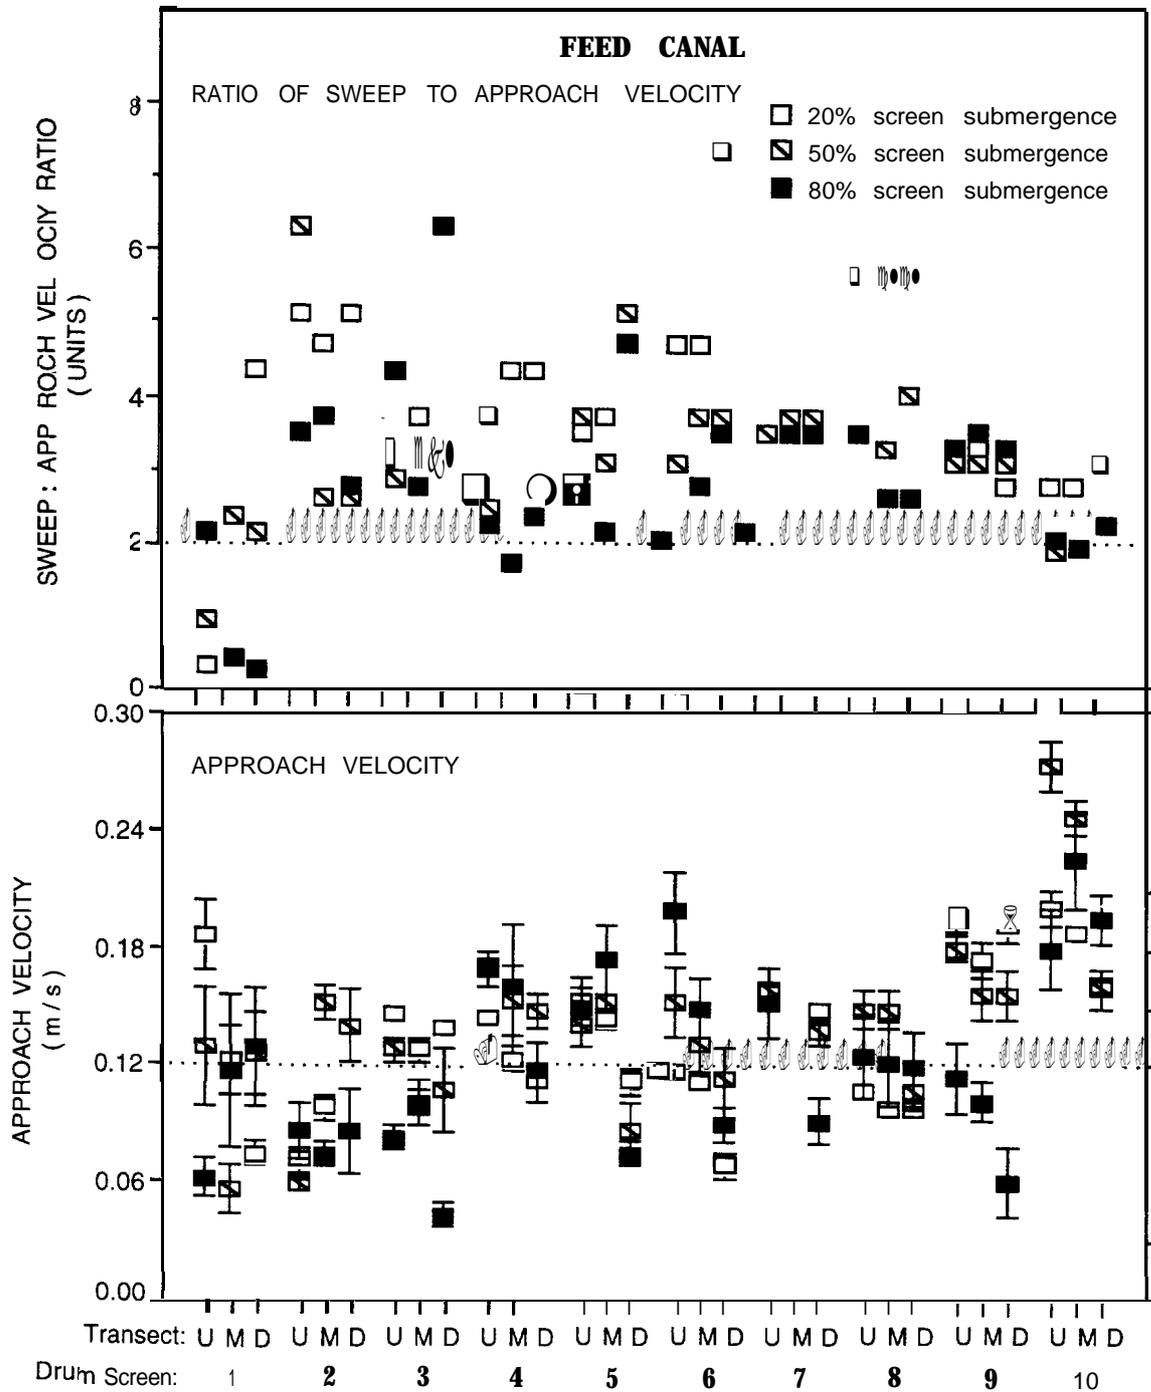
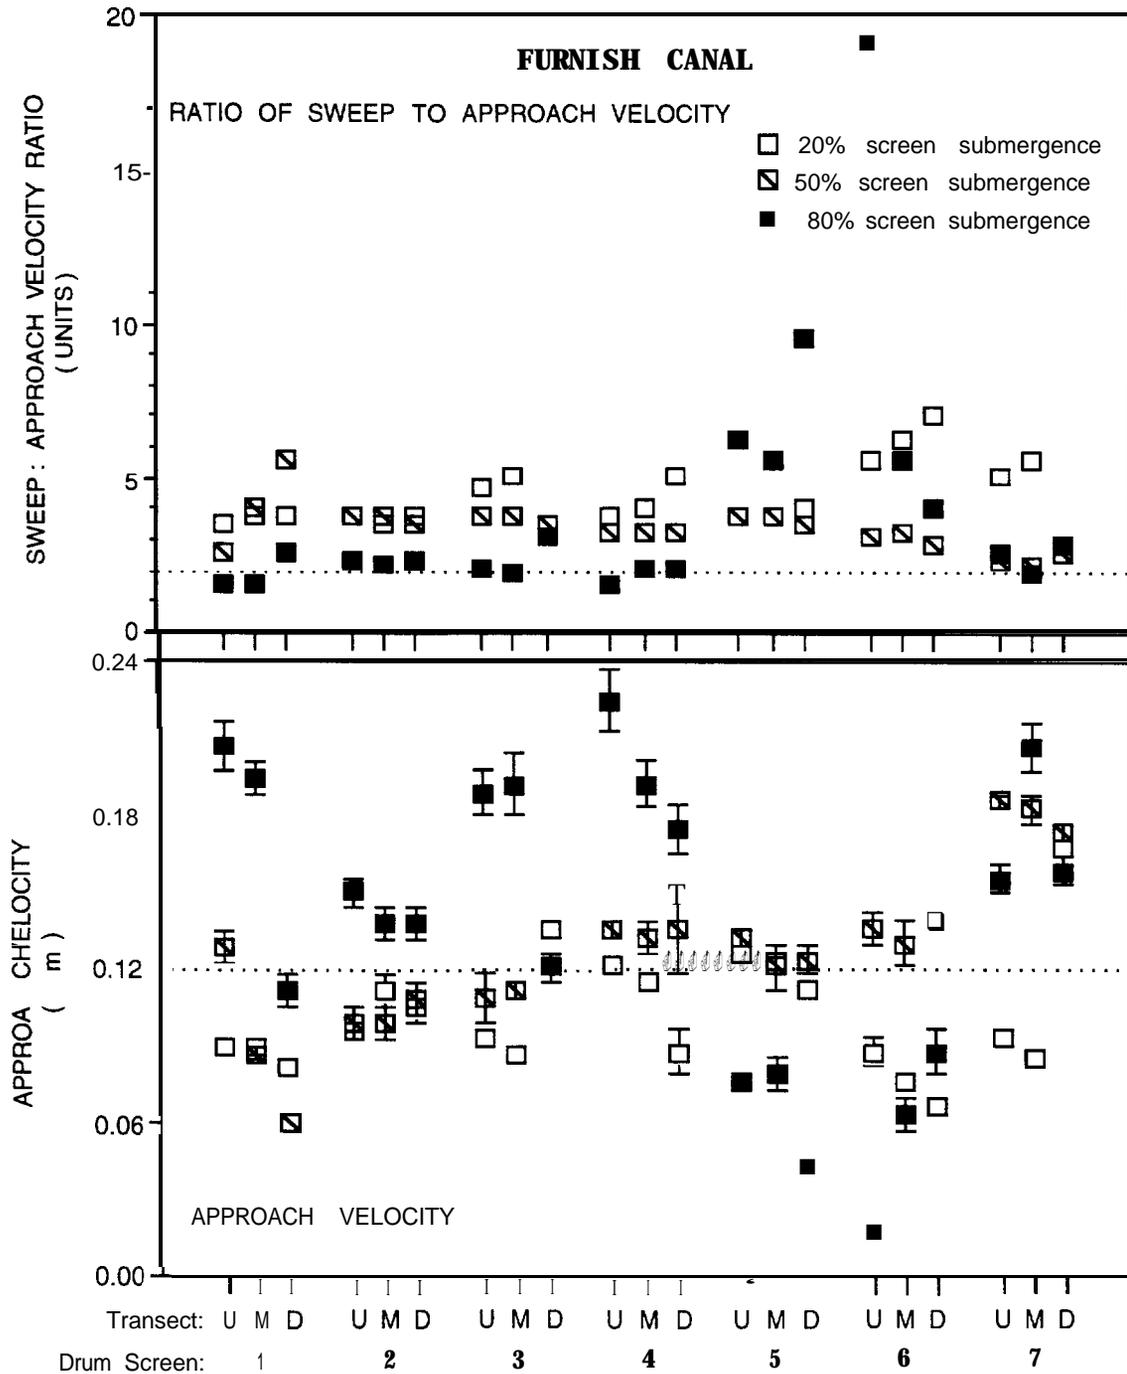
Flow patterns in front of drum screens varied with the number of screens at each site. At sites with seven or ten screens (Westland, Feed, and Furnish canals), the highest approach velocities and lowest sweep to approach velocity ratios were measured at screens at the ends and middle of the screening facility (Figures 13-15). Non-laminar flow increased the variability of measurements in these areas. At West Extension Canal, approach velocities were fairly uniform among all four screens with the exception of a few high readings at 20% water depth near the middle of the screening facility (Figure 12). At Maxwell Canal, approach velocities were generally highest at 50% water depth and at the ends of the three-screen facility.

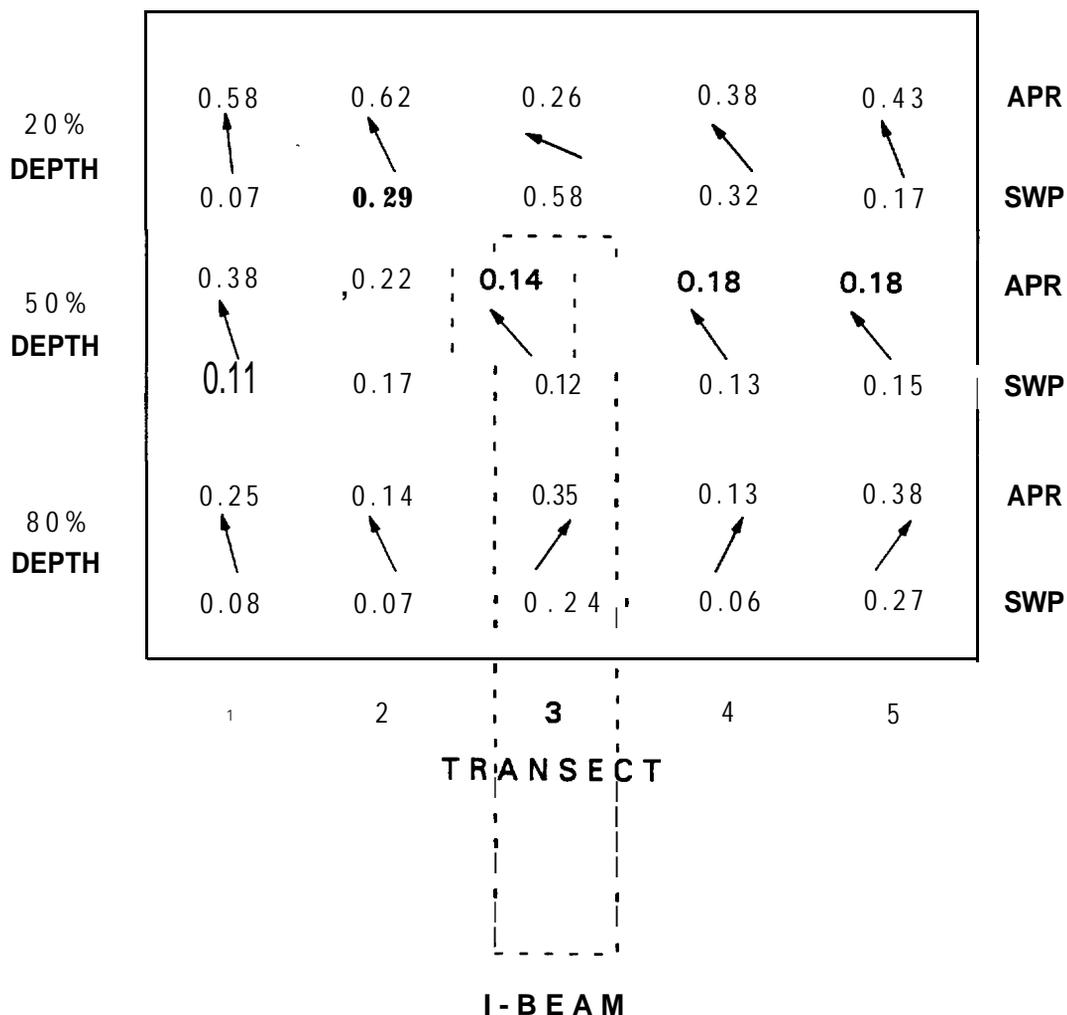
## DIFFUSER 1

**Figure 16.** Approach (above arrows) and sweep (below arrows) water velocity (m/s) measured in front of Diffuser 1 located in the passage section of the fish ladder at Three Mile Falls Dam, Umatilla River, Oregon. Arrows indicate direction of flow. Flow perpendicular to the diffuser is depicted by arrows pointing straight up.

We conducted underwater video work in 1996 that documented large numbers of fish in front of Diffuser 1 (Knapp et al. 1997). Hundreds of fish were observed on numerous occasions following currents across the upstream side of Diffuser 1 and frequently impacting on it. Subyearling fall chinook salmon appeared to impact the diffuser more frequently than the yearling chinook salmon or steelhead, apparently because of weaker swimming ability. These observations are consistent with laboratory experiments indicating normal movement of juvenile salmon is interrupted by vertical bar openings less than 76 mm (Hanson and Li 1983). Current openings are at the maximum design criteria (25 mm) established to prevent gilling of immature adult salmon. Both yearling and subyearling chinook salmon appeared to pass more readily through portions of Diffuser 1 where flow was directed at (rather than across) the diffuser. Fish exit gates were only 55% open when we conducted the injury tests. Partial openings of the gates appear to increase the velocity and turbulence of flow through the gates. Flow patterns in front of the diffuser might be improved by raising the fish exit gates to full open.

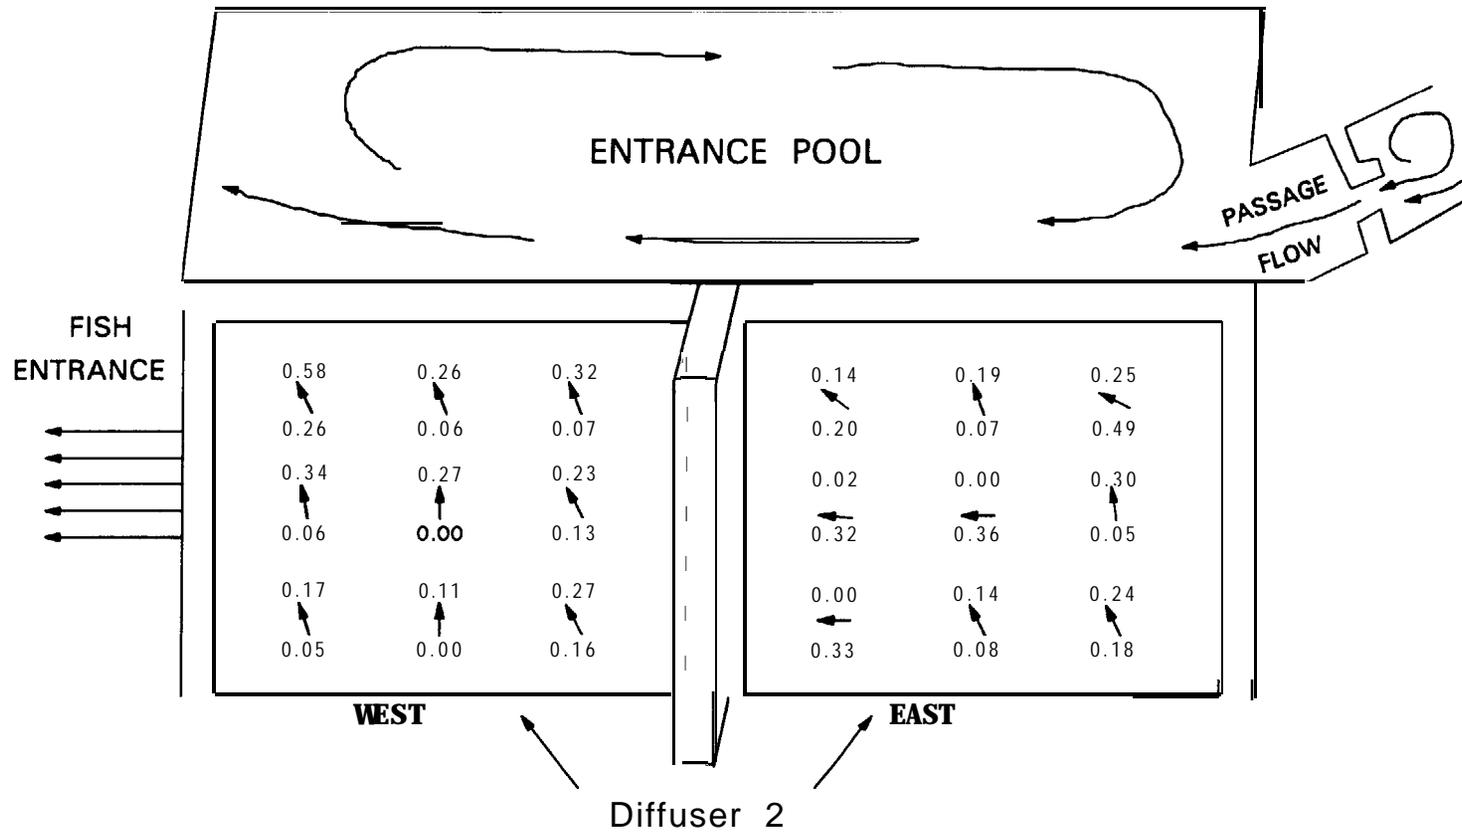
**Figure 17. Approach (above arrows) and sweep (below arrows) water velocity (m/s) measured in front of Diffuser 2 located between the auxiliary water system and entrance pool of the fish ladder at Three Mile Falls Dam, Umatilla River, Oregon. Arrows indicate direction of flow. Flow perpendicular to the diffuser is depicted by arrows pointing straight up.**
