April 2001
**GRANDE RONDE BASIN
FISH HABITAT
ENHANCEMENT PROJECT**

Annual Report 2000

Project No. 8402500

Oregon Department of Fish and Wildlife
107 20th Street
La Grande, OR 97850

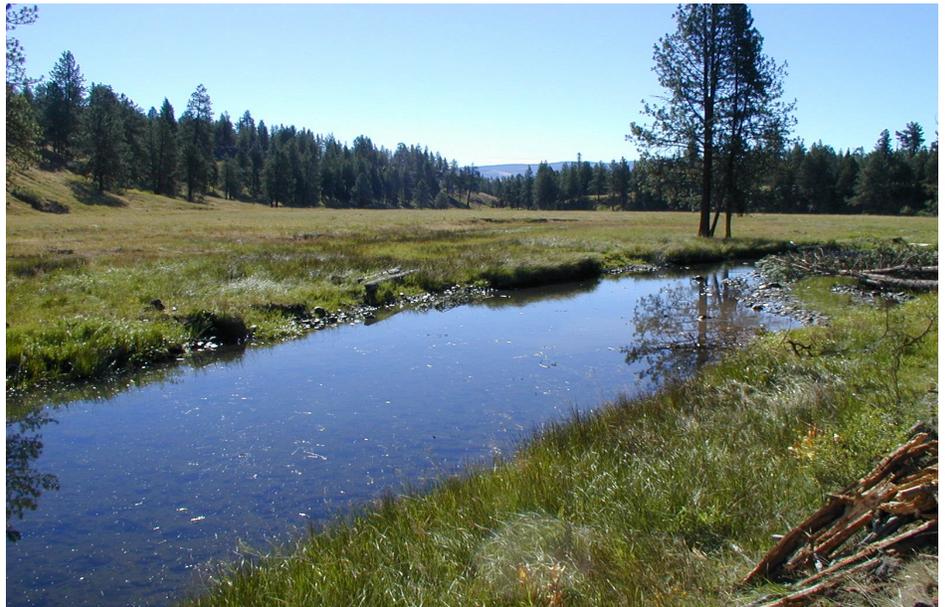
Figure 4. Meadow Creek, Habberstad property, instream work Site 1, from the right bank looking downstream, 7-24-2000. A typical wide, shallow stream channel with very little shade or instream cover. An old meander scar is evident on the far side of the creek.

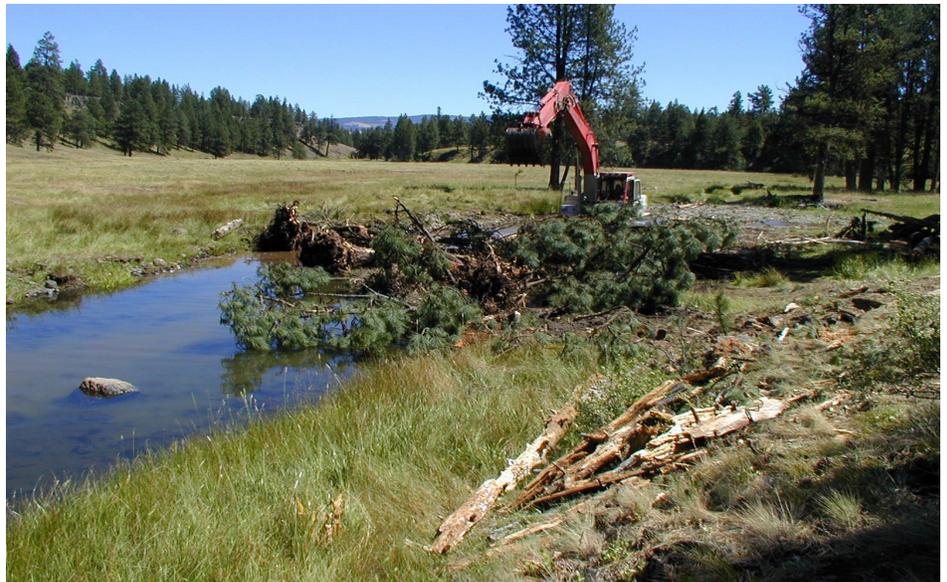
Figure 5. Meadow Creek, Habberstad property, instream work Site 1, 7-25-2000. An Engineered Log Jam (ELJ) was installed to create complex pool habitat and encourage reestablishment of the former meander.

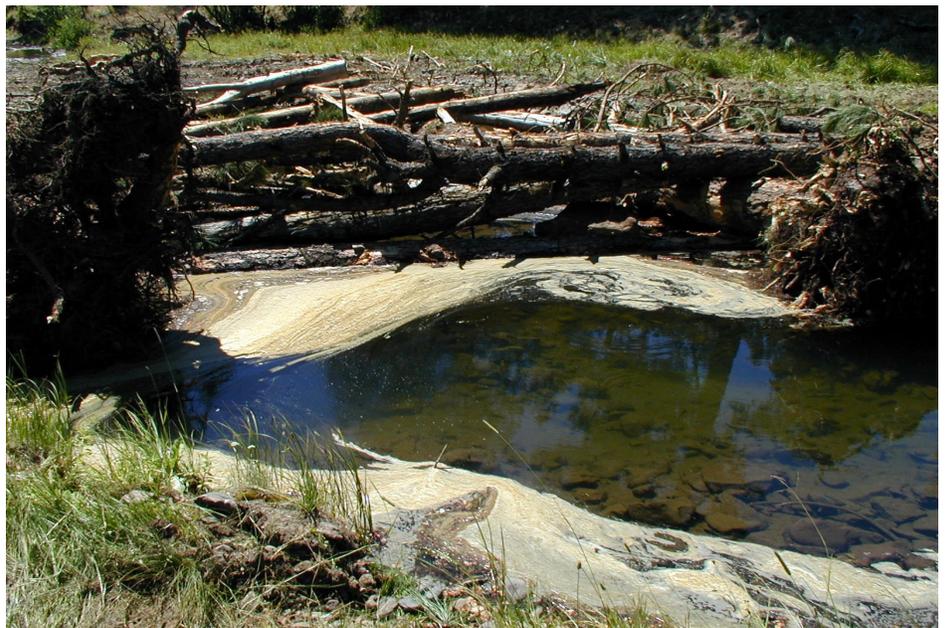
Figure 6. Meadow Creek, detail of the completed structure from the left bank looking downstream, 7-25-2000. Large rootwads facing upstream will encourage scour during high flows and maintain the depth of the excavated pools. Cross members have been cabled together to maintain integrity of the structure and will recruit additional small floating wood. Deposition will occur on the downstream (background) side, and eventually the channel thalweg will move to the left and recharge the old meander.

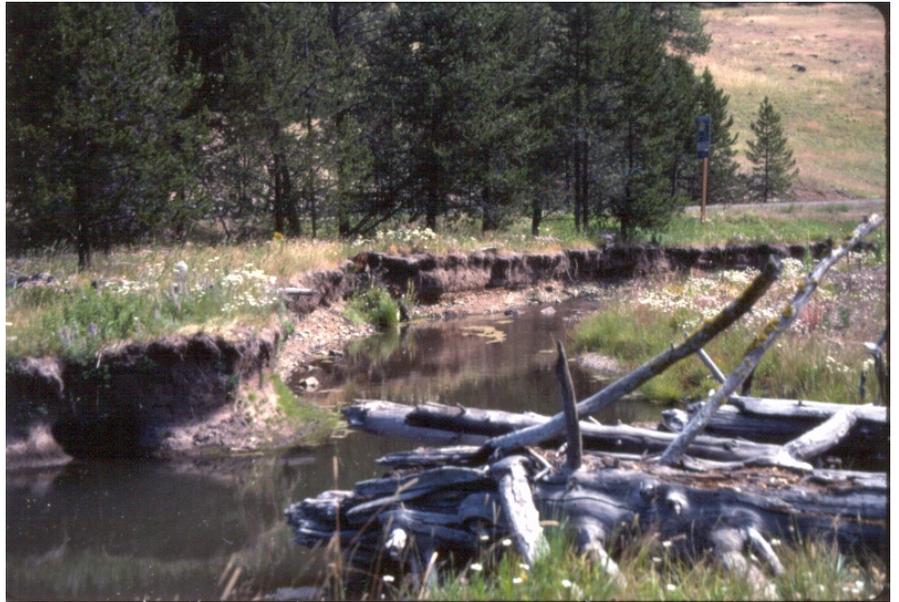
Figure 7. A vertical (6 ft.) eroding streambank on Camas Creek, 8-6-2000. This area was providing poor habitat and producing sediment downstream; if left unattended it would eventually damage Highway 244 in the background.

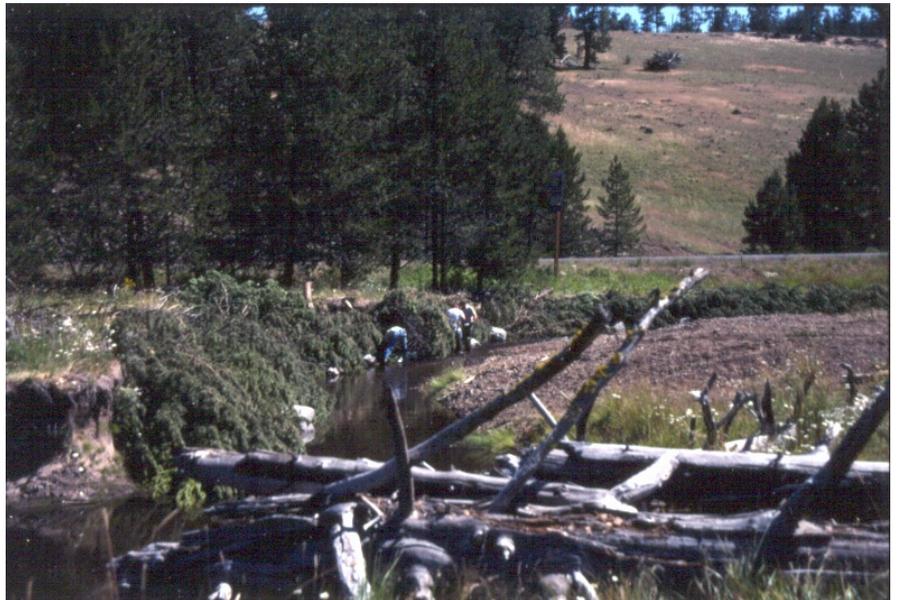
Figure 8. Installation of lodgepole “riprap” at the same site, 8-8-2000. This soft approach will provide both habitat enhancement as well as bank stability, and is a better alternative than rock riprap which would likely have been installed if erosion continued. ODFW personnel cabled or wired trees and toe boulders together for stability during flooding. In the short term the whole trees and boulders provide valuable instream cover for salmonids. Over the years the “riprap” will collect fine sediments and establish seedbeds, allowing new vegetation or planted willow cuttings to become established. The landowner donated all of the trees for this work.

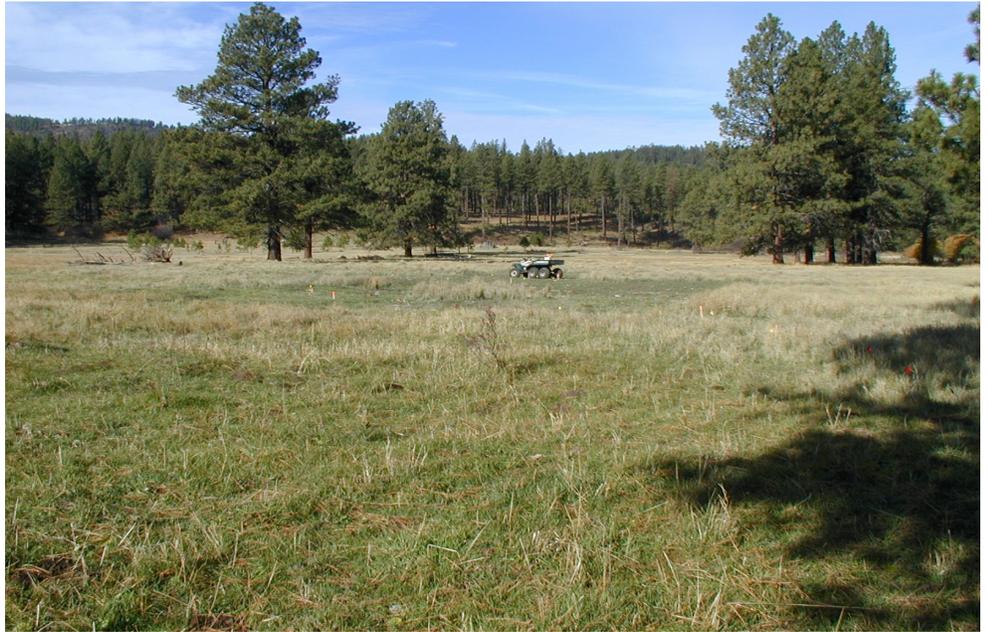
Figure 9. Milk Creek/Hall Ranch project area, October, 16, 2000. This pre-project photo is taken from the upstream end looking northwest. The existing stream channel (not visible) is to the right of the photo and runs in a ditch next to Highway 203. In addition to inadequate fish passage due to an undersized culvert, the current stream channel is artificially steepened, has no meanders and very little pool habitat. Stakes and flags indicate locations of pools and riffles of the new channel. Channel design was based on a Reference Reach section immediately upstream of the project.

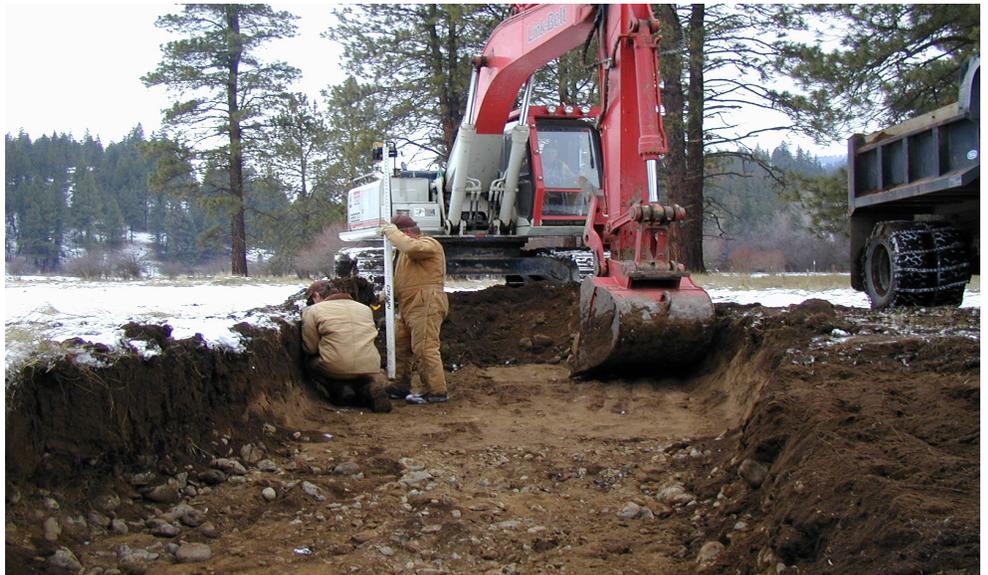
Figure 10. Milk Creek, November 14, 2000. ODFW crews survey in thalweg and bankful indicators near Pool #7 during construction. Ken Coe of Mitrac Construction excavates the initial rough cut and loads spoils into an ODFW dump truck. During the excavation cobbles and gravels are separated from silt/loams and placed into riffle sections where needed. These will act as natural grade control areas and help prevent channel degradation (downcutting).

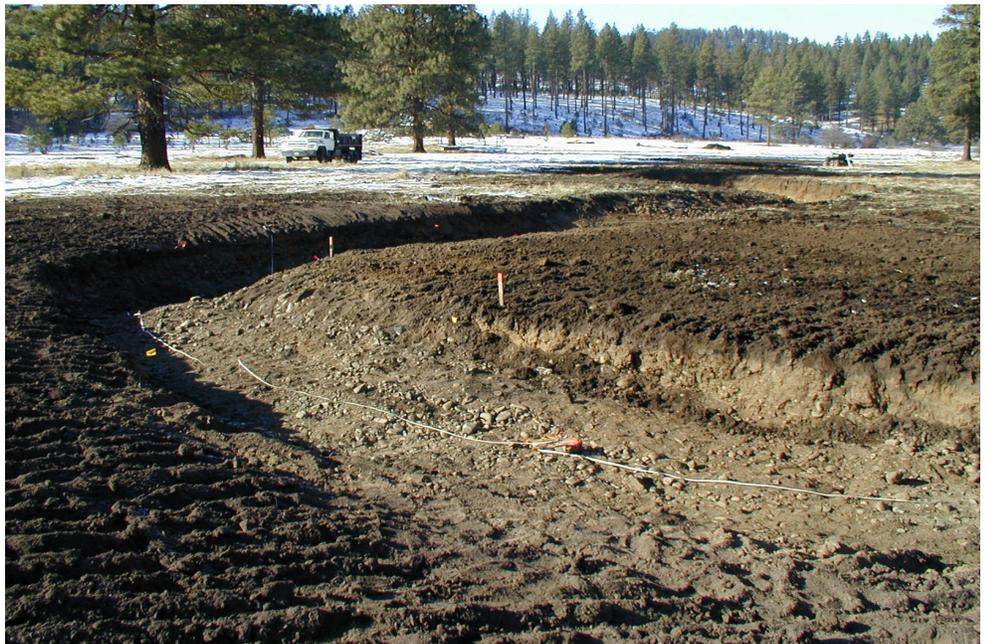
Figure 11. Milk Creek, November 15, 2000. Final shaping is completed and resurveying of the new channel in progress. The photo is taken at Pool #4 looking downstream. Points bars have been sloped back at about a 10:1 ratio and are ready to receive sedge/rush transplants from excavated wetland soils. An artesian well was plumbed in that supplied 12 gpm to begin wetting the channel and help establish riparian plants prior to the first winter floods that will occur in 2001-01.

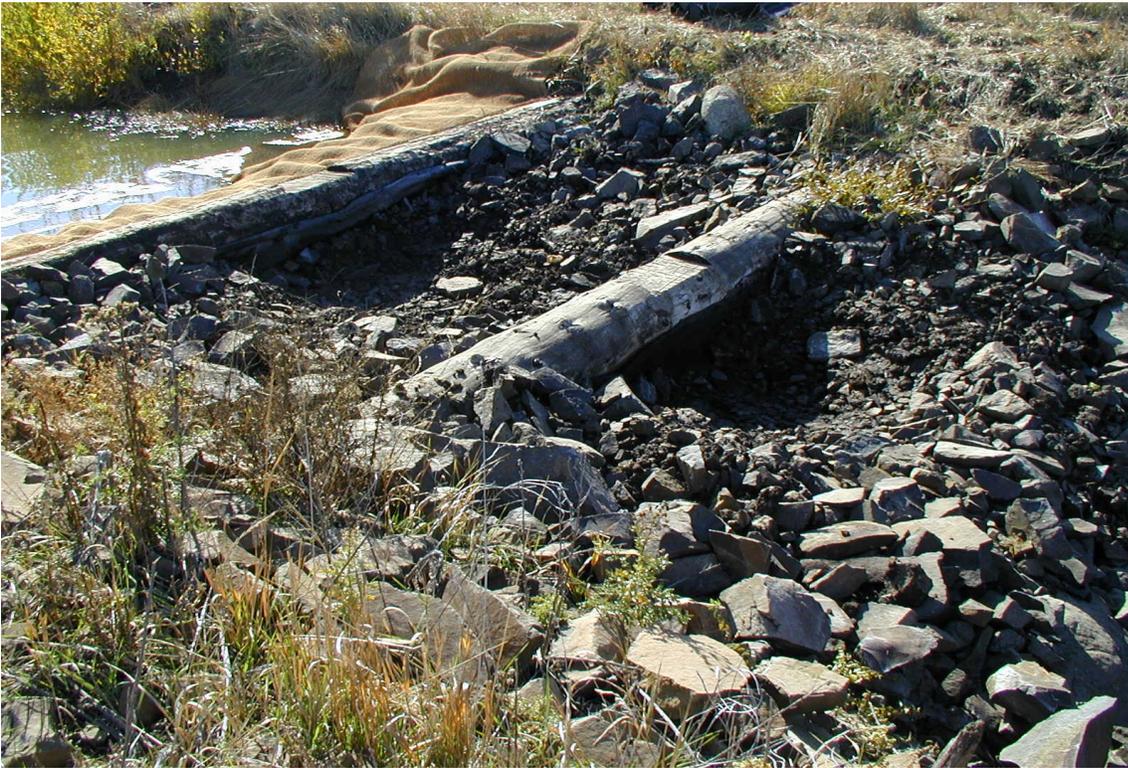
Figure 12. Bear Creek/Cunha Ranches, October 18, 2000. Jump pools were excavated behind log weirs to improve fish jumping ability. Coir fabric or geotextile cloth was trenched into the upstream faces of the structures to improve sealing/trapping of water.

3. Adding deeper layers of coir fabric or geotextile cloth on the upstream faces of the weirs to seal them better (Figure 5). Originally only a 6-ft. deep layer of cloth was installed that was inadequate to prevent subsurface flow from occurring from June to December. In some cases bentonite was distributed on upstream faces of the weirs to speed up the sealing process.

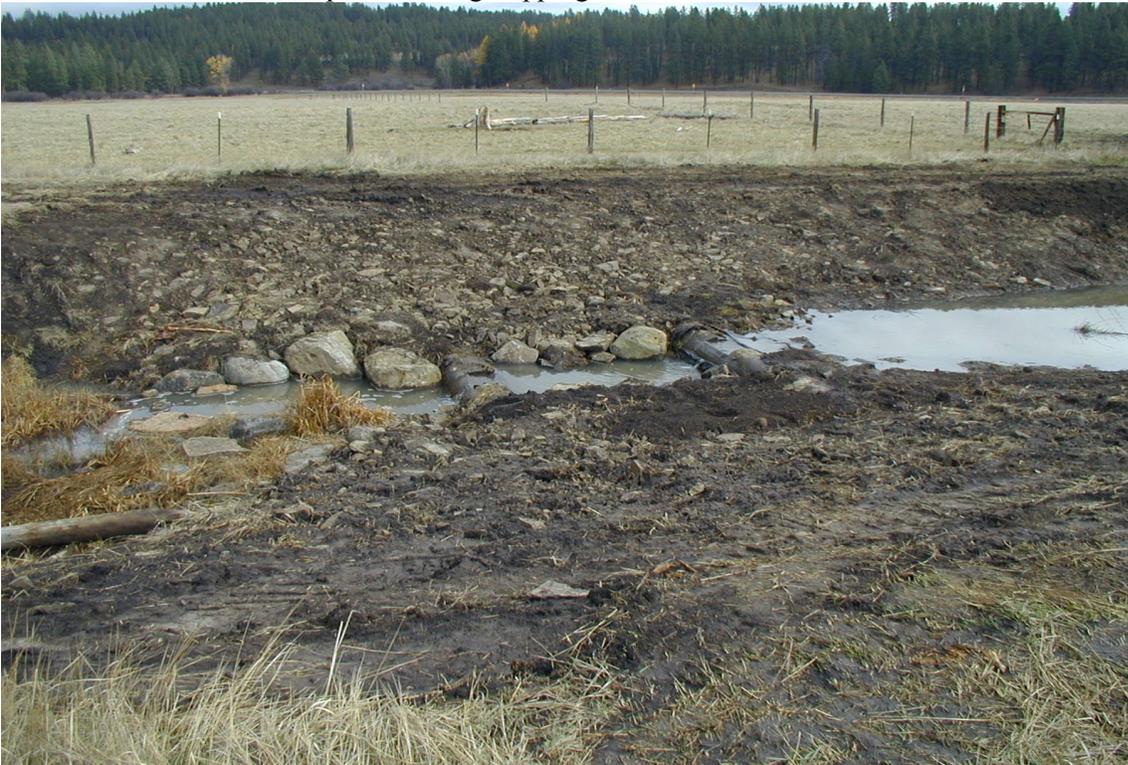
Figure 13. Bear Creek/Cunha Ranches, October 20, 2000. A completed set of weirs that has sealed up and is now running water over the tops. Banks have been sloped which will allow riparian vegetation to become established. However, this work is only a temporary fix, and in 2001 and beyond additional work will include reestablishment of a natural stream channel with constructed meanders, pools and riffles.

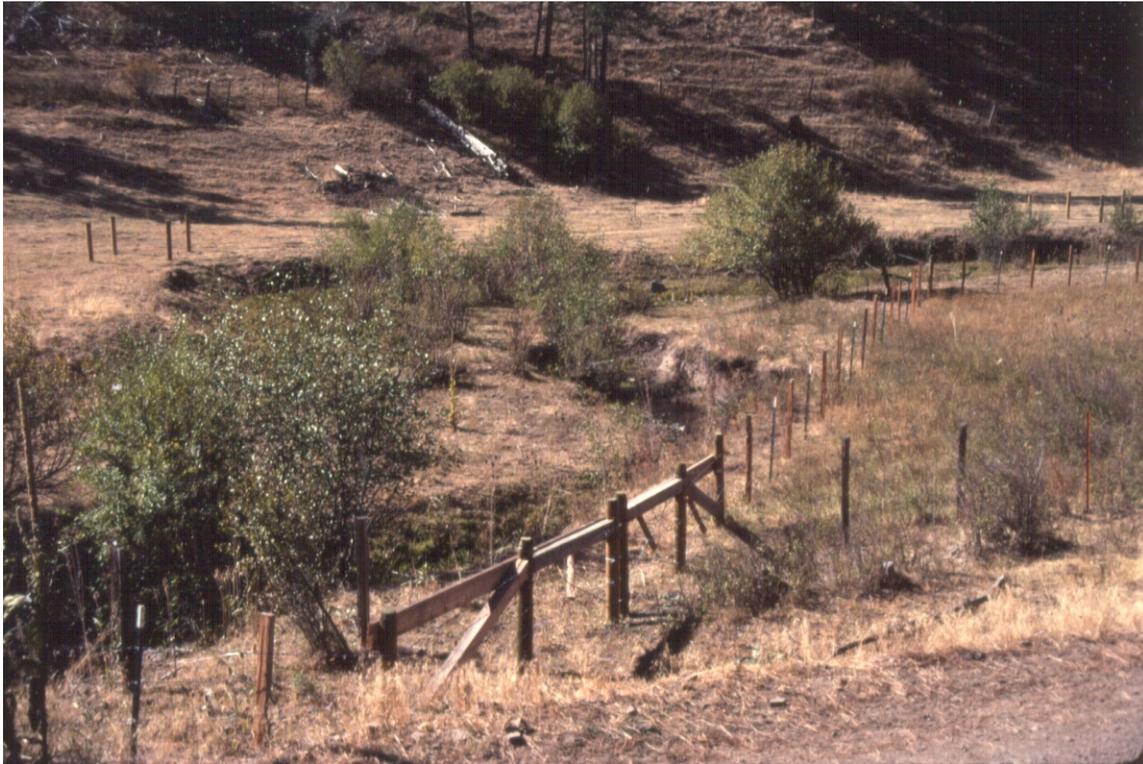
Butte Creek, McDaniel property, Photopoint #5, September 25, 1991. Vertical cut banks and only moderate amounts of riparian vegetation are evident. The newly constructed fence on the right bank appears to have been placed too close to the streambank.

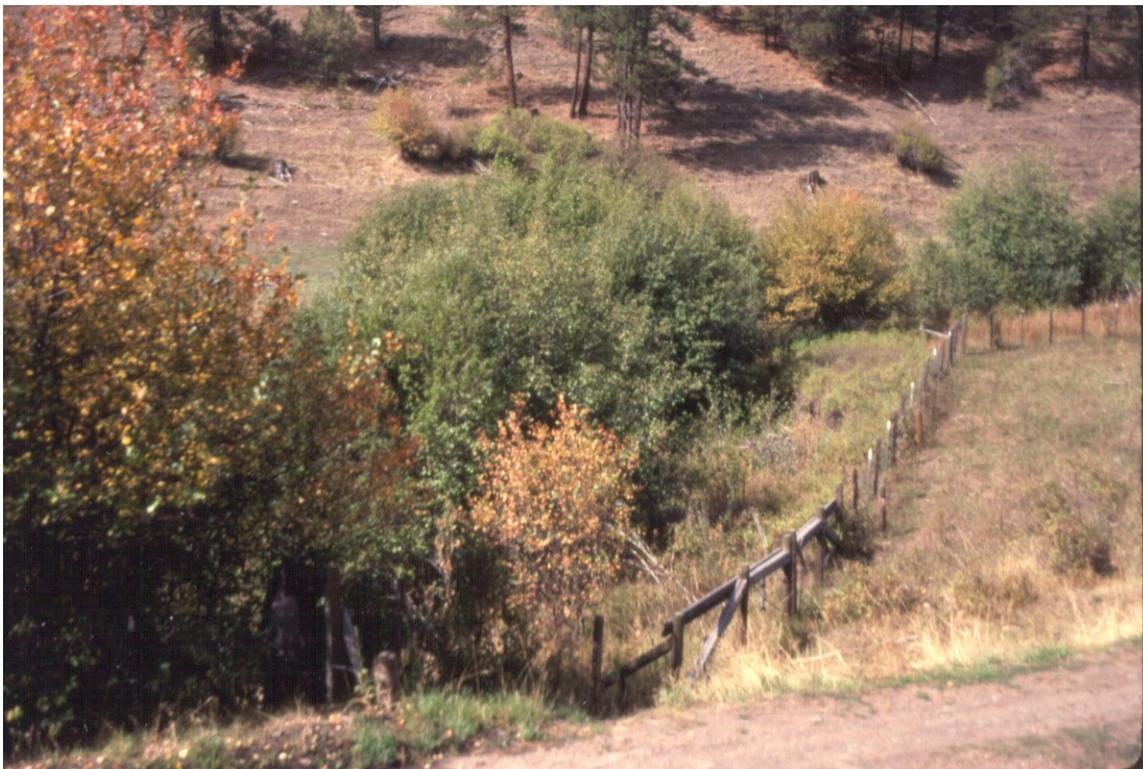
Butte Creek, McDaniel property, Photopoint #5, September 7, 2000. A dense canopy of alder, willow and hawthorns is now shading the stream channel which is no longer visible. Erosion on the right bank has halted even though the stream experienced severe flooding in 1997 and 1998.

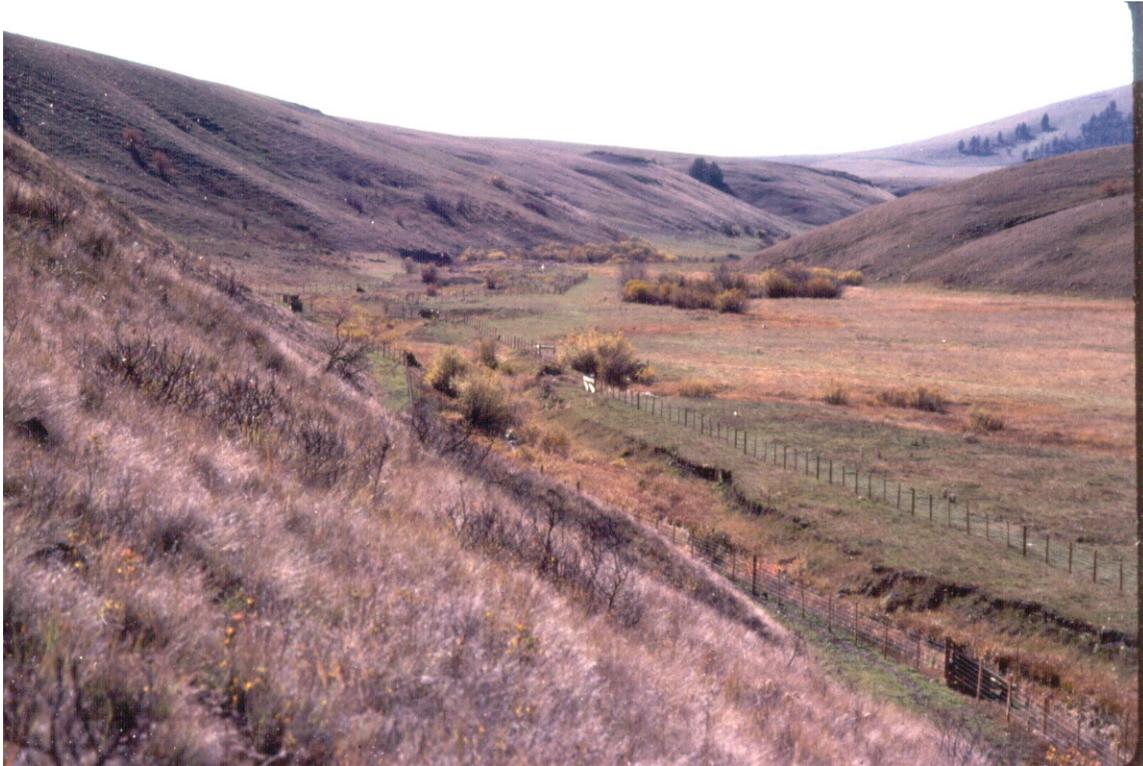
Salmon Creek, McClaran property, Photopoint 4a, October 10, 1989. In years past the stream channel had been pushed against the hillslope, and the channel had downcut several feet. Old stream meander scars are evident in the center, right side of the photo.

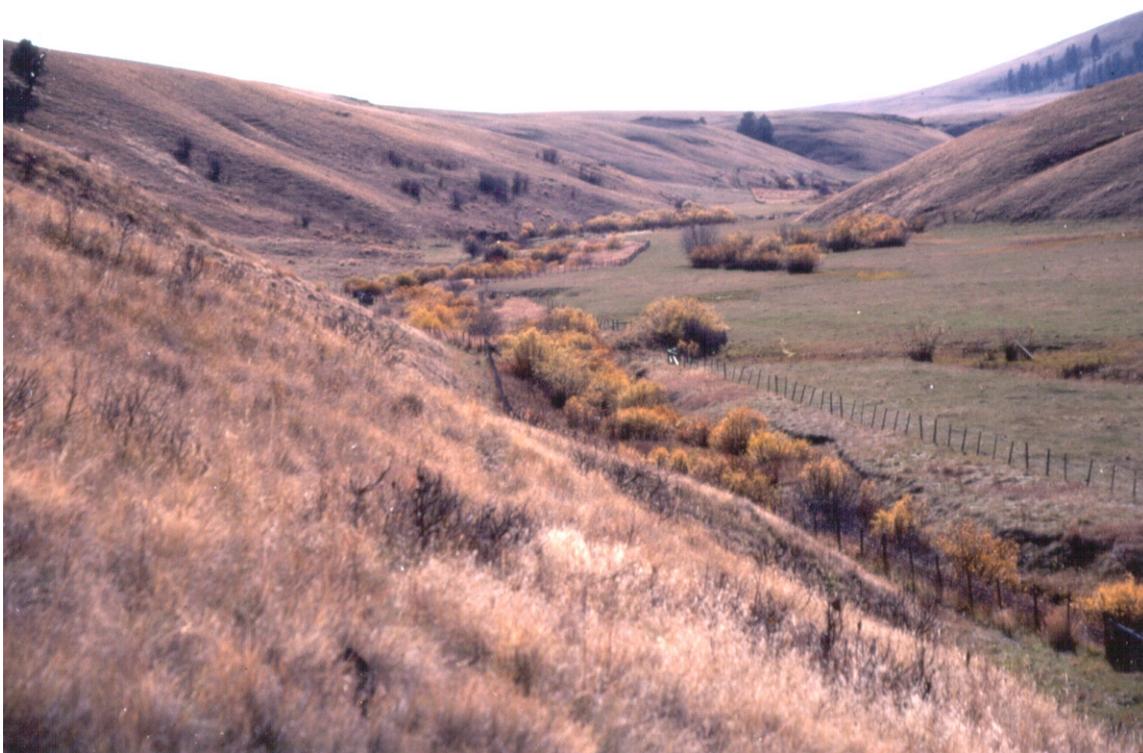
Salmon Creek, McClaran property, Photopoint 4a, October 17, 2000. A canopy of willows has developed, and the stream has evolved from a Rosgen G→F→C stream type within the entrenched area. Stream temperatures are 3-4 degrees Celsius cooler at this site compared to a monitoring station 2.3 miles upstream.

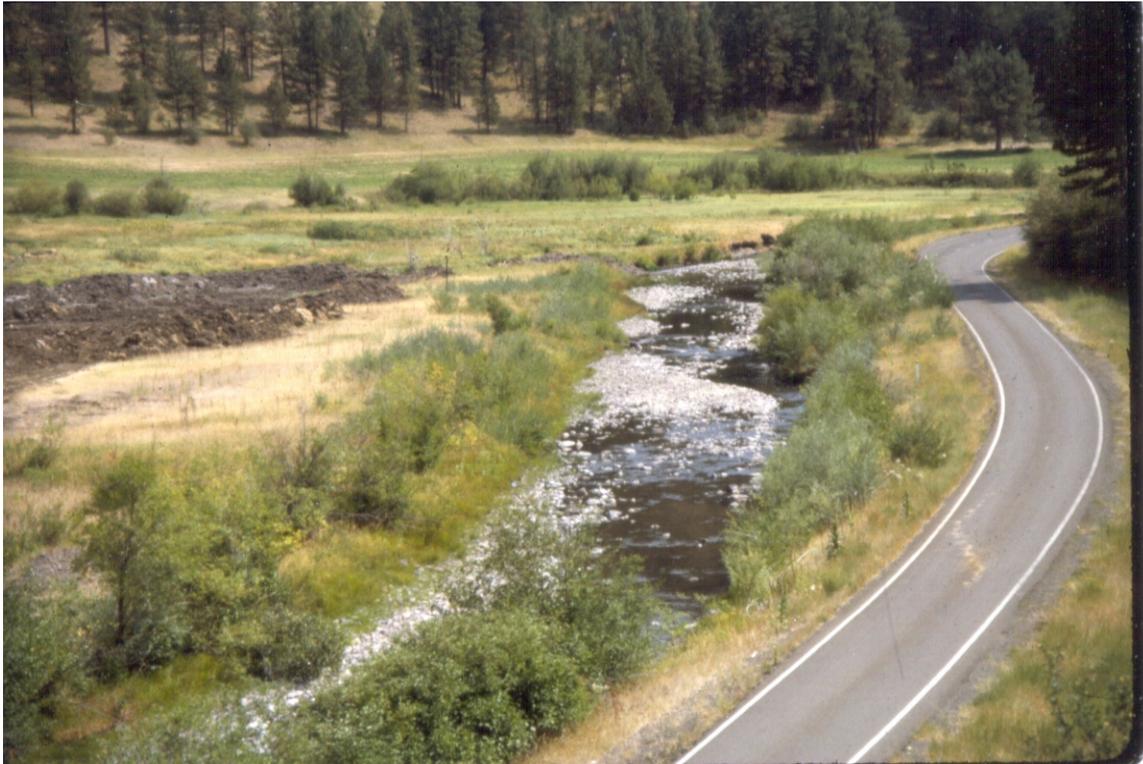
Chesnimnus Creek, Yost property, Photopoint #5, August 7, 1987. A wide, shallow stream channel with bare gravel bars are evident in this pre-project photograph. The bare soil on the left is a pond constructed by the landowner.

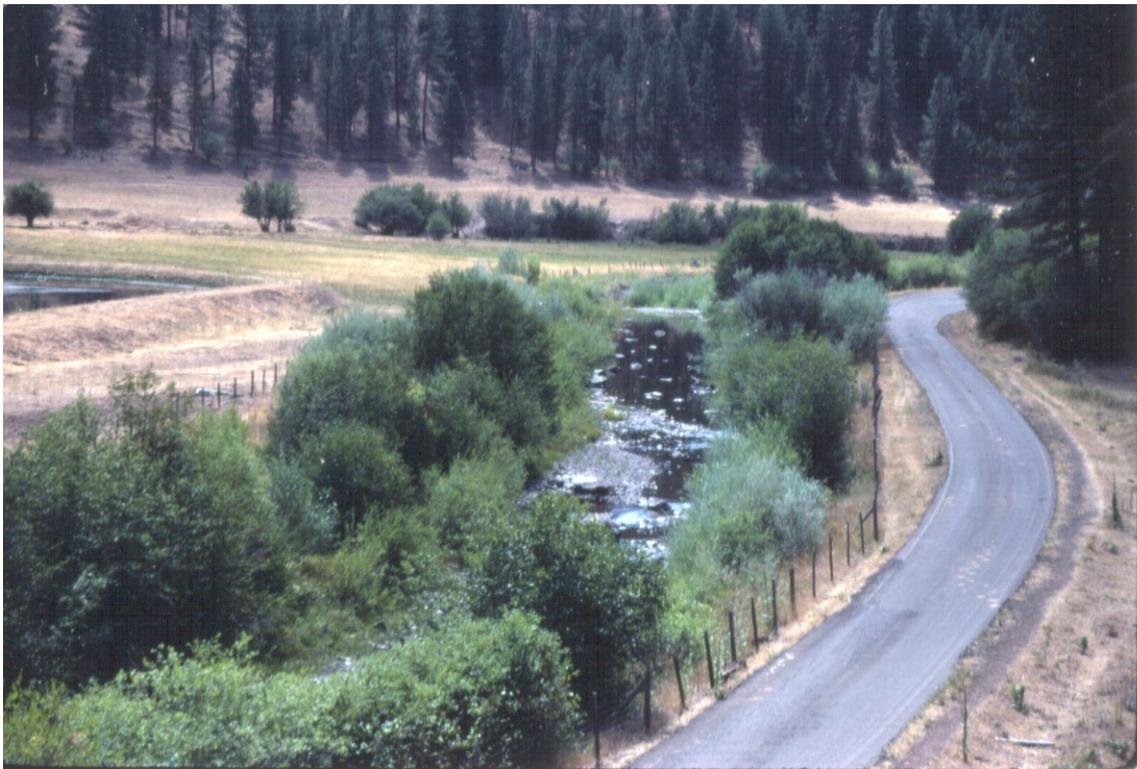
Chesnimnus Creek, Yost property, Photopoint #5, August 10, 2000. Despite the fact that beavers have constructed dams several times in this area, the riparian vegetation has flourished. The channel has narrowed and deepened, and is more shaded.

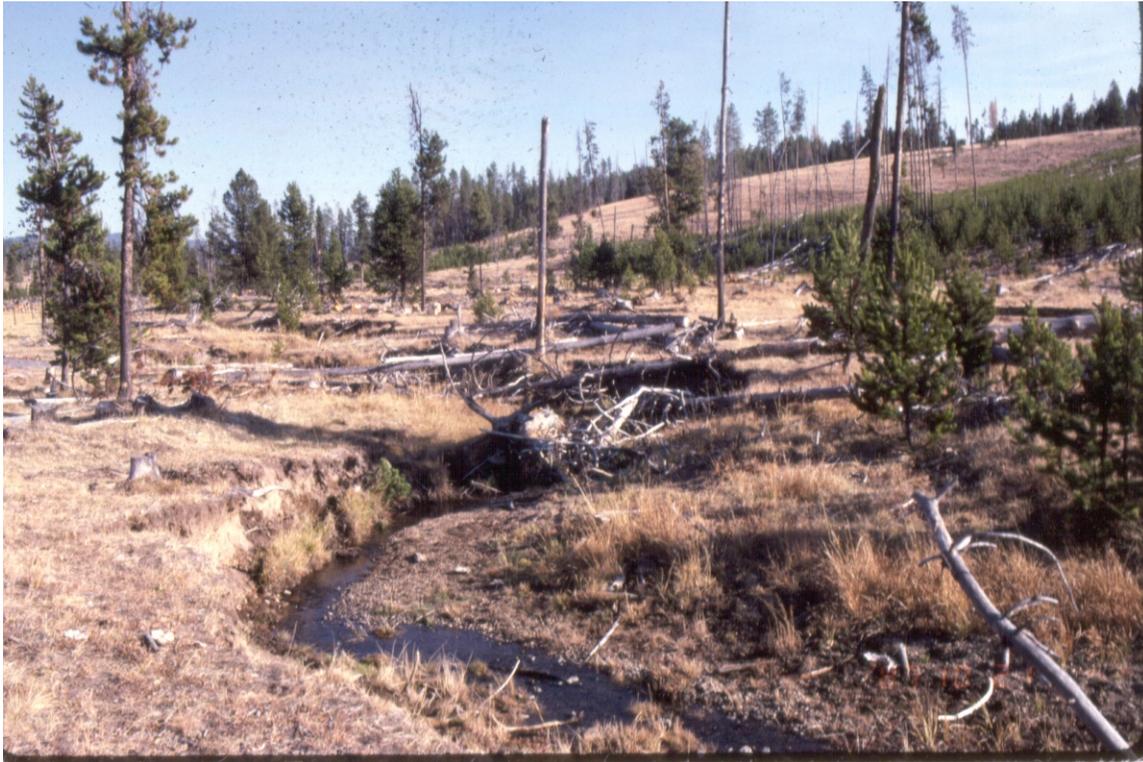
Fly Creek, Smith property, Photopoint 7, October 21, 1987. The pre-project photograph shows a stream suffering from intense grazing pressure and timber harvest.

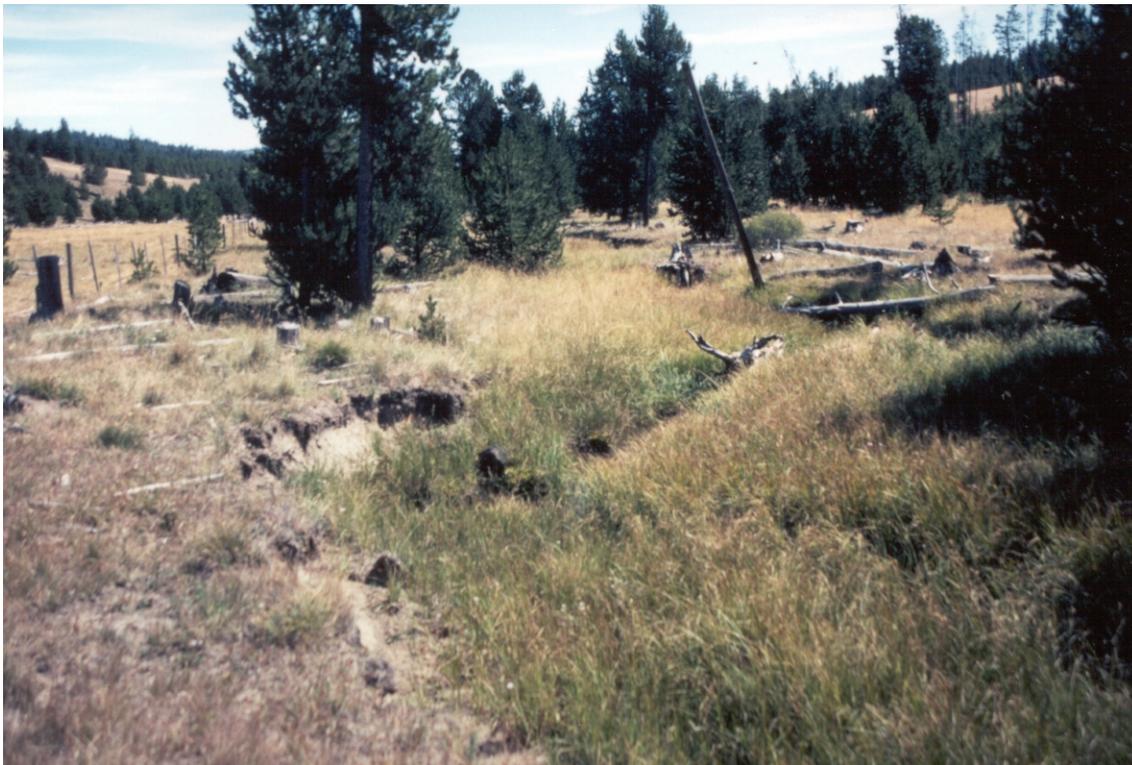
Fly Creek, Smith property, Photopoint 7, August 22, 2000. After 13 years of recovery young lodgepole pine are recolonizing the site. The stream channel (no longer visible) has evolved into a low width/depth ratio Rosgen E type stream due to the establishment of a thriving sedge community.

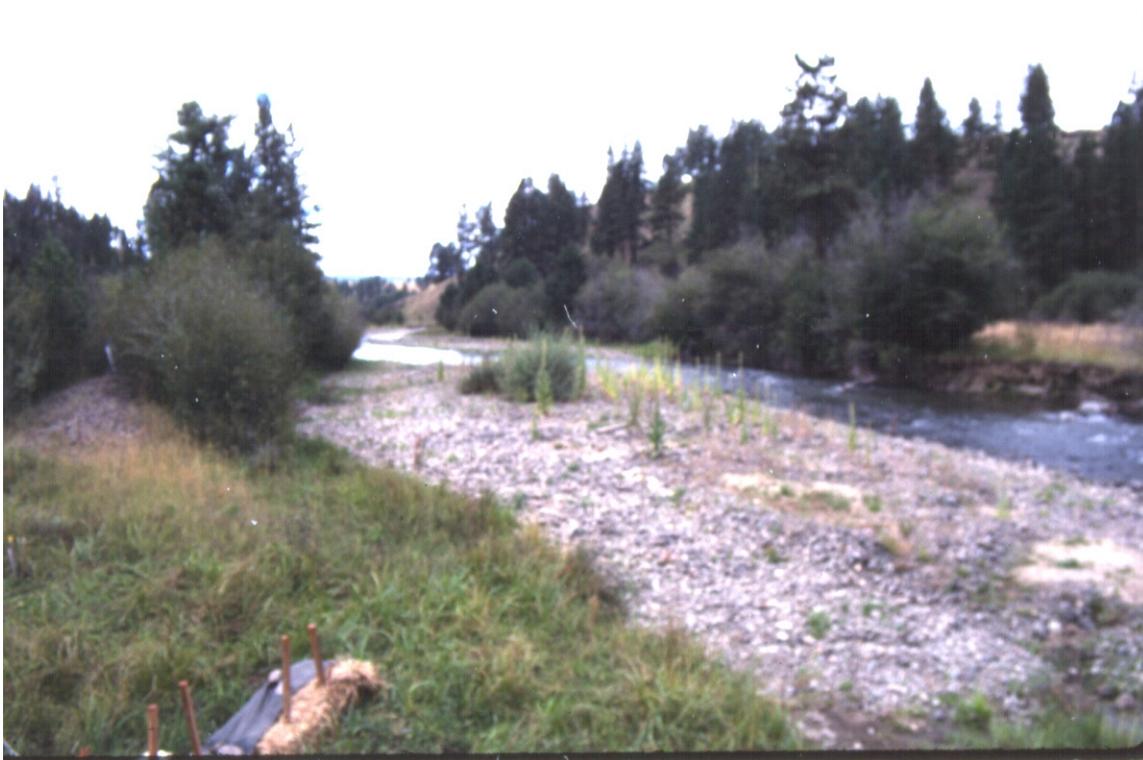
Upper Grande Ronde River, Delve property, Photopoint 1a, August 24, 1993. High bedload movements occurred during the flooding of May 1991, and this reach has been artificially constricted by the landowner and from highway construction in the areas upstream and downstream of the photo. Note erosion control matting in lower left of the photograph.

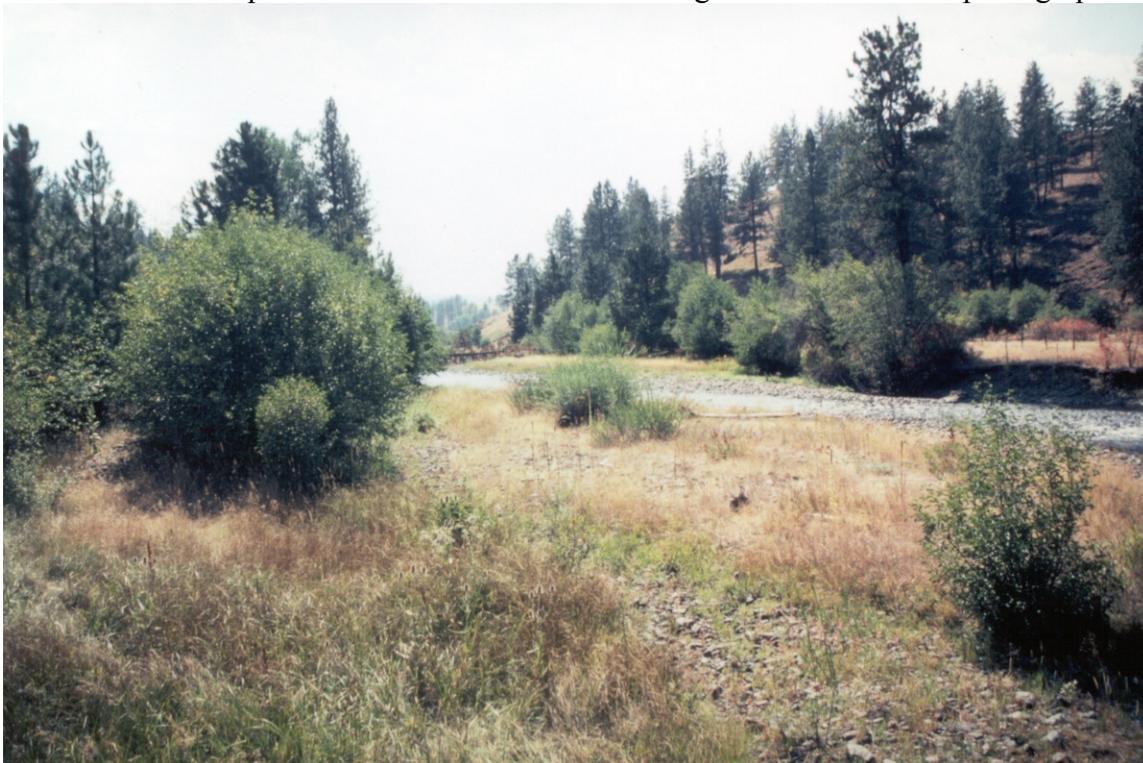
Upper Grande Ronde River, Delve property, Photopoint 1a, September 6, 2000. Recovery has been slow, but the channel is beginning to reshape itself as deposition has occurred on the point bar, and young sedges and alders become established. The opposite bank is still cutting, but this is necessary in order for the stream to restore itself into the correct pattern.

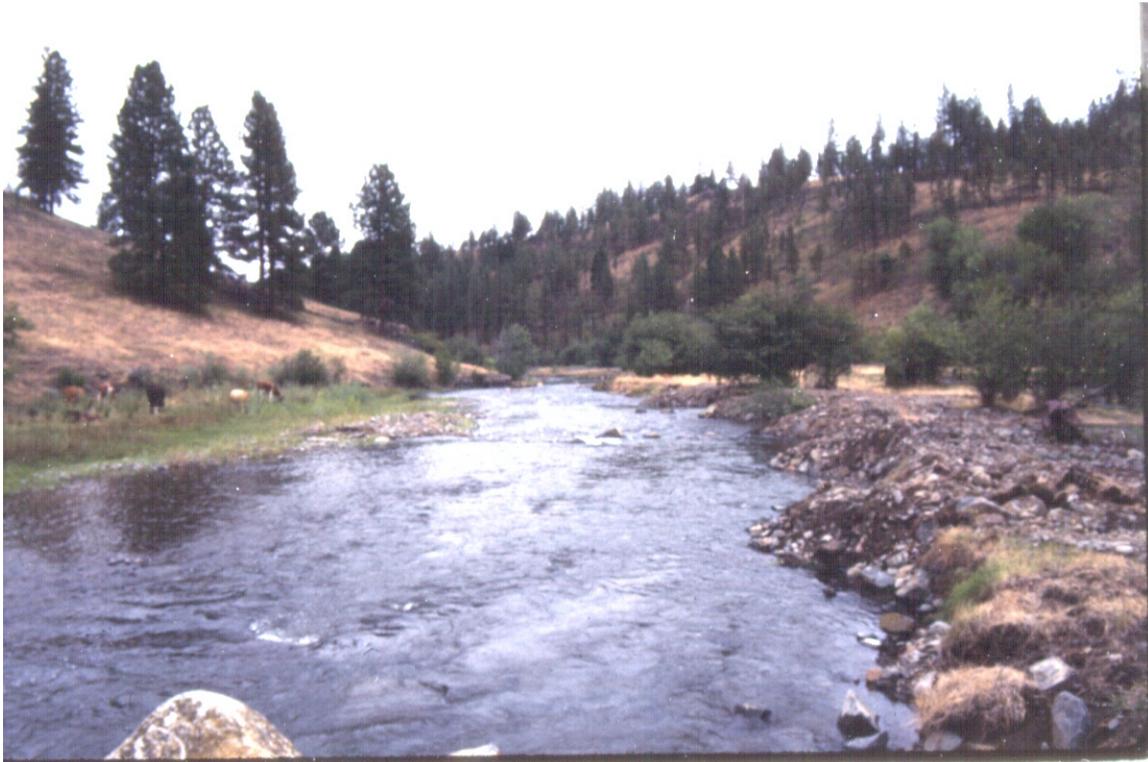
Upper Grande Ronde River, Bowman/Hoeft property, Photopoint 6, August 20, 1990. Prior to fencing a series of rock jetties were placed on the right bank to prevent further erosion. A wide, shallow stream channel is evident, and very little streamside vegetation is present.

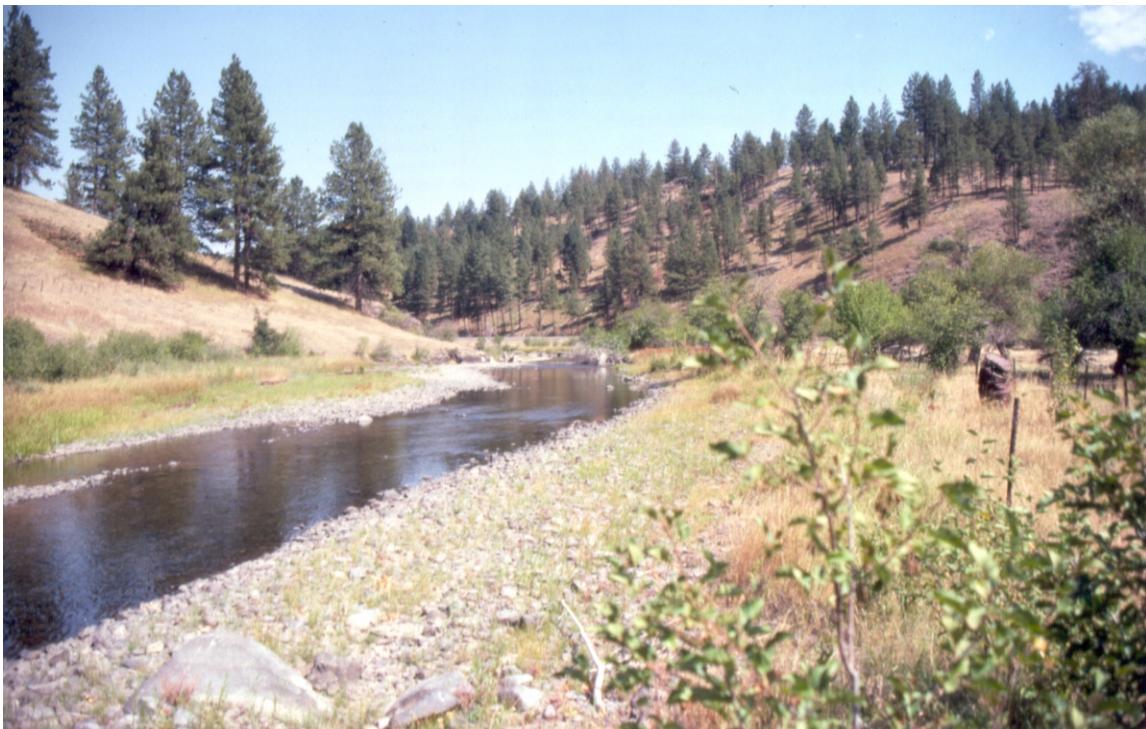
Upper Grande Ronde River, Bowman/Hoeft property, Photopoint 6, August 17, 1990. Although the jetties are no longer the preferred method of bank stabilization, they quickly trapped sediments during the flooding of 1991 (note deposition below the protruding boulder on the right bank), and the channel has narrowed. Recovery is slow in this reach, but some young alders are becoming established.
