John Day Watershed Restoration Projects

**Annual Report
2000 - 2001**

FY 2001 Watershed Restoration Projects

Project Number: 98-018-00

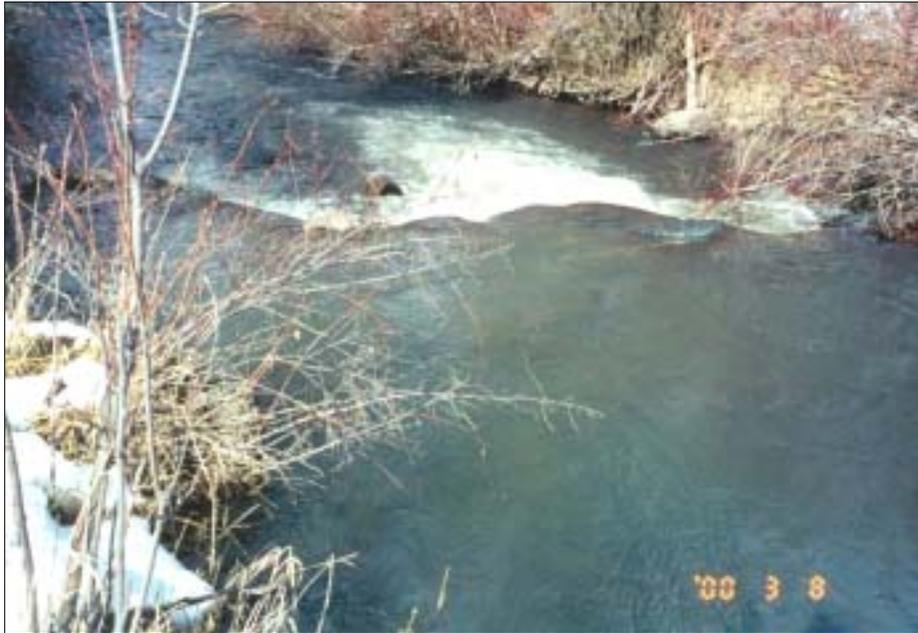
Photo 1. Pre-project photo of the Beaver Dam Diversion site at high flows

Project Background: Irrigation water on the Riverside Ranch (Alan Jacobs, owner) historically has been diverted by a gravel and rock push-up diversion, which directed water through an open canal. Typically, this diversion type is reconstructed several times on an annual basis. The diversion is constructed using material generally excavated from the riverbed and surrounding stream channel. Commonly, materials such as boulders and concrete support the gravel and cobble structure while

Permanent, "lay-flat" stanchion diversions are promoted in the John Day basin as a replacement option for gravel push-up diversions. These structures consist of pre-cast concrete boxes that span the width of the stream, sheet-steel pilings to direct water flow and protect banks from erosion, and stanchions to allow for installation of flashboards to impound water (see Appendix 1, Typical Permanent Diversion Installation Photos). A fish-way notch provides for fish passage for all life-history stages at all instream flow levels and a headgate allows for accurate regulation of the water right to rate and duty (see Figure 9).

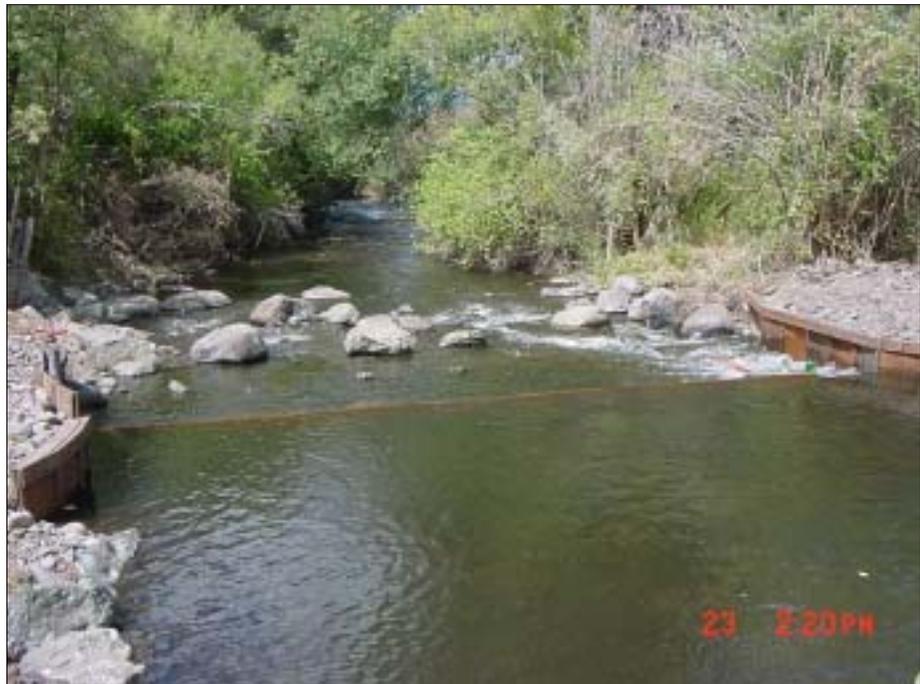
Photo 2. Beaver Dam Diversion Post-Construction

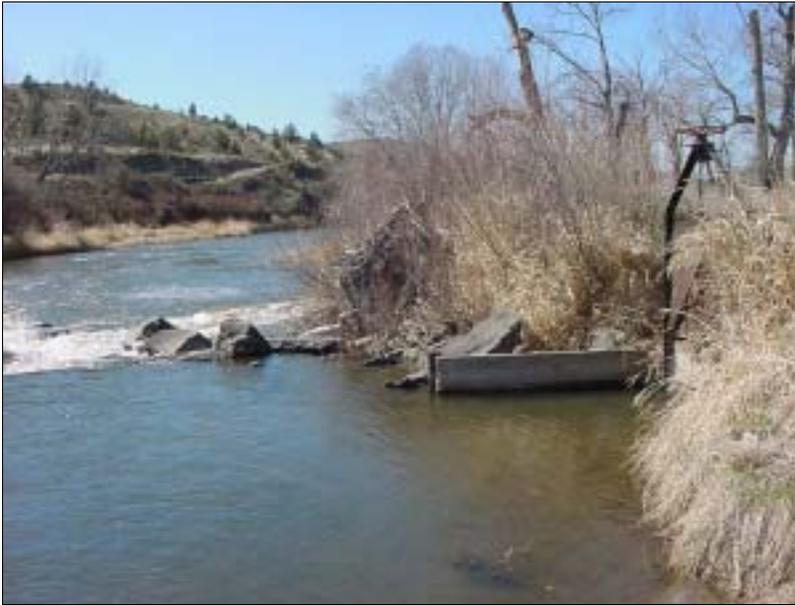
Photo 3. Pre-project photograph of Clausen pumping station

Project Background: Currently, water for irrigation is diverted using annually installed push-up structures. Typically, these types of diversions are reconstructed at least on an annual basis and frequently as river flows decline during the summer irrigation season. Materials used in the construction of the diversion are generally excavated from the riverbed and surrounding stream channel. Commonly, materials such as boulders and concrete support the gravel and cobble structure while tin, plywood, or plastic/fabric cloth seal the upstream face of dam (see Appendix 1, Photo 14. Typical gravel push-up diversion). Structurally, these types of

To eliminate the use of the gravel push-up diversion, we replaced at rate and duty, the annually installed diversion with a pressure pump system. (see

Appendix 3) The point of diversion was relocated down stream approximately 2 ditch miles, closer to the point of application. A permanent pump station and sump with an approved fish screen and totalizing flow meter was installed at the new location. Approximately 2640 feet of buried PVC mainline pipe were installed to convey the water to the 44.5 acres of farmland that has been converted from flood irrigation to sprinkler irrigation. This pump station represents phase one in the project to retire the Throop Snyder Diversion and approximately 0.7 miles of inefficient open conveyance ditch. This diversion is a potential fish barrier and the landowners are anxious to replace it. Phase two is scheduled for implementation in 2002.

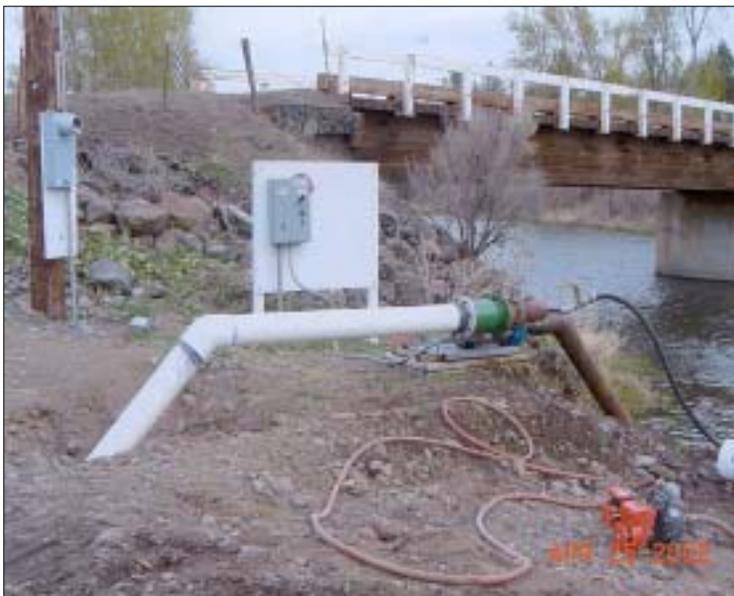
Photo 4. Post-construction photo,

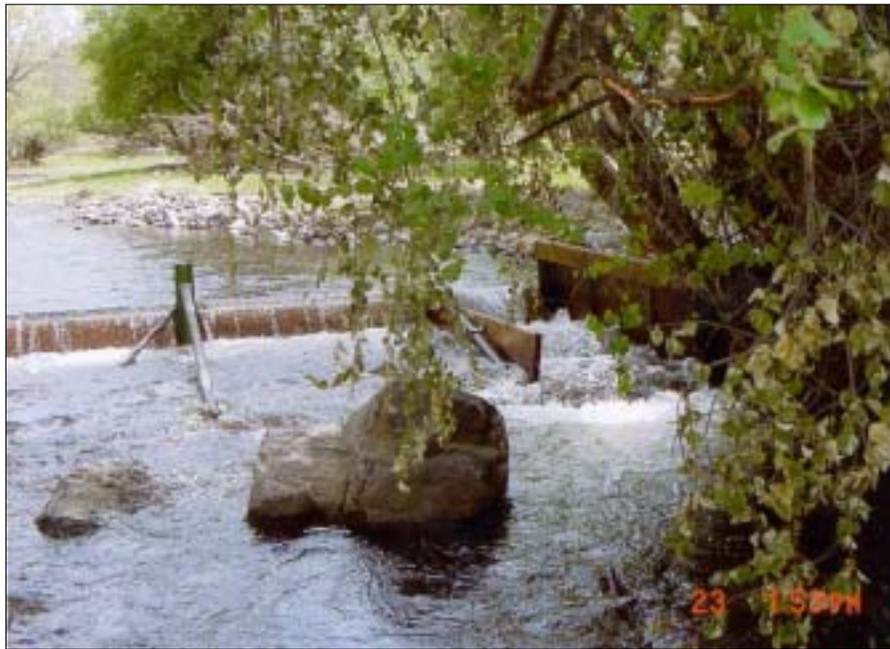
Project Background: The project involved the installation of a permanent lay-flat diversion to replace the temporary push-up diversion. Removing the push-up diversion allows unrestricted fish passage at all river levels, reduced sediment input, halts streambed/streambank degradation, and allows the aquatic and terrestrial system to recover. Typically, these types of diversions are reconstructed at least on an annual basis and frequently as river flows decline during the summer irrigation season. Materials used in the construction of the diversion are generally excavated from the riverbed and surrounding stream channel. Commonly, materials such as boulders and concrete support the gravel and cobble structure while tin, plywood, or plastic/fabric cloth seal the upstream face of dam (see Appendix 1, Photo 14. Typical gravel push-up diversion). Structurally, these types of diversions can be extremely inefficient due to their physical construction and site location. Commonly, the diversion is left in place following the end of the irrigation season. While in place, the diversions can become a partial to total barrier to migrating fish, depending upon river flow condition, affecting both the up- and downstream movement of subadult and the

Photo 5. Coolie Island diversion, post-construction

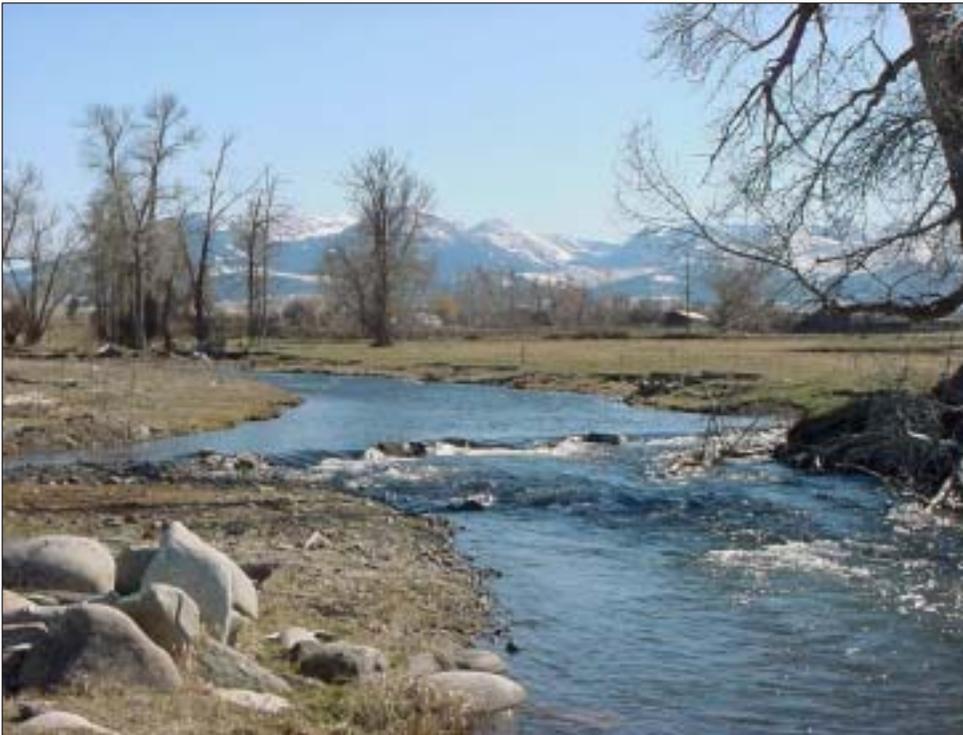
Photo 6. Lower McHaley diversion, pre-construction

Project Background: This project combines two separate diversions into one point of diversion for both irrigation ditches. Irrigation flows were previously diverted from the John Day River using two gravel push-up diversions.

To combine the two diversions into one location the POD will be moved upstream approximately 200 feet from the upper diversion site to a more stable location. The project will combine the upper and lower diversions into one diversion located at a new POD. To aid fish passage and improve river flow, a permanent lay-flat diversion was constructed. These structures consist of a concrete wall, with lay-flat stanchions. When not in use these diversions can be lowered for unrestricted fish passage. When in use the diversions allow more efficient headgate control and water measurement promotes legal rate and duty at all flow conditions. Maintenance is reduced and sediment input reduced with the use of these structures, as well as a reduction in streambank/streambed degradation. This allows for both aquatic and terrestrial recovery in the system.

At the Lower McHaley site approximately 40 feet of PVC pipe will be installed to connect the existing open conveyance system to the new diversion system and the POD will need to be moved to the new location. The existing fish screen was incorporated into the projects and a measuring device was installed for water use regulation at the new diversion site.

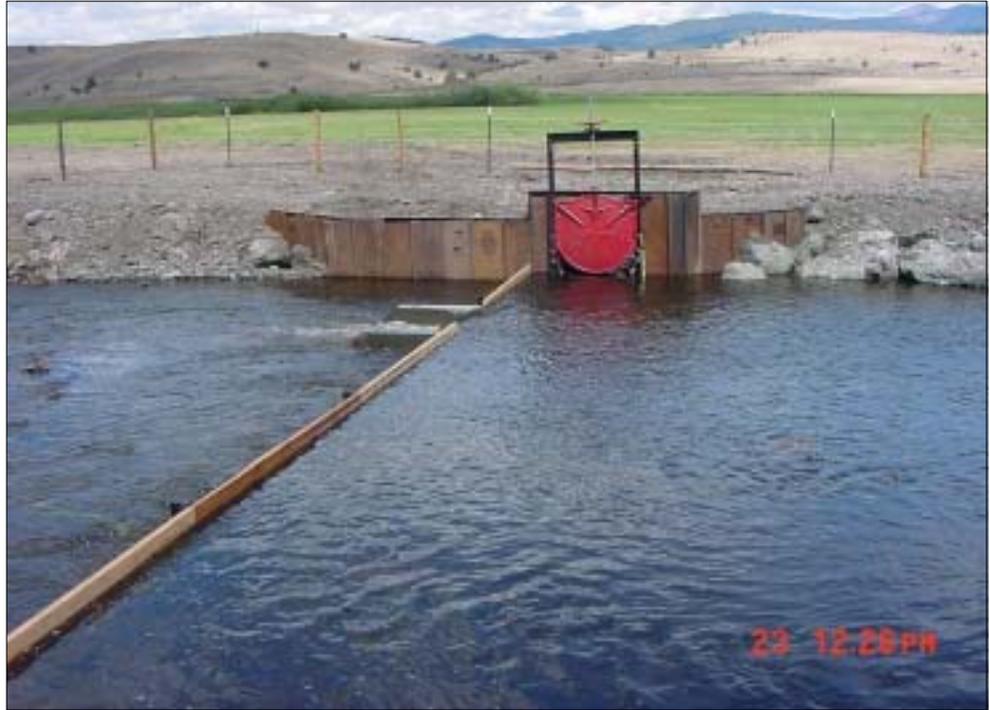
Photo 7. Upper McHaley diversion, post-construction

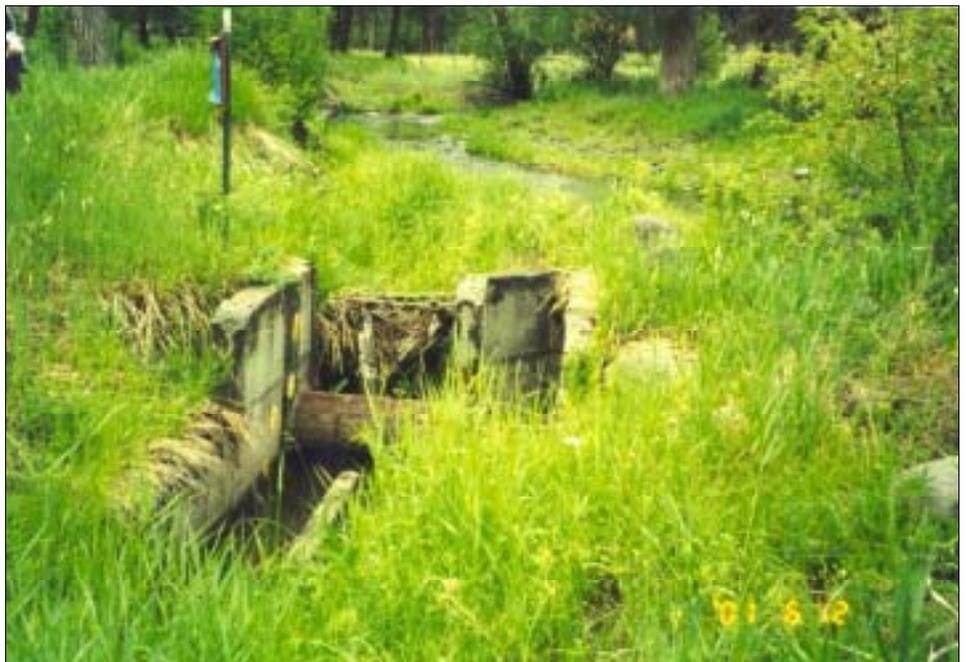
Photo 8. O’Rorke East Side infiltration gallery, pre-construction

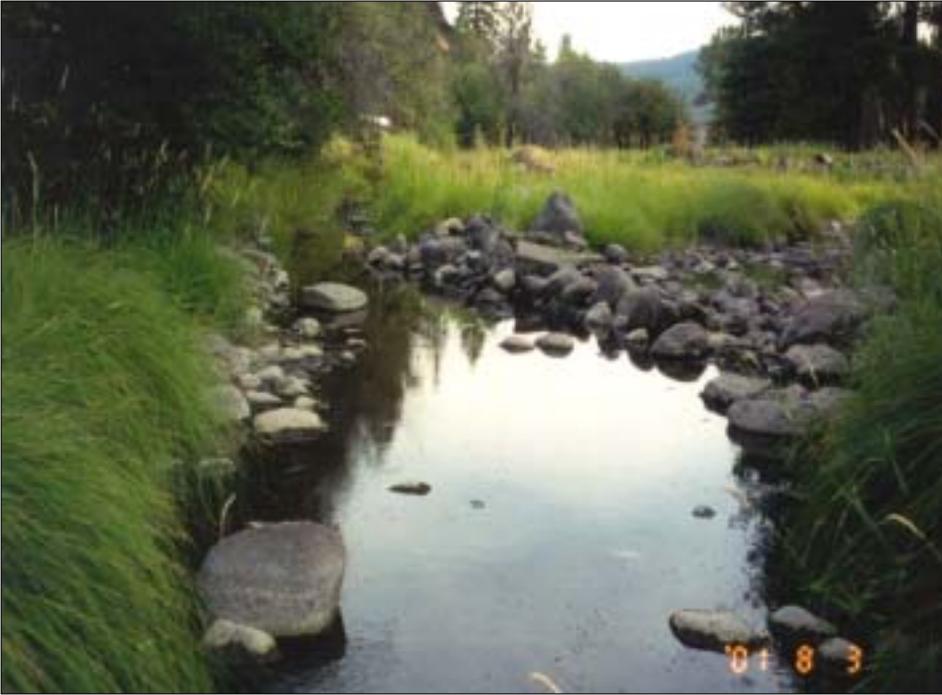
Photo 9. O'Rorke East Side infiltration gallery, post-construction

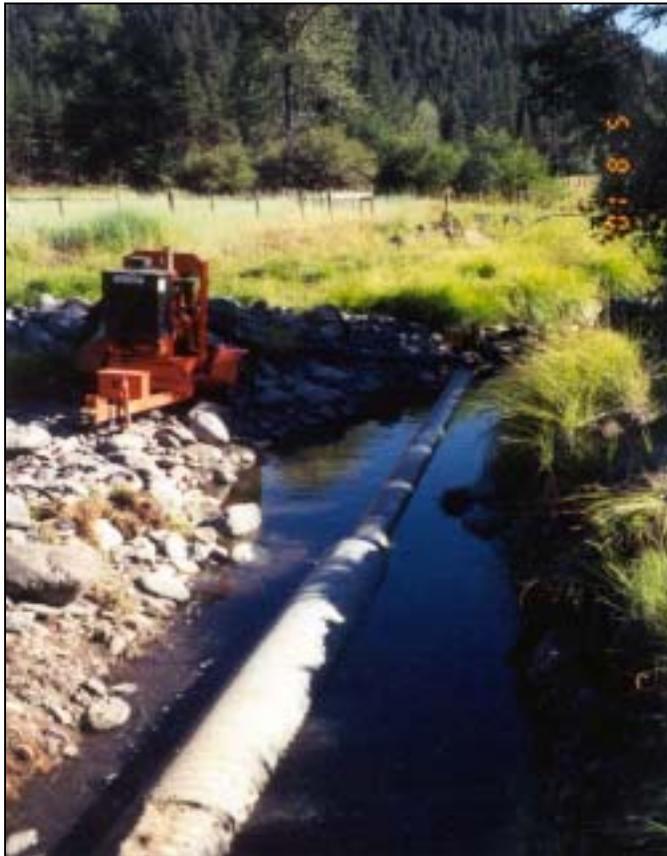
Photo 10. O'Rorke Lane Infiltration Gallery Installation.

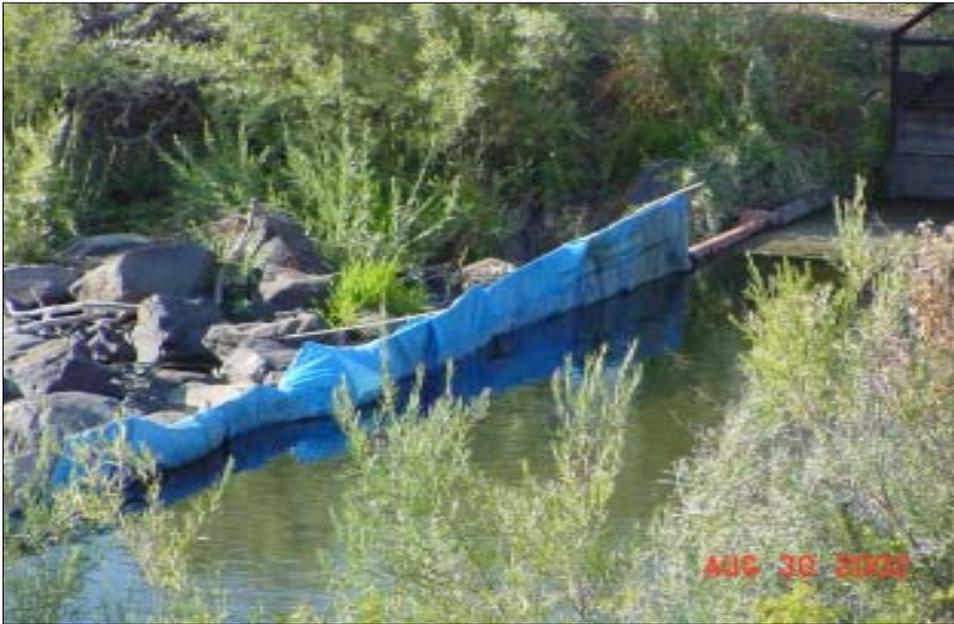
tin, plywood, or plastic/fabric cloth seal the upstream face of dam (see Appendix 1, Photo 14. Typical gravel push-up diversion). Structurally, these types of diversions can be extremely inefficient due to their physical construction and site location.

Photo 14. Typical gravel push-up diversion
