# Protecting and Restoring Fishing (Waw'aatamnima) Creek to Legendary Bear ('Imnaamatnoon) Creek Watersheds Analysis Area

**Annual Report**  
**2003 - 2004**

**Watershed Restoration in the Upper Lochsa River Basin**  
***Protecting and Restoring Fishing (Waw'aatamnima) Creek<sup>1</sup> to***  
***Legendary Bear ('Imnaamatnoon) Creek<sup>2</sup> Watersheds Analysis Area***

Annual Progress Report  
June 2003 – May 2004

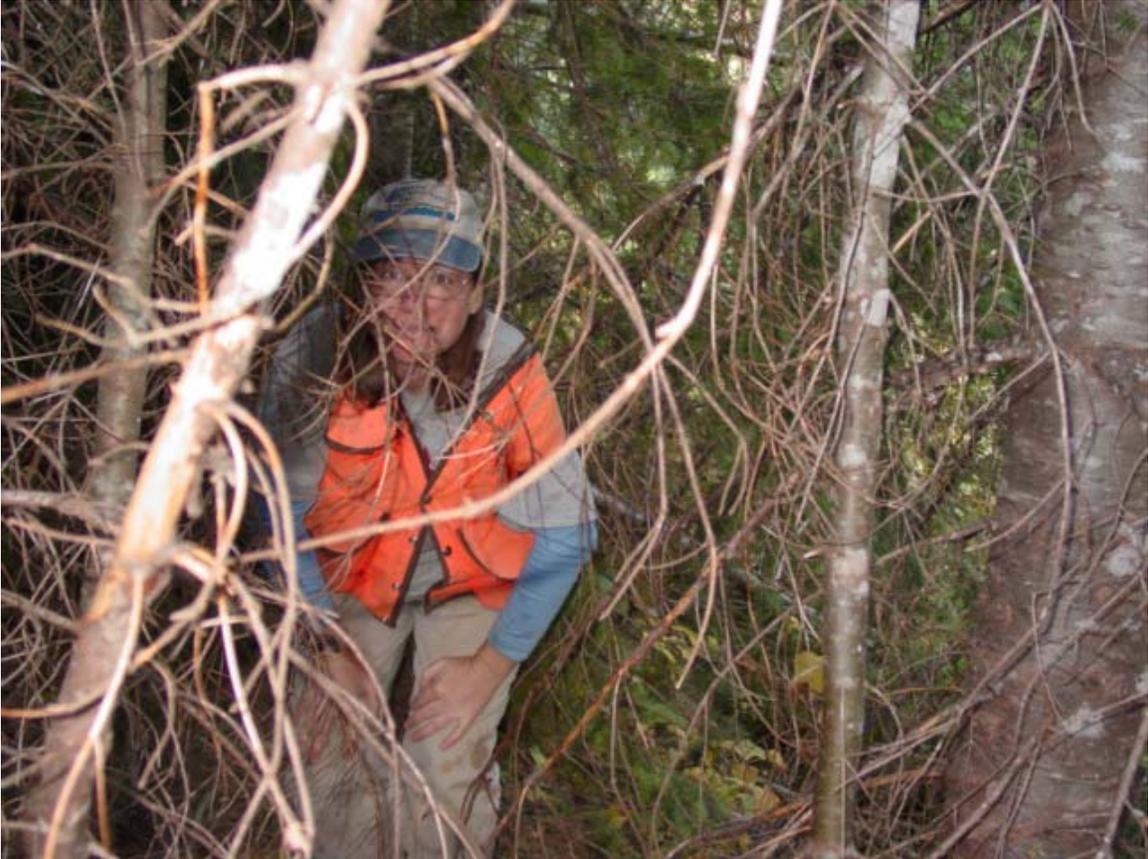
Figure 3. Pre-obliteration survey on over-grown road. Badger Creek summer 2003.

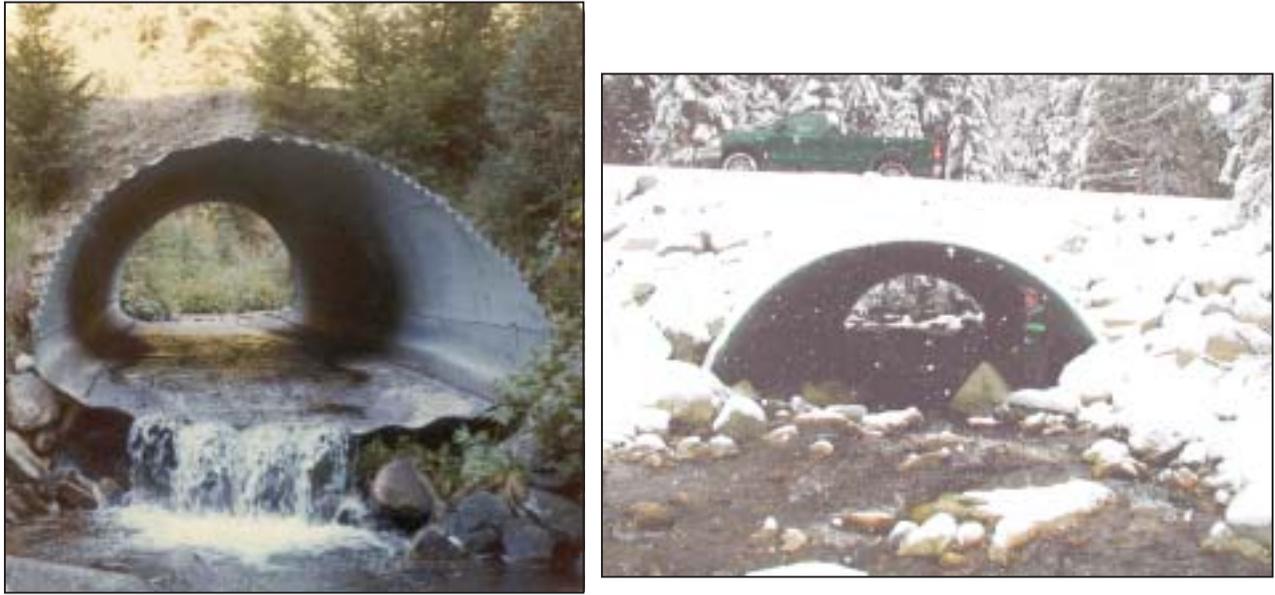
Figure 4. West Fork of Fishing Creek culvert replacement, before and after, a pipe arch replaced with a bottomless.

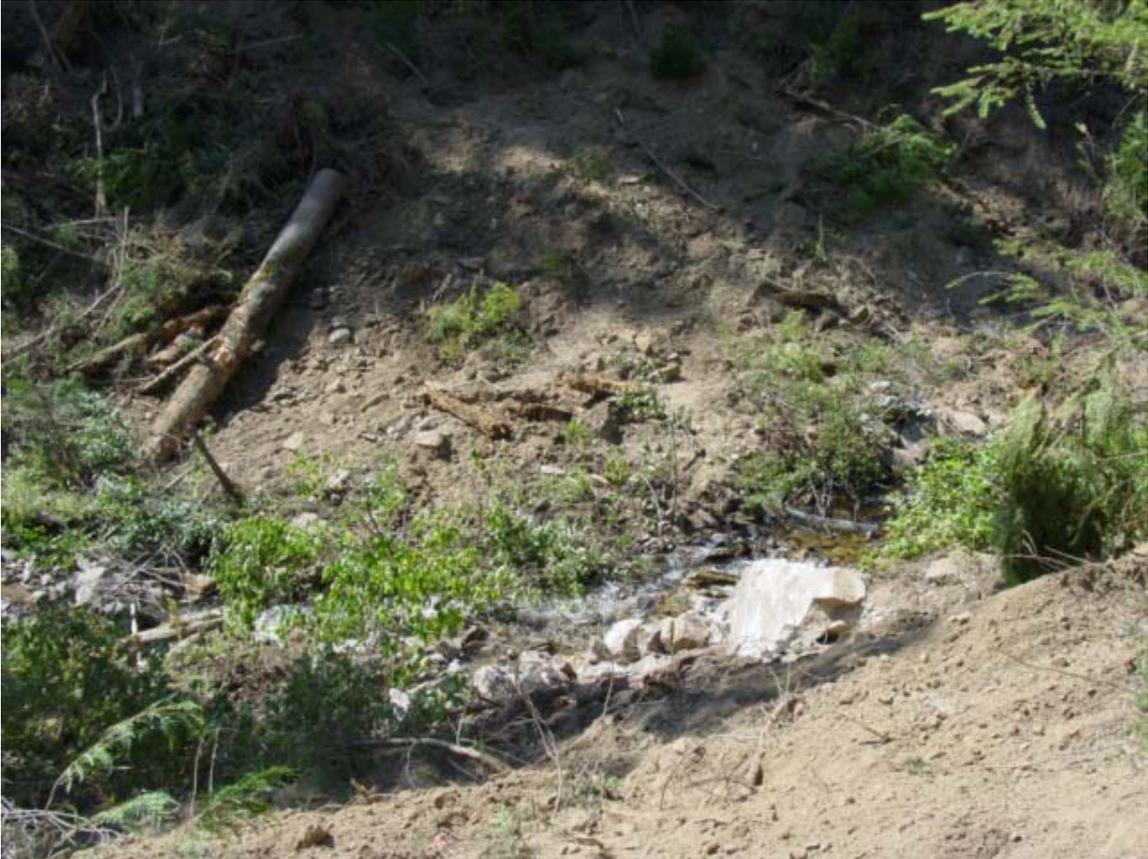
Figure 5. A completed stream crossing reconstruction after pulling a log culvert. Parachute Creek, 2003.

All roads were treated with recontour and outslope. Two excavators and one D6 size dozer worked in these drainages. The 18 miles of road removed were far short of our target miles. We failed to reach our targets this year as a result of Powell Ranger District being closed to contract work for two months of the field season. In addition, shortened hours reduced productivity. For one month of the field season (July) our hours were restricted under a "Hoot Owl" policy which allows contract work to occur between the hours of 1 a.m. and noon. As our work must occur during daylight our days were shortened to 7 and 8 hours. Powell Ranger District closed in response to a large number of fires on the Lochsa. The District reopened at the end of September with the end of fire danger.

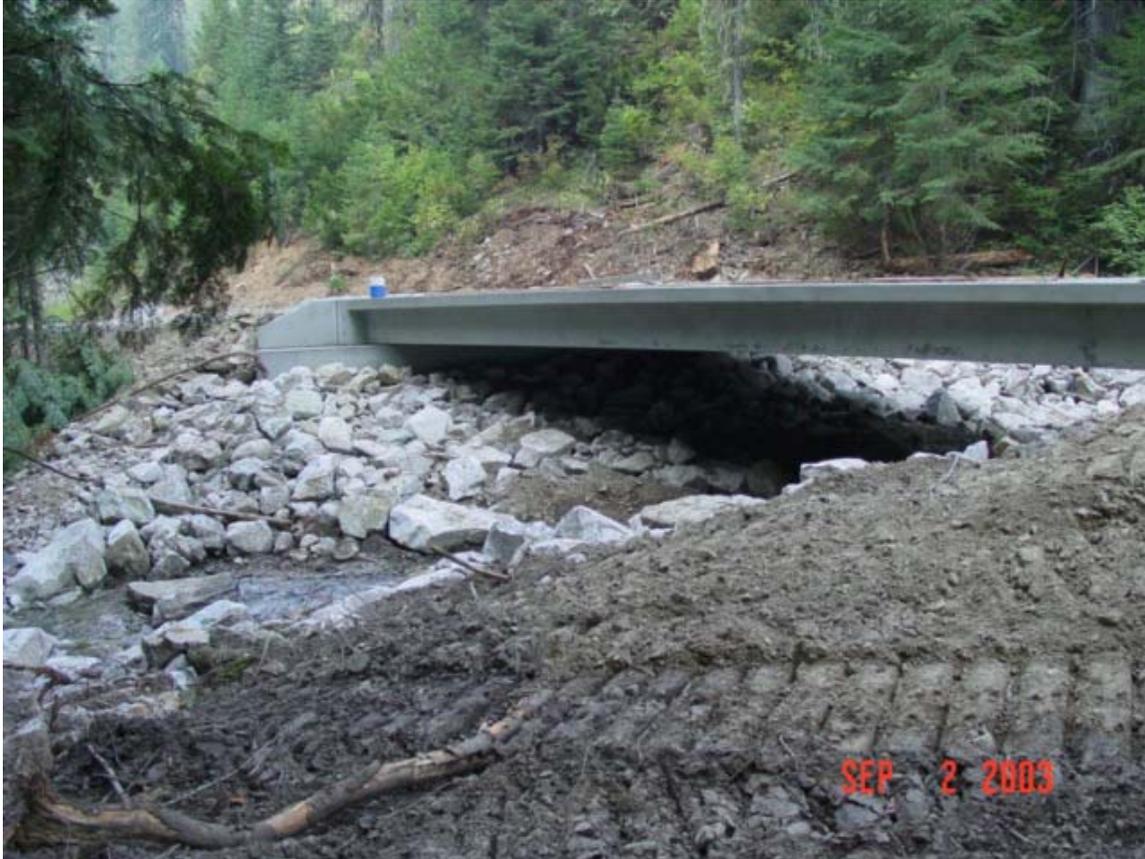
Figure 6. Legendary Bear Bridge nears completion, September 2003.

We replaced an undersized culvert at the 3.2 mile post on Forest Road #568 (Legendary Bear Creek) with a bridge. The bridge was built at a 17' span to accommodate a 14' wide active channel; this replaced an 11' wide structural plate pipe arch culvert. During the fall of 2003, NPT and CNF worked together with a local non-profit organization's volunteers to plant the disturbed soil around the bridge. The area was planted with sprigs of willow and rooted stock of native brush species.
