# North Fork John Day Dredge Tailings Restoration Project

**Final Report**  
**1997 - 2002**

DOE/BP-00004994-1

December 2002

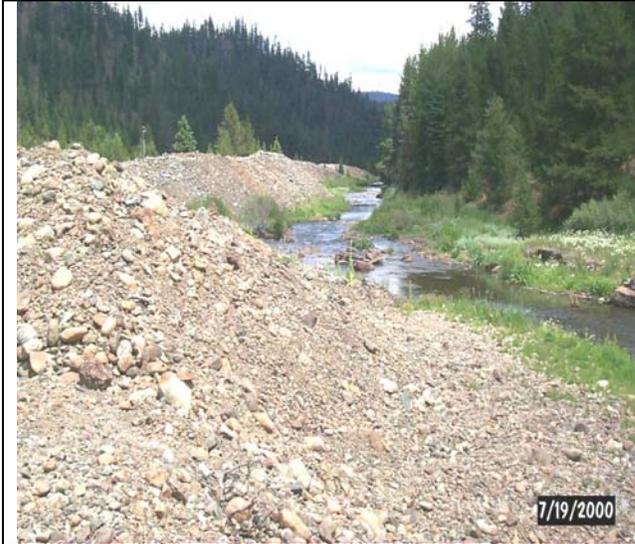
Photo Point 1  
Before Floodplain Restoration

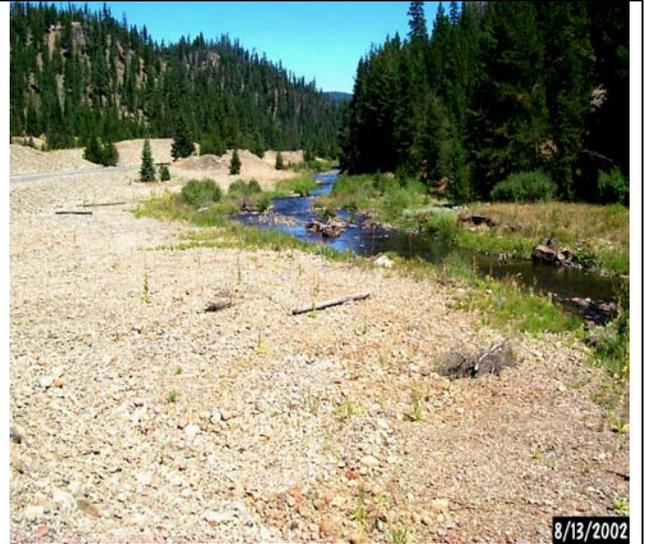
Photo Point 1  
After Floodplain Restoration

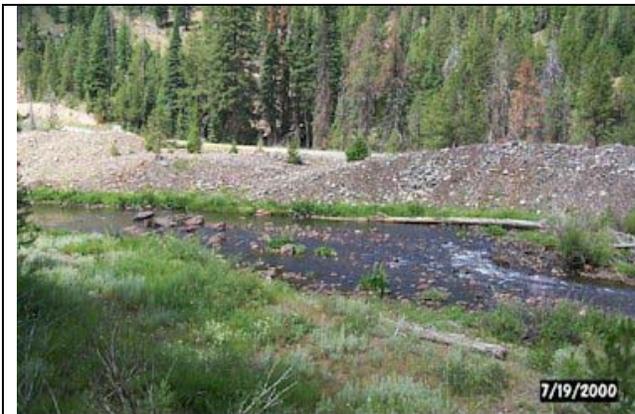
Photo Point 2  
Before Floodplain Restoration

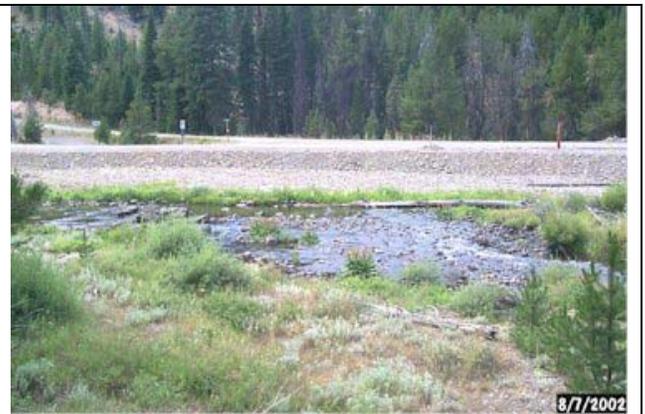
Photo Point 2  
After Floodplain Restoration

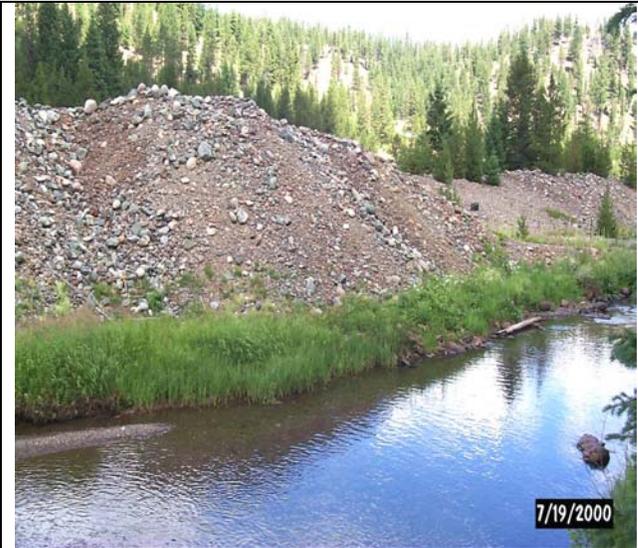
Photo Point 3  
Before Rock Haul

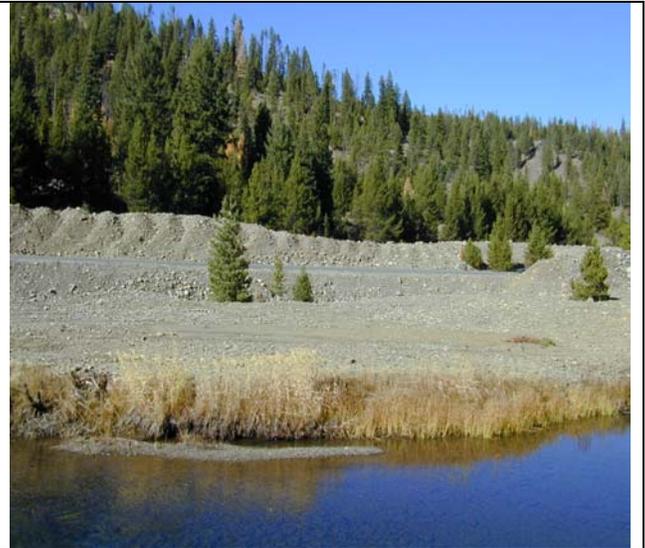
Photo Point 3  
After Rock Haul 10/24/2000

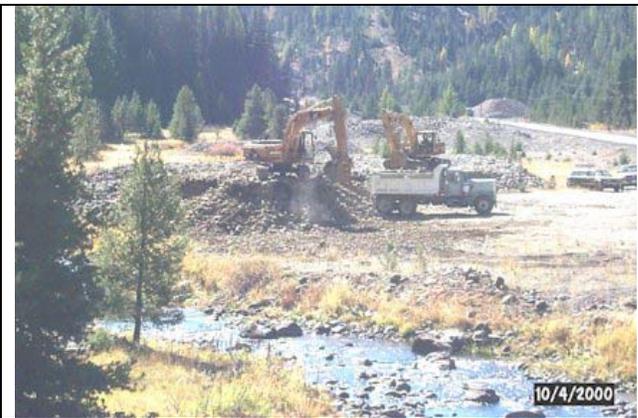
Photo Point 4  
Before Floodplain Restoration

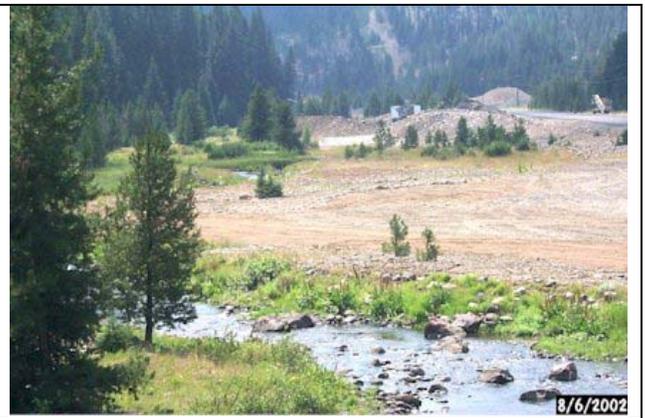
Photo Point 4  
Before Floodplain Restoration

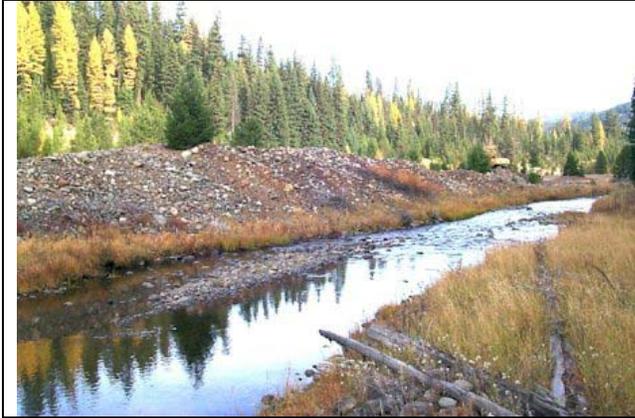
Photo Point 5  
Before Floodplain Restoration 10/2001

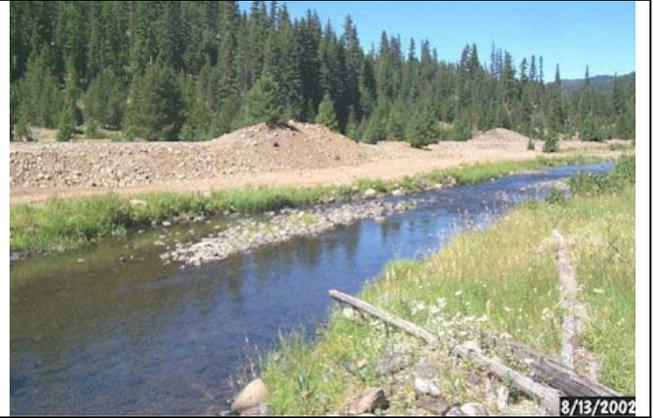
Photo Point 5  
Before Floodplain Restoration

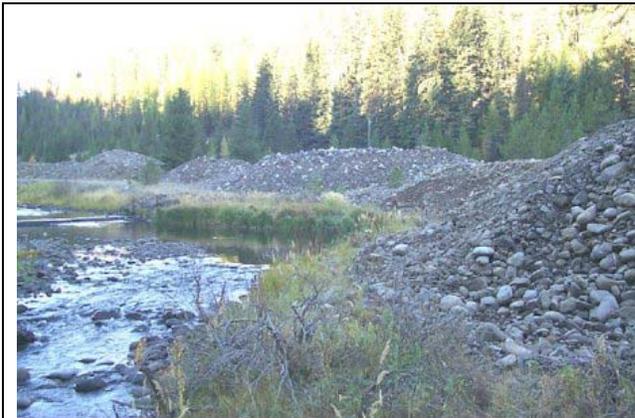
Photo Point 6  
Before Floodplain Restoration 9/2001

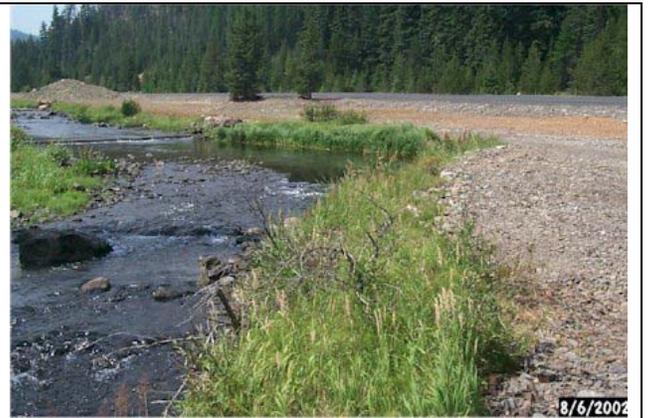
Photo Point 6  
Before Floodplain Restoration

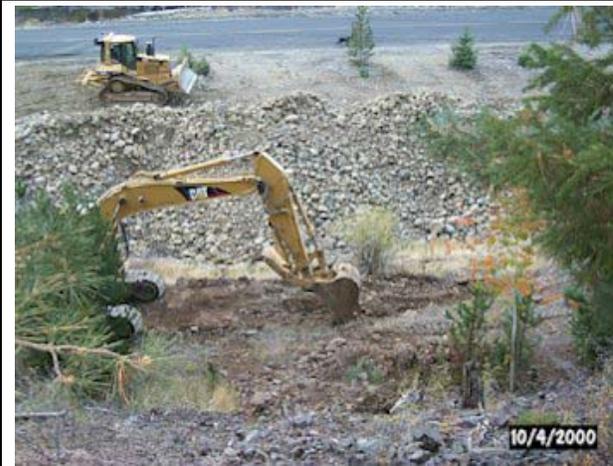
Photo Point 7  
Site Prep for the waste site

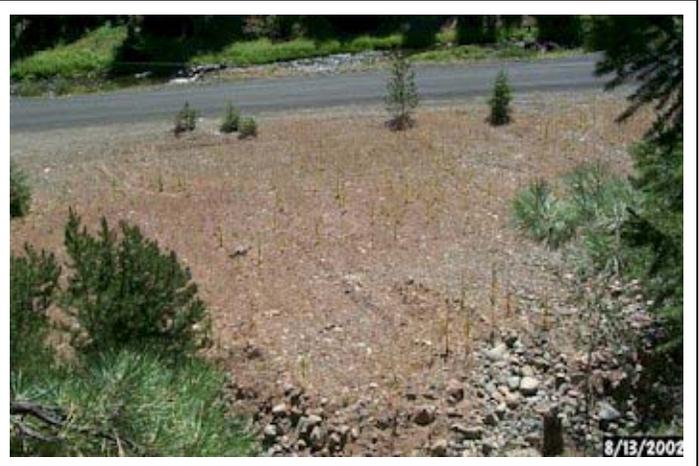
Photo Point 7  
Waste site hillside restoration completed
