John Day River Fish Habitat Enhancement

1989
ANNUAL PROGRESS REPORT

Oregon Department of Fish and Wildlife

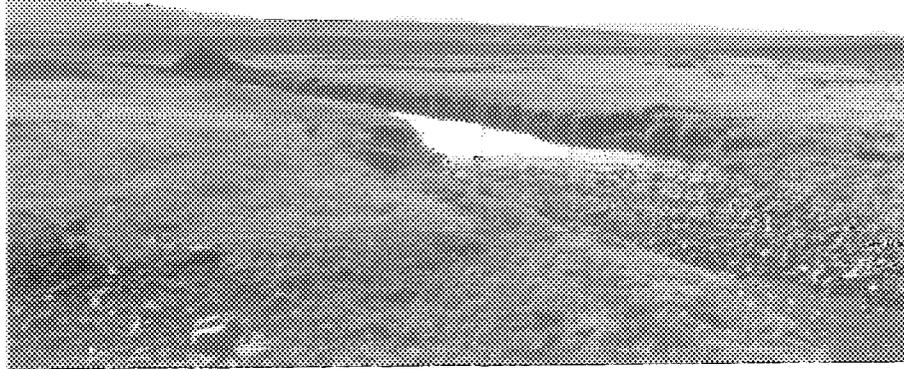
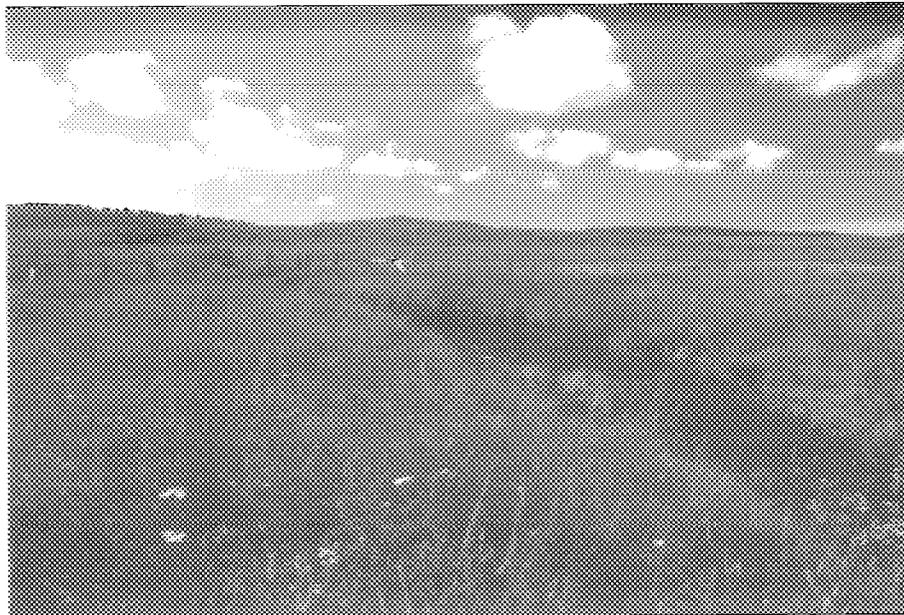
Fox Creek

Season long cattle grazing had left this creek with a wide, shallow profile that caused extreme water temperatures, provides little fish: cover and provides far very little bank storage of water. Riparian corridor fencing has allowed the vegetation to return and provide recovery for these undesirable conditions. After only two years of rest this stream reach has narrowed and deepened, began forming new banks instead of eroding them and flows with cooler water in the summer,

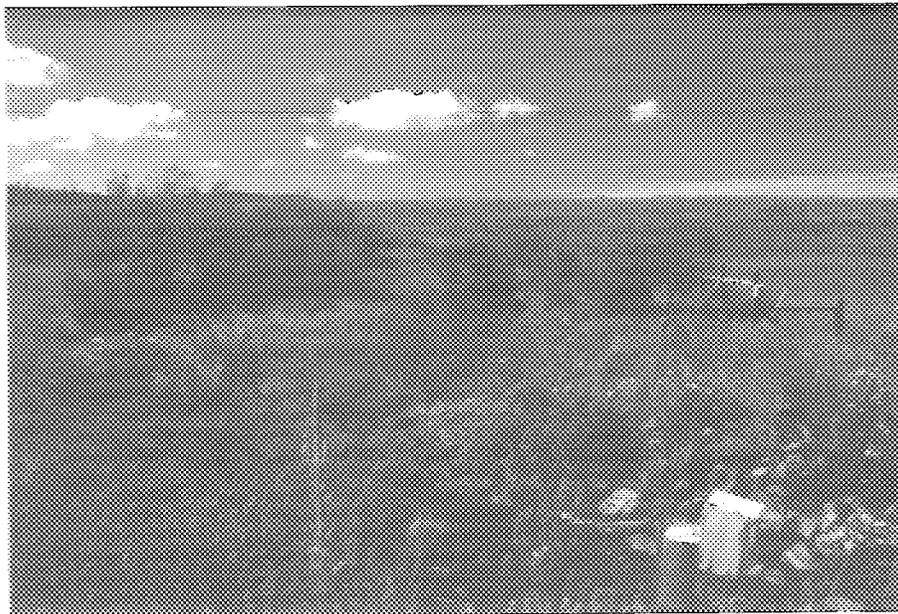
Fox Creek

Narrowing and deepening can also be accomplished by installing a rock checkdam and raising the water table.

Here we show one just constructed in the top photo and after 2 years in the bottom photo, allowing vegetation to recover will shade the water and allow it to remain even cooler.

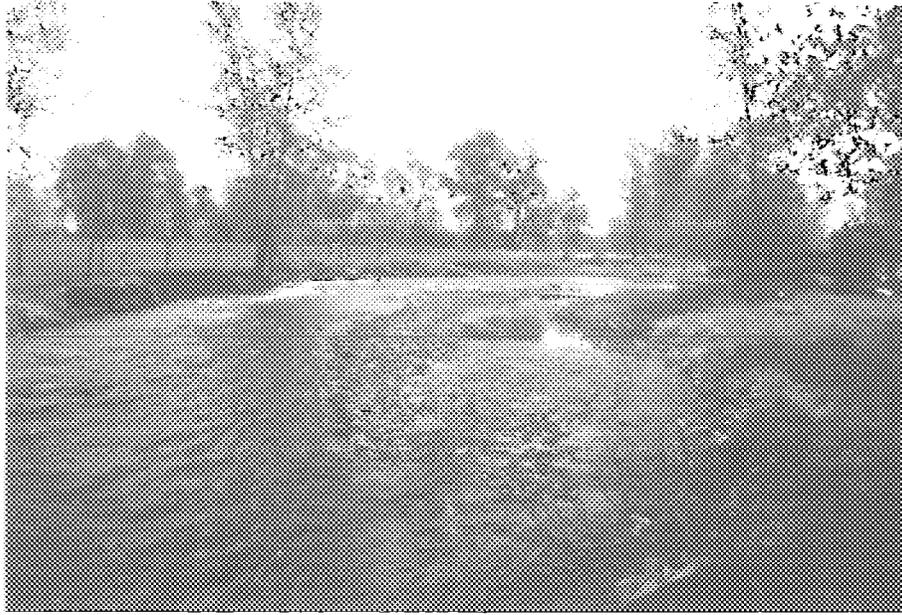
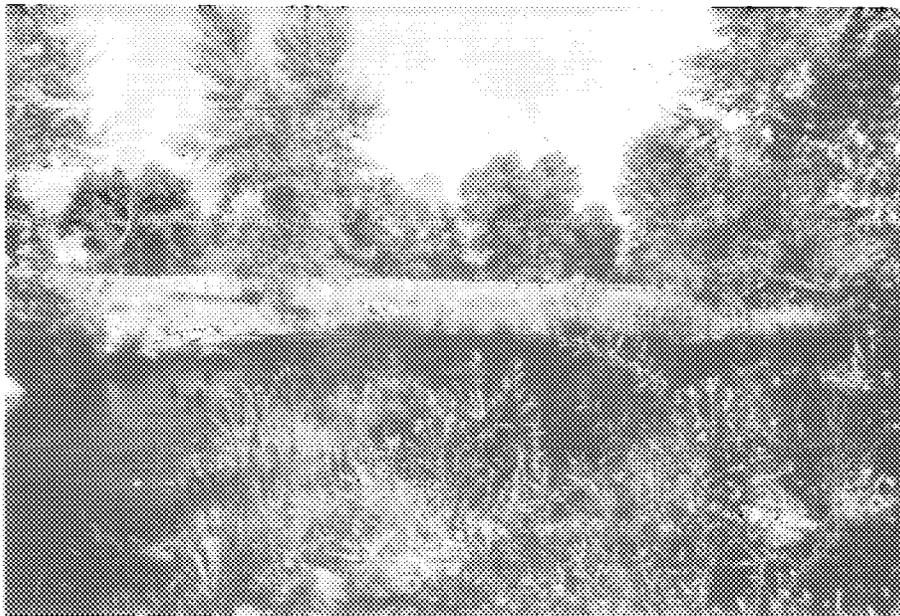
Mainstem John Day River

Narrowing and deepening of a stream reach is a very effective way to reduce stream temperatures. Here we accomplished this by armoring an eroding bank and excluding livestock.

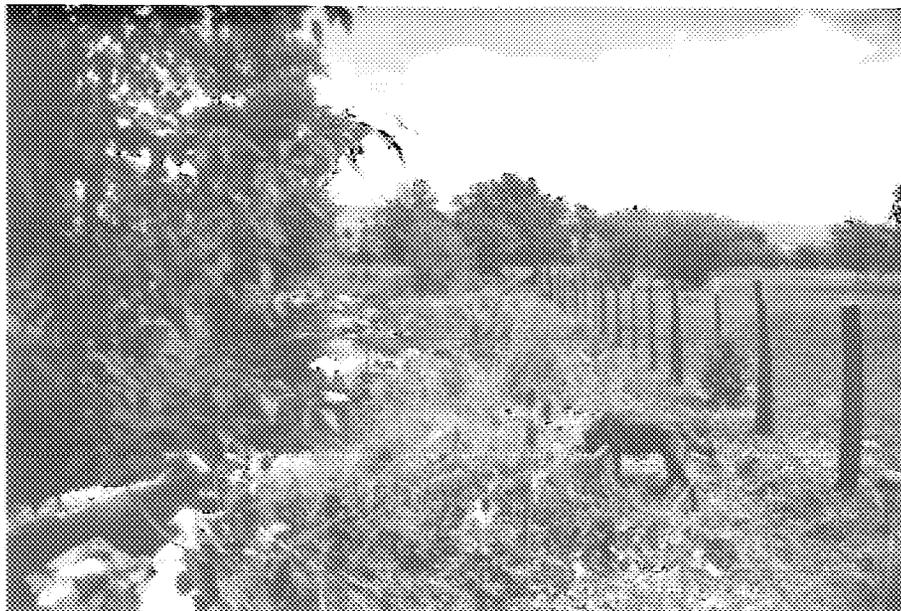
Minstem John Day River

The top photo shows a cutbank being eroded during spring flows within our Spring Chinook spawning grounds. This sediment later settles in and upon the salmon redds and smothers the eggs.

Erosion structures were placed to end the cutting, provide deep pools, and create more fish rearing cover, Riparian fence was constructed and now many cottonwood starts are visible that will eventually shade the river and provide bank support.

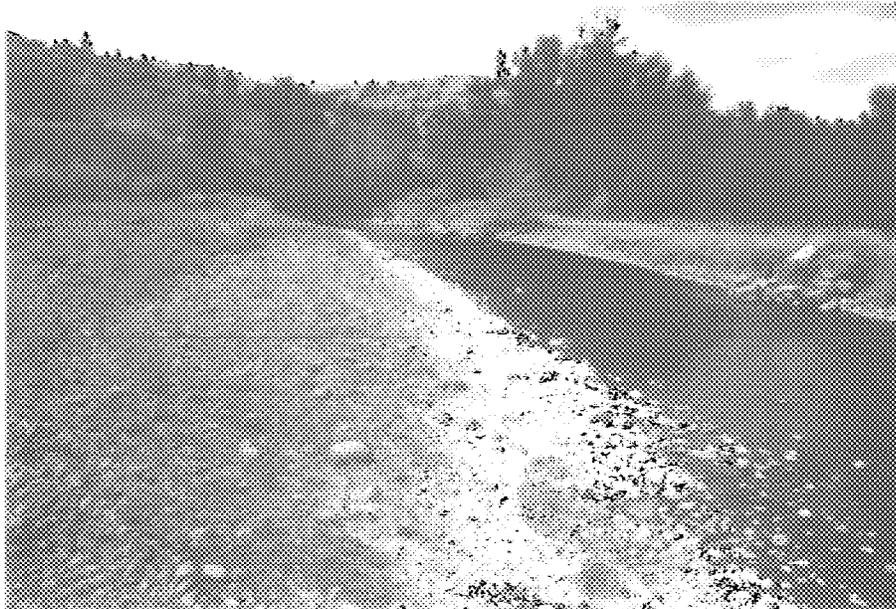
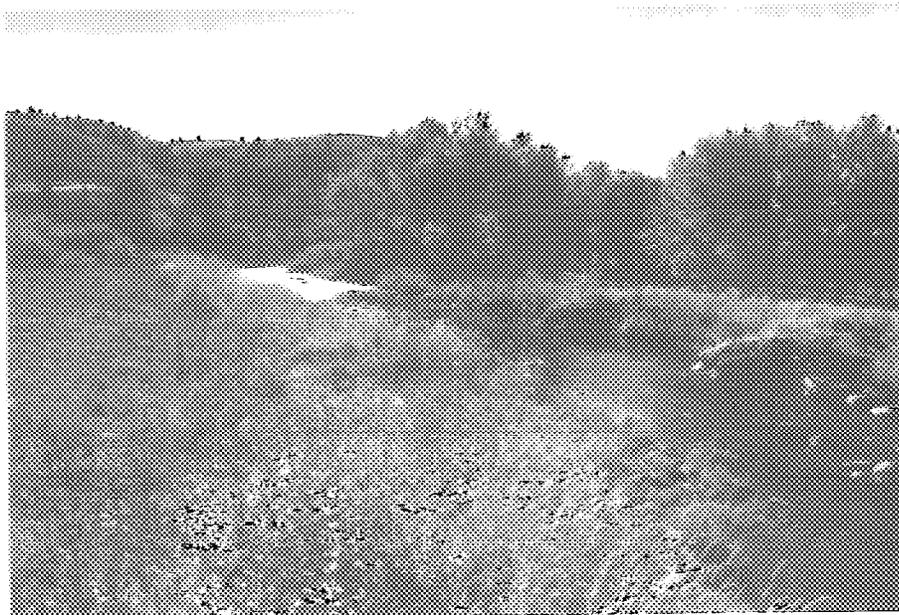
Mainstem John Day River

The top photo shows a wide, flat, featureless section of the river with a small jetty constructed at the landowner's expense. Very little fish cover exists. We were able to come in and construct the proper amount of jetties and insert some habitat boulders to narrow and deepen the channel and provide much more fish cover. Livestock exclusion has allowed streambank vegetation to begin a strong recovery.

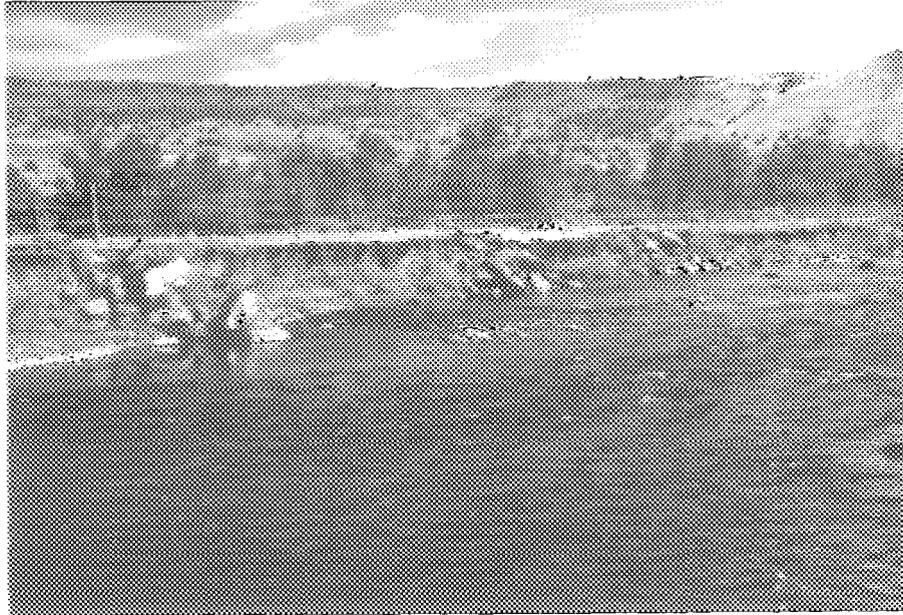
Maifestem John Day- River

Treeless riverbanks are the reason for a lot of problems affecting fish. With no shade the water temperatures become lethal, with no root masses the banks fall apart, and with no woody debris you get very little fish cover. This area demonstrates how to grow trees on a 4 ft. vertical bank. We used structures to collect sediment and fence to exclude livestock. After 4 years we now have young cottonwoods 8 to 12 feet tall.
