Wind River Watershed Restoration Project

US Forest Service

**Annual Reports
2000 - 2002**

Bair, Brian, Anthony Olegario, Paul Powers, David Doede, Eric Plimmer, Jennifer Deshong, "Wind River Watershed Restoration Project, Segment II", Project No. 1998-01900, 66 electronic pages, (BPA Report DOE/BP-00000407-1)

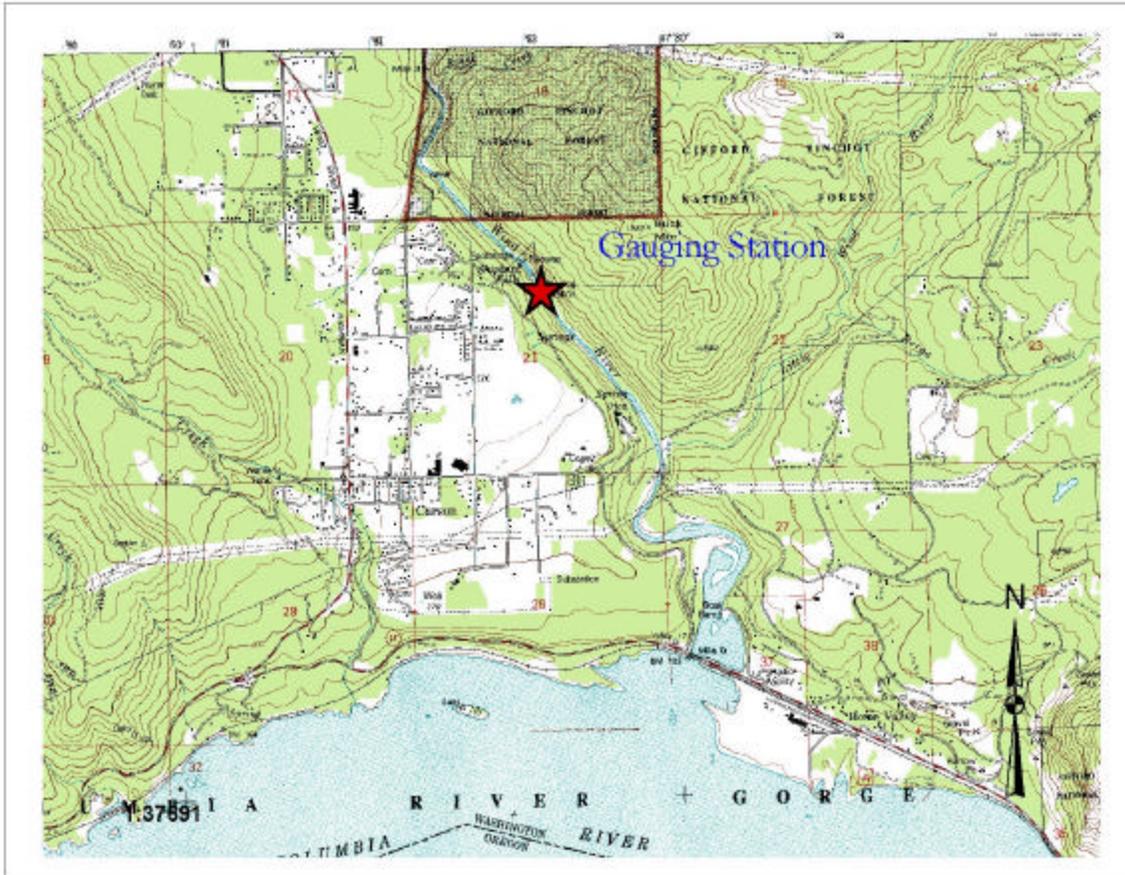
Figure 1. Gauge station location, T3N R3E Sect. 21, Skamania Co., WA.

Results and Discussion: The USFS was able to secure a utility easement through Washington Department of Fish & Wildlife property and installed a telephone cable approximately 1550 feet to the gauging station below Shipherd Falls on the Wind River. The data recorder and remote sever were installed and activated in May of 2002. Discharge data has been downloaded on a monthly basis since that time. Discharge profiles are currently being correlated with adult and smolt steelhead migration. In addition, the reactivated gage was programmed to call and alert technicians and biologist during rapidly changing flow conditions and has been instrumental in protecting the adult and smolt traps.

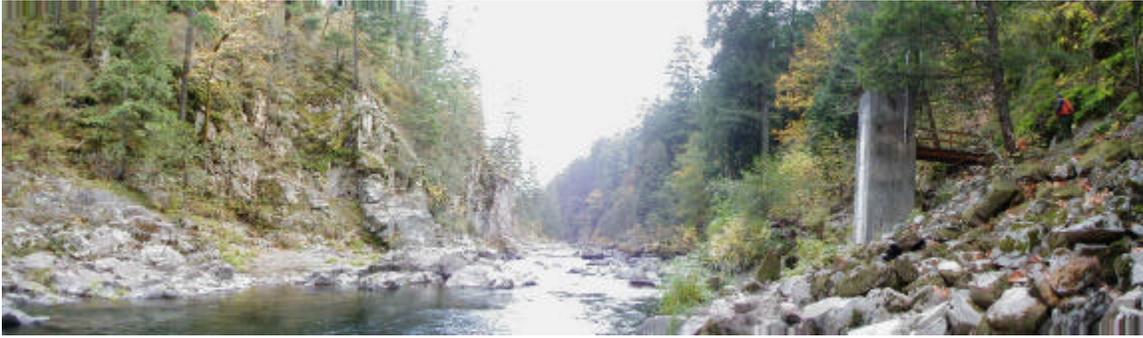
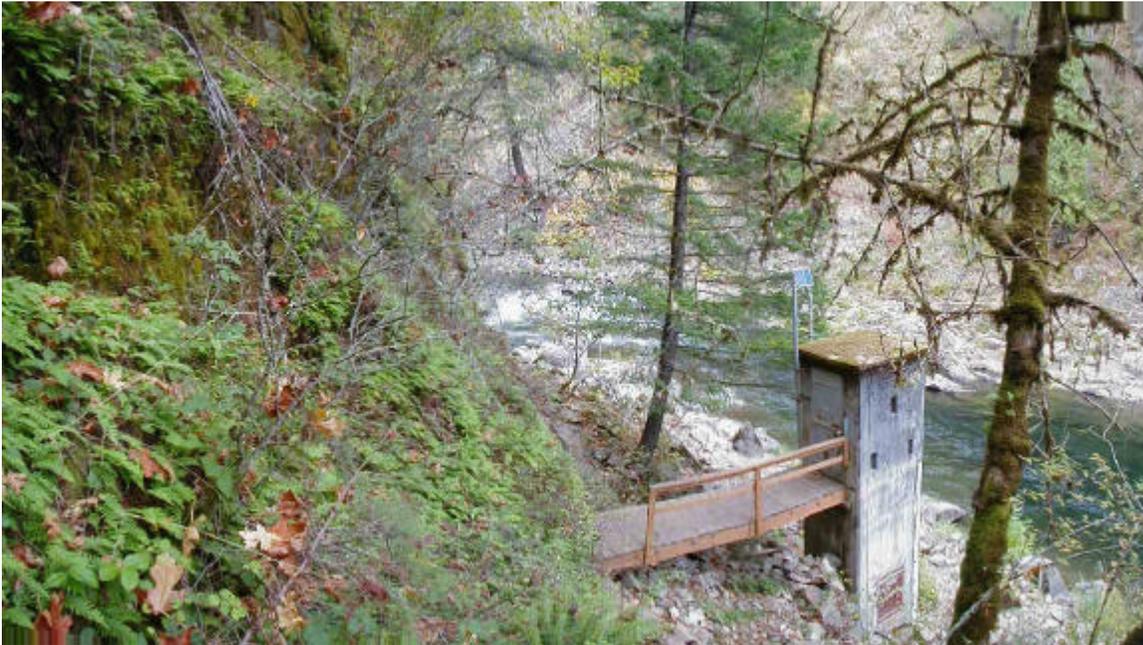
Photo 1. Downstream (top) and upstream (bottom) views of the gauge station on the Wind River just below Shipherd Falls.

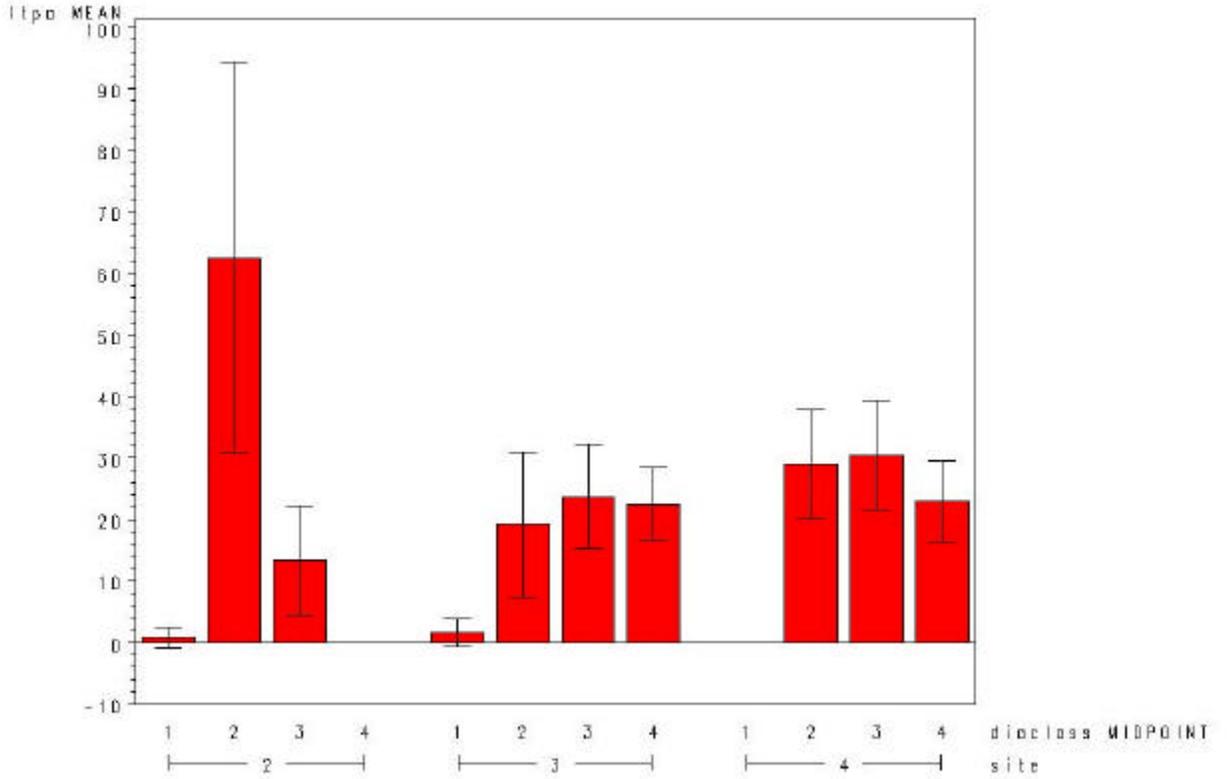
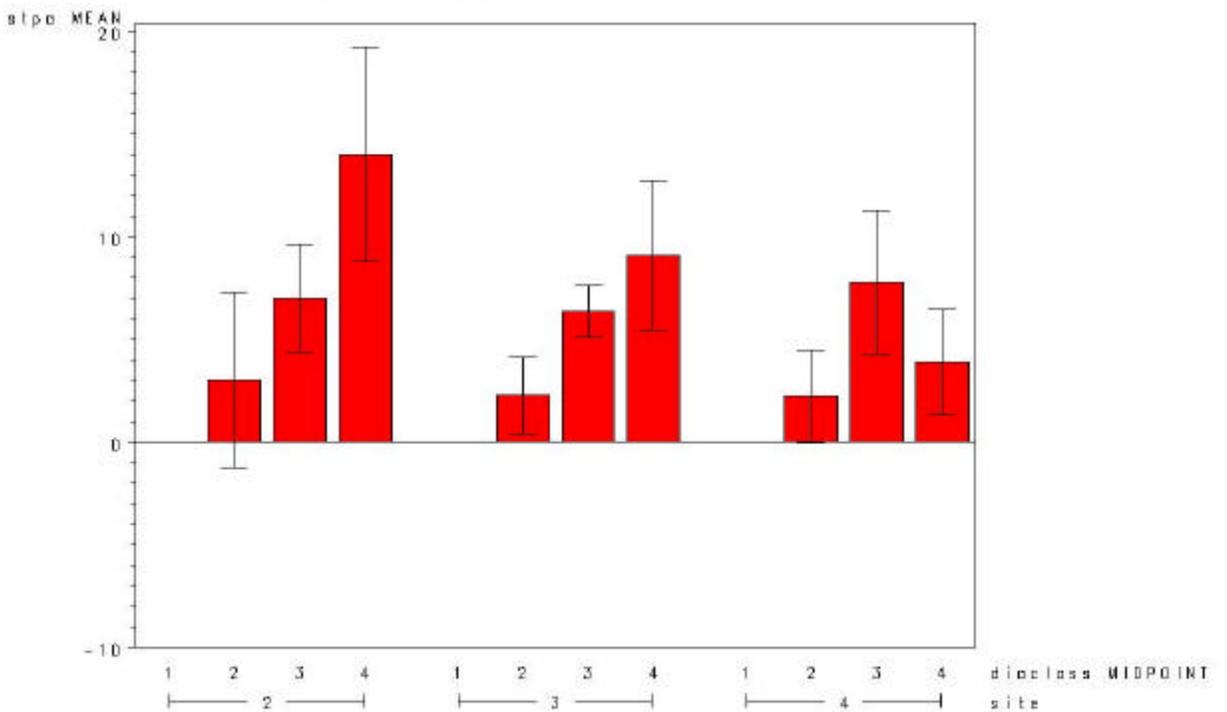
Figure 5. Average live and snag TPA (error bars are 80% confidence intervals) by diameter class for 3 sites (2=Crater, 3=Trout Cr., 4=Wind R.).

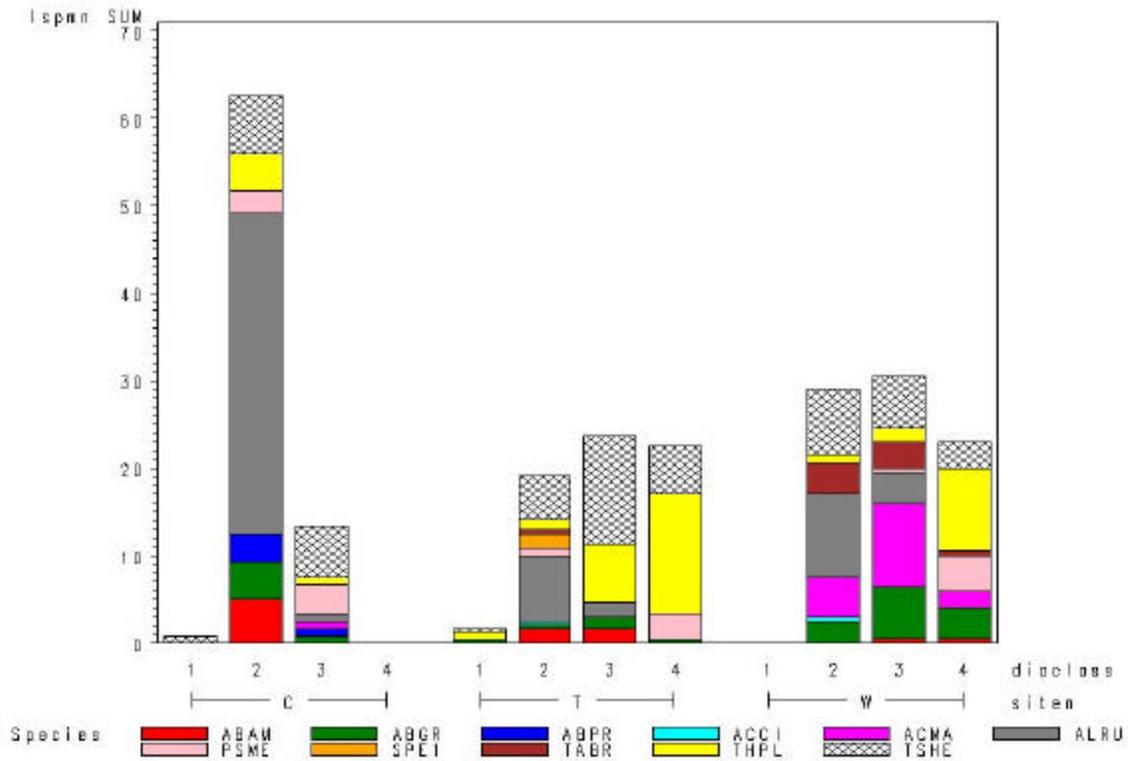
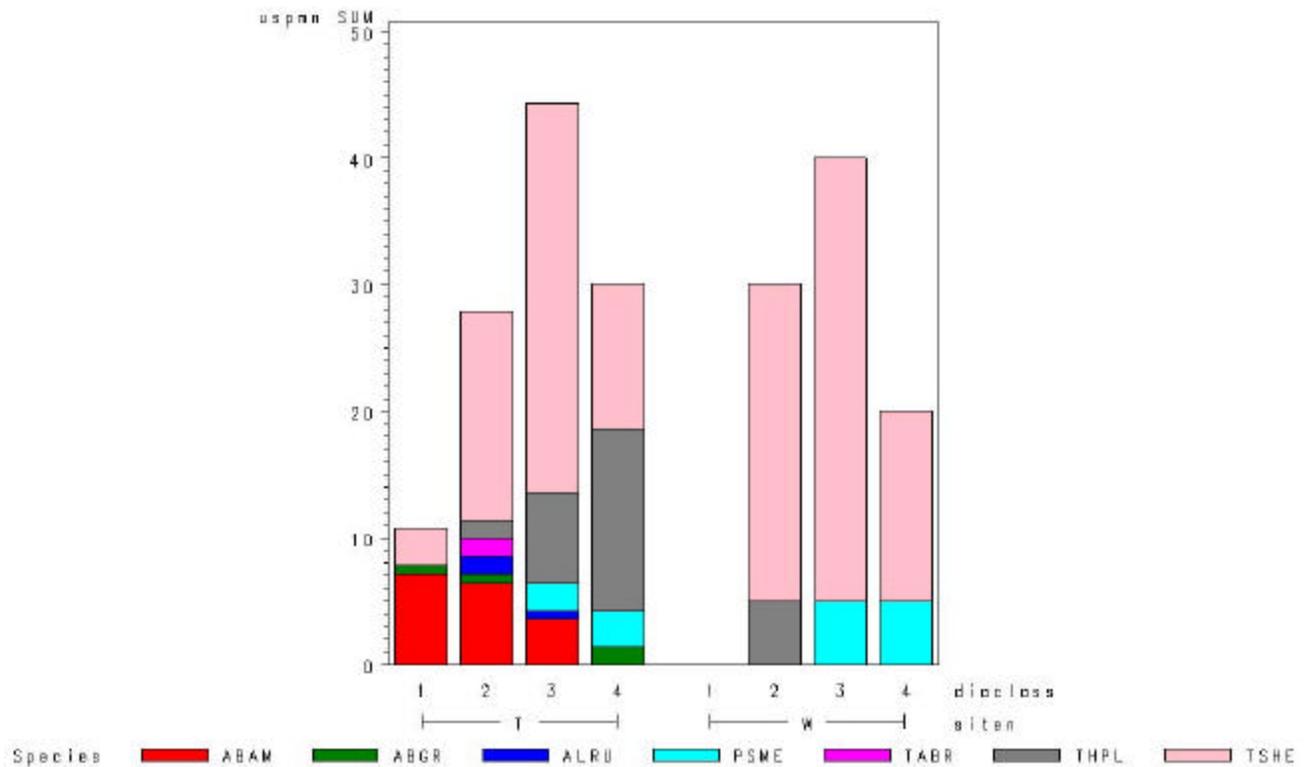
Figure 6. Species distribution (in trees per acre) for lower and upper riparian areas at 3 sites. (CR=Crater, T=Trout Cr., and W=Wind River.)

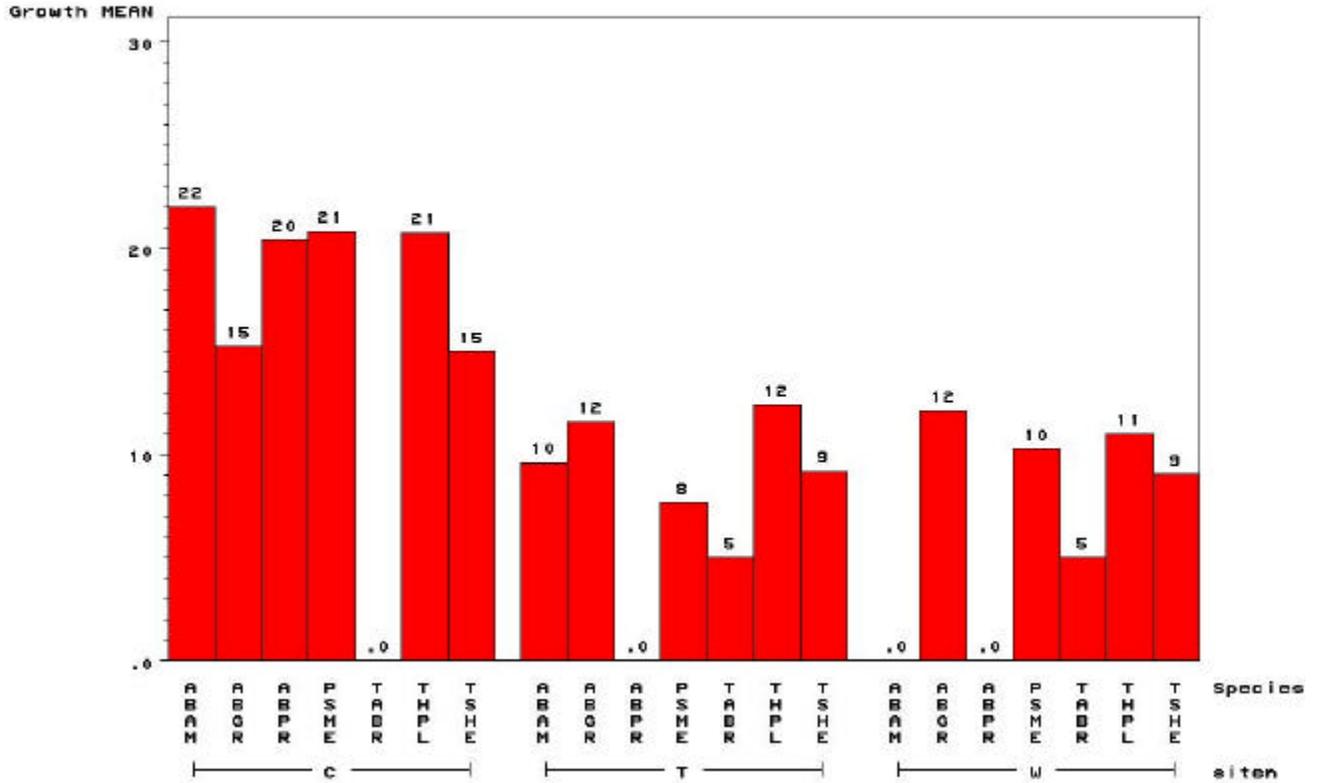
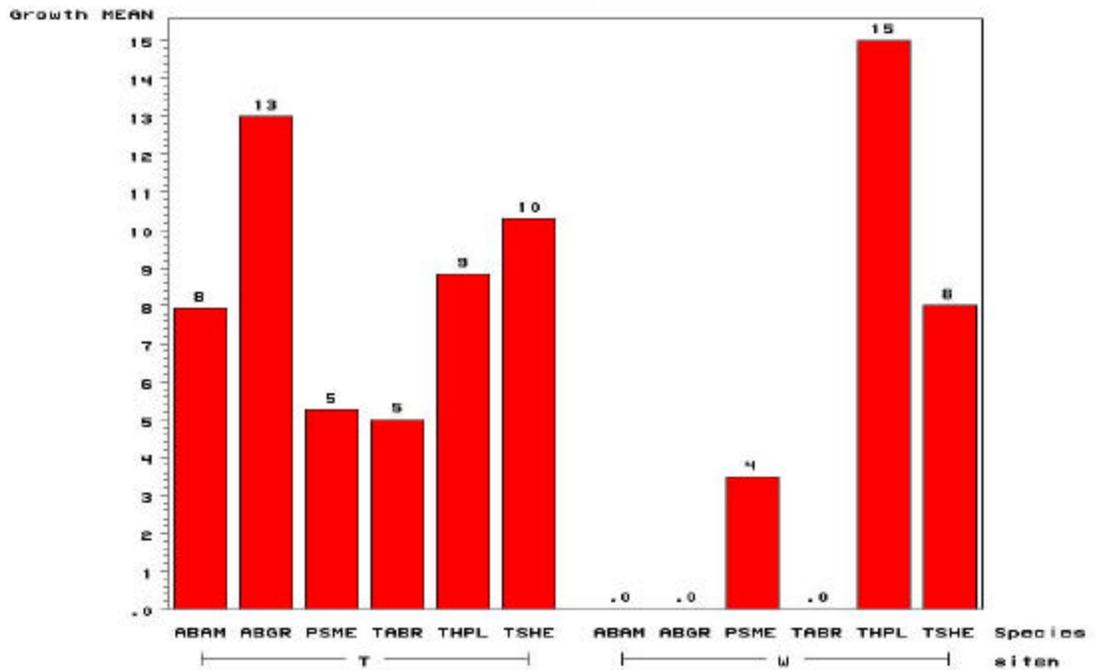
Figure 7. Mean growth rate by species for lower and upper riparian areas at CR, TC, and WR sites.

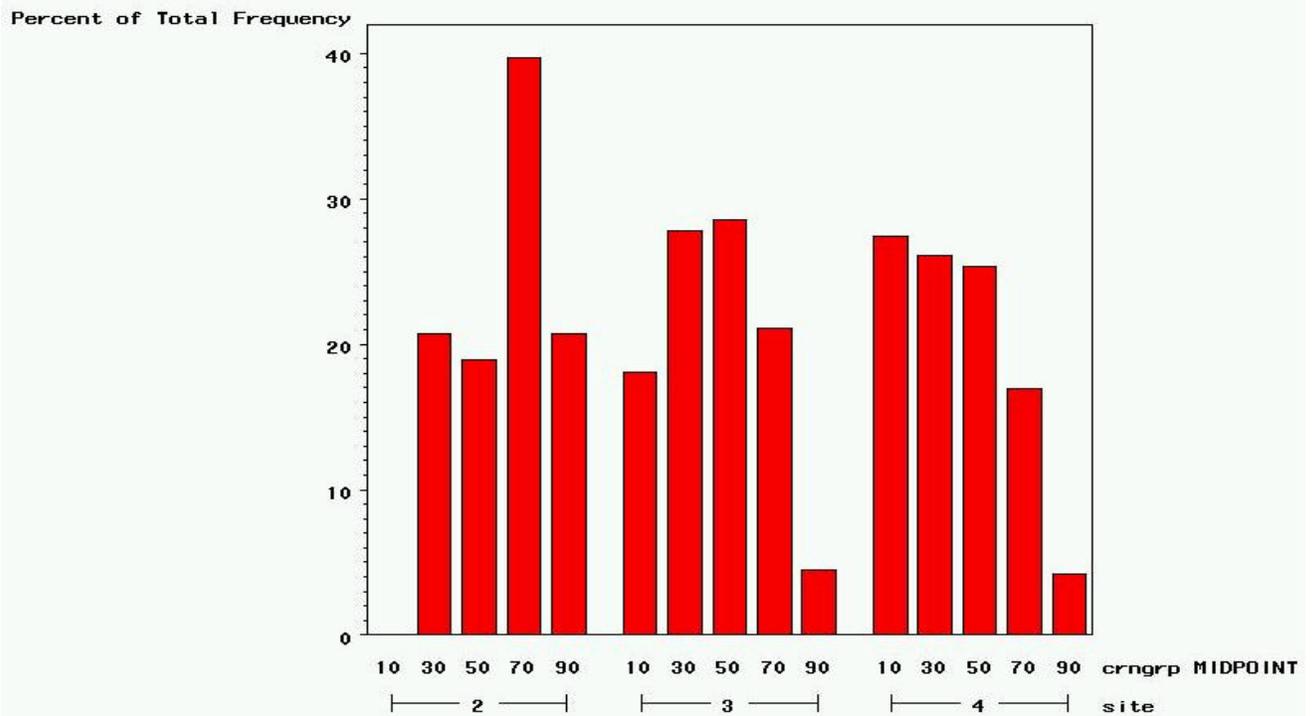
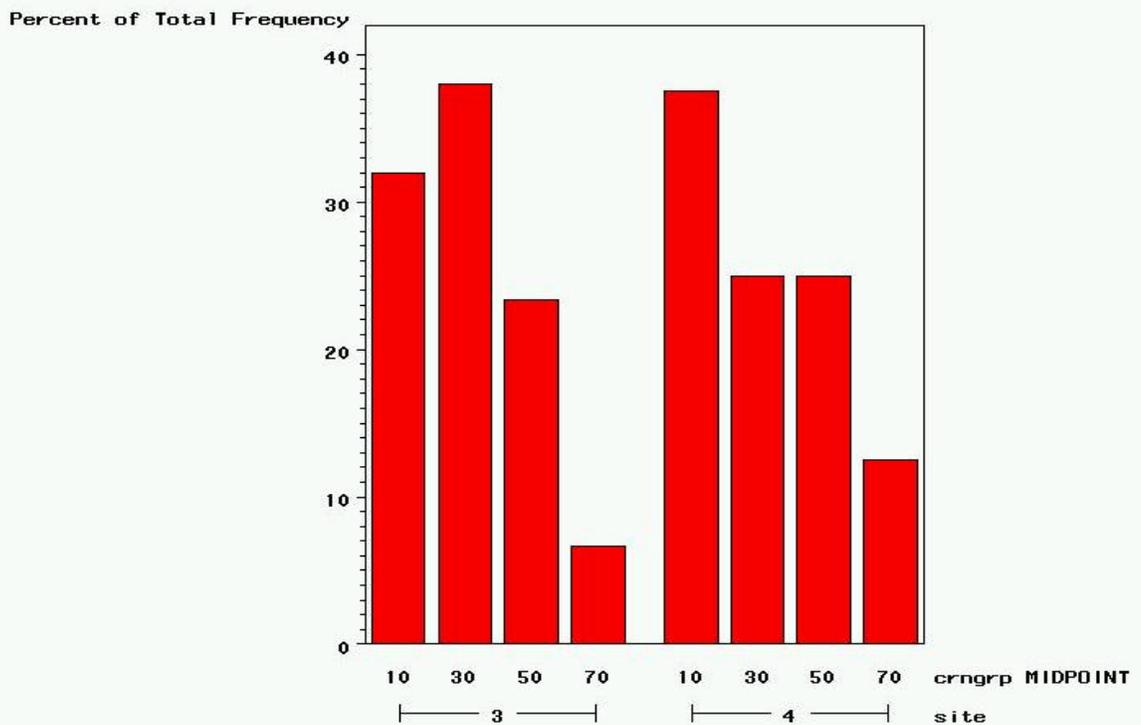
Figure 8. Crown ratio distribution of sample trees at lower and upper riparian areas at CR, TC, and WR sites.

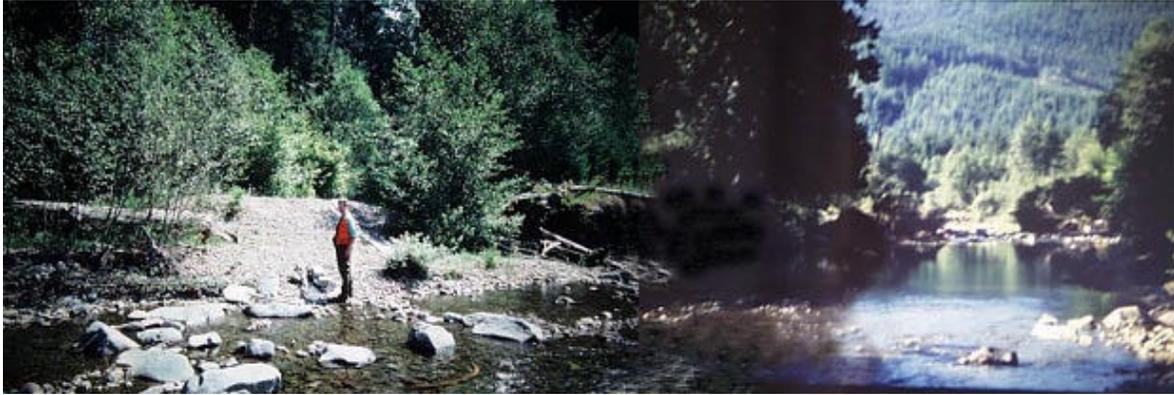
Photo 2. 1995 Photo of the entrance to the Trout Creek old growth channel, Skamania County, WA. A logjam that was thought to be a migration barrier was removed in 1981. The removal of the logjam initiated the channel to “down-cut” or degrade approximately five feet below the original bed elevation. As the channel degraded the connectivity with the flood plain and the last remaining old growth reach in Trout Creek. (Photos Bair)

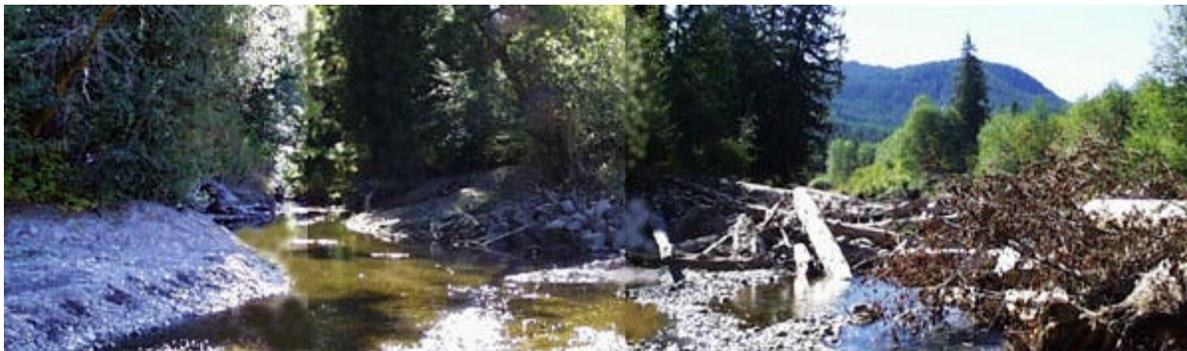
Photo 3. 1999 Photo of the entrance to the Trout Creek old growth channel after restoration of logjam. Stream bed was aggraded over four feet to regain connectivity with flood plain and reactivate 0.8 of a river mile of pristine habitat.

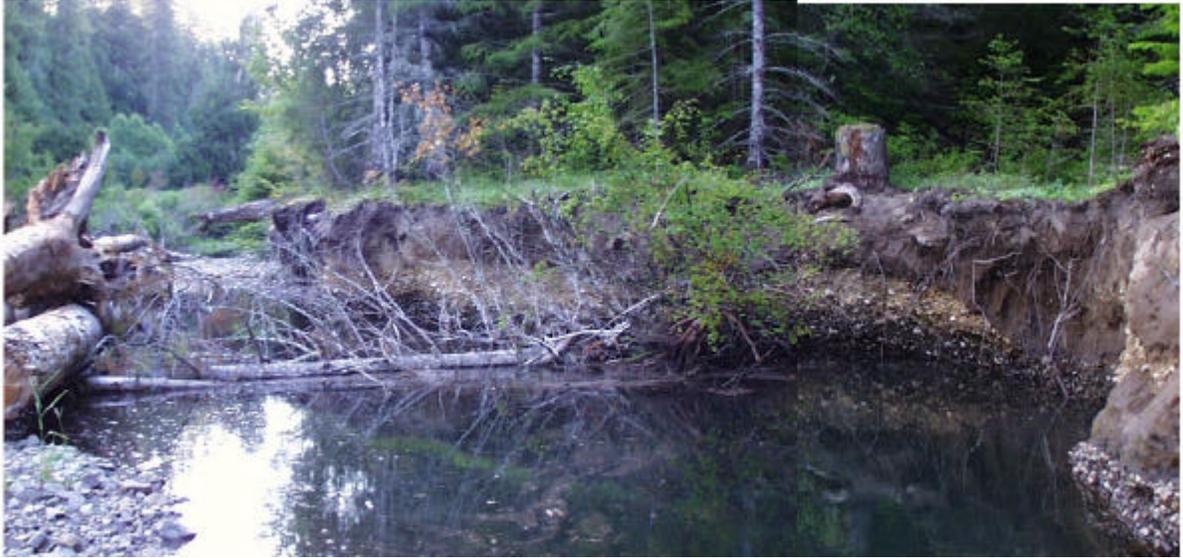
Photo 4. Photo of severe bank erosion on Trout Creek (river mile ~ 7.3) caused by removal of riparian vegetation, in-stream LWD removal and channel degradation. Skamania County, WA. (Photo Bair)

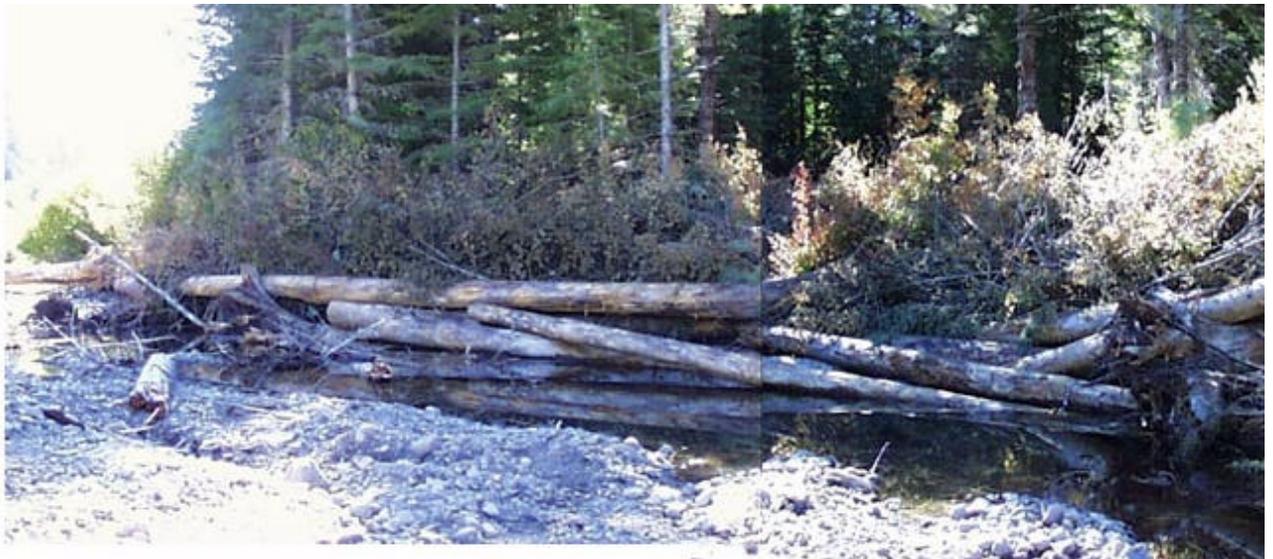
Photo 5. Photo of LWD revetment to reduce bank erosion. Trout Creek (river mile ~7.3), Skamania County, WA. (Photo Bair)

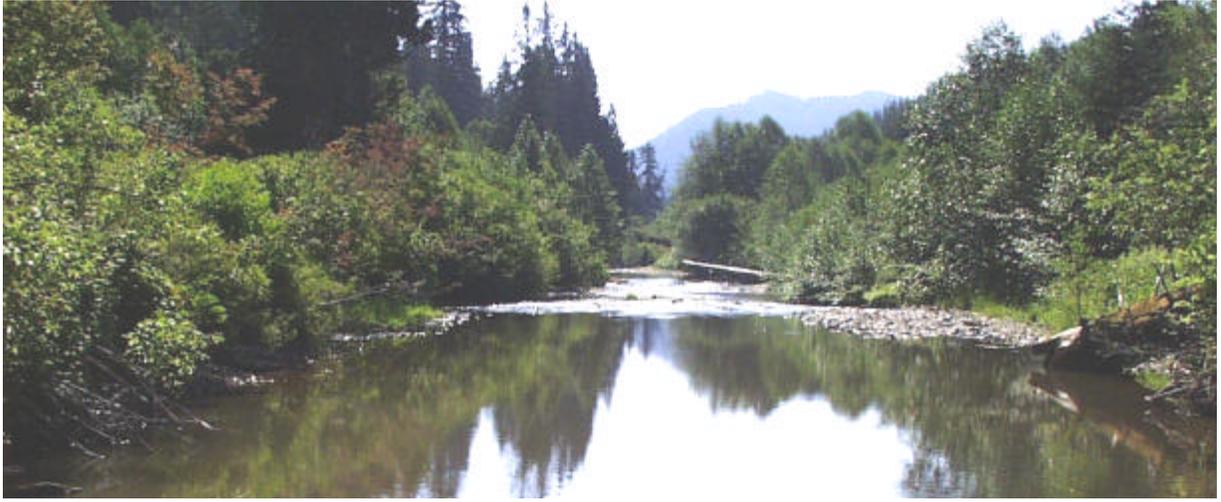
Photo 6. Large width to depth ratios and low stream shade depicted in the above photo increase maximum water temperature and provide poor quality rearing habitat for steelhead. Trout Creek ~ river mile 7.1, Skamania County, WA. (Photo Bair)

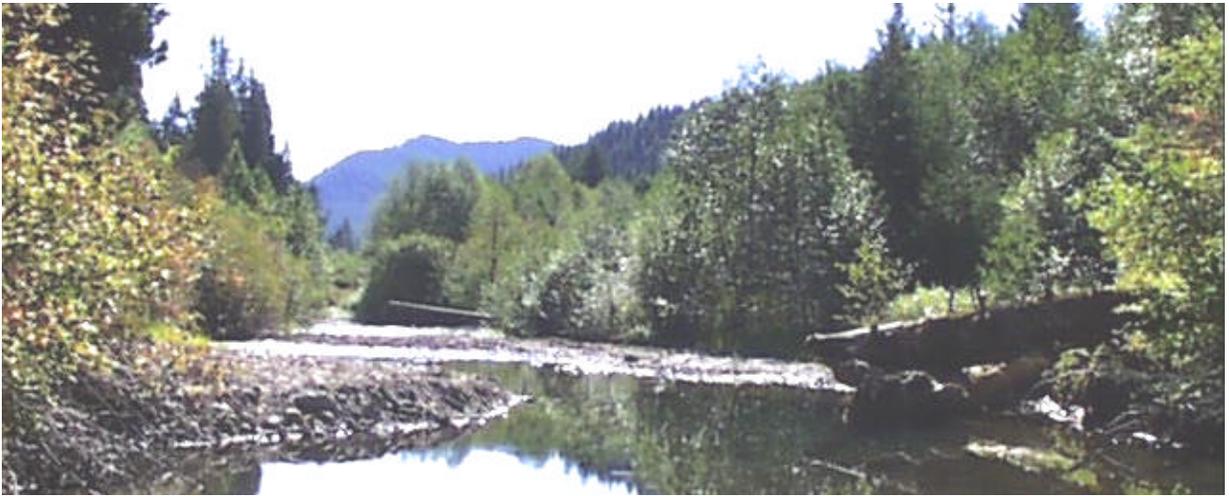
Photo 7. Width to depth ratios were reduced by excavating pools and constructing gravel bars based on empirical hydraulic and geomorphic template data. Width to depth ratios for this photo sequence was reduced from 66 to 17. Trout Creek ~ river mile 7.1, Skamania County, WA. (Photo Bair)

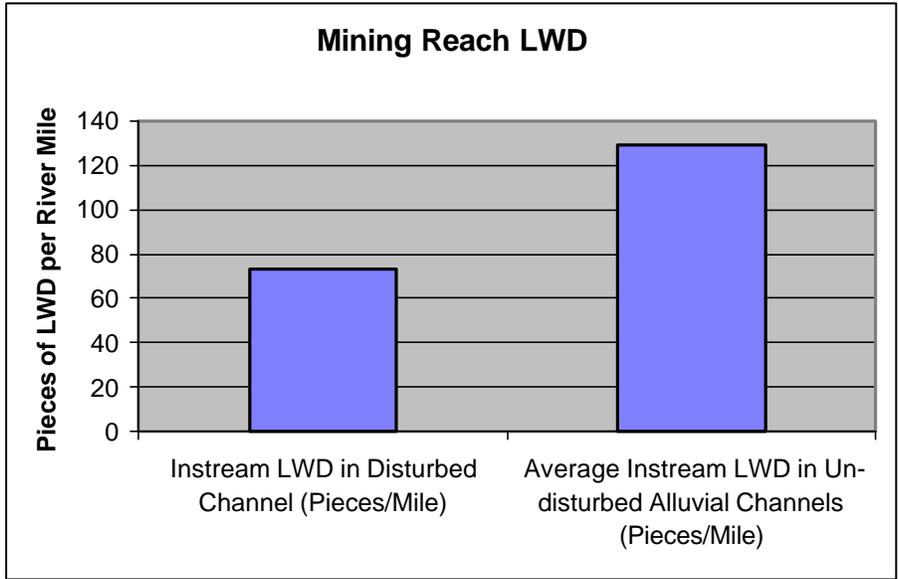
Figure 13. Comparison of existing LWD observed in the Mining Reach and average LWD per river mile observed in 13 alluvial reaches of stream within Wind River, Skamania County Washington. LWD is defined as pieces >24” in diameter and >50’ in length.

(5) Increase in-stream large woody debris >100 pieces per river mile (70 years); LWD increased from 42 pieces per kilometer (67/river mile) to 210 pieces per kilometer (336/rivermile) as a result of treatment.

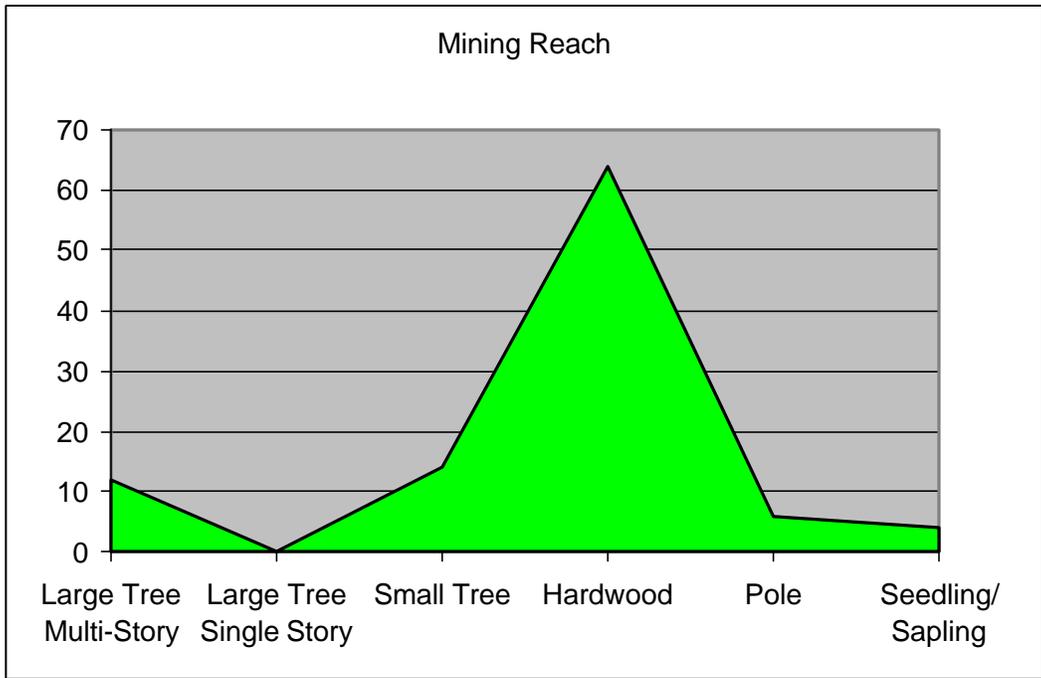
Figure 14. Percent composition of riparian stands* by seral class for the Mining Reach of the Wind River, Skamania County Washington.

* Riparian stands are delineated by the Aquatic Conservation Strategy standards; 360’ from bank full channel. Seral class definitions: Large tree = 48”-32” in diameter, Small tree = 32”-9” in diameter, Hardwood = alder, maple, cottonwood, Pole = 9”-5” in diameter, Seedling/Sapling = <5” in diameter, Large tree multi-storied is a mix of large and small class/ old growth.

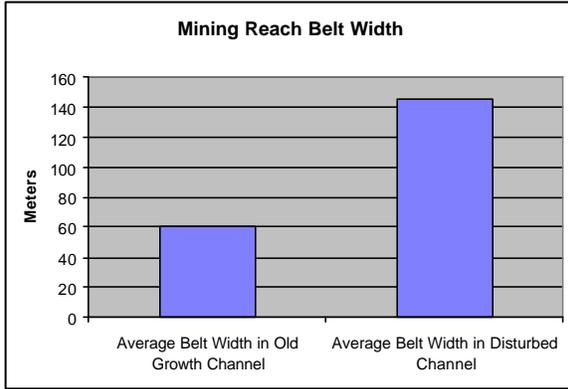
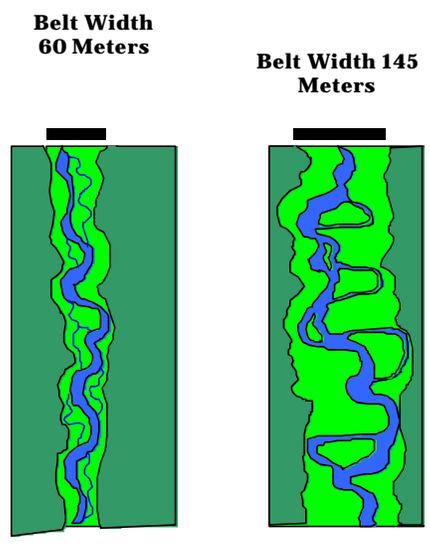
Figure 15. Comparison of belt widths in old growth and disturbed channels for the Mining Reach of the Wind River, Skamania County WA.

Narrative: The project area was railroad logged from late 1920's to the mid 1930's. The entire riparian area was denuded of its old growth. Riparian areas and channels have not recovered due to the lack of in-stream wood needed for velocity modification that protects young riparian stands from floods. The result has been an acceleration of lateral channel migration that has severely degraded water quality and fish habitat. Stream survey data and aerial photo analysis depict the problems found in the mining reach. Figures 3-6 show the existing channel conditions relative to the up-stream old growth reach and other similar undisturbed channels within the watershed. Large woody debris (>24" in diameter, >50' in length) within undisturbed reaches averaged 120 pieces per river mile in the Wind River watershed. Within the Mining reach average LWD was 73 pieces per river mile (Figure 10). Riparian areas within the Mining reach are dominated with deciduous species such as alder, which will provide limited future LWD (Figure 11). Alder is an early successional species important to aquatic ecosystems. Alder typically reaches climax and die after 30 years. The dominance of alder within this reach 70 years after being logged indicates that channel disturbance has been frequent and the channel or riparian areas have not made significant progress in recovering. Analysis of belt widths provides additional evidence of accelerated disturbance and poor channel stability. Belt width is the width in which a stream contains its meanders. Belt widths in the up-stream section of the Mining reach are dominated with old growth timber. Belt widths within this reach averaged 60 meters compared to an average belt width of 145 meters in the

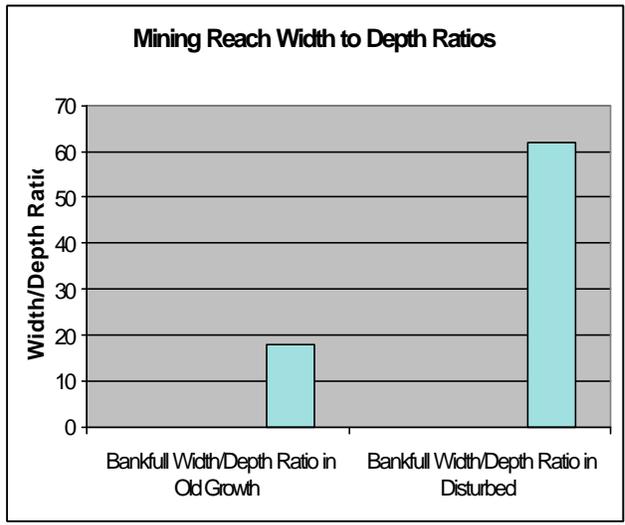
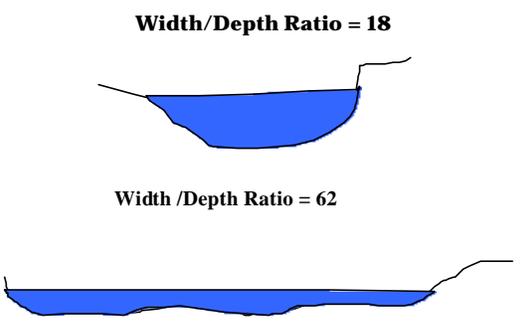
Figure 16. Comparison of the average width to depth ratios in old growth and disturbed channels for the Mining Reach of the Wind River, Skamania County WA.

logged reach just down-stream (Figure 12). Bank full width to depth ratios also provides evidence of poor channel stability and habitat conditions. Bank full width to depth ratios within the old growth Mining reach averaged 18. Down-stream in the logged reach bank full width to depth ratios averaged 62 (Figure 13).

(4) reduce bank full width to depth ratios within identified reaches to less than 25 (2 years); Bank full width to depth ratios decreased by 40%, from 87 to 51 and low flow width/depth ratios decreased 56%. This still falls short of our bank full objective of 25 but we expect a continued decrease of width to depth ratios as structures accumulate fines and scour pools. Pool volume increased by 520% which indicates that habitat conditions are heading in the right direction.

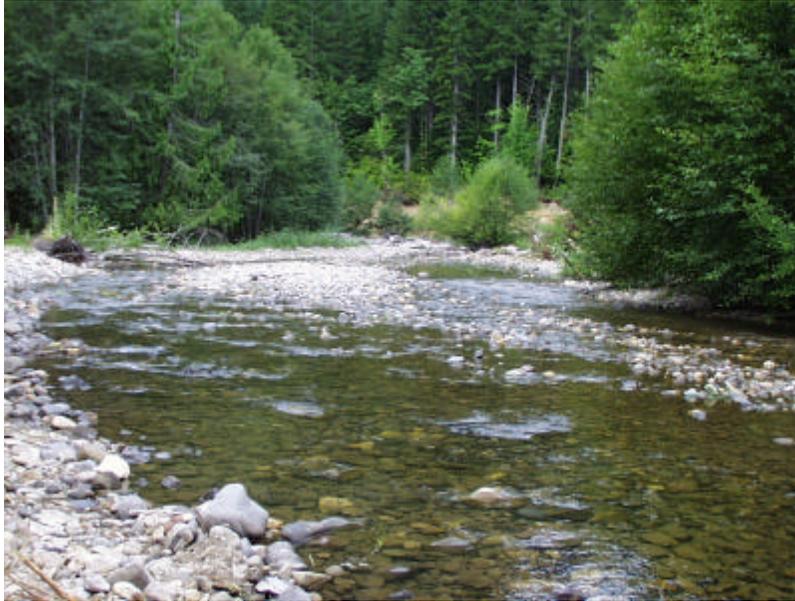
Photo 8. “Mining Reach” of the Wind River river mile ~24.3, Skamania County, WA. Photo Bair, August 1999. The logging that occurred in the early part of the century within the Mining Reach removed the natural lateral stability of the channel. Belt widths and width to depth ratios increased and as a result bank stability, stream shade, pools and cover have been greatly reduced.

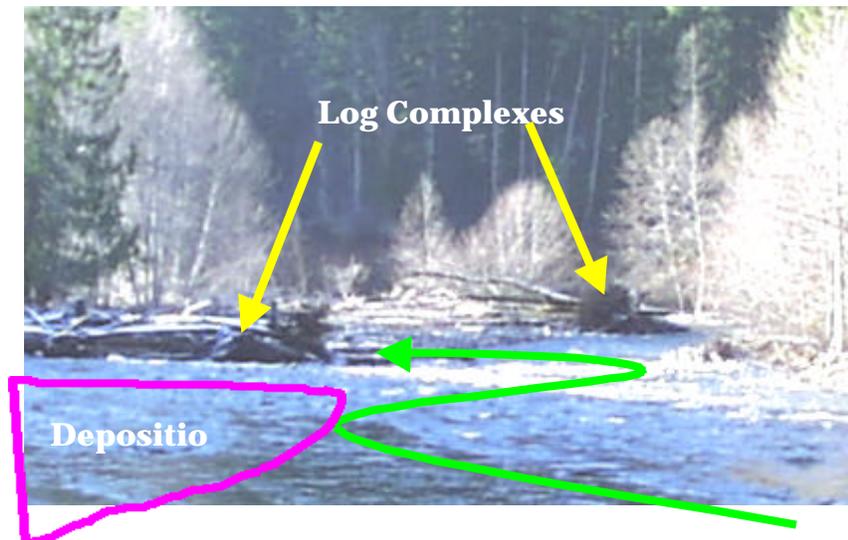
Photo 9. “Mining Reach” of the Wind River river mile ~24.3, Skamania County, WA. Photo Bair, December 1999. This photo is taken in the same location as the one above to demonstrate how log complexes were installed to reconstruct meanders, restore sinuosity, lateral stability, width to depth ratios and restore historic belt width. In addition these structures scour pools and provide hiding cover for adult and juvenile steelhead.

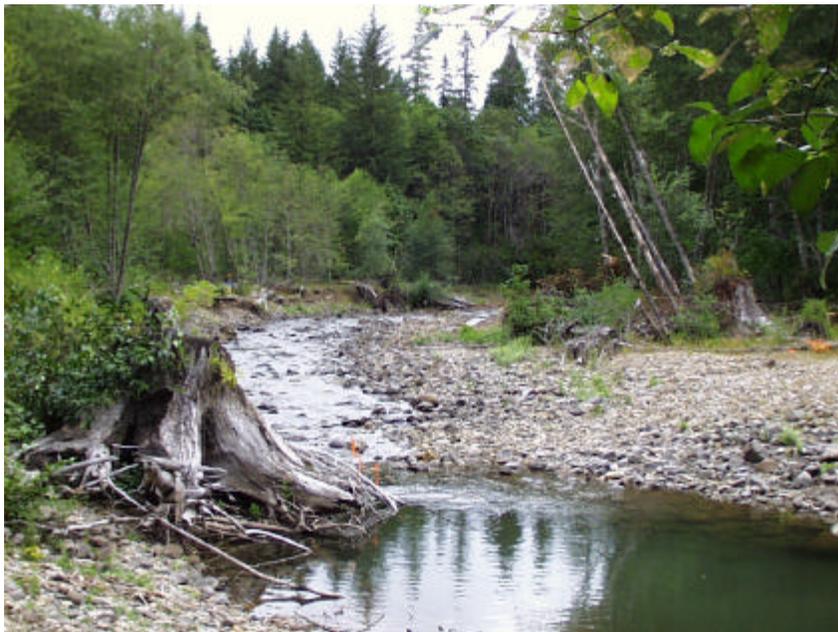
Photo 10. “Mining Reach” of the Wind River, mile ~24.7, Skamania County, WA. Photo Bair, July 1999. Lack of lateral stability promotes meander “cut-off” such as the one shown above. When the channel loses sinuosity channel slope and pool spacing increase, stream bed degrades and the channel becomes incised and drops out of the flood plain. Severe bank erosion ensues as the stream creates a new flood plain.

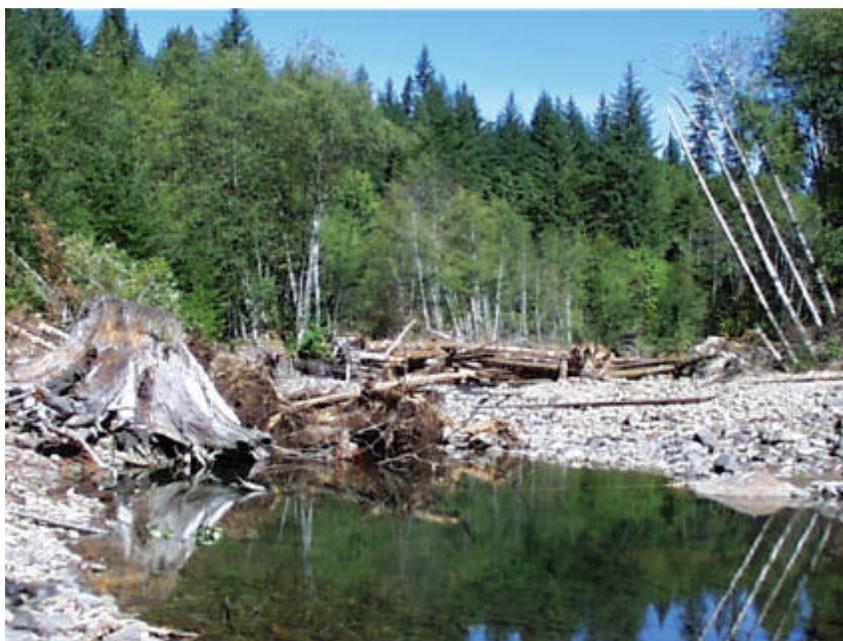
Photo 11. “Mining Reach” of the Wind River, mile ~24.7, Skamania County, WA. Photo Bair, August 1999. Logjams were installed as natural grade controls to aggrade the channel, restore sinuosity, flood plain connectivity, bank and channel stability.

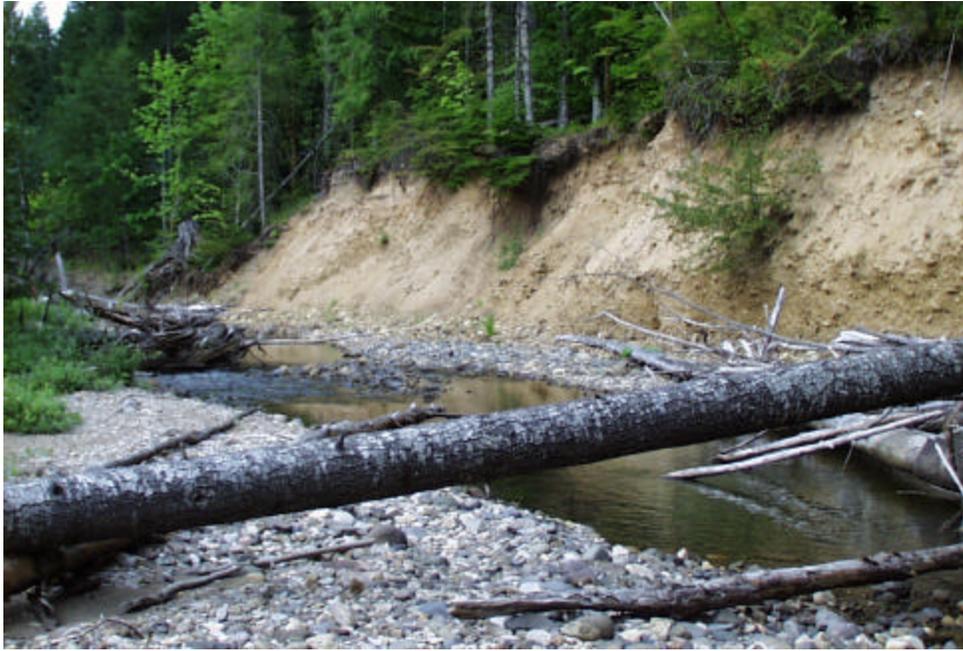
Photo 12. “Mining Reach” of the Wind River, mile ~24.0, Skamania County, WA. Photo Bair July 1999. Mass wasting from banks such as these can introduce very large quantities of coarse and fine sediment to spawning substrate in the reaches below.

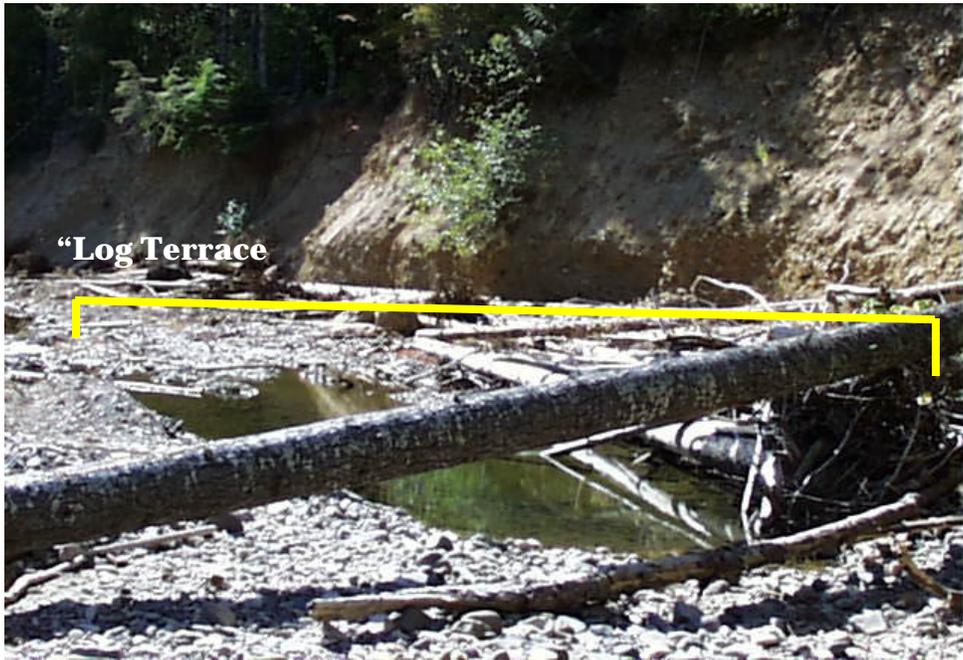
Photo 13. “Mining Reach” of the Wind River, mile ~24.0, Skamania County, WA. Photo Bair August 1999. “Log terrace toes” were constructed at the bank full elevation to prevent undermining of the slope and reduce delivery of coarse and fine sediments.

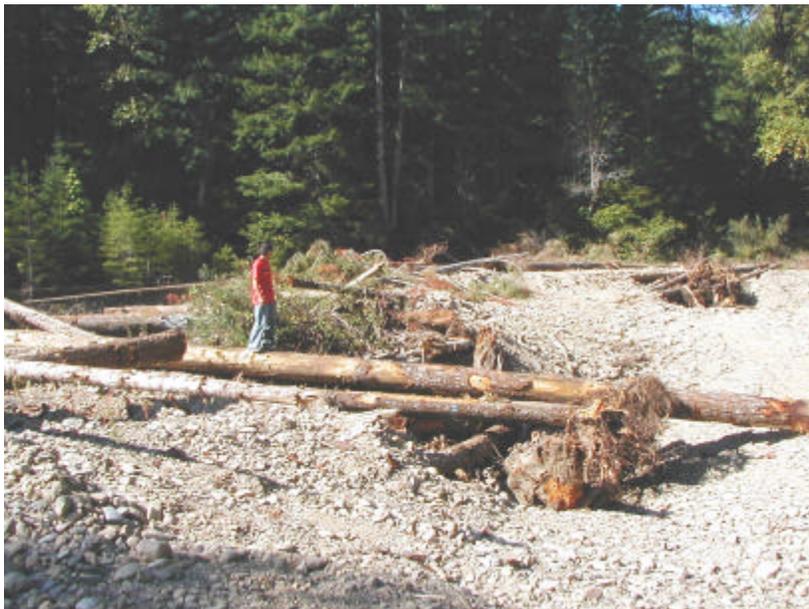
Photo 14. Logjams were placed along eroding banks, gravel bars and floodplains to stabilize the channel and reduce erosion. Reach one of Dry Creek, T.4N. R.7E. Section 32, Skamania County, Washington. (Photo: Olegario)

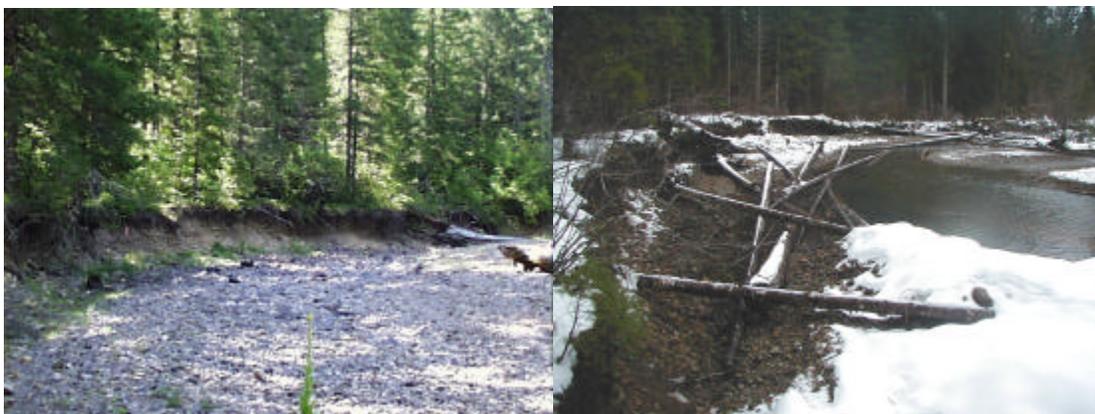
Photo 15. Above: Before (left) and after (right) photos of log placement designed to reduce near bank shear stress on an eroded bend. Reach two, Dry Creek, T.4N. R.7E. Section 29 Skamania County, WA. (Photo: Powers/Olegario)

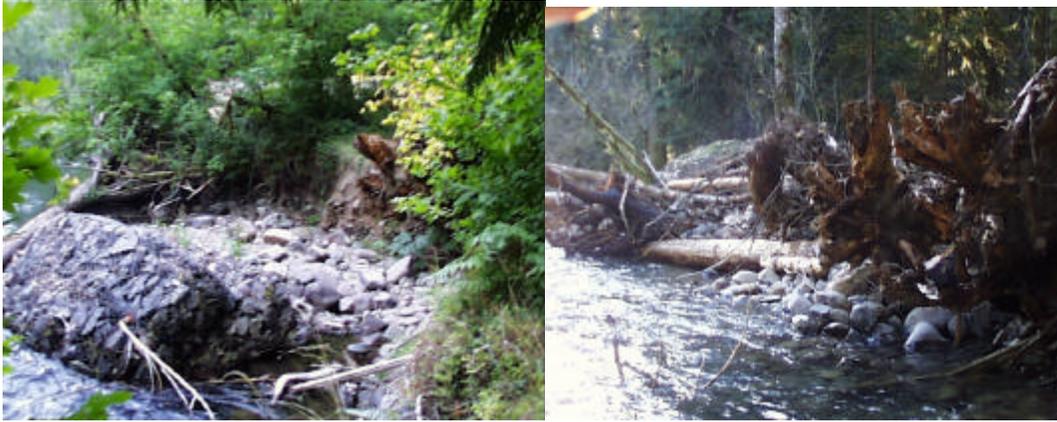
Photo 16. Panther Creek, river mile ~6.0, Skamania County, WA. Gabions were installed in 1980 to protect the Panther Creek campground. During the 1996 flood several were undermined and directing flows against unprotected banks. The gabions were removed and replaced with large tree structures to protect banks/campground, scour pools and provide cover for adult and juvenile steelhead.

Project Actions: Four gabions were removed from the site and replaced with two log structures composed of 15 logs five of which had attached root wads.

Narrative: During the 1996 flood gabions designed to protect the bank bordering the Panther Creek campground were undermined and 175 feet of bank was severely eroded. The gabions were removed and replaced with log complexes to protect banks, scour pool and provide cover for juvenile and adult steelhead.

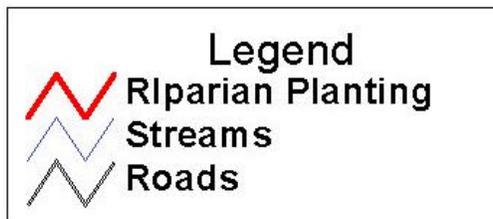
Figure 19. Upper Wind River thinning and conifer planting project area, Skamania County, Washington, T5N, R7E, Sect. 9, 16.
