Wind River Watershed Restoration Project

US Forest Service

**Annual Reports
2000 - 2002**

Bair, Brian, Anthony Olegario, Paul Powers, David Doede, Eric Plimmer, Jennifer Deshong, "Wind River Watershed Restoration Project, Segment II", Project No. 1998-01900, 66 electronic pages, (BPA Report DOE/BP-00000407-1)

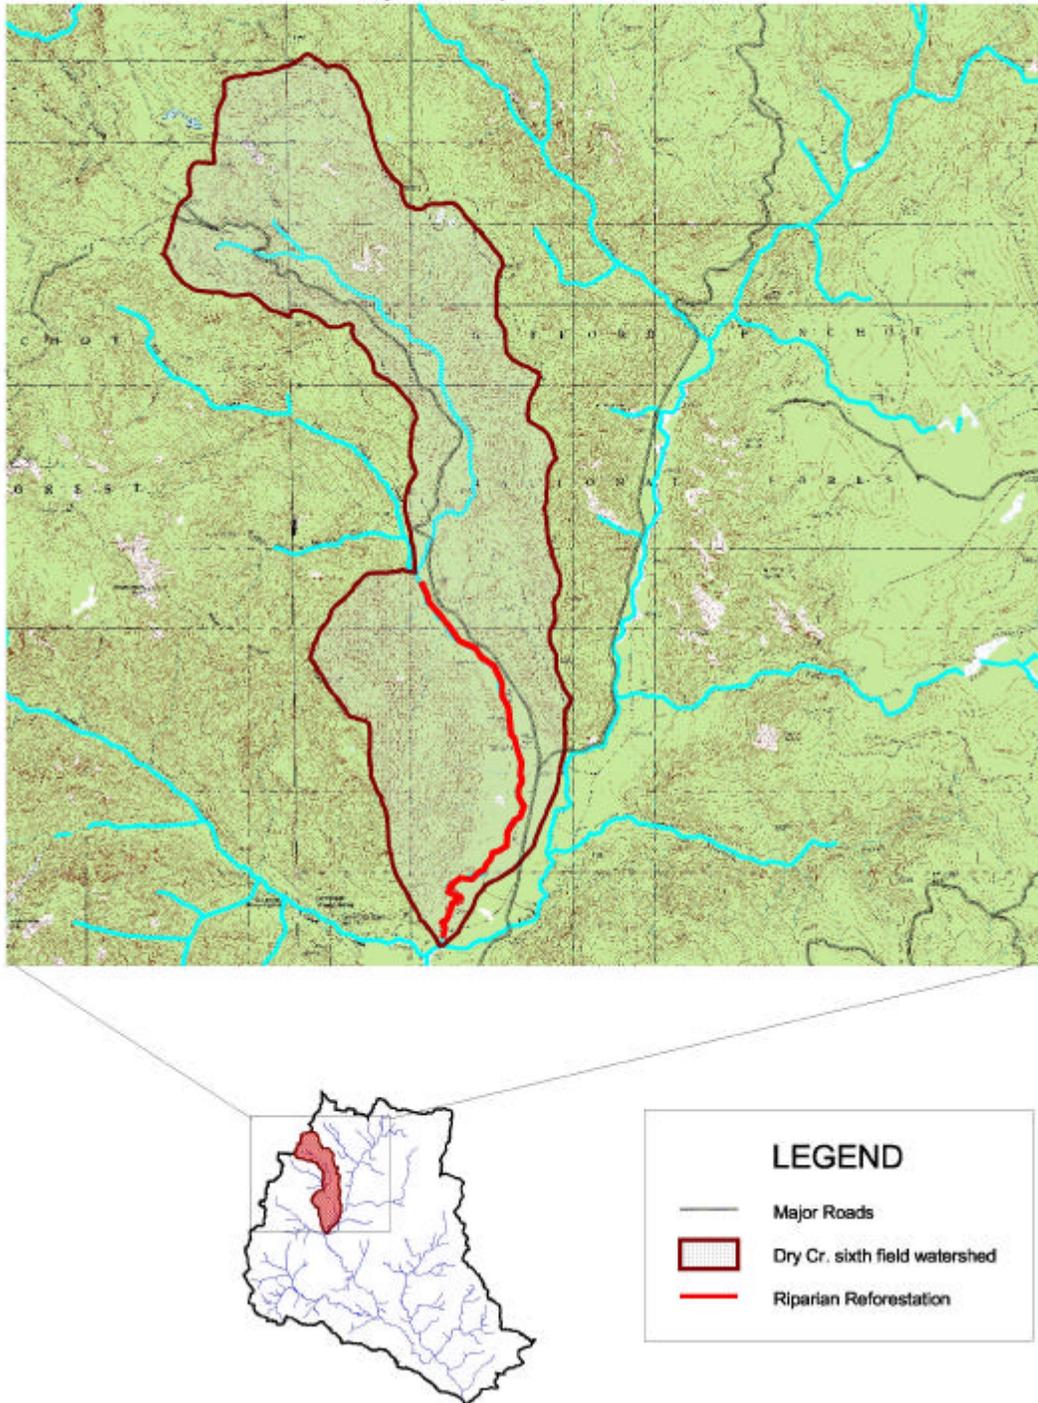
Figure 21. 2000-2002 planting site map for Dry Creek riparian reforestation project site map; T.4N. R.7E. Sections 20, 29 & 32, Skamania County, Washington.
