# John Day River Subbasin Fish Habitat Enhancement Project

**Annual Report  
2001**

DOE/BP-00005632-1

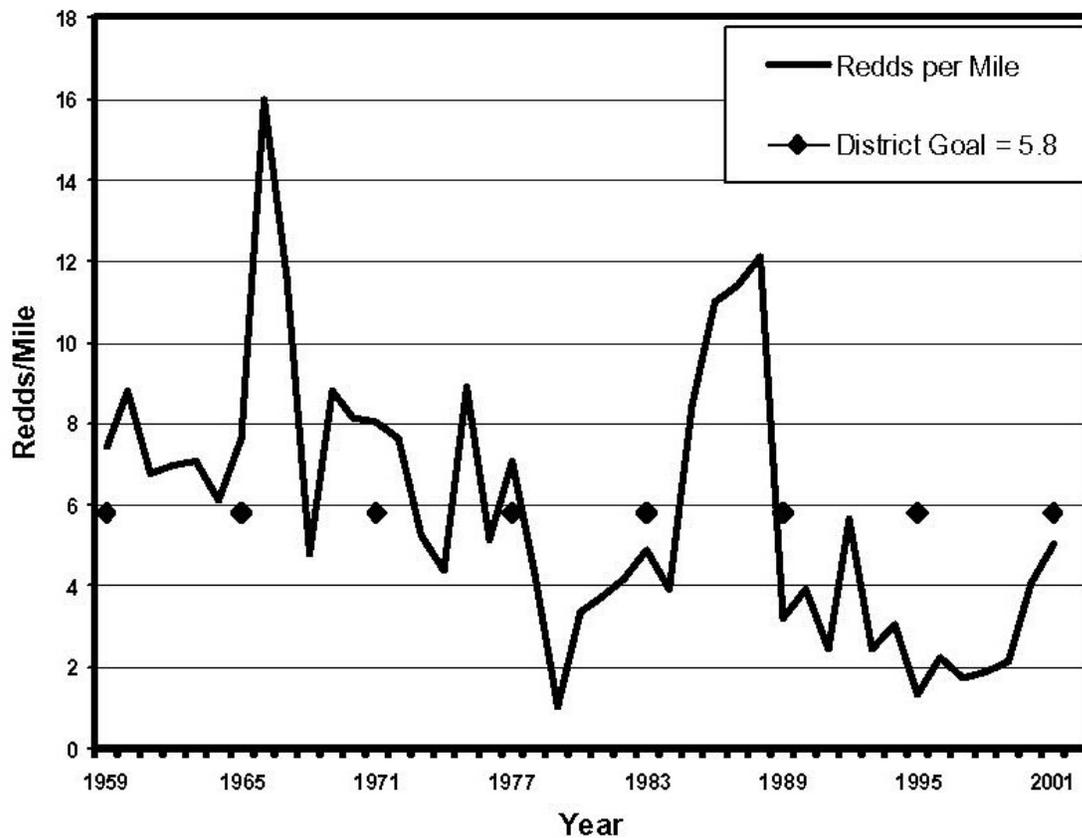
Figure 1 John Day Steelhead Spawning 1959-2001

Steelhead Spawning Annual index steelhead spawning surveys were completed on June 5 totaling 85.7 miles of stream. A total of 433 redds were observed for a density of 5.1 redds/mile. The ten-year average is 2.7 redds/mile. (Figure 1 and Table 2)

Miscellaneous monitoring and evaluation activities may include Chinook salmon and steelhead redds counts, juvenile fish population surveys, streambank stability surveys, and evaluating riparian vegetative recovery and/or planting success. See Appendix 1 (Table 2 & 4 and Figure 1 & 2).

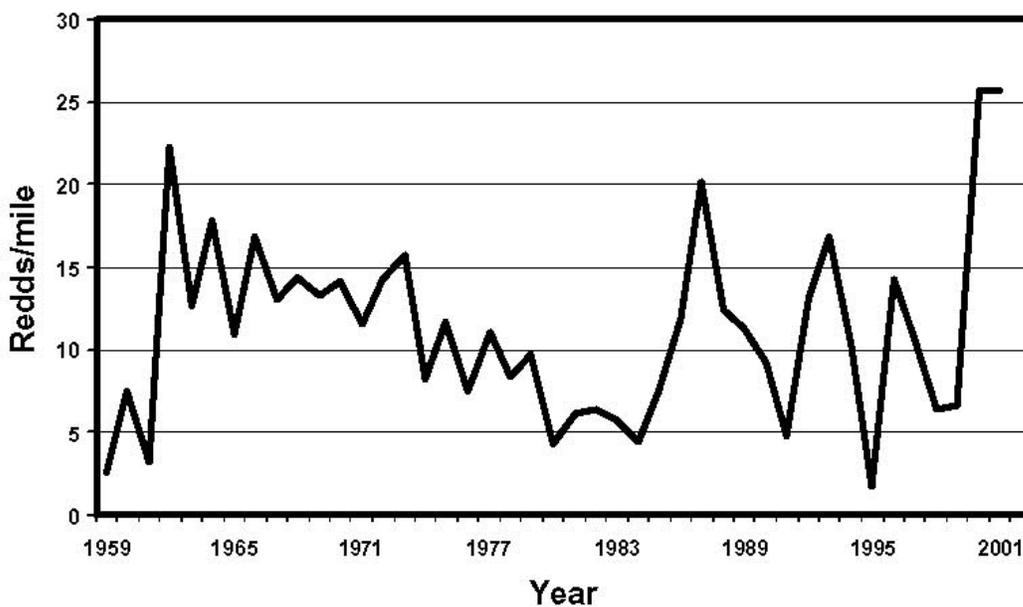
Figure 2 John Day Basin Spring Chinook Redd Counts

Spring Chinook Spawning Surveys were performed on 55 miles of index streams, with a count of 1411 redds, for a basin average of 25.7 redds/mile. This ties the record set last year for the highest returns to the John Day Basin since counts began in 1959. A summary of results is presented in Table 4. Using the estimated ratio of index to index plus extensive counts with the conversions to adults of 3 fish per redd, the estimated spawning escapement was 6,048 adult spring chinook in the John Day River. The Mainstem increased from last year's 20.5 % to 23% redd counts (See Figures 2). The highest spawning density in the basin occurred on the North Fork with 43% of the redds. The Middle Fork and the Granite Creek System held steady at 19 % and 13.5 % respectively. A preliminary estimate of nine hatchery strays (thought to be fin clipped) was found this year, which comprised 1.4 % of the Spring Chinook sampled. Fifty-two pre-spawn mortalities were found this year, which comprised 8.6 % of the Spring Chinook sampled.

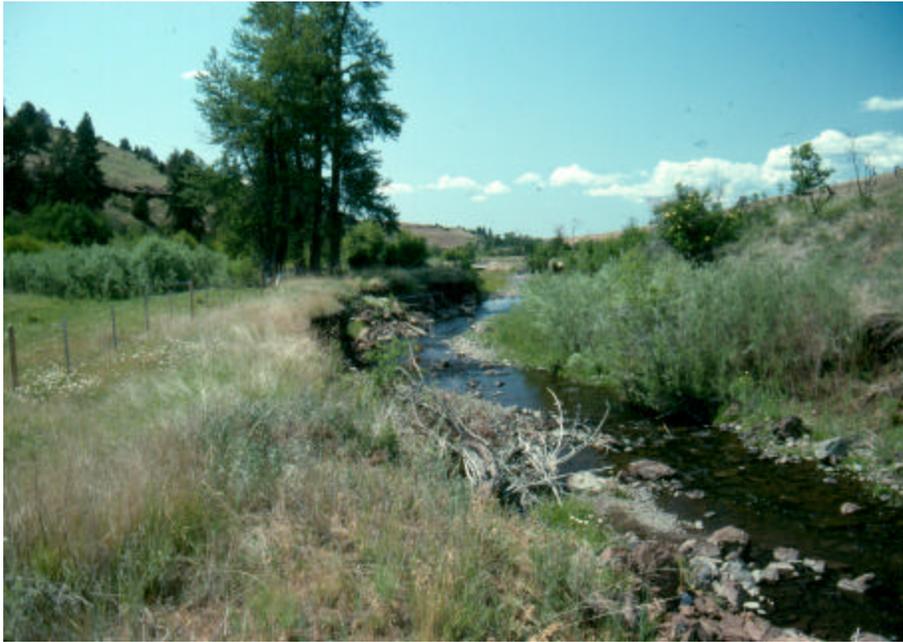
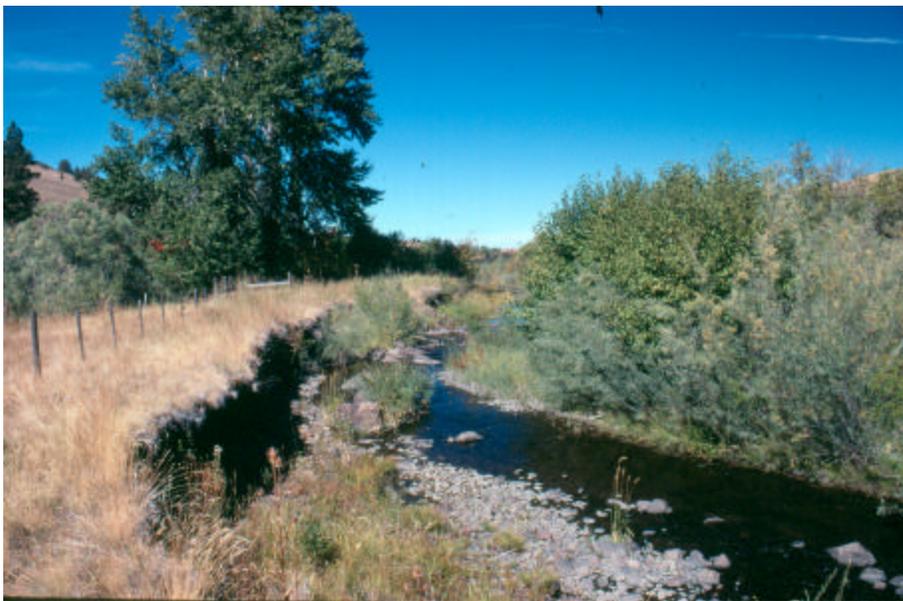
Photo Pt #5, Richard Courchesne Property  
**June 1992** above, and below **August 2000**,  
depicting recovery after two flood events in  
1997.
