**ASOTIN CREEK
INSTREAM HABITAT ALTERATION PROJECTS
HABITAT EVALUATION, ADULT & JUVENILE HABITAT
UTILIZATION & WATER TEMPERATURE MONITORING**

2001 Progress Report

DOE/BP-00006230-1

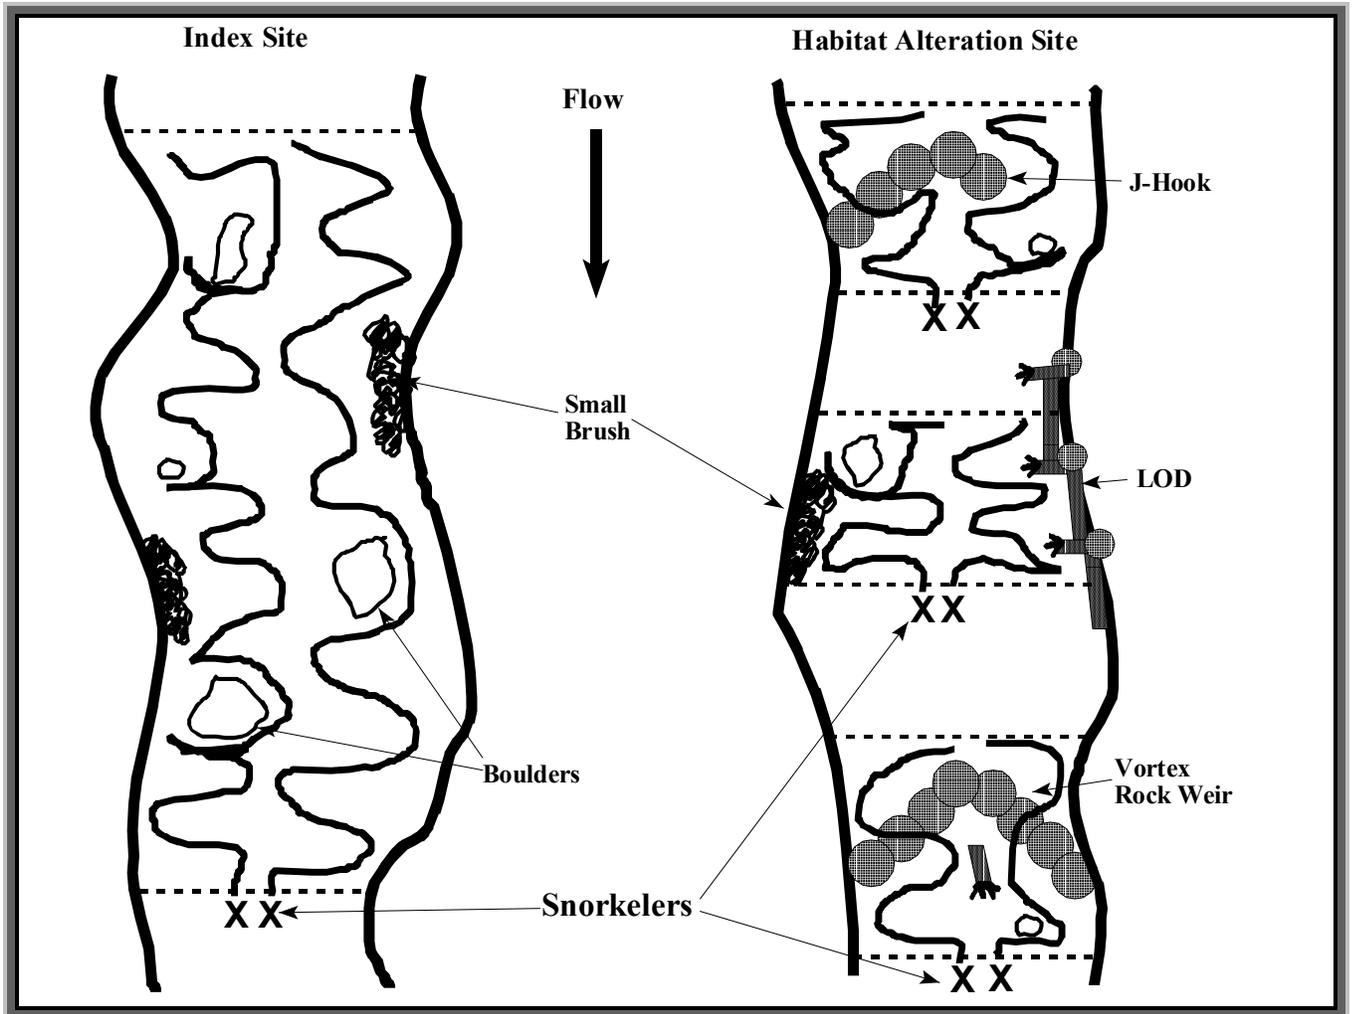
Figure 1. Visual representation of snorkel surveys conducted showing approximate areas snorkeled within index (control) and habitat altered (treatment) sites.

Length, and three to five width measurements were collected from habitat altered or index snorkel sites to standardize the fish counts into fish densities (fish/100 m²). The length of each snorkel site was generally measured before snorkeling so that an upper and lower end of the site would be known to each snorkeler. However, if measuring the site meant walking through the site and perhaps displacing fish, the snorkelers would pick a landmark (rock, tree) for the upper end of the site, and measure the site after snorkeling was completed. Two biologists snorkeled the site at the same time swimming upstream (Figure 1), each taking approximately one-half of the creek's width. Snorkelers communicated visually about who would count the fish in the middle of stream when the snorkelers would meet.

Proposed site lengths at index (control) sites were 40 meters. This length was considered adequate to represent the general habitat available to fish in the creek, and would generally include a representation of riffles, runs and pools present in the stream. Snorkel site lengths at habitat alteration sites were typically shorter, as the purpose of the area snorkeled was document fish density and usage within the hydraulic control of the instream structures. While entire habitat sites could have been snorkeled, it would have eliminated our ability to examine fish usage and densities at a variety of structures.

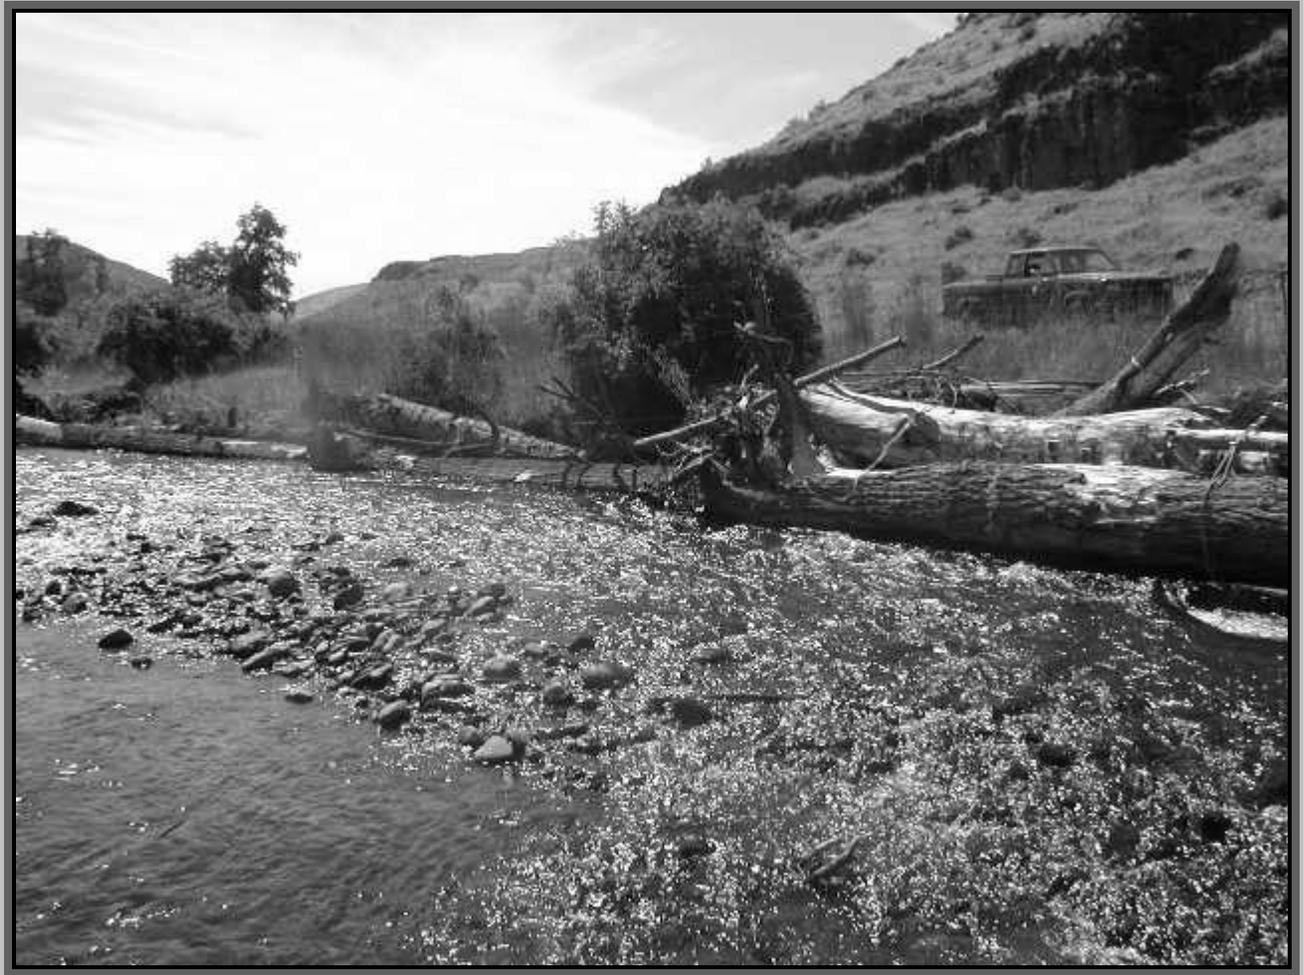
Figure 2. Large Organic Debris (LOD) placements along an eroding bank at Thiessen #5b.

At the Thiessen site, SRL staff split the site into two sections due to the overall length and distance between habitat structures. We felt that evaluating two smaller sites would provide greater sensitivity of the data (see discussion in Wargo et al. 2000). The project intent for Thiessen 5A and 5B was to install LOD (with rootwad ends attached) to prevent further erosion of stream banks, yet provide woody material and complexity for fish habitat. One eroding bank was located against a cattle grazing field, with loss of pasture and some riparian habitat should the bank continue to erode. The other eroding bank was located near the Asotin Creek road, and continued erosion could threaten road integrity. At Thiessen 5A, the SD of thalweg increased by over 900%, indicating a greater complexity of the river channel. Also, the area of LOD within the site went from zero in 1999 to 6.9% in 2001 (Table 2). The number of pools increased, as did the mean pool rating and depth of pools. At Thiessen 5B, the SD of thalweg depth increased by nearly 200%. This was likely a result of the construction and placement of the LOD within the site (Figure 2), which over time has allowed certain sections located near the LOD to scour and form deeper pools in the thalweg. The area of LOD within the site increased from 0.4% in 1999 to 7.6% in 2001 (Table 2), an increase of over 1,800%. The number of pools, area, volume, and overall pool rating greatly increased at this site. For both Thiessen 5A and 5B, Class 1 and 2 pools dominated the site prior to construction. Following the work, nearly all the pools rated as Class 2 or Class 3 (Table 3).

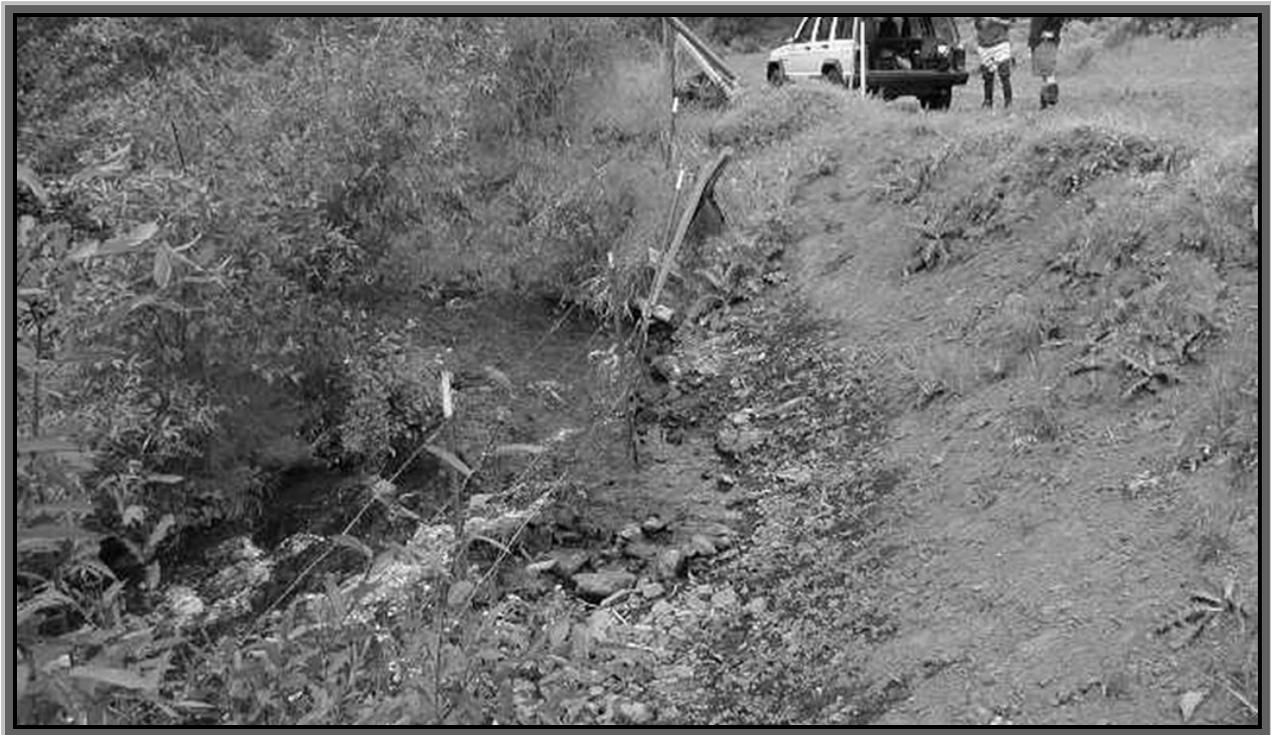
Figure 3. Photo of eroding bank along existing road along Charley Creek.

Charley Creek #'s1-3, 2001: A private road, which lies along Charley Creek, is used by the landowner for access to his cattle grazing operation. Also, cattle graze on the road and in the creek adjacent to the road. This primitive road is being eroded away by Charley Creek in many locations, and has partially washed out an existing fence at one site (Figure 3). The landowner indicated that in the interest of stream restoration, he would be willing to fence off these areas from cattle grazing. However, fencing off the stream would be useless unless the eroding stream bank could be stabilized. ACCD proposed to place fish habitat structures (rock J-Hooks and rootwad revetments) to stabilize the bank. This would also provide increased LOD and pool area within the site that are currently lacking. Each site will also be planted with native woody and herbaceous species.

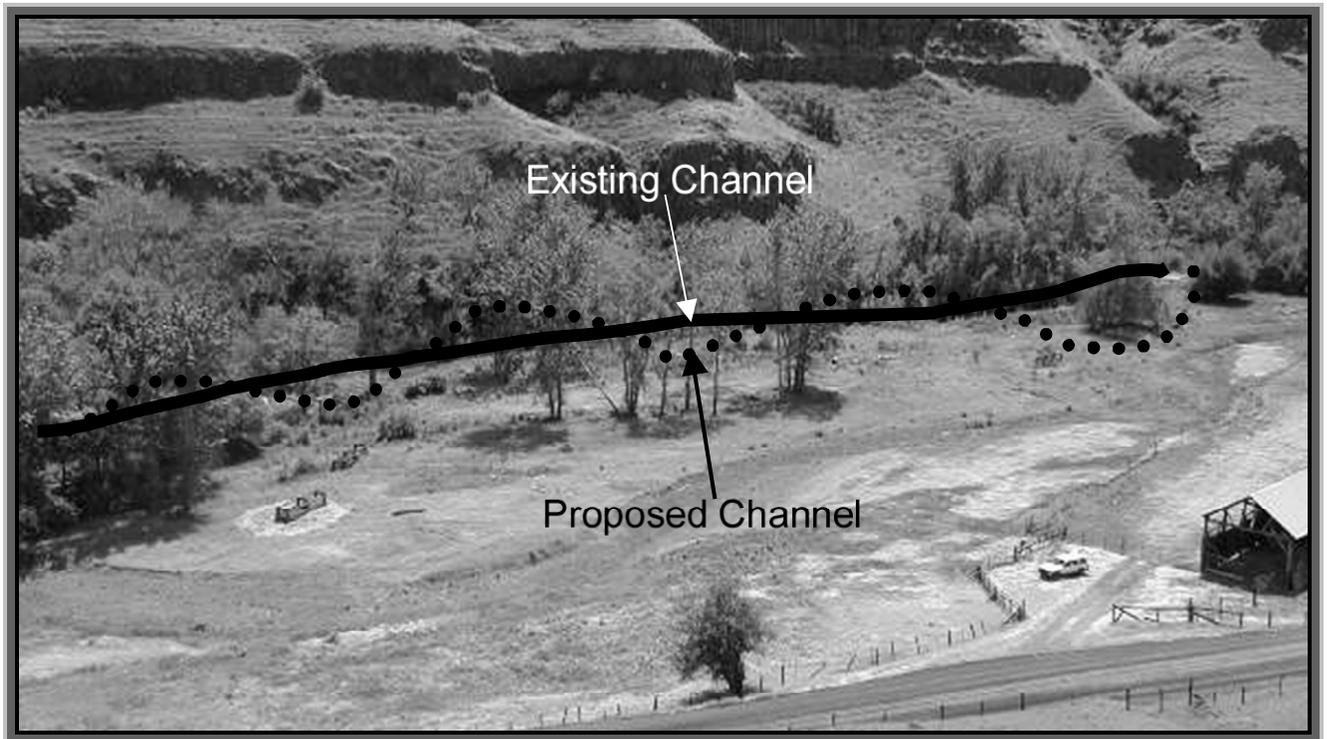
Figure 4. Proposed channel reconstruction at the Hendrickson project site.

Hendrickson #1-01: The creek within this project site was pushed back along side a rock cliff following floods in 1996 and 1997, and was straightened for about 200 meters (Figure 4). The current flood channel is very narrow, and will likely expand should a flood event occur. Further, complex structure within this section is currently lacking due to confinement of the river channel. The purpose of this project will be to increase the stream length by creating more of a meander pattern within the existing river channel. Estimated stream length may increase by as much as 25% once completed. Instream structures will increase pools and woody debris for fish habitat. Further, the landowner has agreed to eliminate all grazing from this section of the creek so that the riparian corridor can be enhanced, and erosion of the stream bank will be reduced.

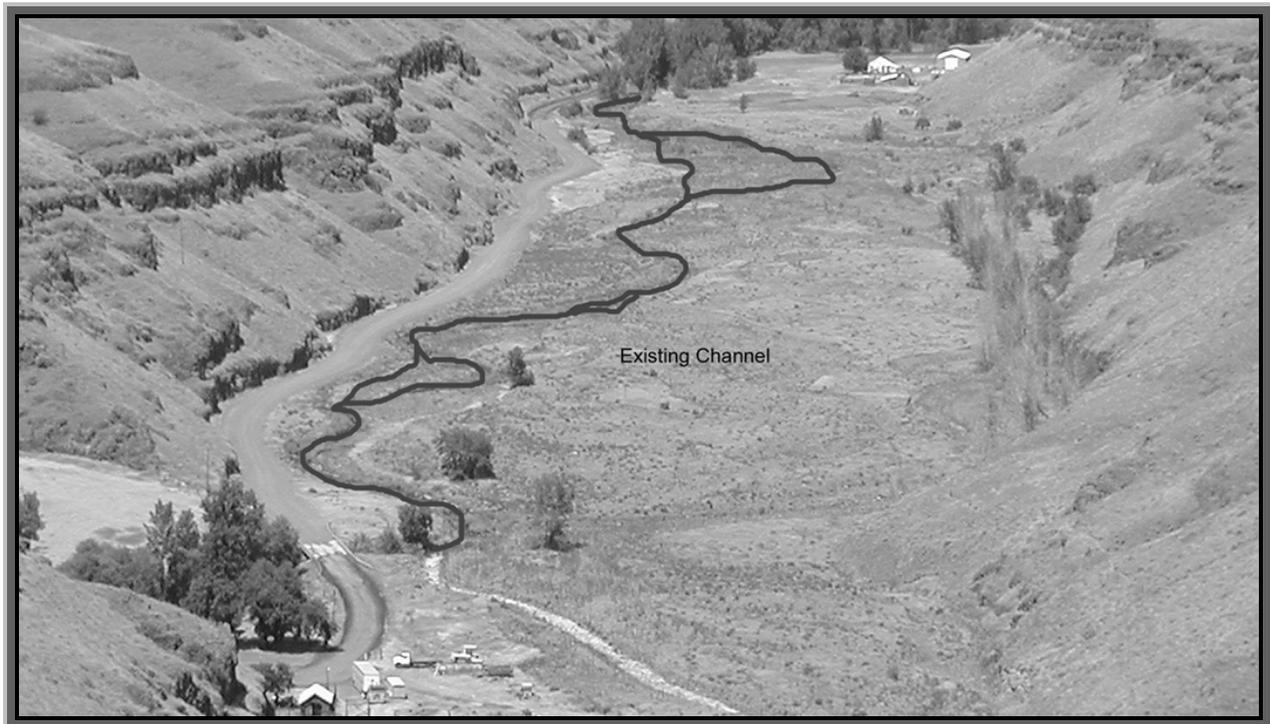
Figure 5. George Creek project site.

George Creek #1-01: This section of George Creek was completely blown out by previous floods. No riparian vegetation remains and numerous large gravel bars create conditions that during summer flows causes the creek to go sub-surface (Figure 5). The purpose of this project is to re-establish the stream channel to maintain surface flow, increase the stream channel length by constructing a meander pattern, and to add complex fish habitat to provide pools and large

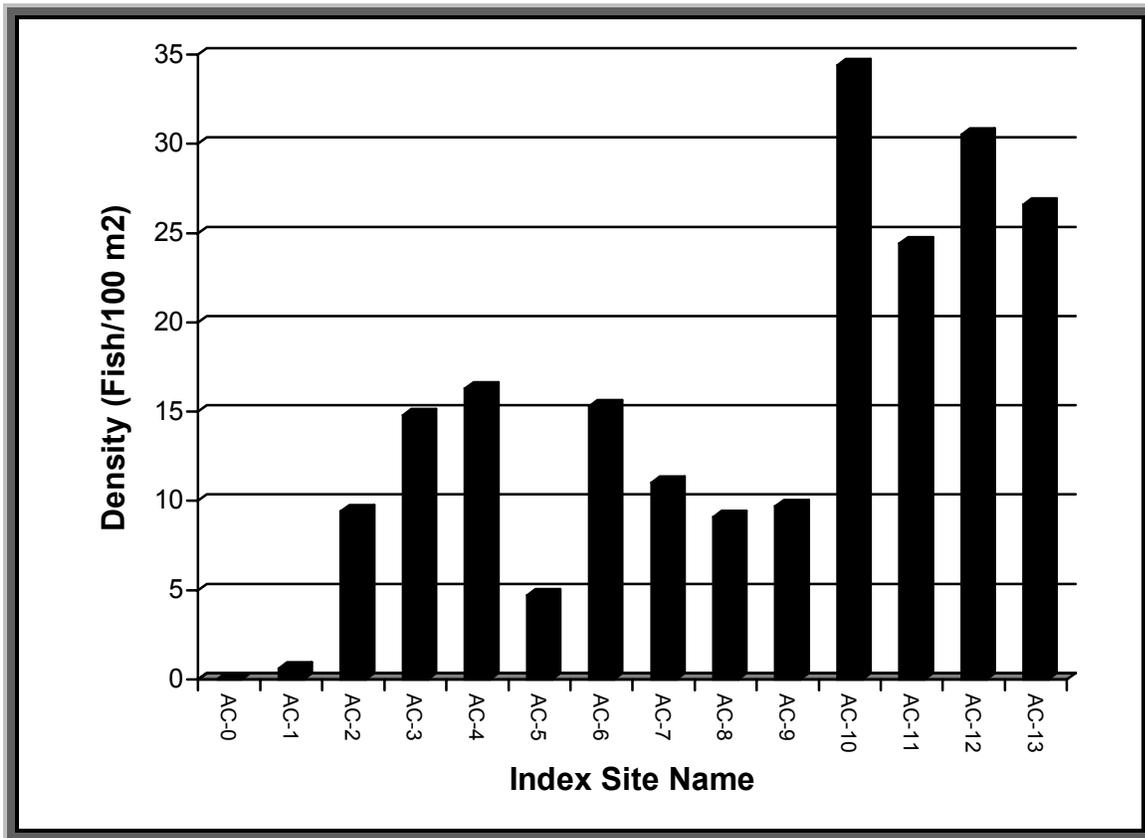
Figure 6. Age 0 juvenile steelhead densities at index sites in mainstem Asotin Creek, 2001.

Juvenile steelhead (Age 0 and Age 1+) were found in all index sites in mainstem Asotin Creek (Figures 6 and 7), though densities in the lower reaches below George Creek were significantly lower than sites above that point. Overall, mean densities of Age 0 juvenile steelhead in 2001 were lower than was observed in 2000, and slightly higher than in 1999, while densities of Age 1+ steelhead were higher than the previous two years (Wargo et al. 2000, Bumgarner and Schuck 2001). A number of factors can influence changes in densities, and results presented are merely an indication of relative abundance or desirability of fish to inhabit pool areas, and should not be considered in direct result of the habitat restoration activities described within this report.

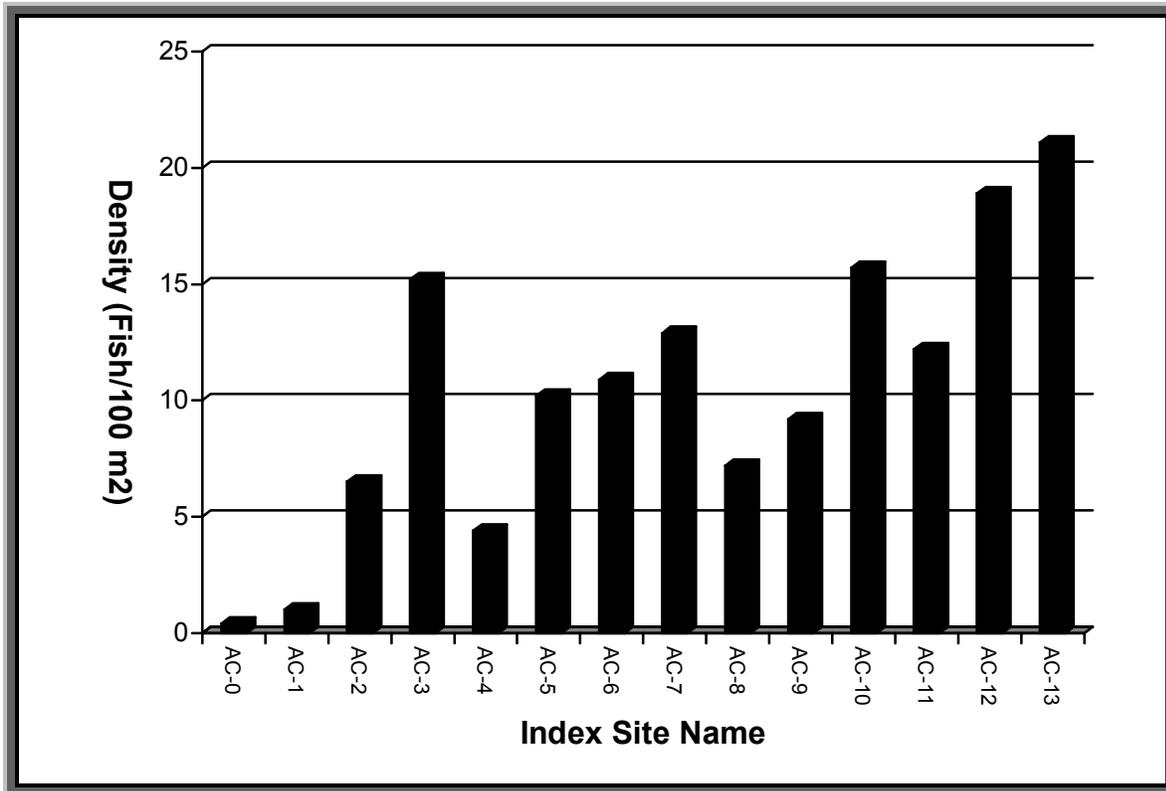
Figure 7. Age 1+ juvenile steelhead densities at index sites in mainstem Asotin Creek, 2001.

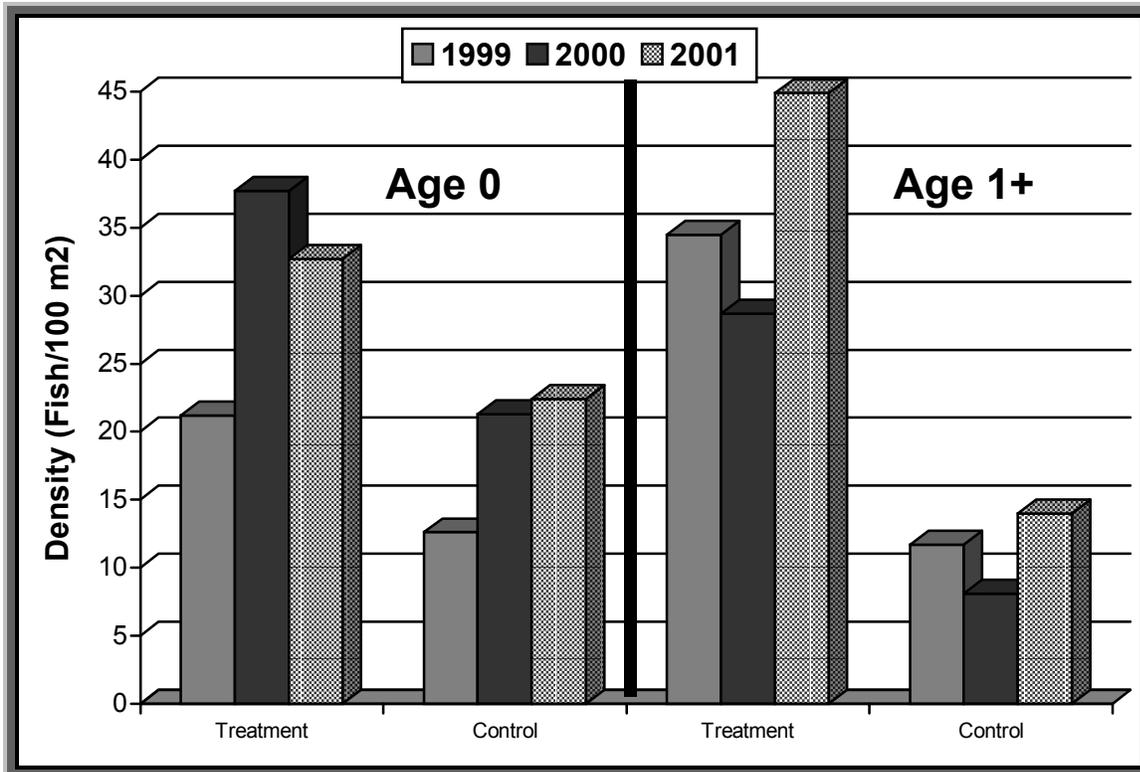
Figure 8. Mean densities of Age 0 and Age 1+ juvenile steelhead at habitat alteration and index sites in mainstem Asotin Creek in 1999, 2000, and 2001.

Mean densities of Age 0 and Age 1+ juvenile steelhead in habitat altered sites were significantly greater (Age 0: t -test = 3.6, $P < 0.001$, $df = 41$; Age 1+: t -test = 4.2, $P < 0.001$, $df = 41$) than mean densities observed in index sites (Figure 8).

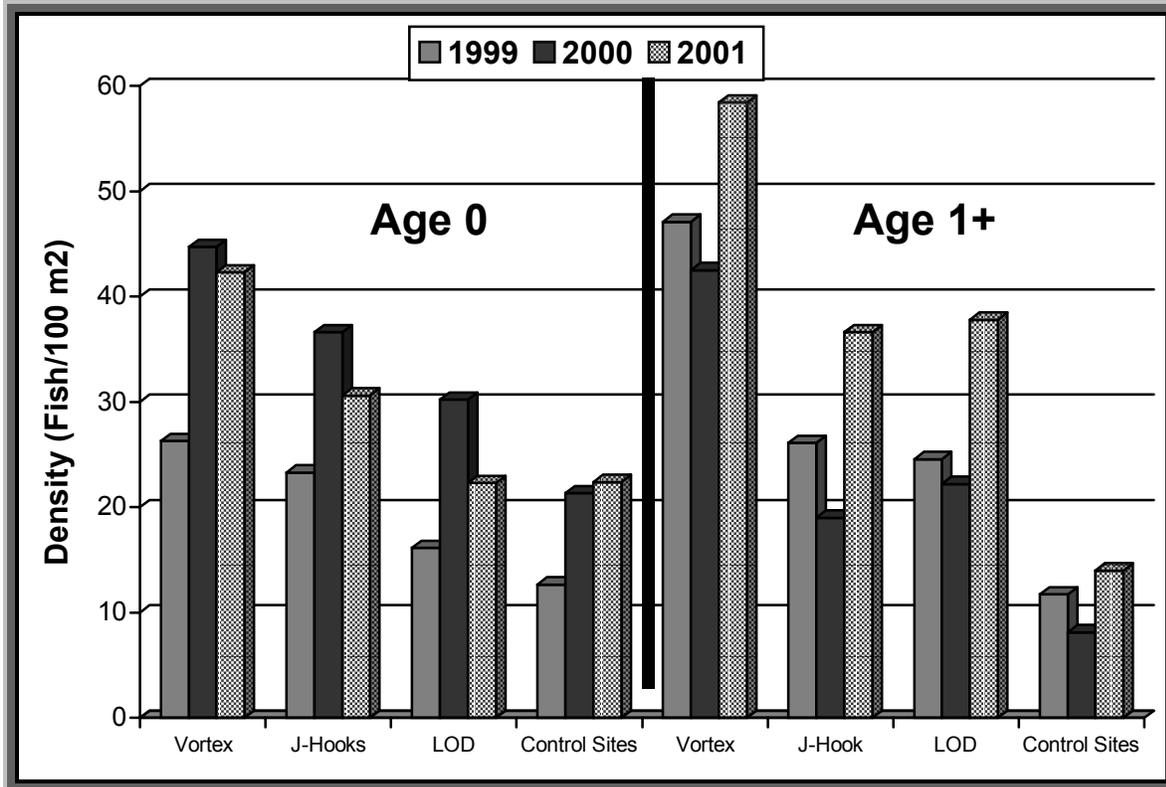
Figure 9. Mean densities of Age 0 and Age 1+ juvenile steelhead in three habitat structure types within habitat alteration and index sites in mainstem Asotin Creek, summers of 1999, 2000, and 2001.

A one-way ANOVA determined that juvenile steelhead densities within grouped habitat structures (i.e. vortex, LOD, J-hook) were significantly greater in Age 1+ juveniles ($F=9.7$, $P<0.001$) from the densities within index sites. An ANOVA also found significant difference in densities of Age 0 juveniles ($F=11.2$, $P<0.001$). Tukey's test was performed on both Age 0 and Age 1+ juvenile data, but was unable to determine significant differences among structure type. This is likely due to the small sample sizes available and large variance observed between individual sites, but of the same structure type. While differences between structure types were not statistically significant, densities within some of the habitat structure types for Age 0 juveniles in 2001 (vortex's) were more than double what was observed in index sites (Figure 9). A similar result was also observed for Age 1+ steelhead in some of the same structure types.

While direct comparisons cannot be made between years, it is interesting to note that certain structures tend to have higher densities than others. Structures that contain higher densities of fish should be considered first when new projects are identified. In addition to summer snorkel surveys, SRL conducted winter night snorkel surveys during February, 2000 and January 2001. Results from the winter snorkel surveys are still preliminary, though they potentially demonstrate a different habitat preference compared to the summer surveys. Winter snorkel surveys will be completed again in 2002, and a more complete analysis will be presented in a future report.

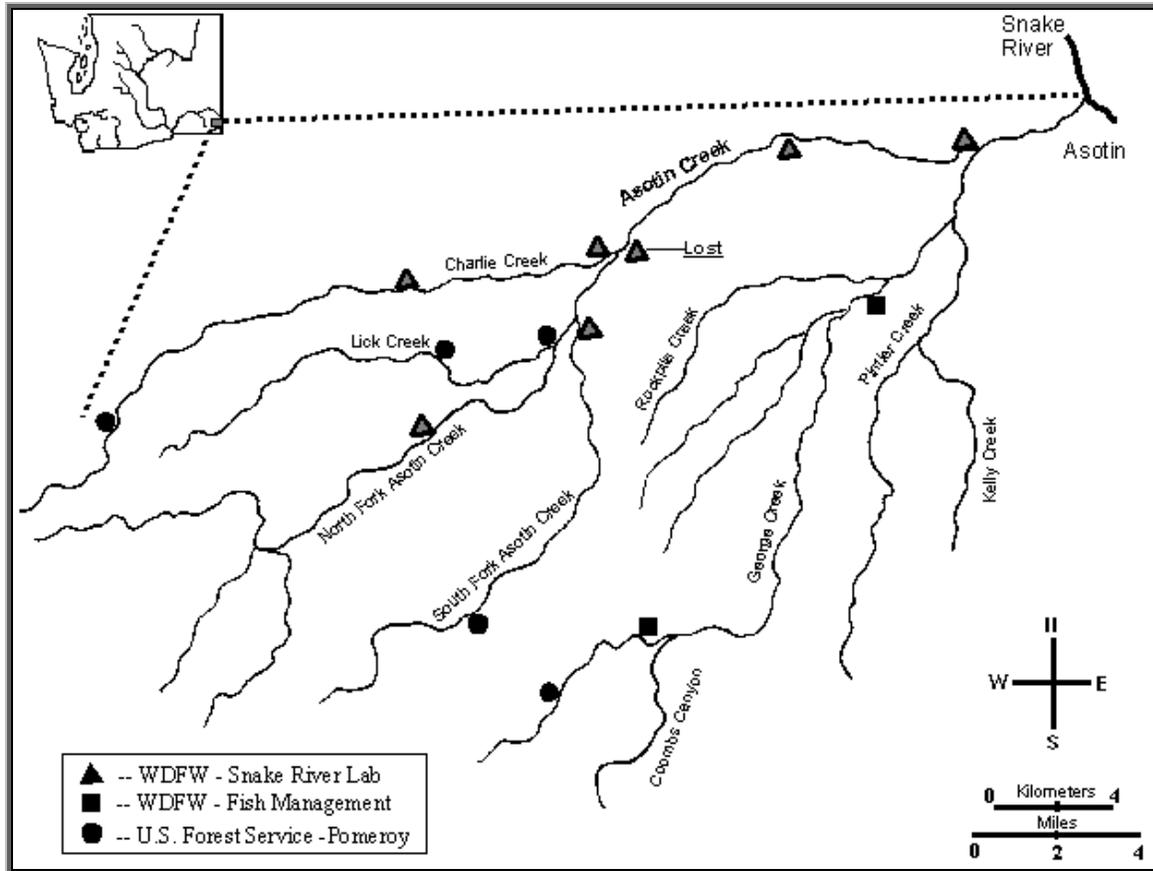
Figure 10. Map of Asotin Creek Watershed and locations of water temperature monitors deployed by WDFW and USFS in 2001.

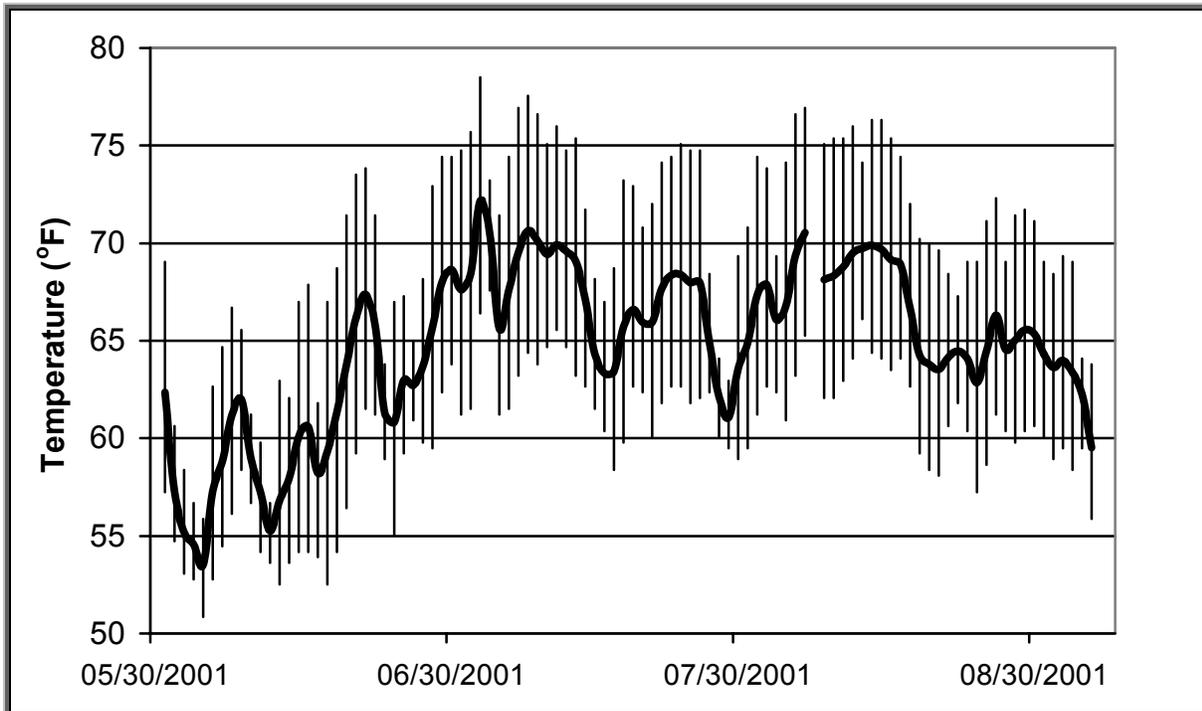
Appendix B: Figure 1. Average, minimum, and maximum water temperature in mainstem Asotin Creek at river kilometer 0.3 in 2001, Asotin City Park.

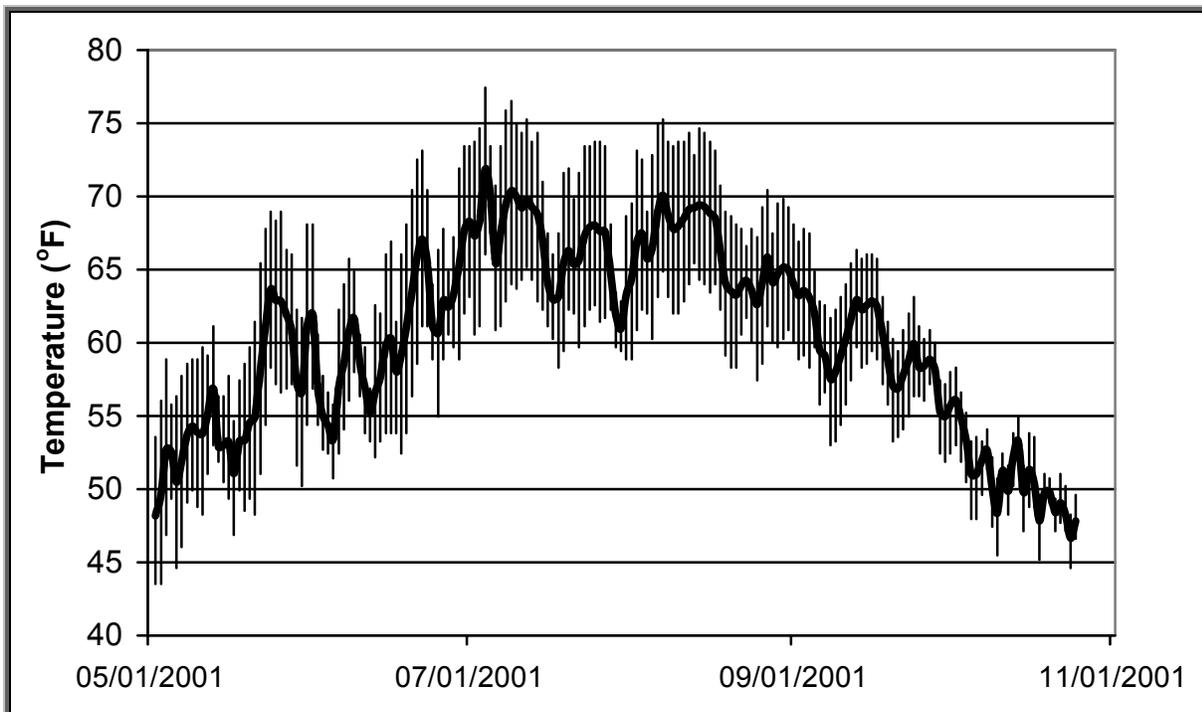
Appendix B: Figure 2. Average, minimum, and maximum water temperature in mainstem Asotin Creek at river kilometer 4.3 in 2001, above where the mouth of George Creek enters the river.

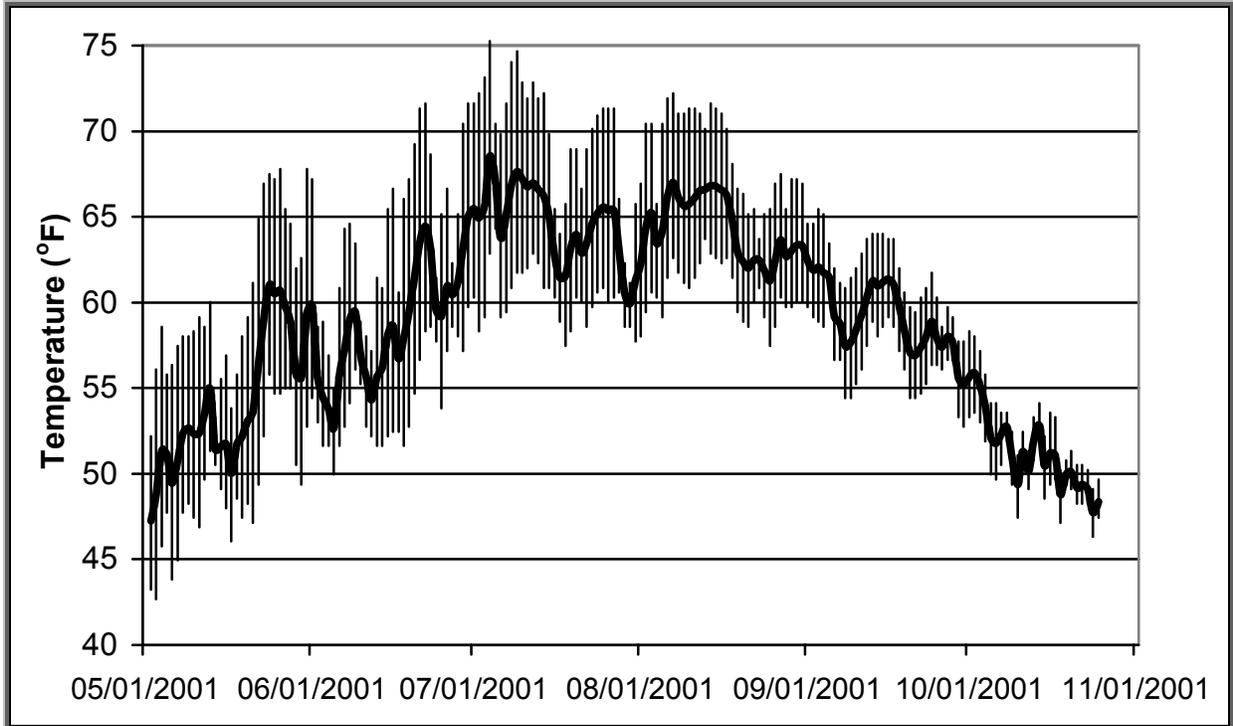
Appendix B: Figure 3. Average, minimum, and maximum water temperature in mainstem Asotin Creek at river kilometer 11.4 in 2001, Headgate County Park.

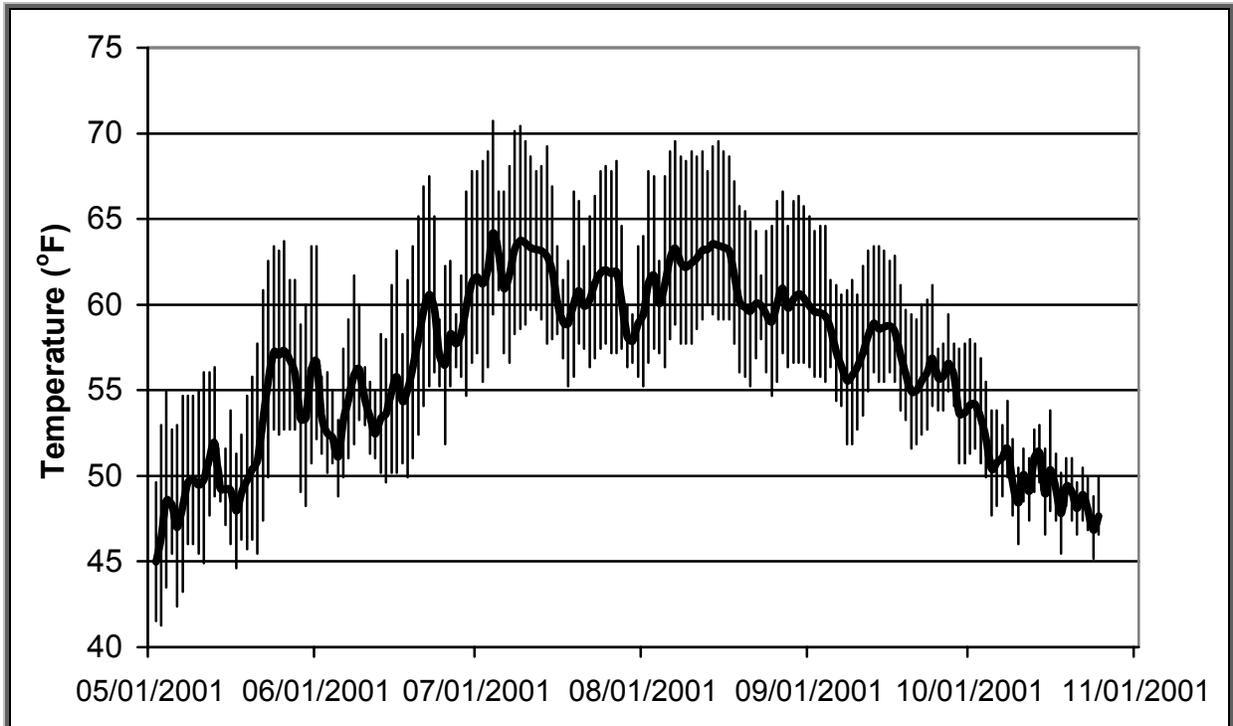
Appendix B: Figure 4. Average, minimum, and maximum water temperature in mainstem Asotin Creek at river kilometer 19.5 in 2001, bridge crossing at confluence of the North and South Forks.

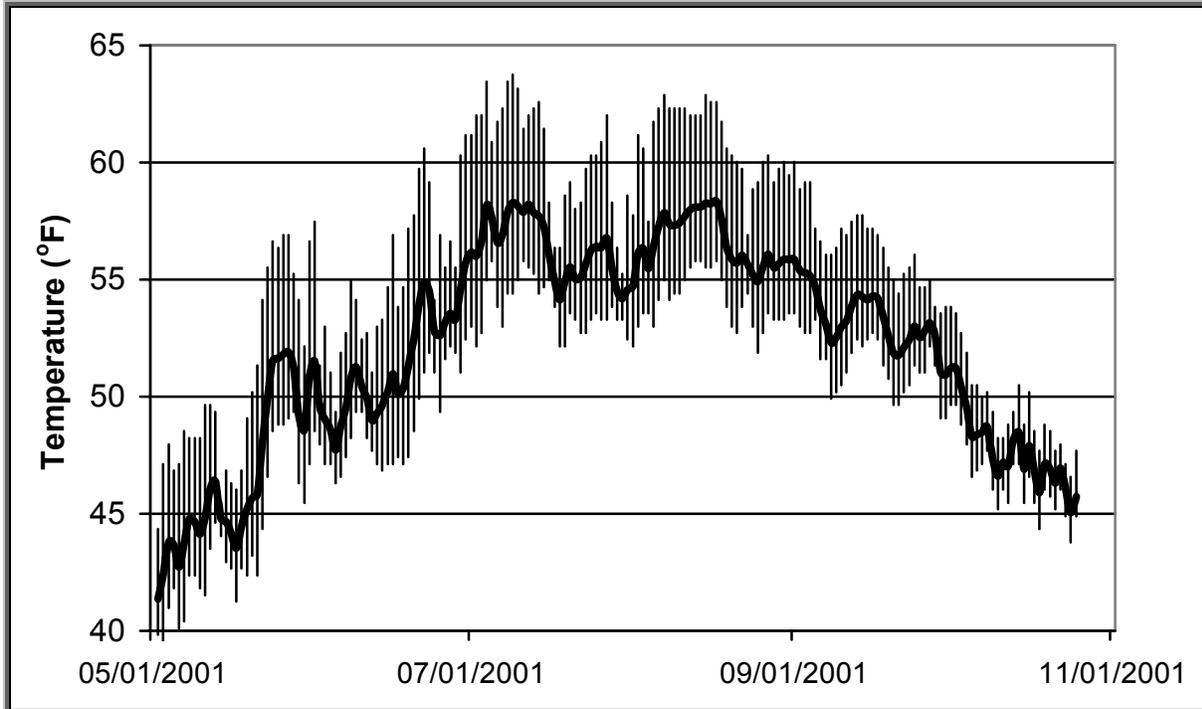
Appendix B: Figure 5. Average, minimum, and maximum water temperature in North Fork Asotin Creek at river kilometer 11.8 in 2001 (U. S. Forest Service boundary fence line).

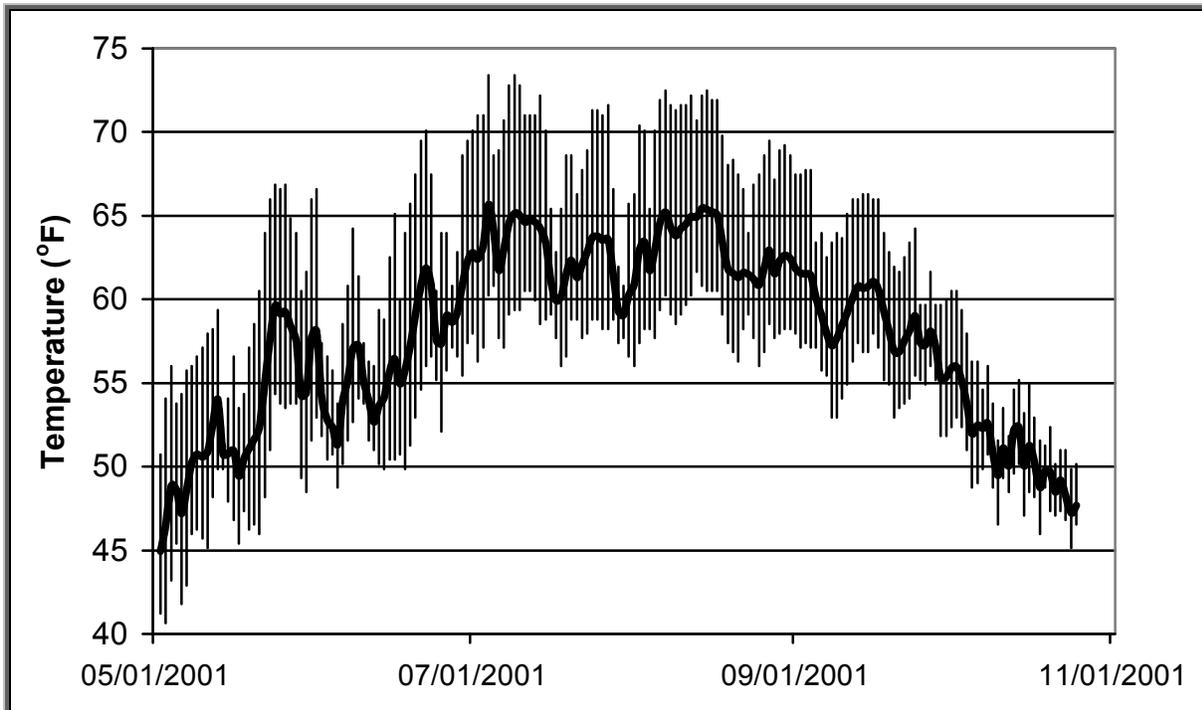
Appendix B: Figure 6. Average, minimum, and maximum water temperature in South Fork Asotin Creek at river kilometer 0.1 in 2001 (near the mouth of the South Fork).

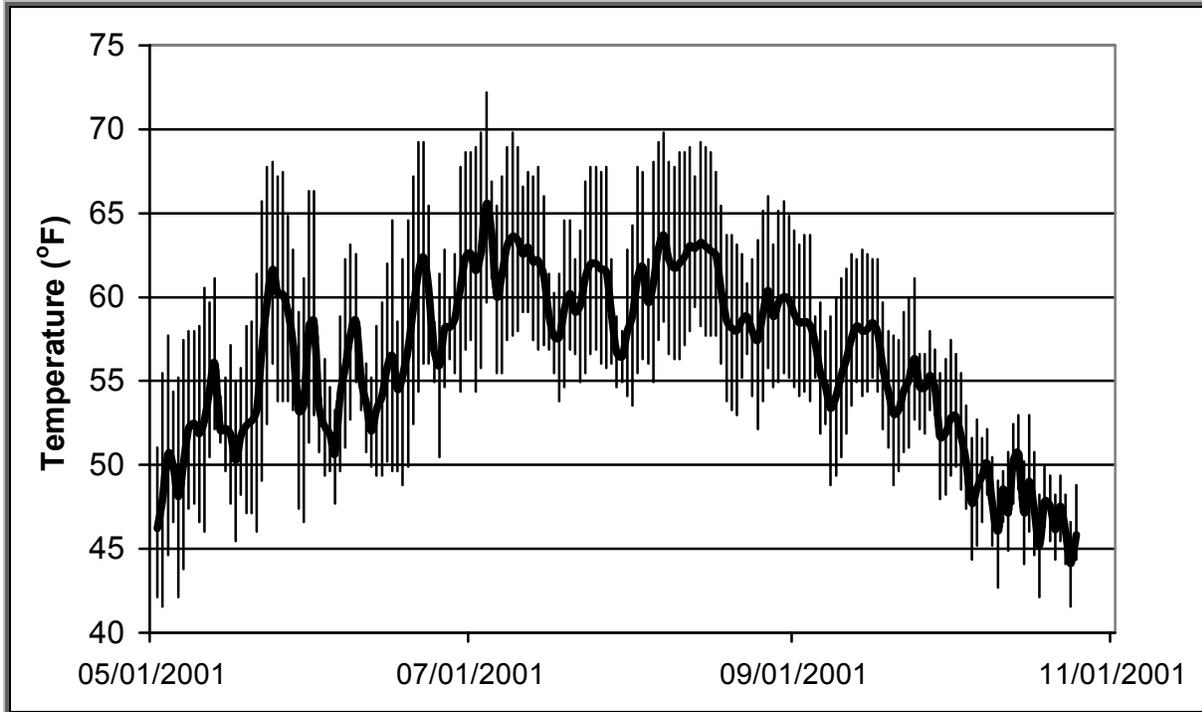
Appendix B: Figure 7. Average, minimum, and maximum water temperature in Charley Creek at river kilometer 0.2 in 2001 (near the mouth of Charley Creek).

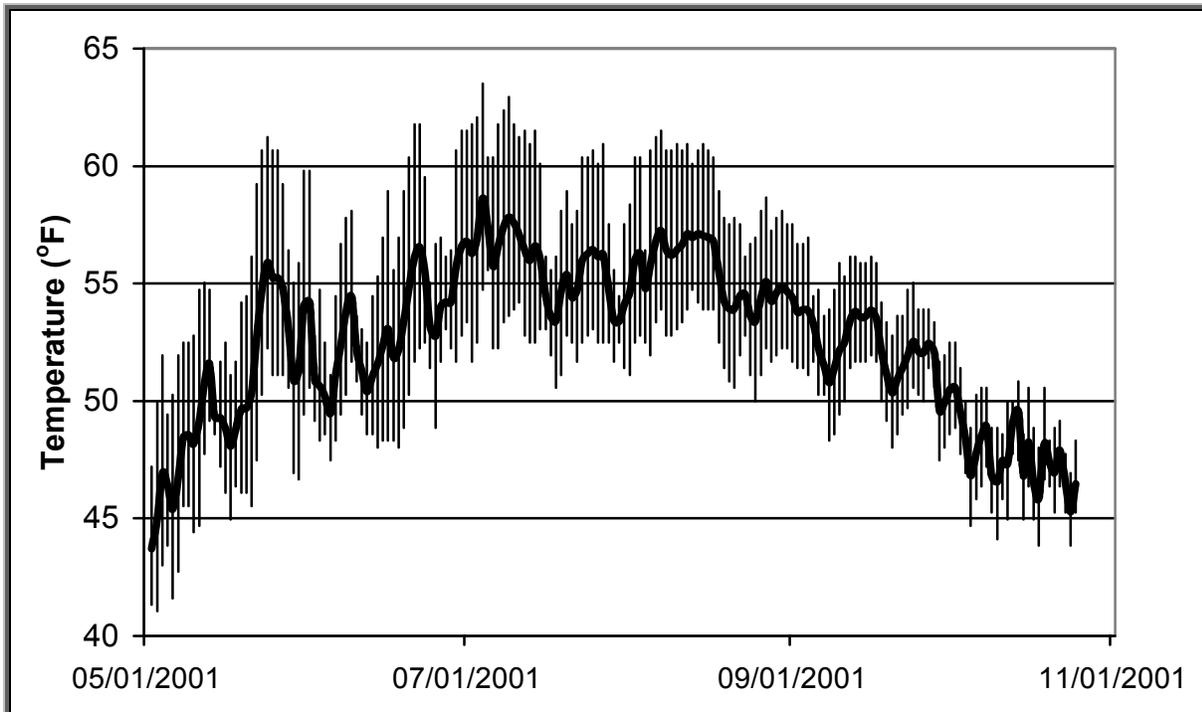
Appendix B: Figure 8. Average, minimum, and maximum water temperature in Charley Creek at river kilometer 8.5 in 2001 (at the boundary fenceline for State land property).
