Walla Walla River Basin Fish Habitat Enhancement Project

**Annual Report
2000 - 2001**

**ANNUAL REPORT OF PROGRESS 2000
(February 1, 2000 to January 31, 2001)**

Project No. 1996-046-01
Contract Number 00006414

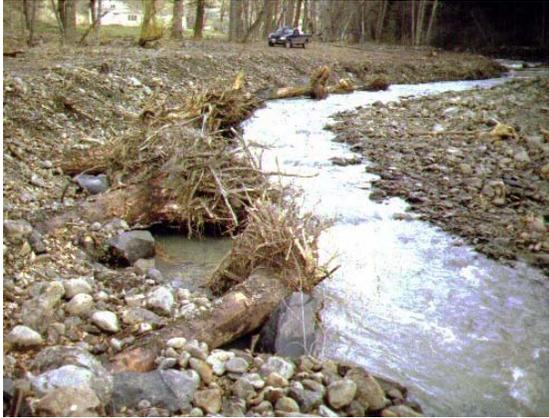
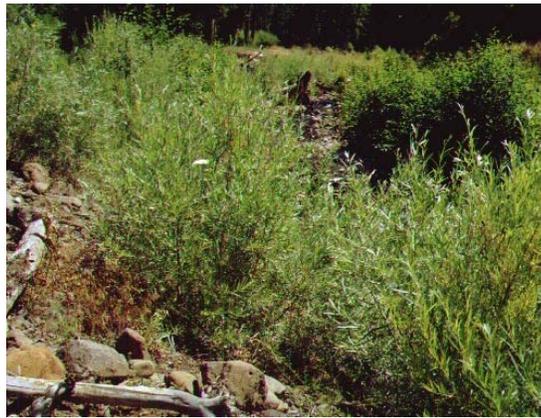
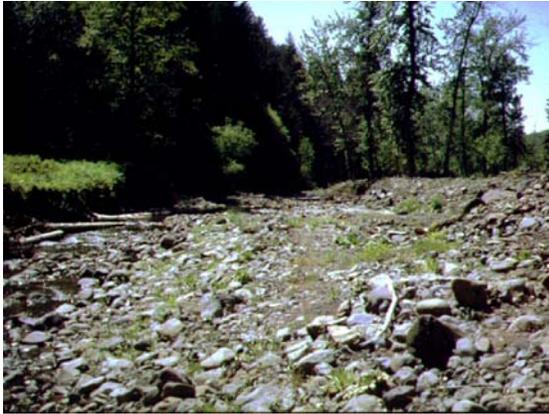
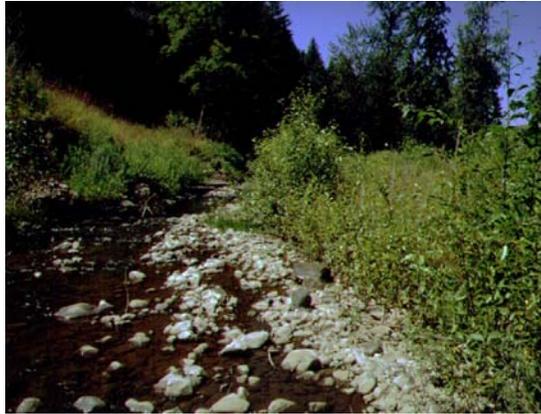
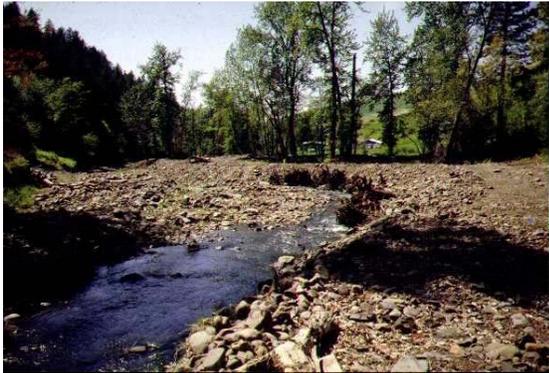
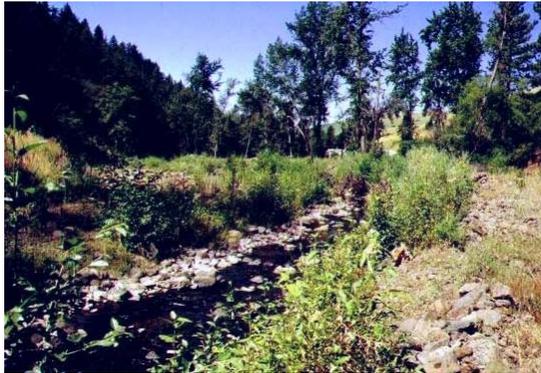
Only monitoring and site maintenance was conducted within the Blue Creek project area during FY2000. The following photo points portray the significant vegetative recovery that has occurred at this project site.

May 1998

July 2000

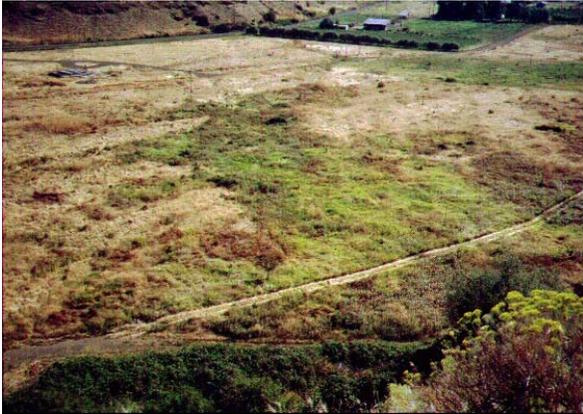
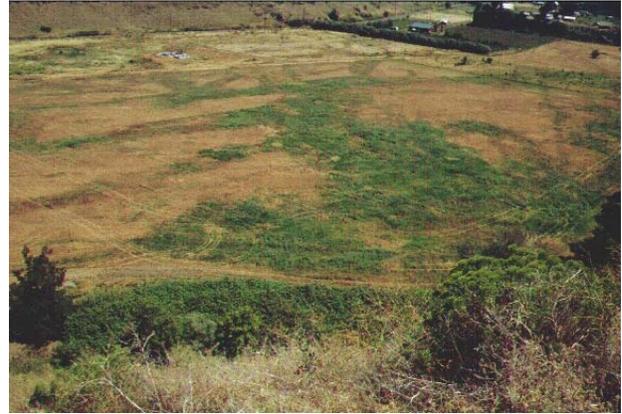
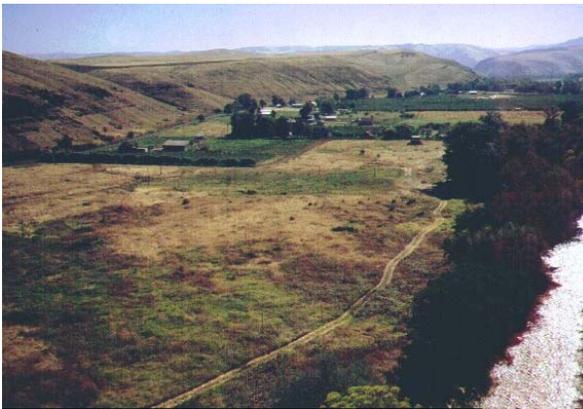
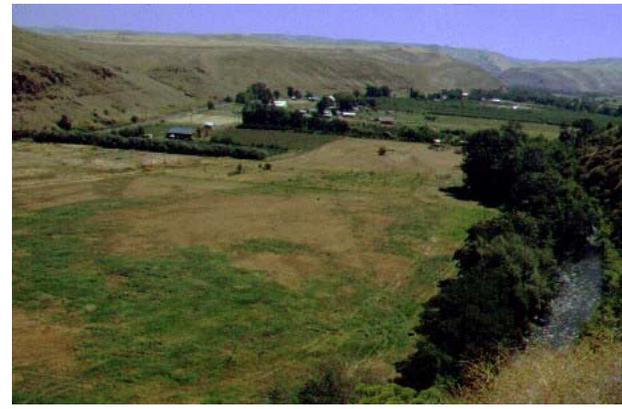
In 1999, the project site was seeded to native grasses; however, the grass did not establish itself well. As a result, during this reporting period, the project area was tilled, sprayed and reseeded. Bids were solicited for tilling and reseeding the entire project area (18 acres) in February, and all seeding was completed in March. A contract for chemical broadleaf weed control was developed with Pendleton Grain Growers (PGG) of Pendleton, Oregon. Two applications of broadleaf herbicide were applied during the summer months. Photo points were collected in July.

August 1998

July 2000

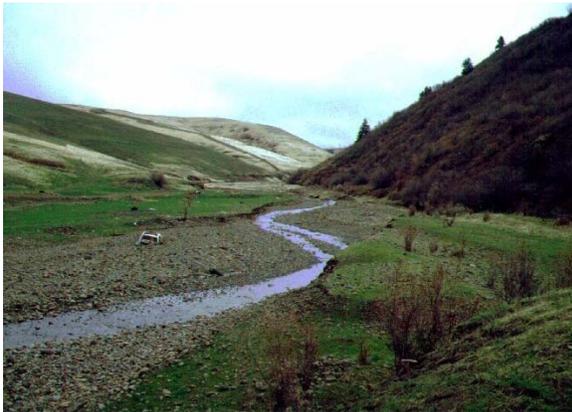
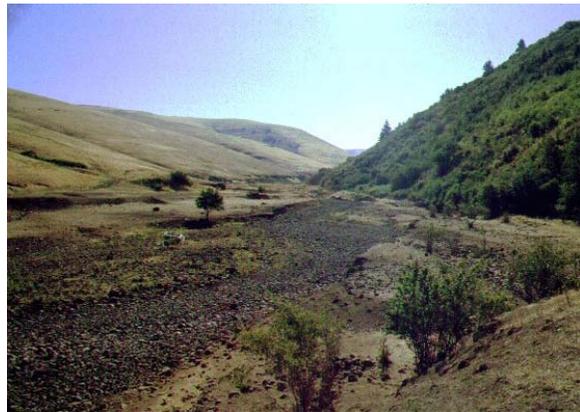
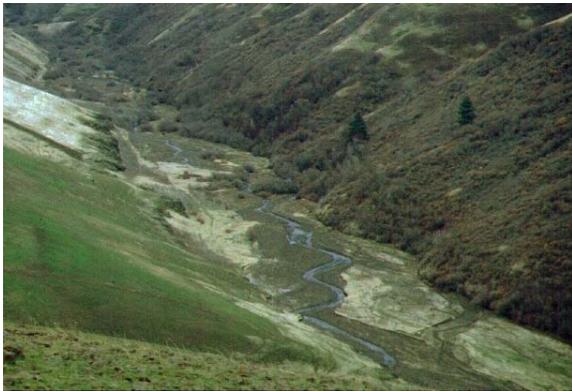
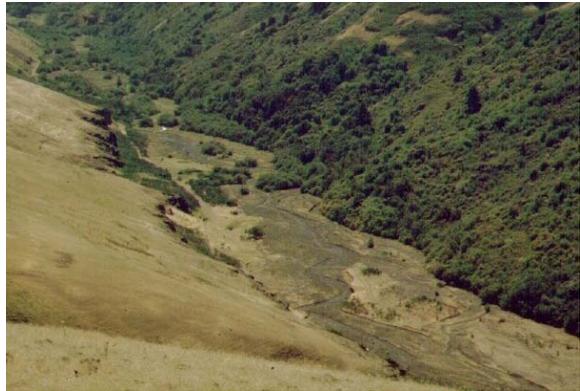
The project continued coordination with the landowner, his lessee, and NRCS/FSA through the CREP program. Several days were spent by project technicians maintaining the livestock exclusion fence and water gaps. Monitoring information and photopoints were collected in July.

December 1999

July 2000

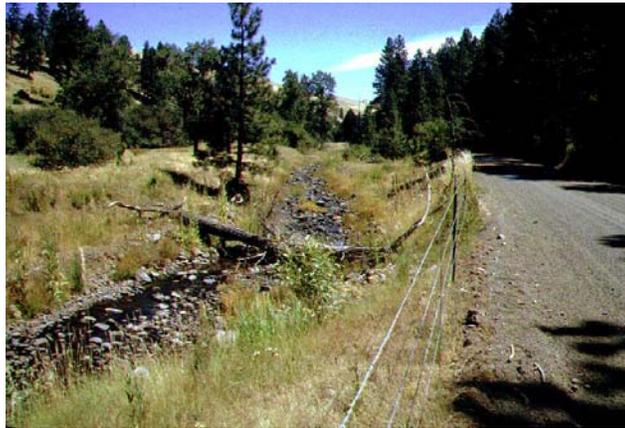
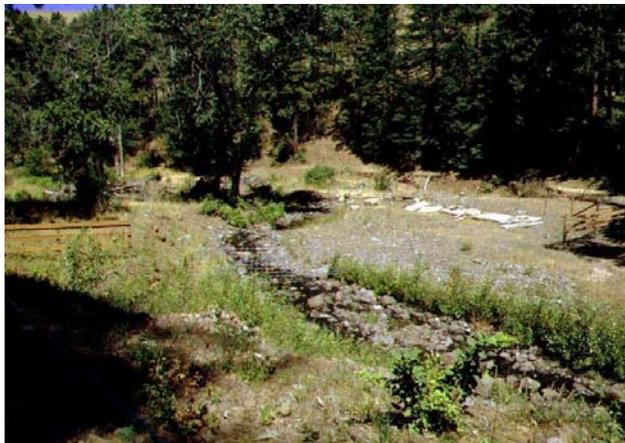
on October 4 of the reporting period. The final implementation plan included the construction of eight vortex weirs, two rootwad revetments, two keyed log jams, meander bend enhancement and point-bar development. Additionally, willow cuttings were installed by both trenching and stinging.

July 2000
