WHITE RIVER FALLS FISH PASSAGE PROJECT

VOLUME II: APPENDIX A

FISHERIES HABITAT INVENTORY

MT. HOOD NATIONAL FOREST

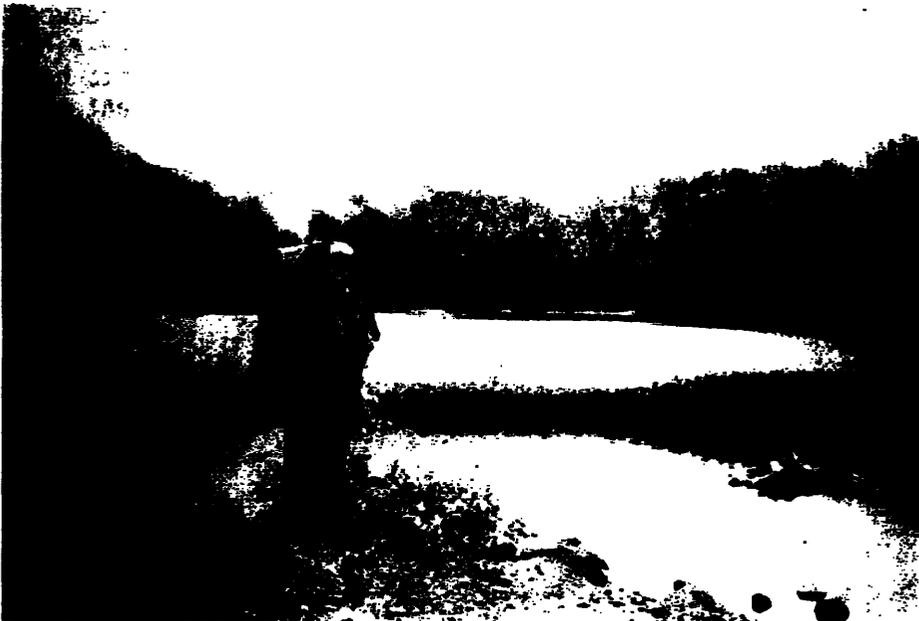
Badger Creek heads in Badger Lake (35 acres), 22.1 miles above the stream's confluence with Tygh Creek. A small dam has been installed at the lake outlet which has increased storage capacity and allows regulation of the stream for supply to the irrigation diversion downstream. As a result, the stream from the lake to RM 15.3 has a good baseflow and excellent habitat conditions during summer periods. The lake appears to be suitable for rearing juvenile anadromous fish (chinook, coho, steelhead, and sockeye).

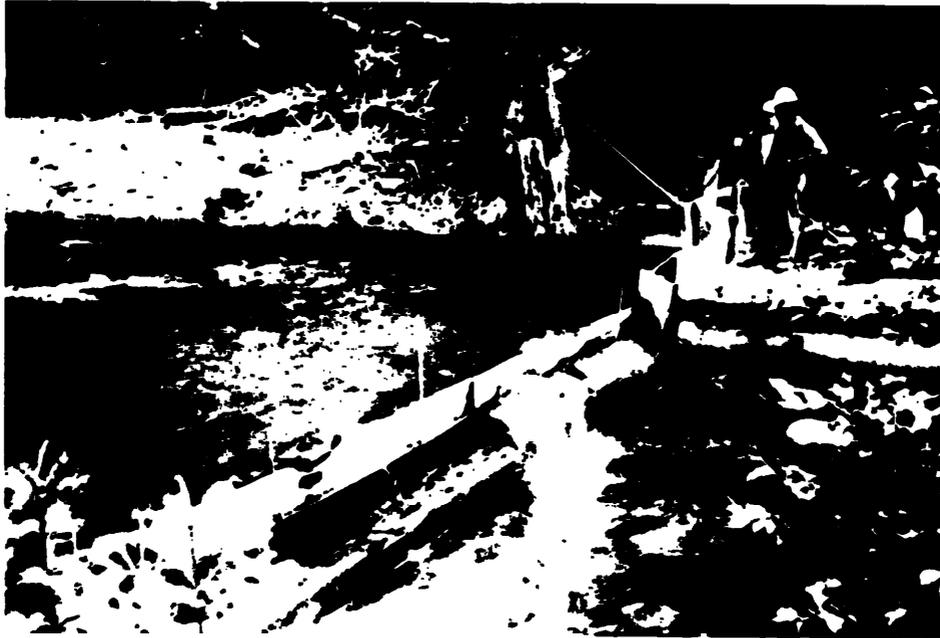
The Crane Creek ditch crosses the stream at RM 3.1, diverting 70% (25 cfs) of the streamflow at that point. Riparian and fish habitat quality is affected for two miles downstream by the water withdrawal. The diversion dam presents a partial barrier to fish migration; passage enhancement would likely require jump pool development. Diverted water is utilized for irrigation of the White River State Wildlife Management Area.

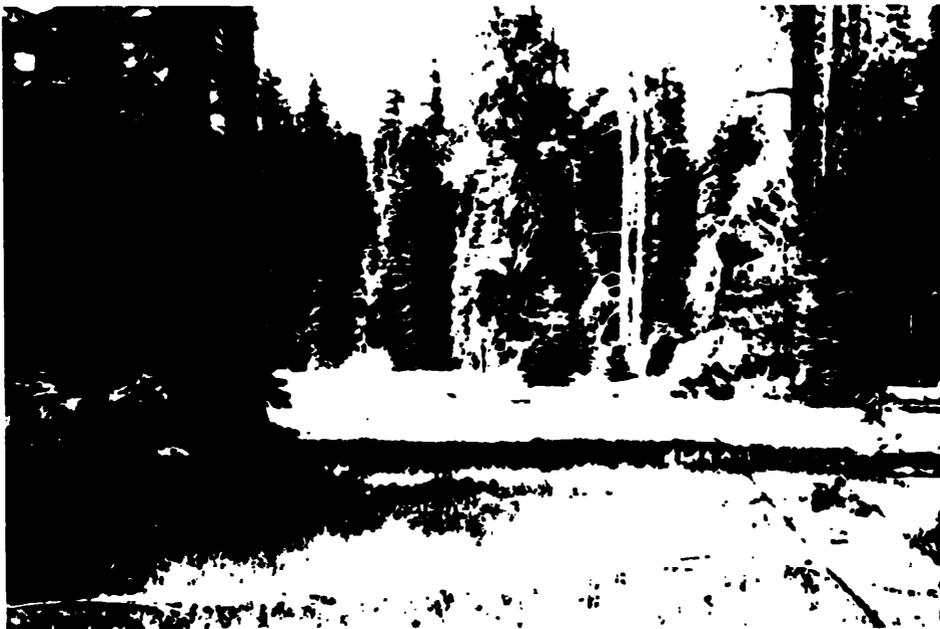
Large wetland development is exceptionally high in the 1000 foot wide valley bottom of Reach IV. Riparian habitat conditions are rated very good (RcR=8.5) in this reach. wildlife use, especially big game, appears to be very heavy. Open meadows of 10-20 acres such as this one at RM 10.0 (shown) are common in this upper third of the drainage.

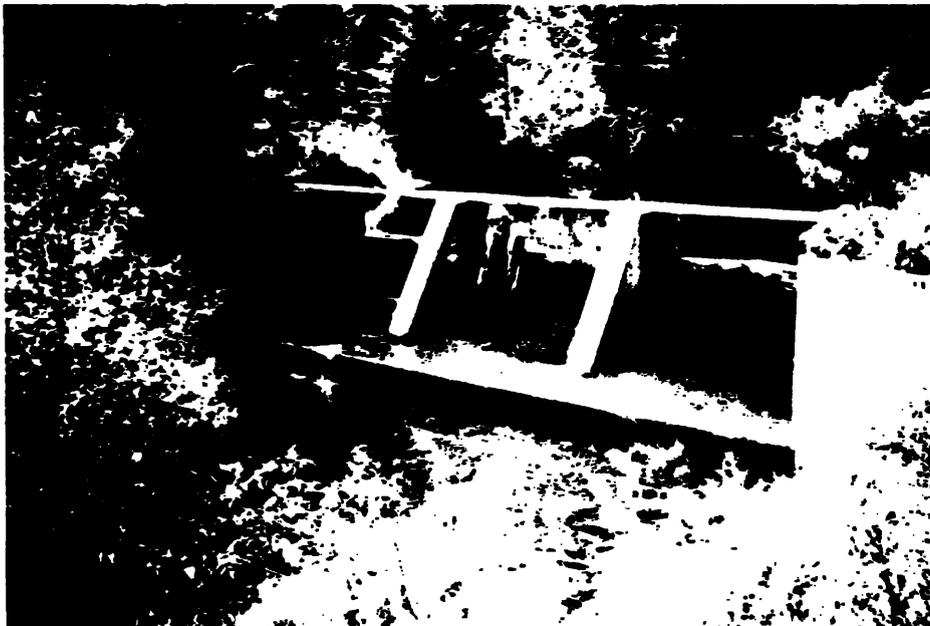
Clear Creek irrigation ditch diversion structure at RM 7.8. About 95% of low flows are diverted at this point (25 cfs), and habitat quality is significantly decreased for two miles downstream by this water withdrawal. The structure is a total barrier to upstream fish migration. Four miles of exceptionally high quality habitat (potentially suited for coho, steelhead and sockeye) lie above this dam. three small logjams present partial to full migration barriers below this point (RM 1.4 - 2.5).

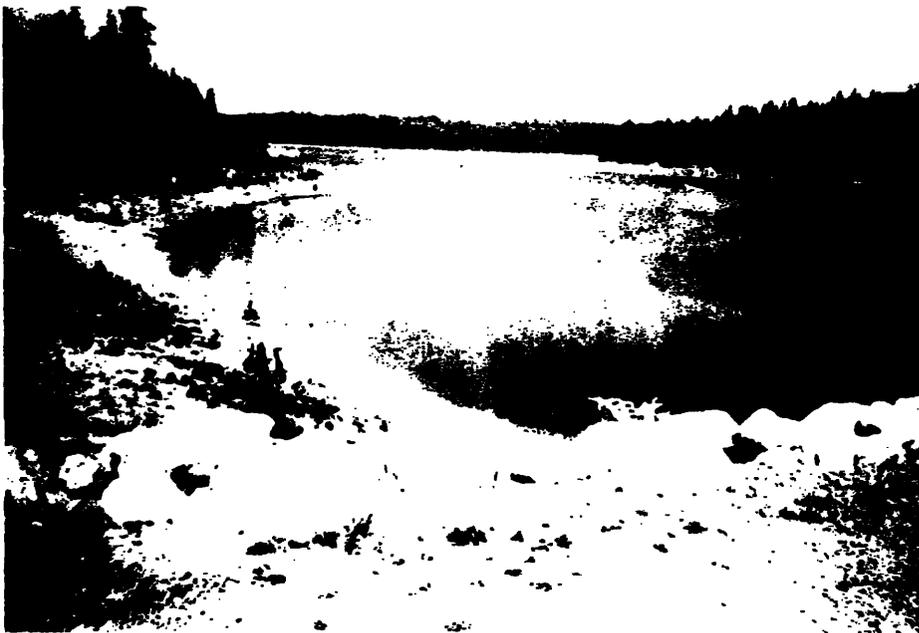
A fifty foot dam at RM 11.8 creates Clear Lake (550 acres) and also presents a complete barrier to upstream fish migration. The lake currently supports resident brook and rainbow trout, and is also stocked with trout by the ODFM in response to heavy recreational fishing pressure on the lake. This impoundment appears suitable for rearing juvenile anadromous fish (chinook coho, steelhead, and sockeye).

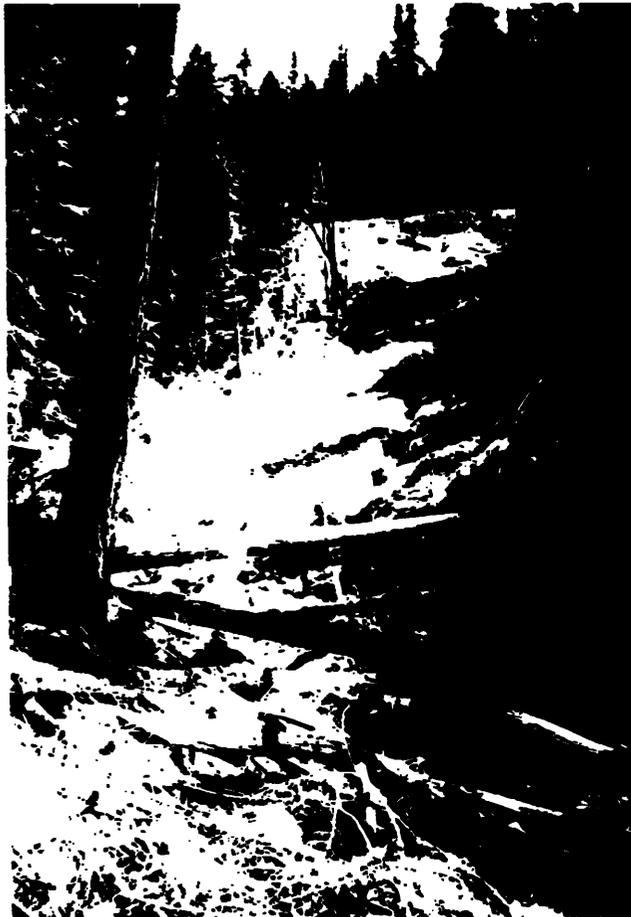
At RM 1.3 on Red Creek, a very large landslide (2000 cu. yards.) has entered the channel (right and center middleground). The slide was apparently triggered by underlying springs and the collapse of sidecast material from road construction (background). Rehabilitation opportunities at the site include stabilization of the eroding sideslope and streambanks in this area to reduce sediment loading of the stream.

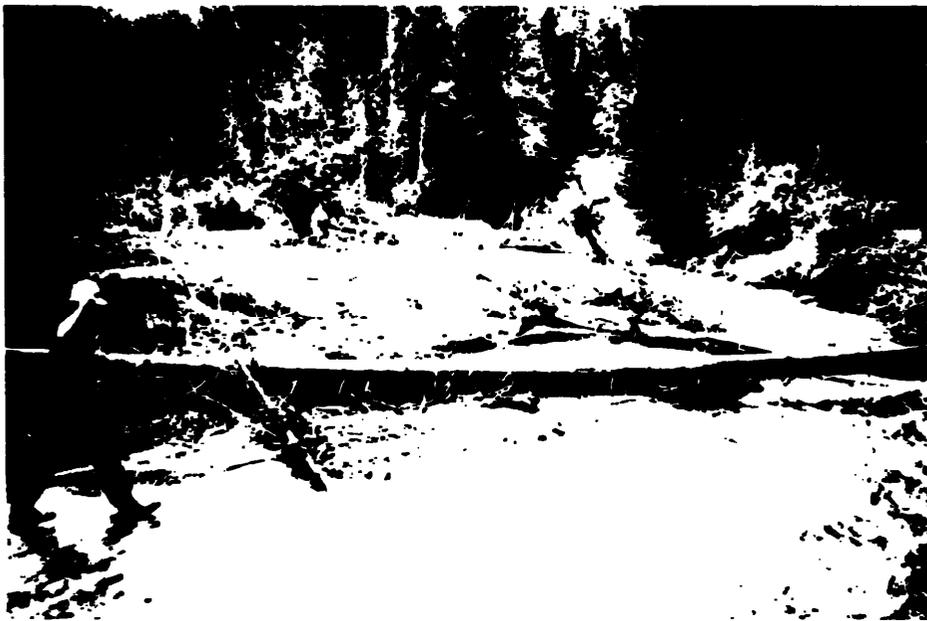
View of a typical section in Reach I (R.M. 1.7). The flow regime in this reach is very flashy. At RM 2.7 a new channel of White River has captured the established Iron Creek channel. Channel and flow characteristics in Reach I are therefore a blend of White River and Iron Creek. Channel and bank stability are low. Fish habitat is fair, with fast flowing riffles and runs dominating the stream surface area. Pool size is small (1 sq. yard).

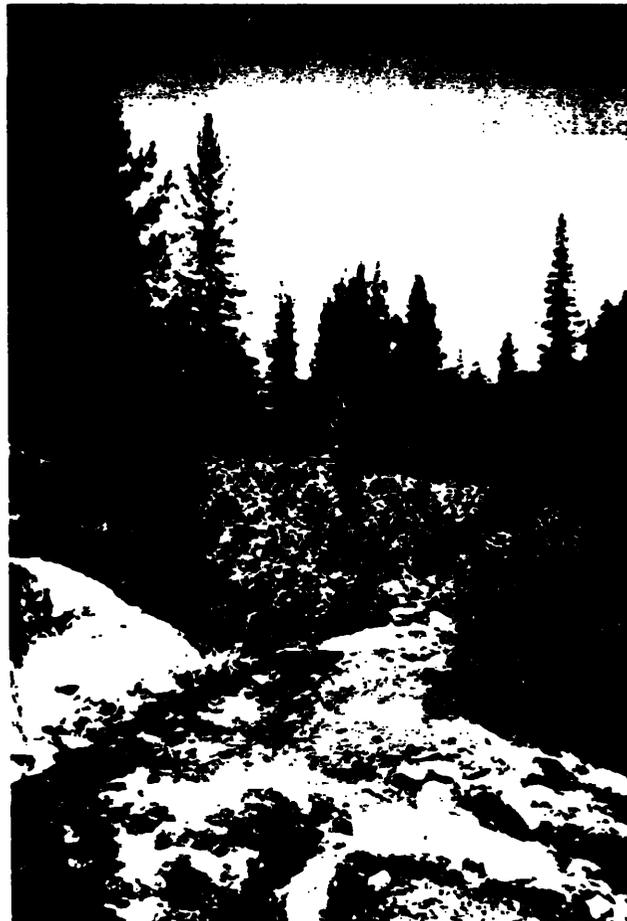
Bank and channel stability increase in Reach II due to decreased flow and increased bank vegetation. Pool surface area increases (P:R = 4:6) and is attributed to an increase in boulder structure. Rearing habitat is fair. Pools are small (avg. = 1 sq. yd. with shallow to moderate depths and high effective cover (view at R.M. 2.6).

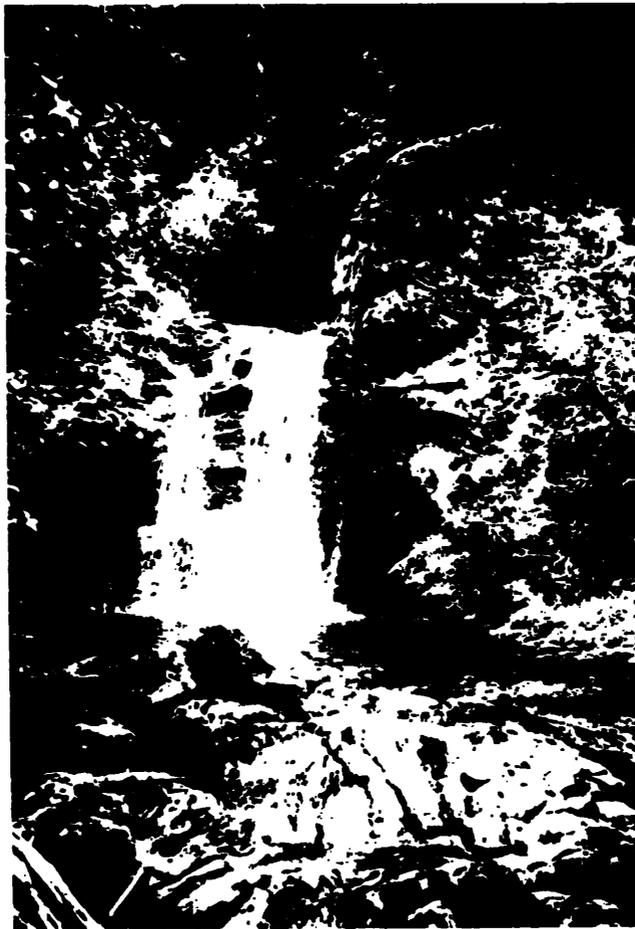
Carp Creek is a major tributary to Iron Creek at R.M. 1.7. A series of waterfalls greater than 12 feet high are present on Carp Creek above RM 0.4 (shown). They present a total barrier to fish migration. No anadromous fish habitat appears to exist above the falls.

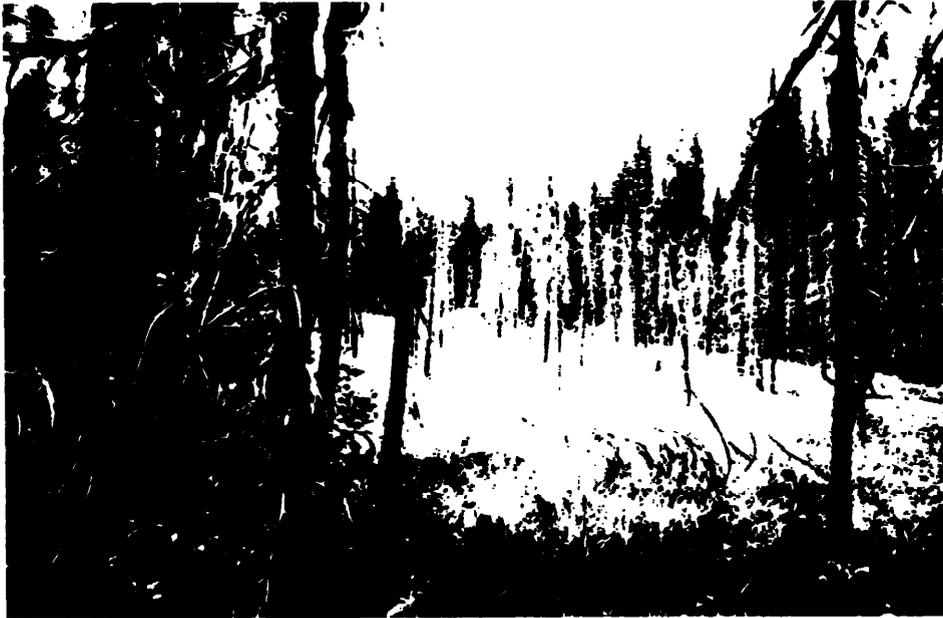
Two large sedge meadows at Rm 1.5 and 3.4 [shown] between the Iron Creek and White River floodplains add diversity to riparian habitat in Reaches I and II. Big game utilization of these areas appears heavy

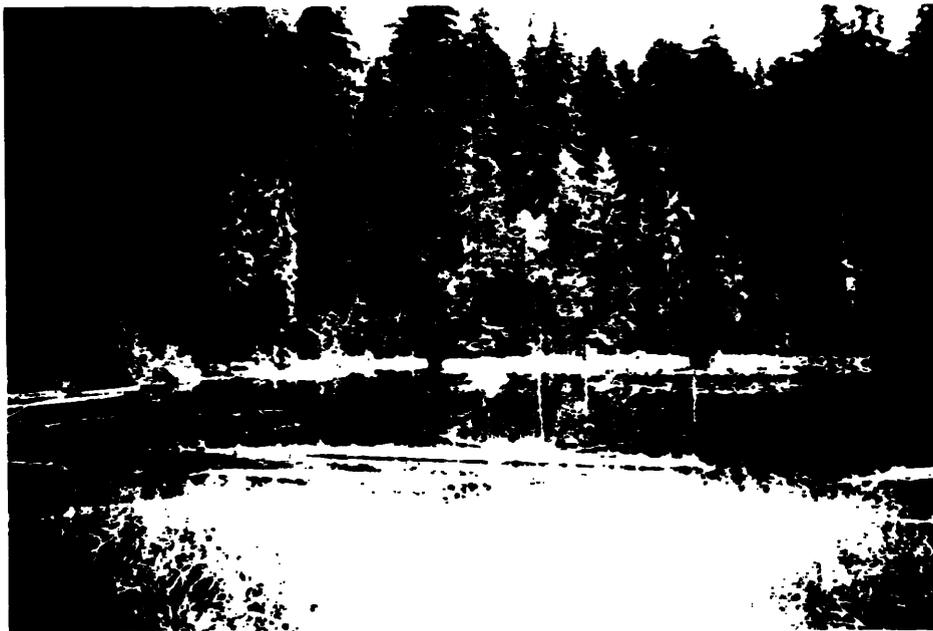
A small pond on the east Side of the floodplain at Rm 0.2 covers about an acre. Riparian wildlife habitat in this area is exceptionally diverse both in **terms** of vegetative structure and number of species. A great blue heron and female smalarld were using the pond at the time of the survey- Deer and elk sign were common also

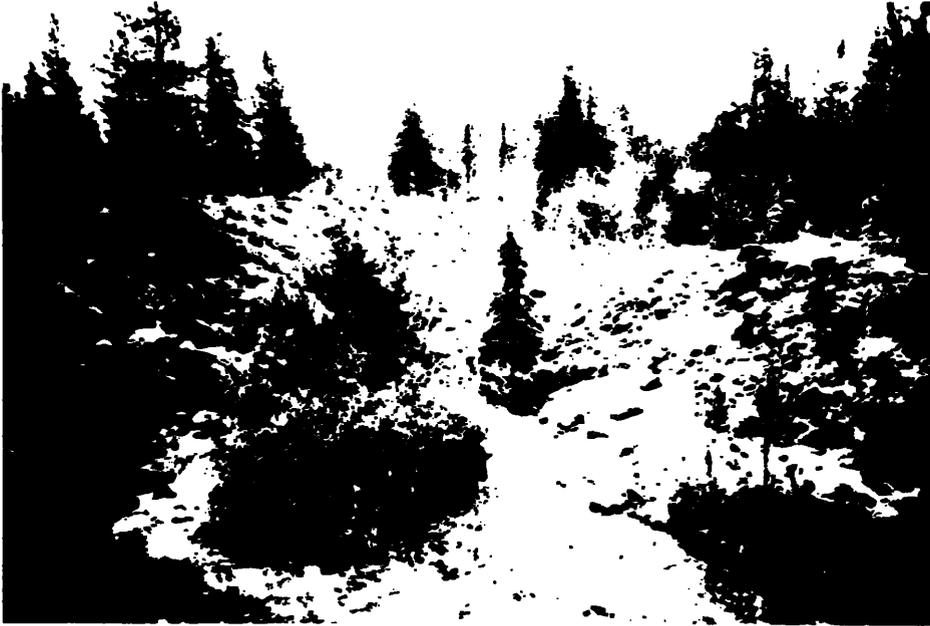
Upper Tributary C flows within the White River - Iron Creek floodplain. Riffles dominate the stream area (P:R = 3:8). Pools are small (1 sq. .vd) and shallow with low effective cover. The stream braids into a large sedge meadow before re-establishing a channel and flowing into Iron Creek. Photo at R.M. 1.0.

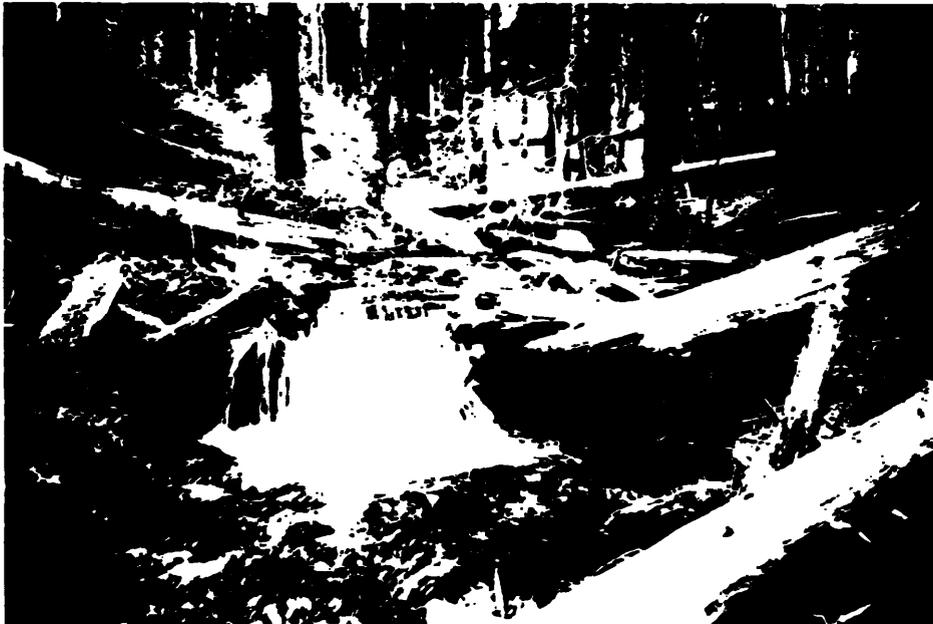
Worth Fork Iron Creek has an overall 11% gradient; large woody debris (LWD) and boulders create a stair-step profile. Pools are 2-3 square yards in area with shallow to moderate depths. This view is at R.M. 0.1,
