Natural Propagation and Habitat Improvement, Volume I

Oregon

Annual Report
1982 - 1983

DOE/BP-243

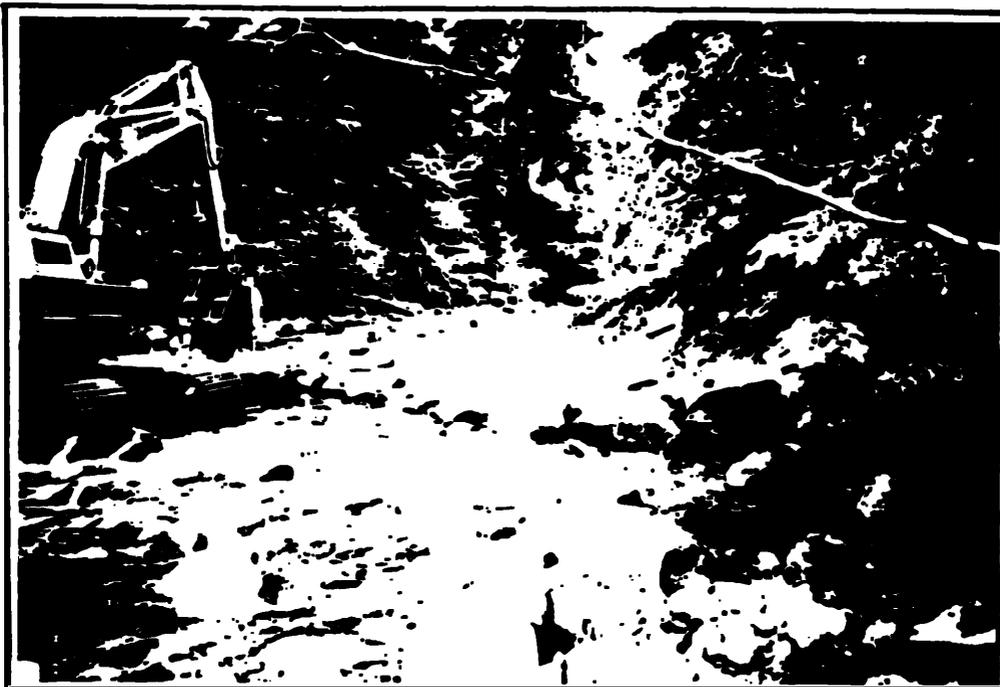
Backhoe Constructing primary row of boulders of arm of houlder berm. Lamest boulders in the reach of stream are used for this row.

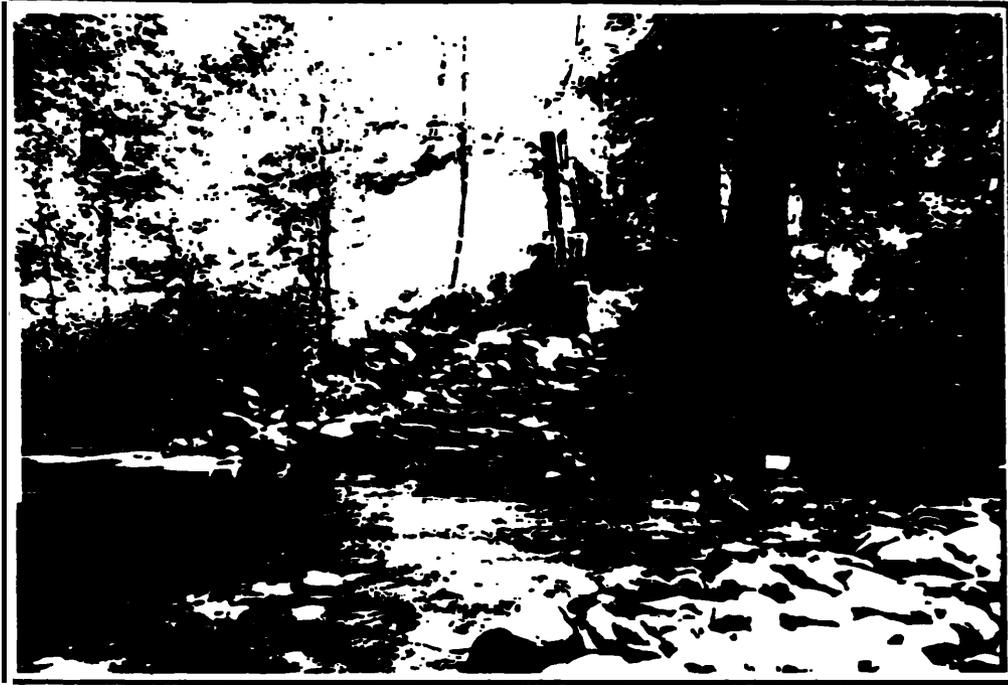
Rip-rap of stream bank at access into Fish Creek.

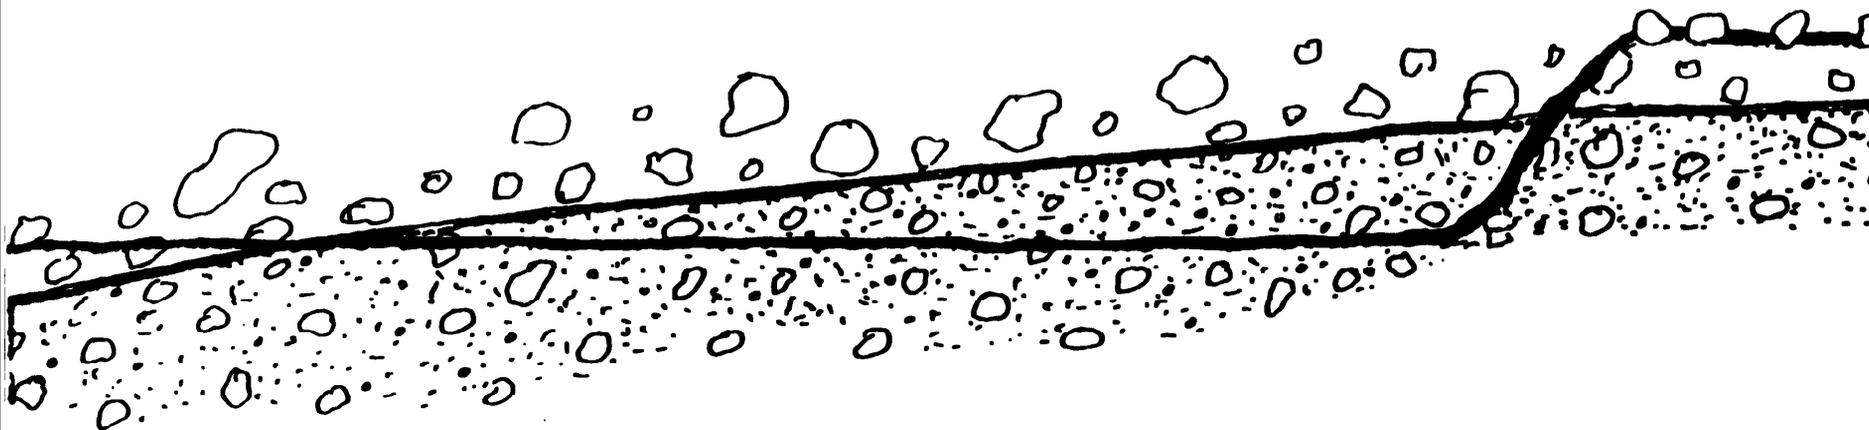
SECTION THROUGH FALLS

LOOKING SOUTH OCT. 1983

As the stream deposits erode, the cemented ash tends to stay in-place until it is sufficiently undercut, then it fails by peeling off in near-vertical slabs. The result at this point is a waterfall about 10 feet in height. As the erosional processes continue, the falls will move upstream, increasing in height while the downstream side continues to erode, maintaining a relatively flat gradient.

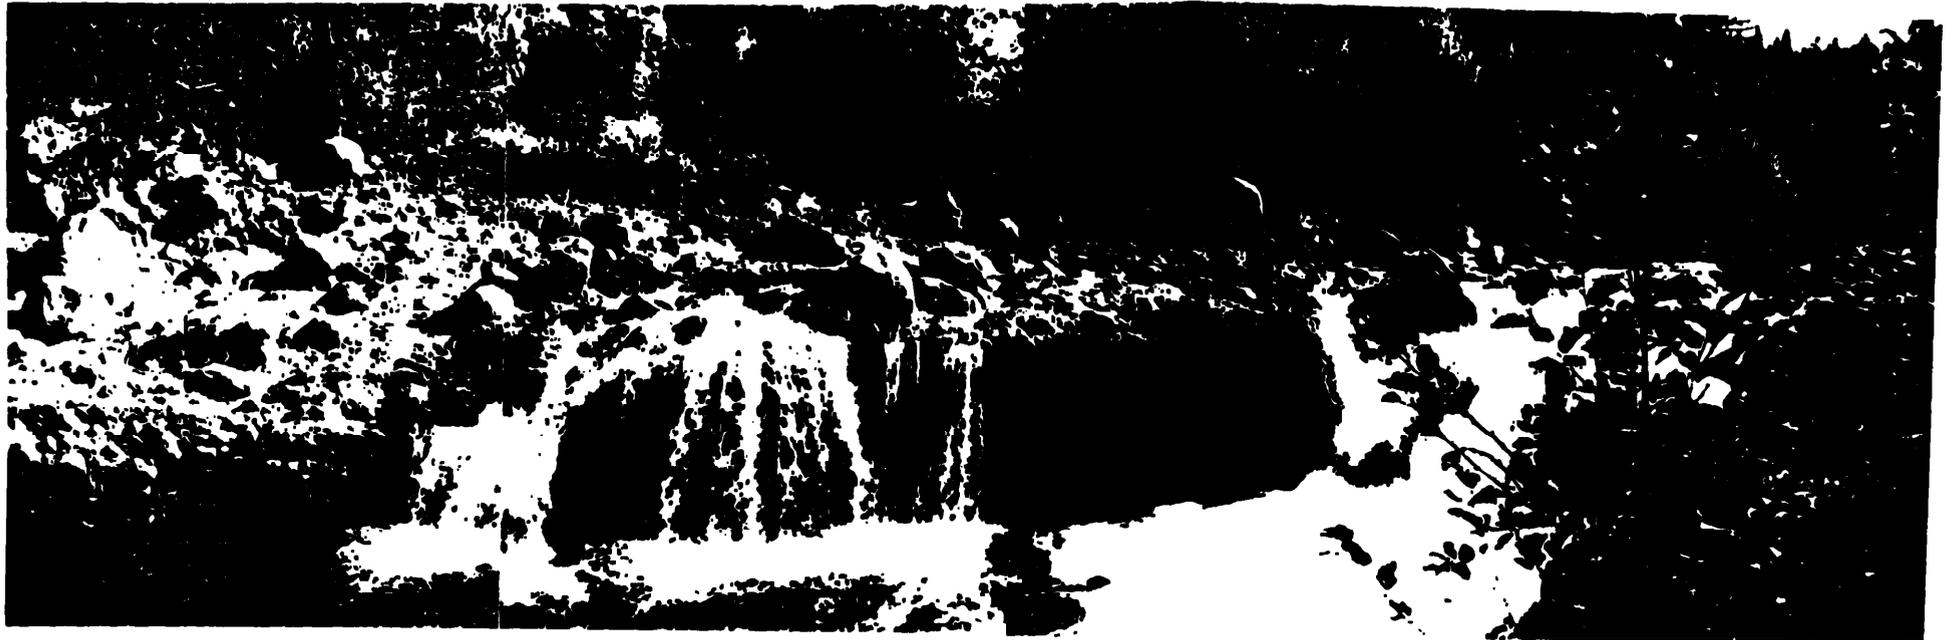
OVERALL VIEW OF FALLS

Note Undercutting

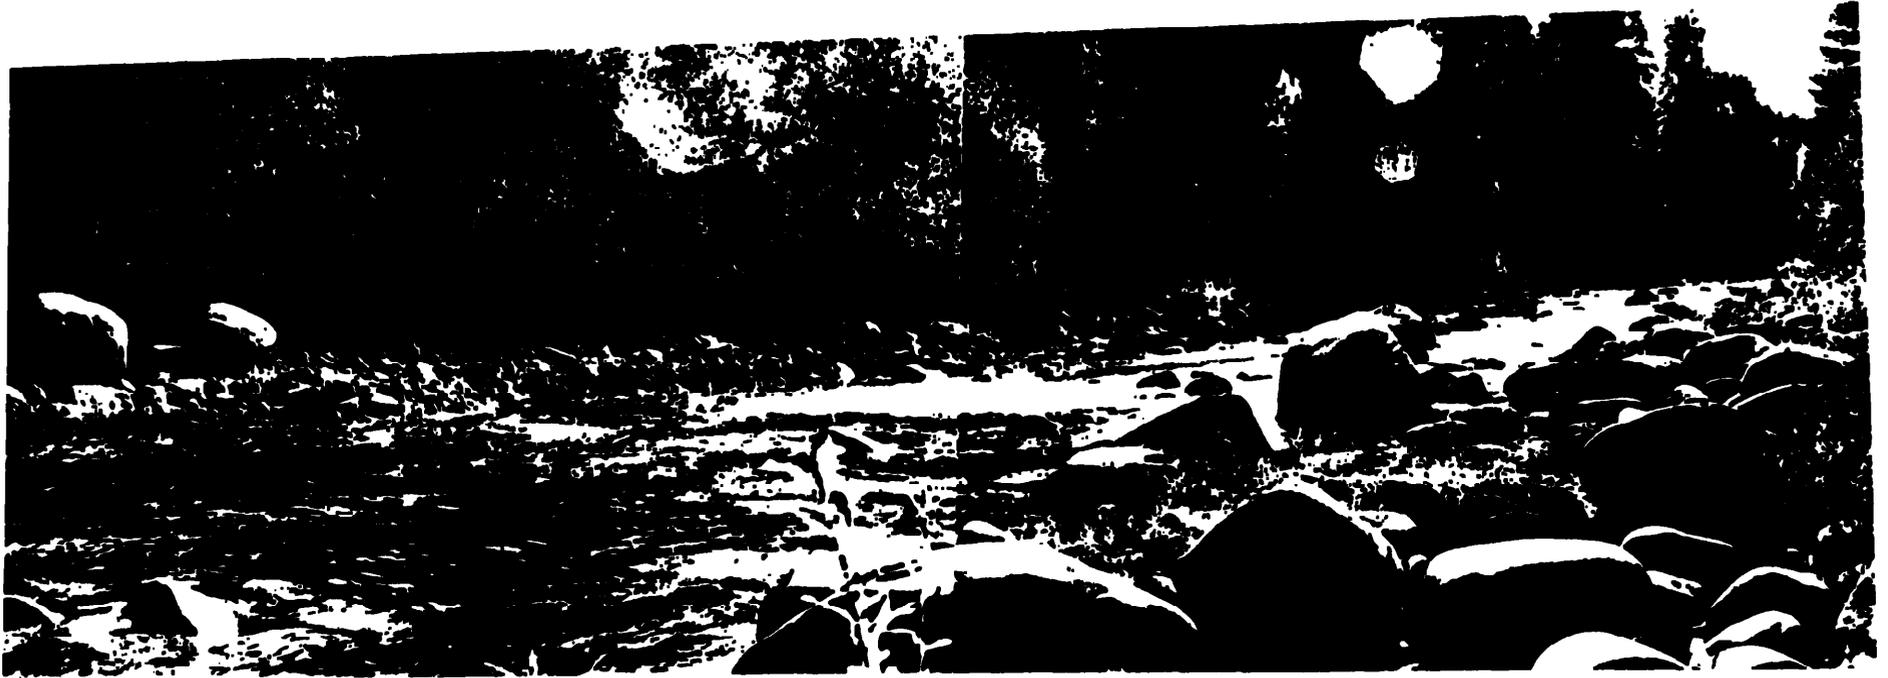
**VIEW UPSTREAM FROM FALLS SHOWING
BROAD CHANNEL AND FLOOD PLAIN
Note Boulders 4'.6' in Diameter**

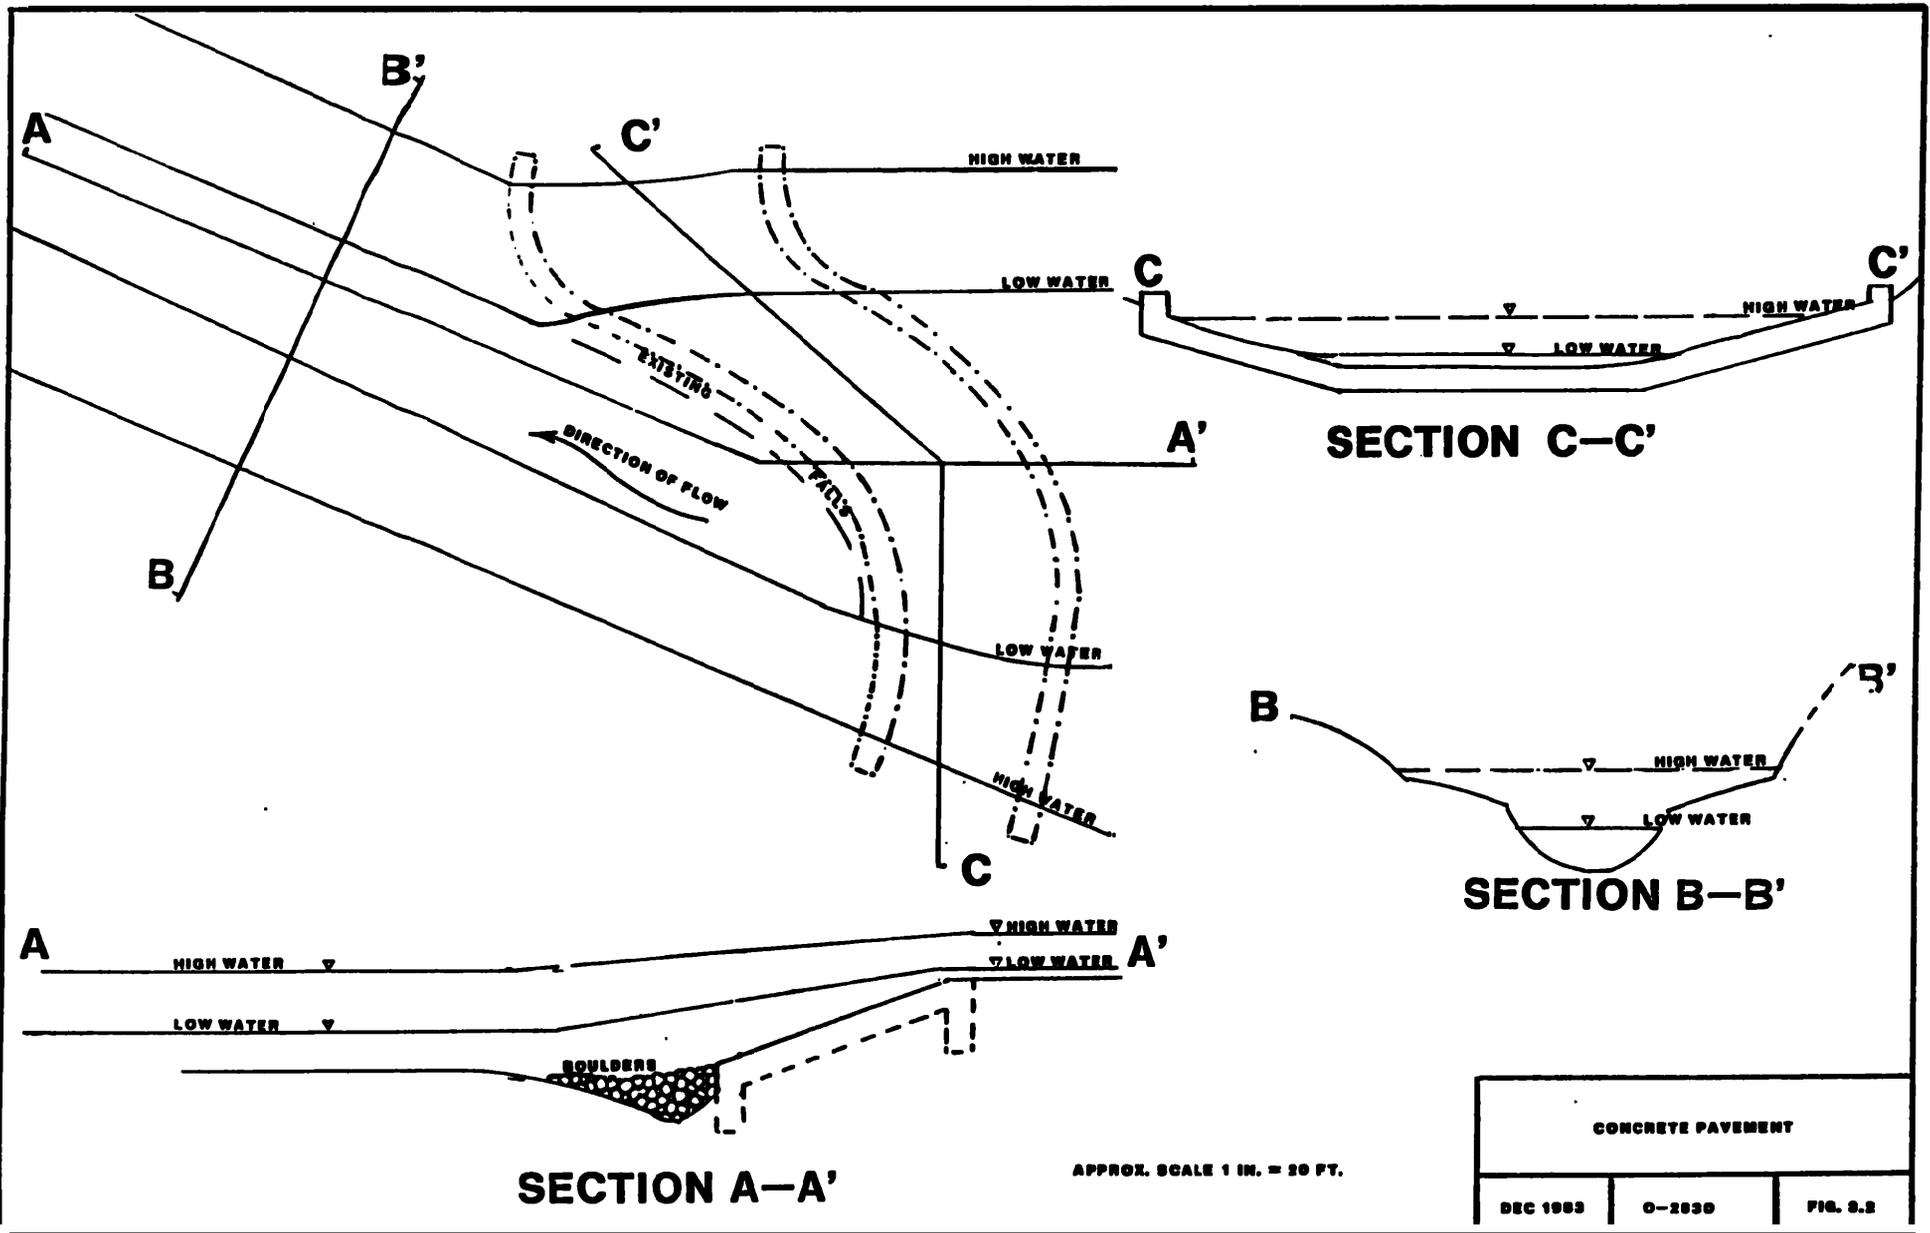
This solution consists of grading the falls to a uniform slope and paving the slope with a layer of reinforced concrete. One possible configuration for this design is shown on Figure 3.2. This solution indicates a bouldery fill at the downslope end to prevent scour. Other possibilities include a paved downstream blanket or a small weir and stilling pool. This sketch shows a curved configuration that approximates the existing falls, a straight configuration (possibly with a dog-leg) is probably a more likely final design.

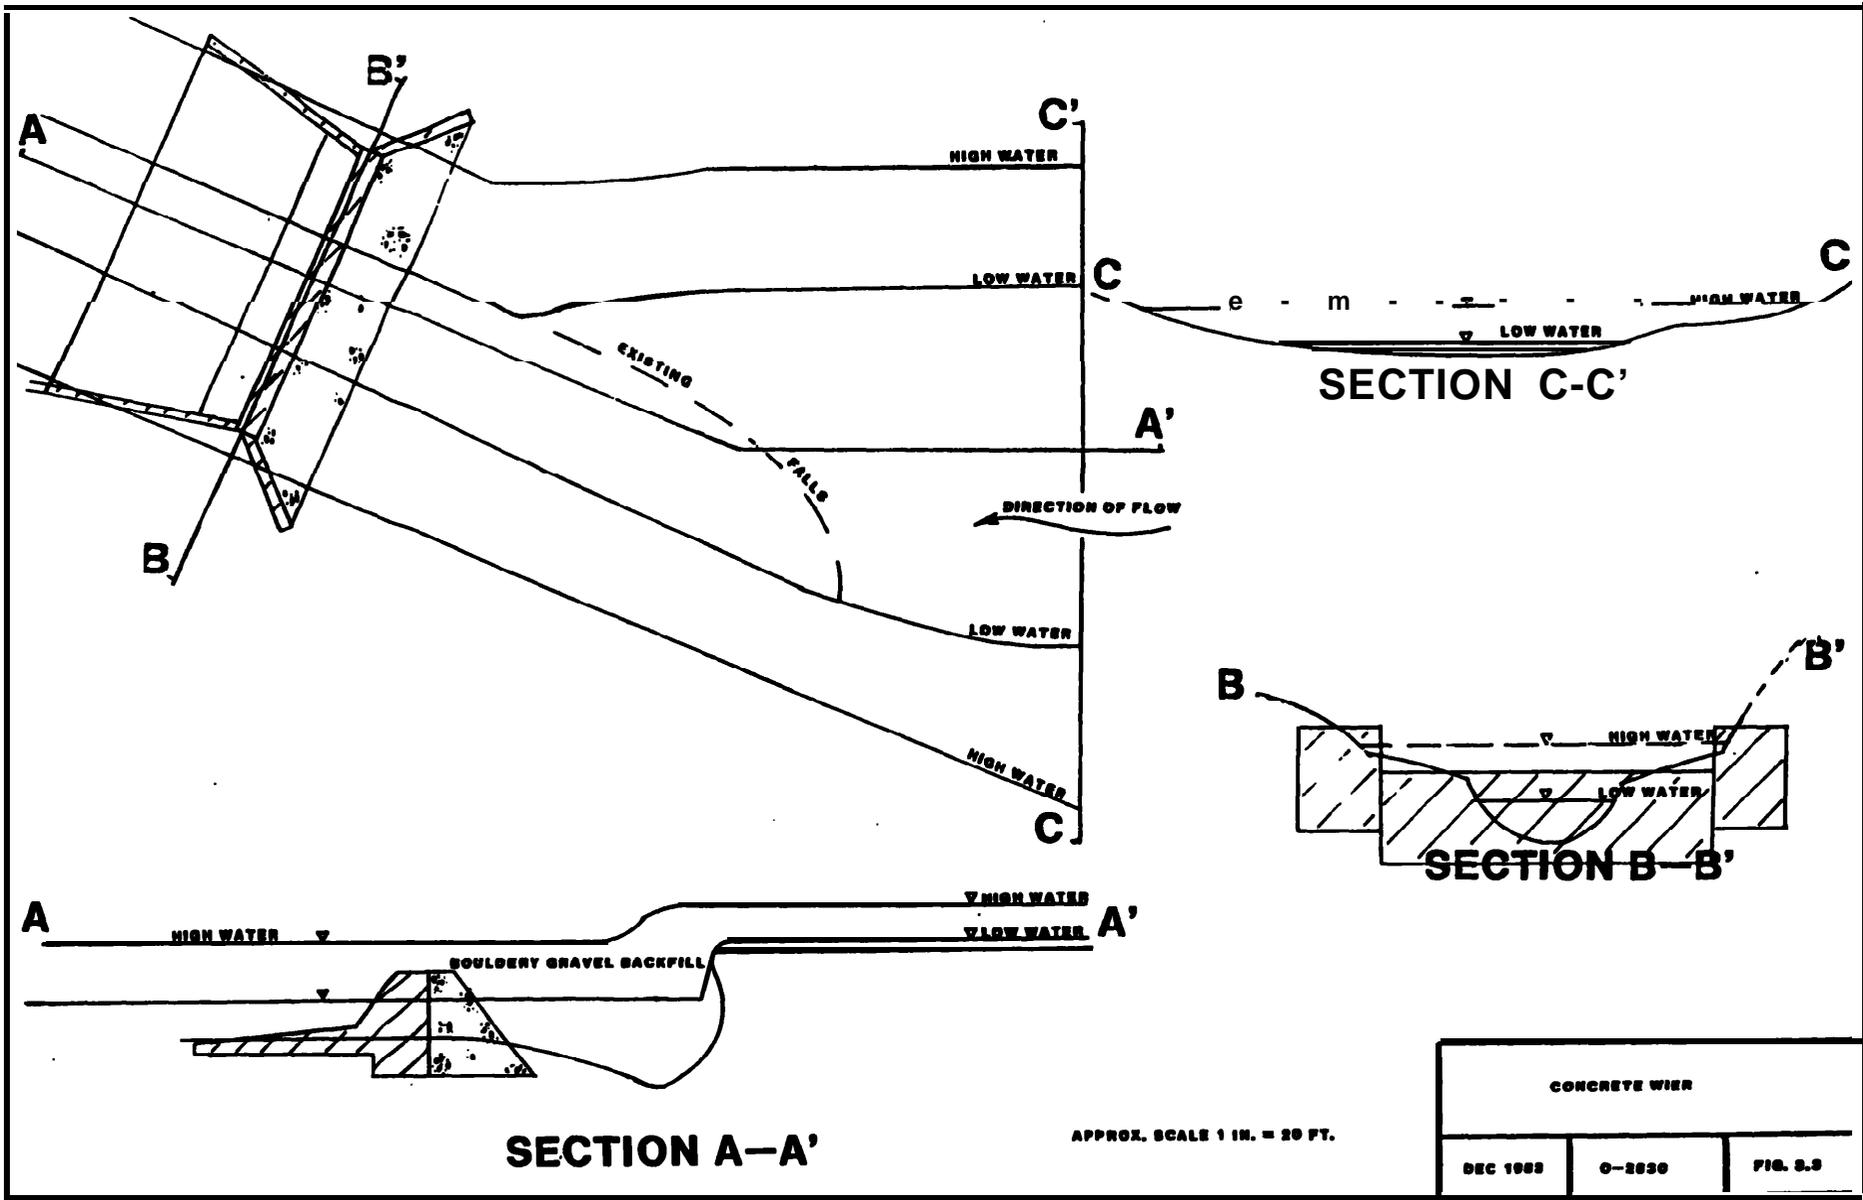
CONCRETE WEIR		
DEC 1988	O-2830	FIG. 2.3

A concrete wier is illustrated on Figure 3.3. The design concept is similar to the gabion check dam. This figure illustrates a paved downstream blanket although a wier and stilling pool is also an option. The figure illustrates only a partial backfill (to cushion boulder impact) rather than the full backfill shown with the gabion structure. If the wier is sufficiently high, the upstream pool will back water above the falls., and the existing scour hole will backfill naturally. Alternatively a low wier would require complete backfill as shown on Figure 3.1 (Gabion Check Dam).

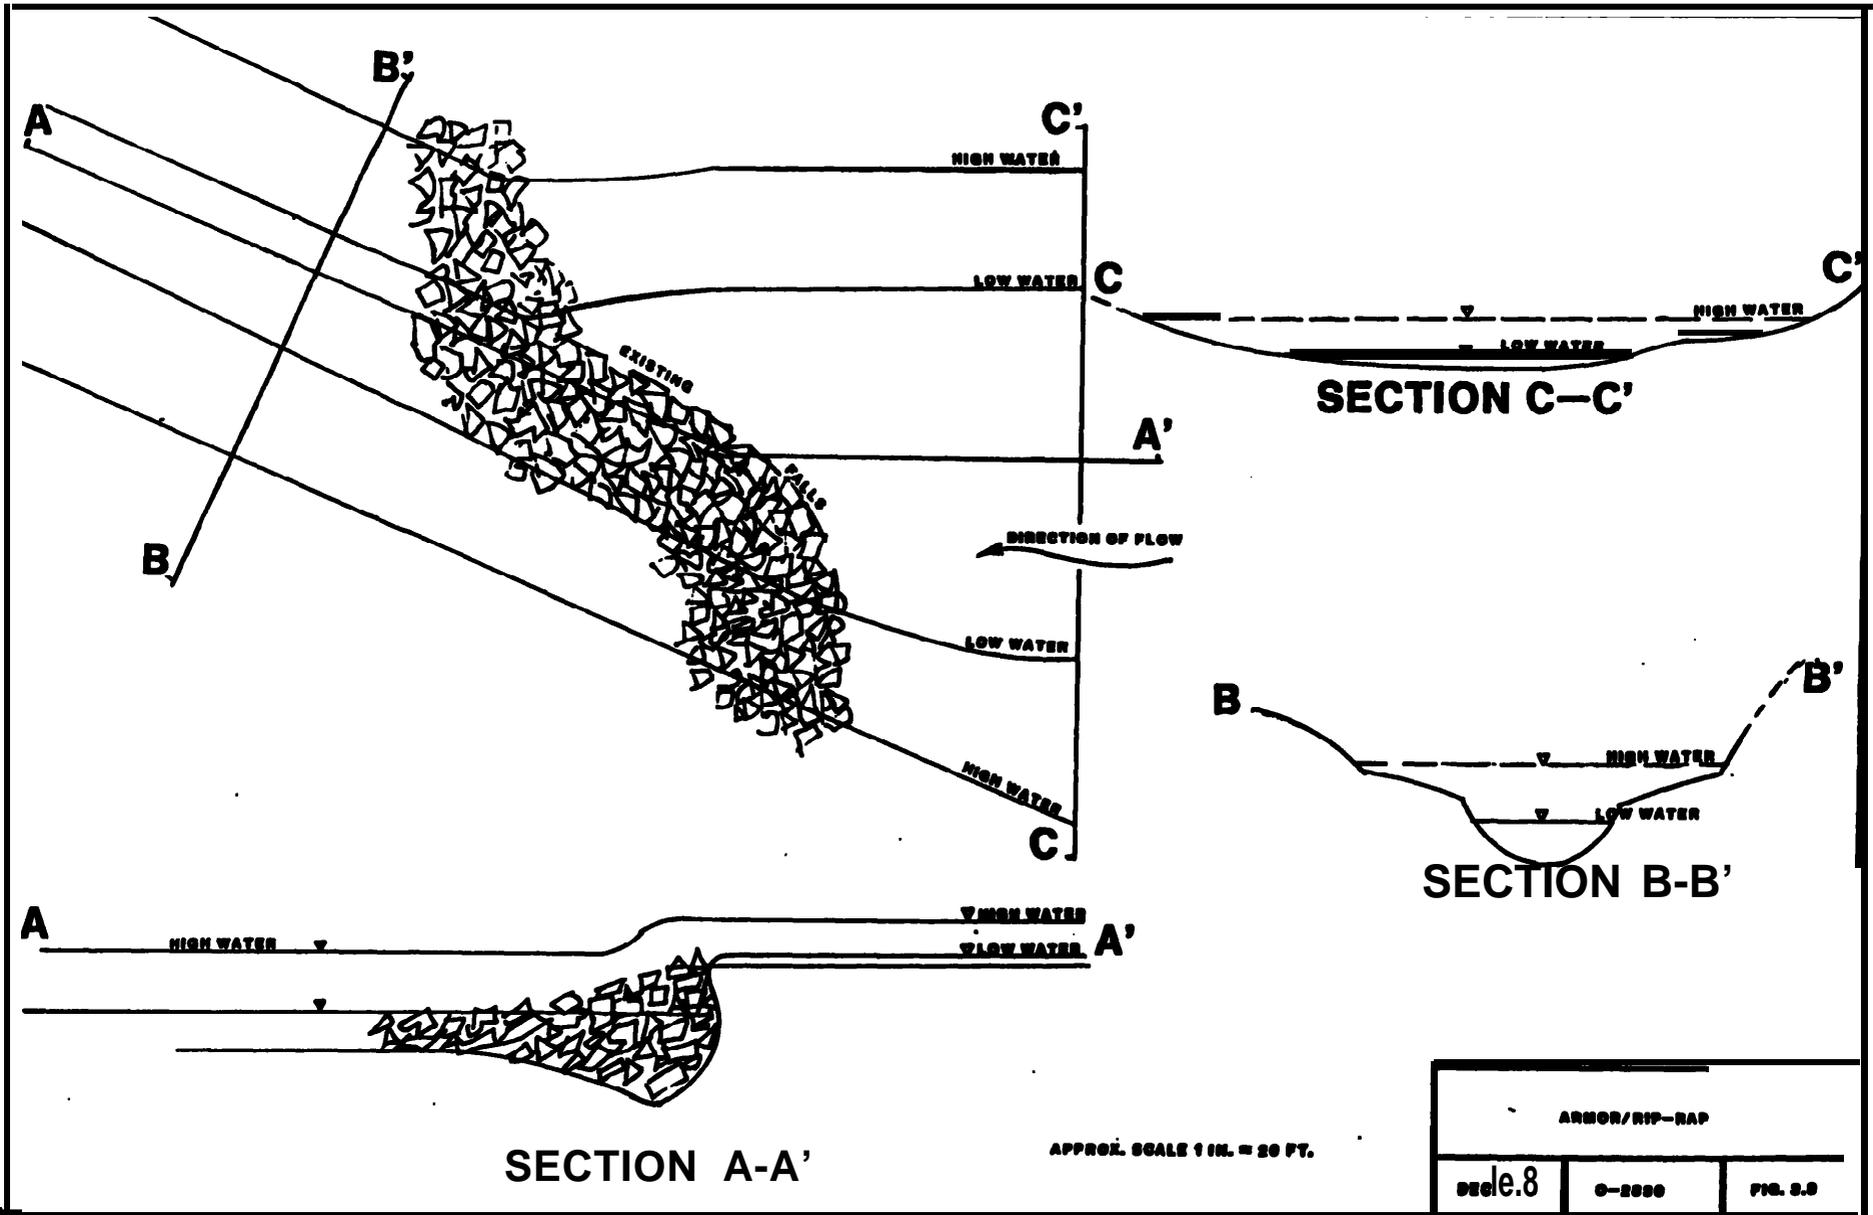
Heavy armor rock can be provided to resist erosion. This solution is shown schematically in Figure 3.8. Although not subject to rigorous analyses, it is probable that angular basalt quarry rock in the range of seven to eight feet in diameter would be adequate to resist erosion. Alternatively many other waste type materials may be available locally, including crushed automobile bodies, waste concrete blocks, concrete pile cut offs and similar materials. Some of these items could be lashed together with cable to increase stability. The principal disadvantage of this type of solution is that it can lead to debris hang-up, channelization of water and somewhat unpredictable points of new erosion. Undercutting of banks would be a major concern and maintenance will certainly be required, but this design could potentially be very economical.
