**UMATILLA RIVER SUBBASIN FISH HABITAT
IMPROVEMENT**

ANNUAL REPORT 1994

**Oregon Department of Fish and Wildlife
Pendleton, OR**

**Project Number 87-100-02
Contract Number DE-AI79-87BP35769**

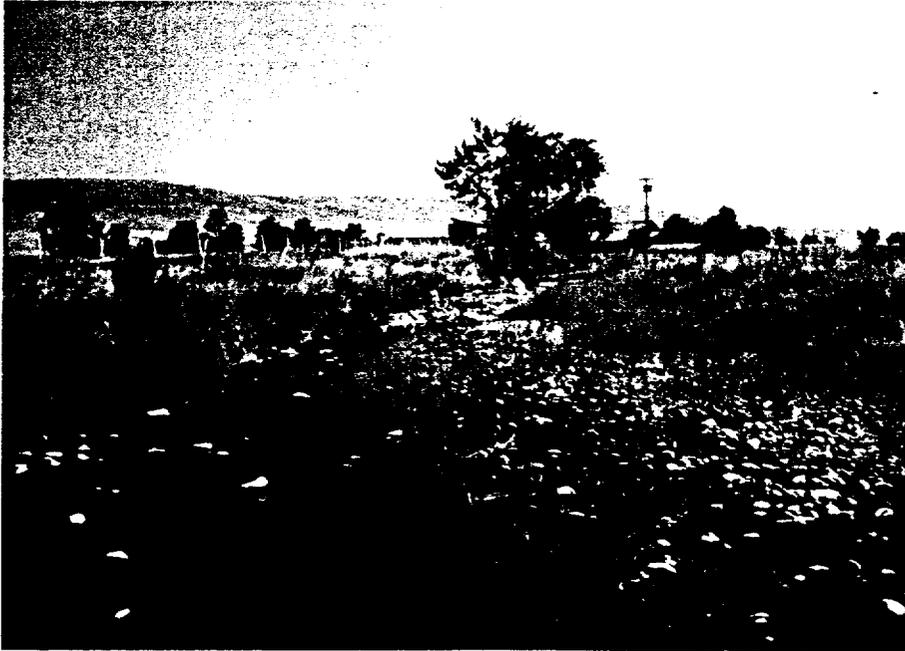
F. E. Straughn Property - 1990. First Fall photograph taken after project implementation.

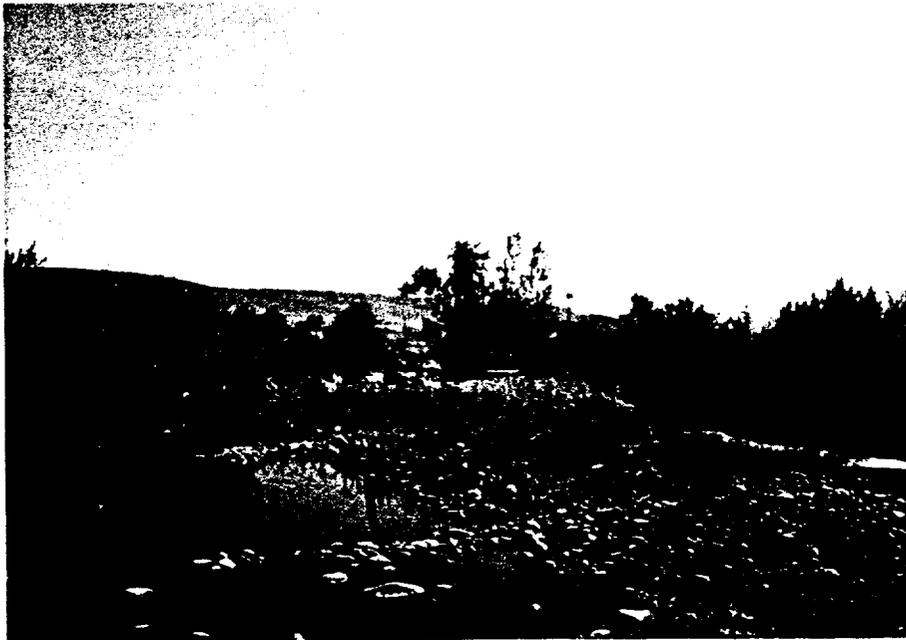
F. E. Straughn Property - 1994. Fall photograph. Note riparian development on right and left banks.

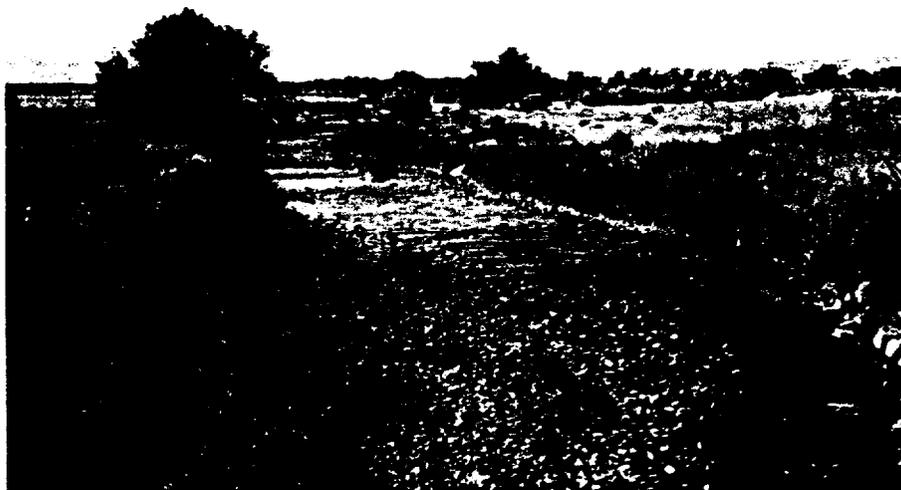
C. Hemphil Property - 1989. First fall photograph. Note absence of deciduous tree component along the stream banks

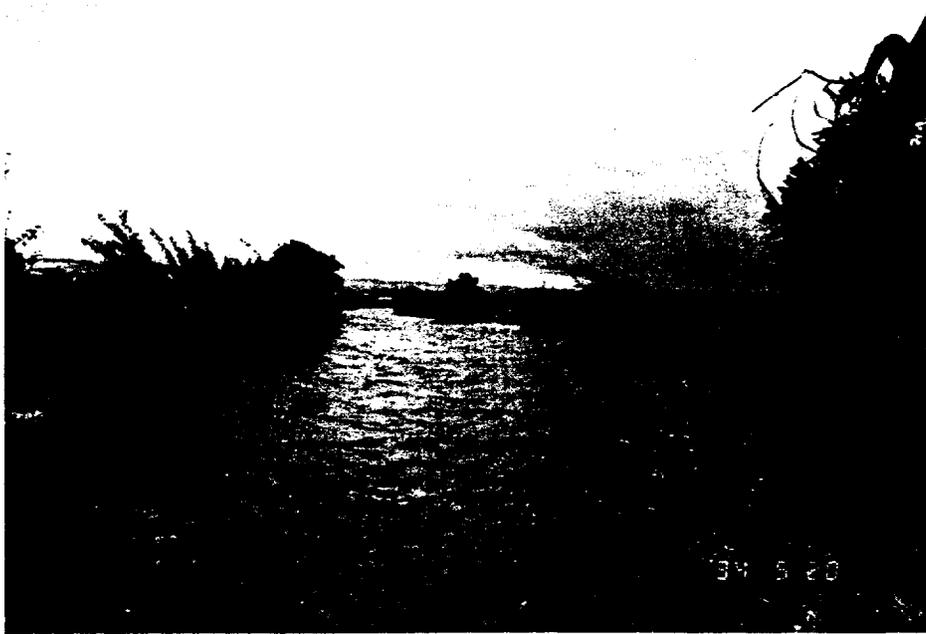
C. Hemphil Property - 1994. May photograph taken during the flood about 2 hours before peak flow.

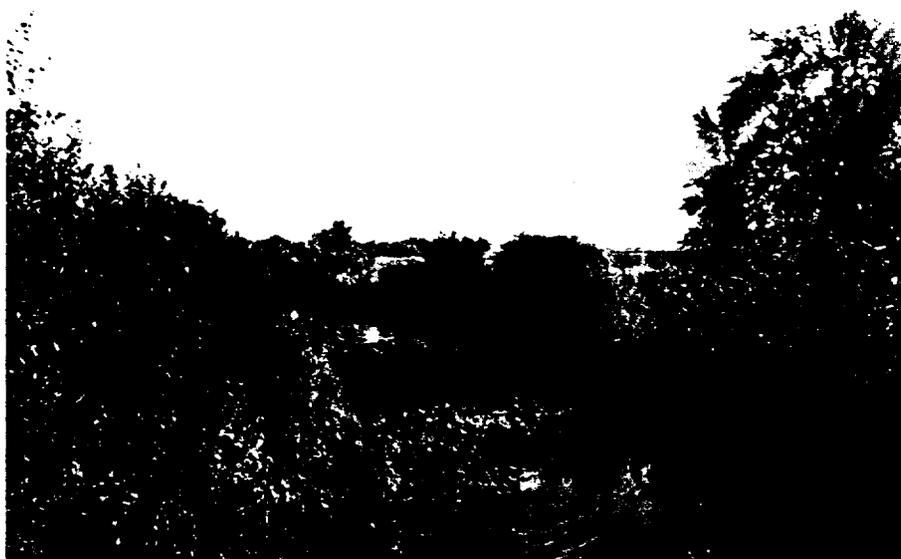
C. Hemphil Property - 1994. Fall photograph. Note riparian recovery as compared to the 1989 photographs.

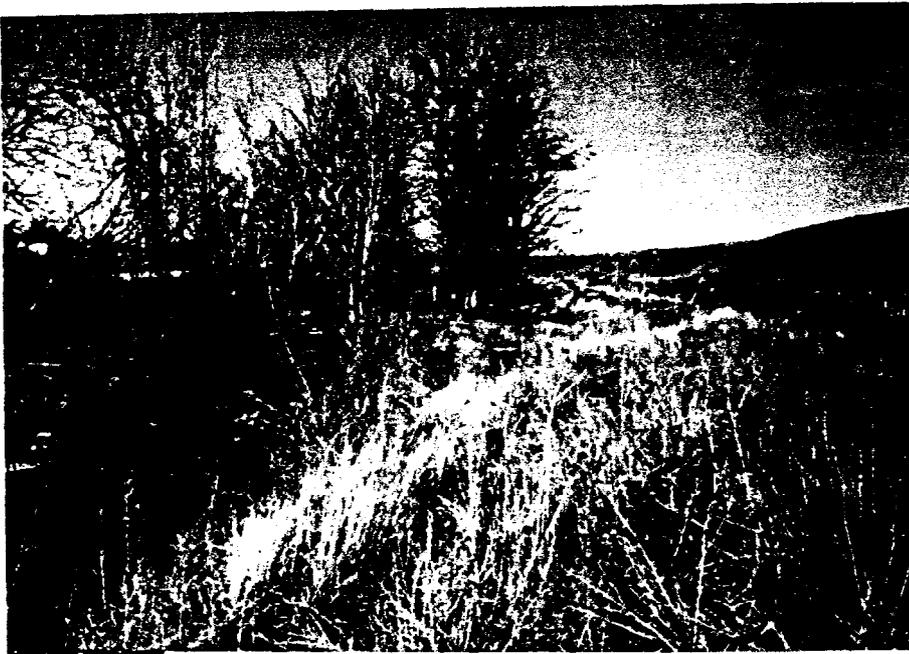
**EAST BIRCH CREEK
T. RUGG PROPERTY
Photopoint #2a**

First photograph of project taken just after fence completion.

NOTE: Bedload in channel as compared to the 1994 photograph of this site as shown below.

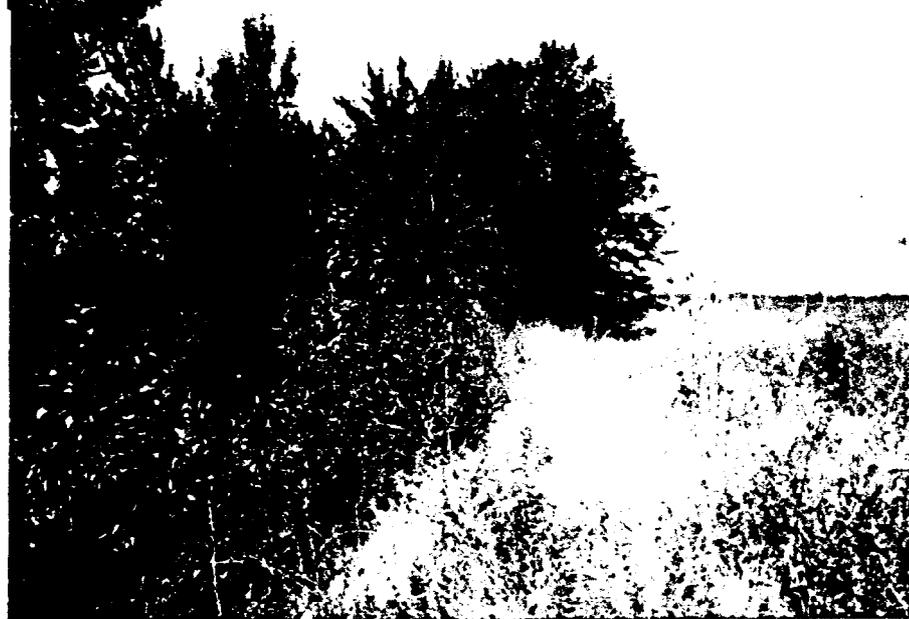
First fall photograph, note juvenile cottonwood recruitment in foreground.

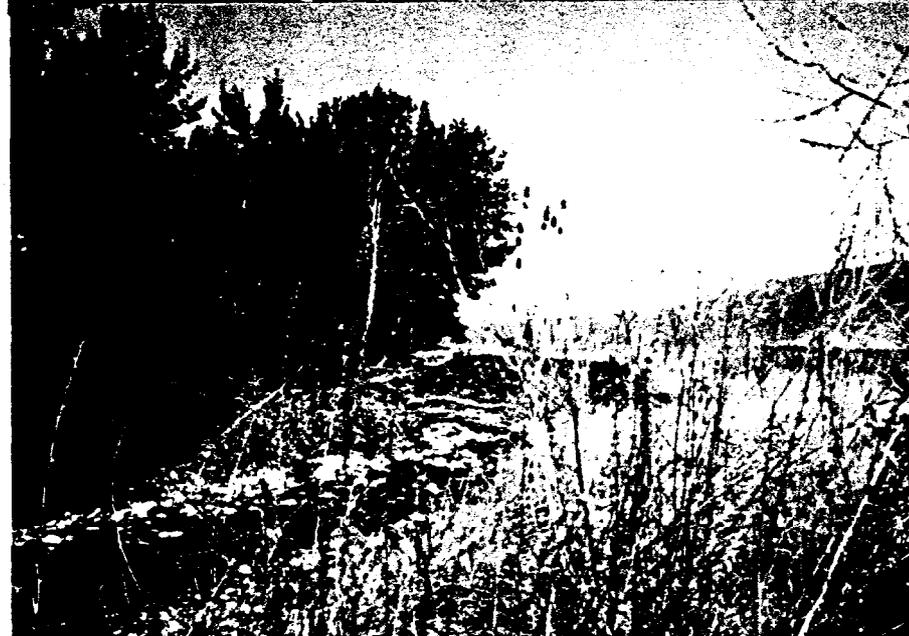
Site after two flood events. NOTE: Channel migration, headcut/erosion on right bank and channel down cutting. This site to be treated with Bio-engineering techniques in 1995 and will serve as one of three demonstrations sites for these practices.

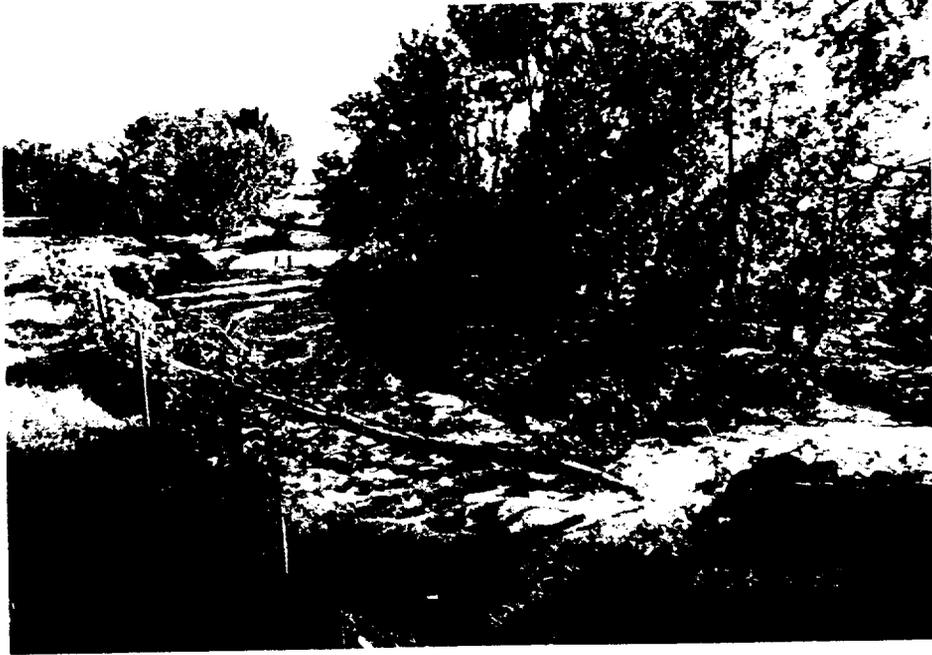
T. Rugg Property - 1994. Eroded streambank. Photo taken two days after peak flow hit during the May flood.

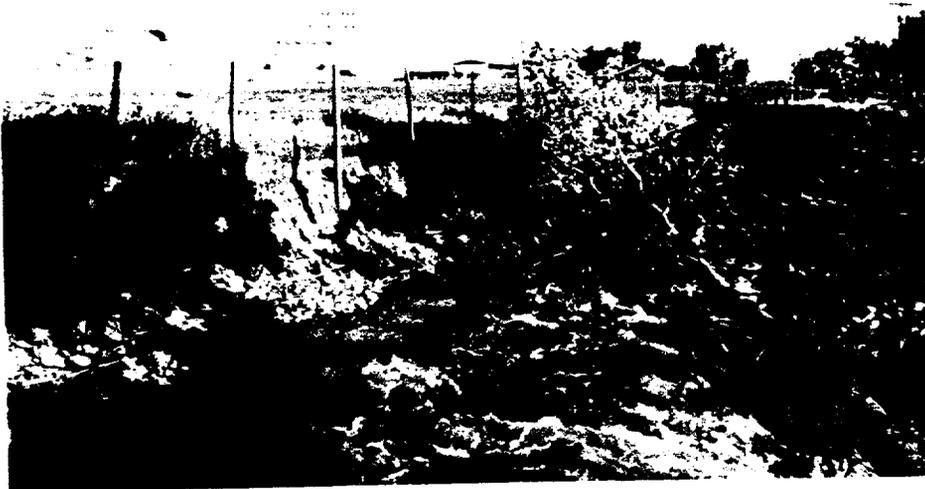
T. Rugg Property - 1994. Cut bank view of the above photo. Streambank to be restored in 1995 using Bio-engineering techniques.

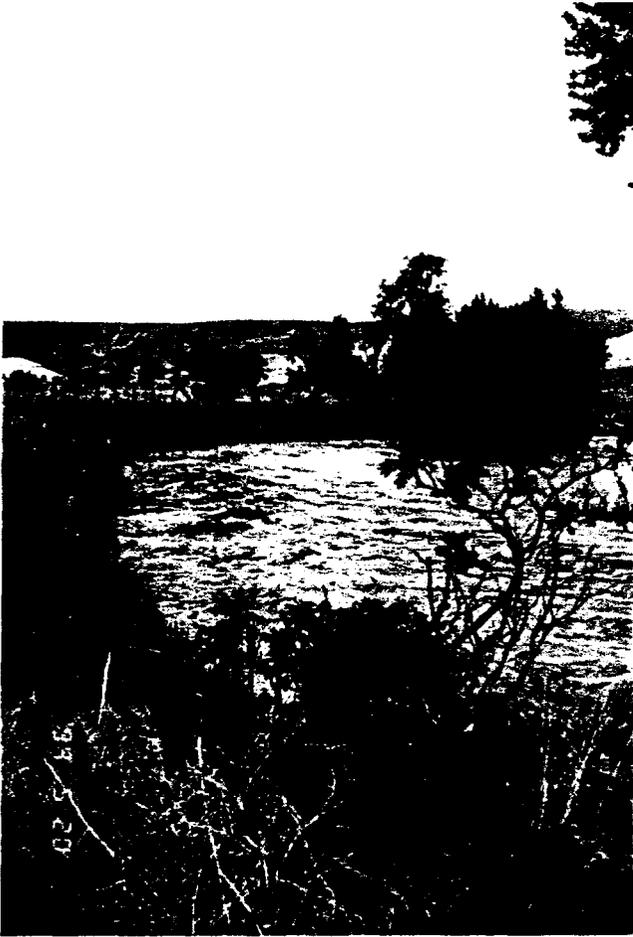
McDaniel Property - 1994. Proposed site for tree planting on left bank during 1995. Photo taken same day of peak flow.

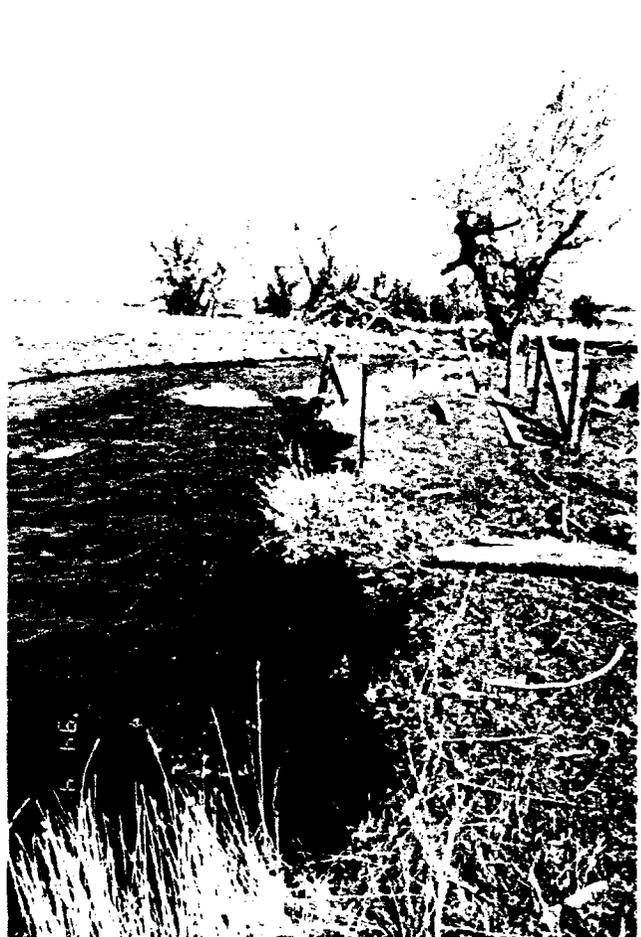
Gambill Property - 1994. Photo taken about 1 month before May flood event. Photo depicts fence lost to winter erosion and shows new program fence constructed on *right*.

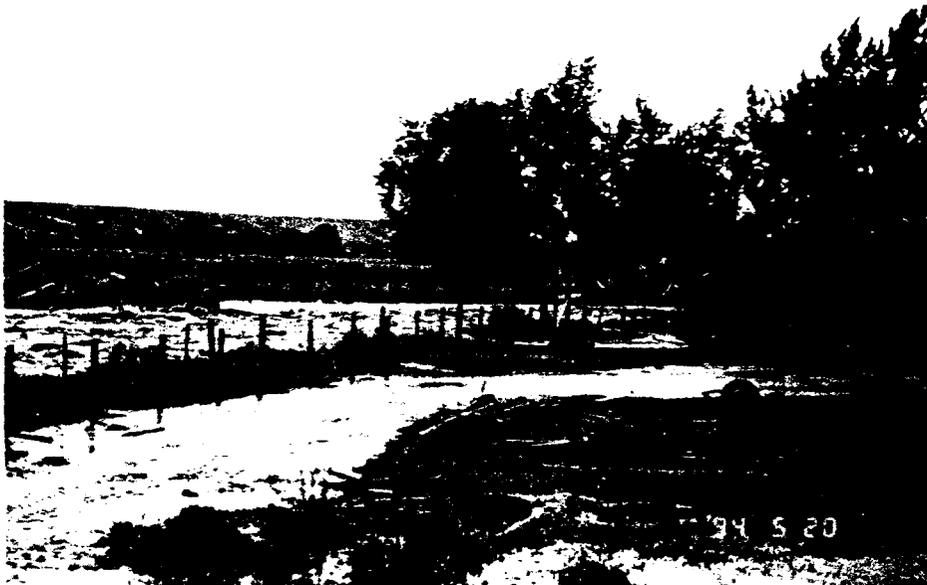
Gambill Property - 1994. Photograph taken during peak flow conditions during the May flood. Site to be planted with willows and cottonwood in 1995.
