**GRANDE RONDE RIVER SUBBASIN FISH HABITAT ENHANCEMENT PROJECT:
JOSEPH CREEK AND THE UPPER GRANDE RONDE RIVER DRAINAGES**

1991 ANNUAL REPORT,

**Oregon Department of Fish and Wildlife
N.E. Region Annex
2111 Adams Avenue Suite B
La Grande, OR 97850**

**U. S. Department of Energy
Bonneville Power Administration
Division of Fish and Wildlife
Contract No. DE-AI79-84BP16114
Project No. 84-25**

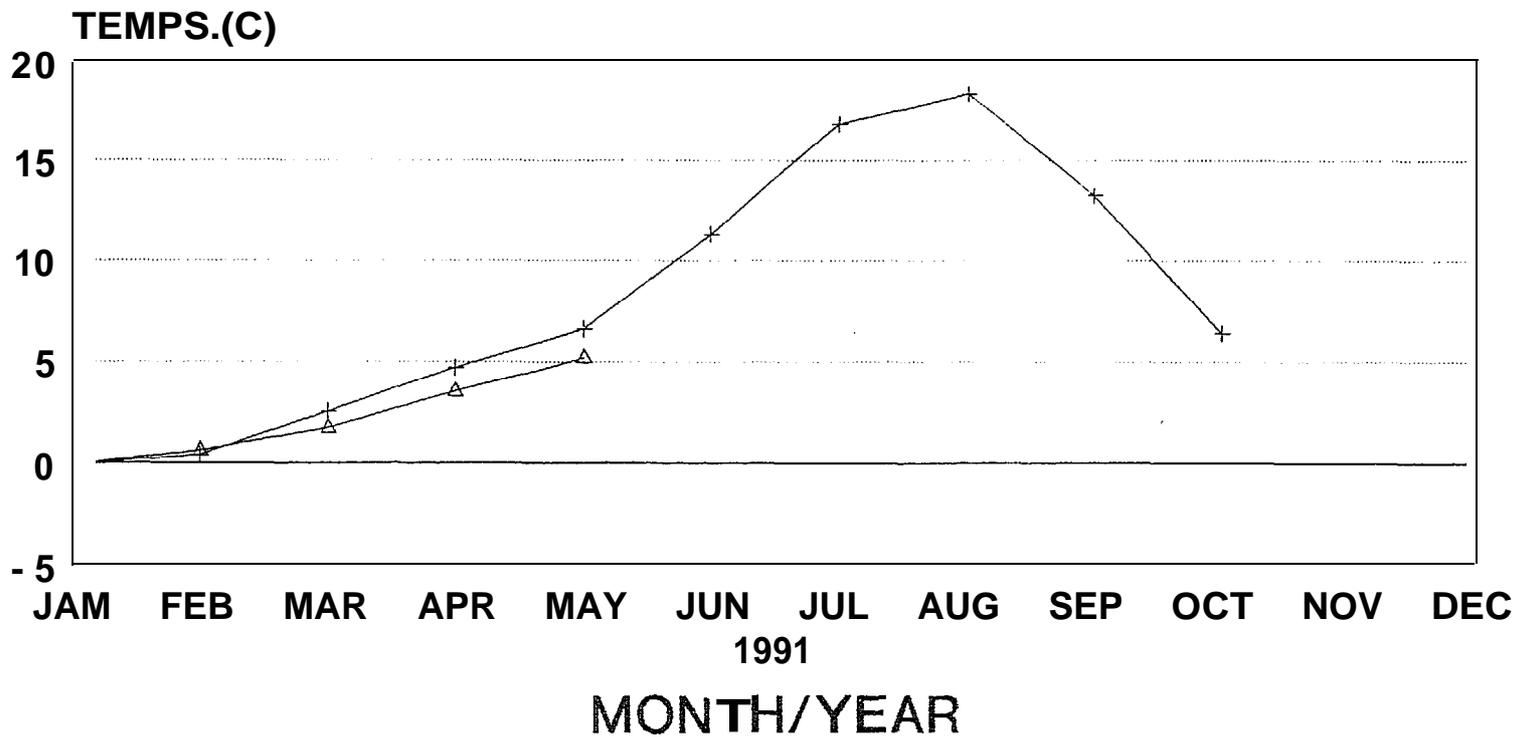
Deployment #006-8

SHEEP CK.- Upper & Lower RTM Monthly Mean Water Temperatures

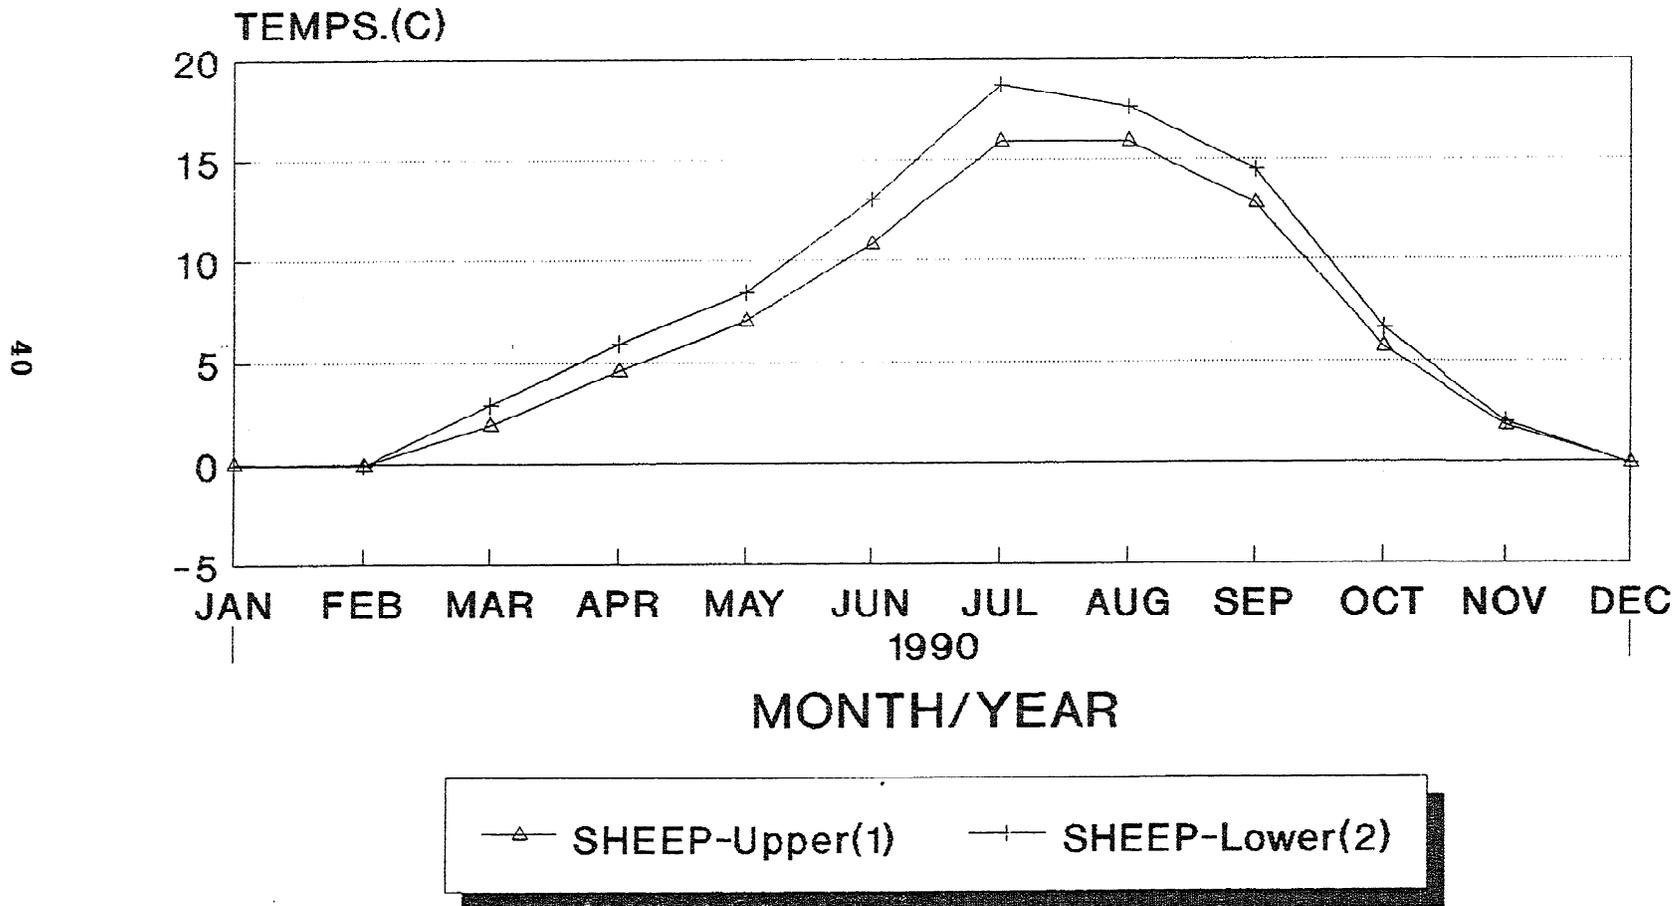
Deployment #004-6

SHEEP CK.- Upper & Lower RTM Monthly Mean Water Temperatures

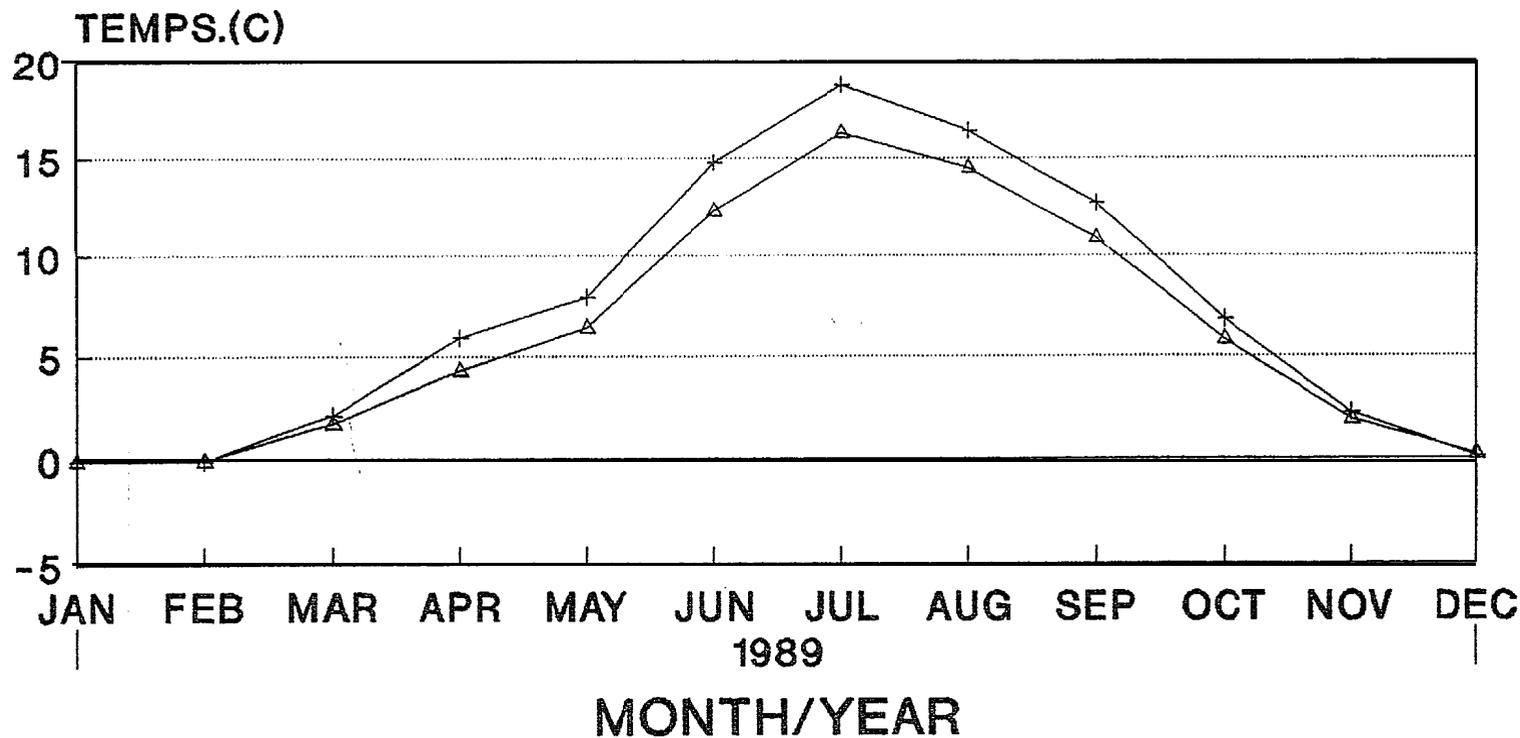
Deployment #002-4

SHEEP CK.- Upper & Lower RTM Monthly Mean Water Temperatures

—△— SHEEP-Upper(1) —+— SHEEP-Lower(2)

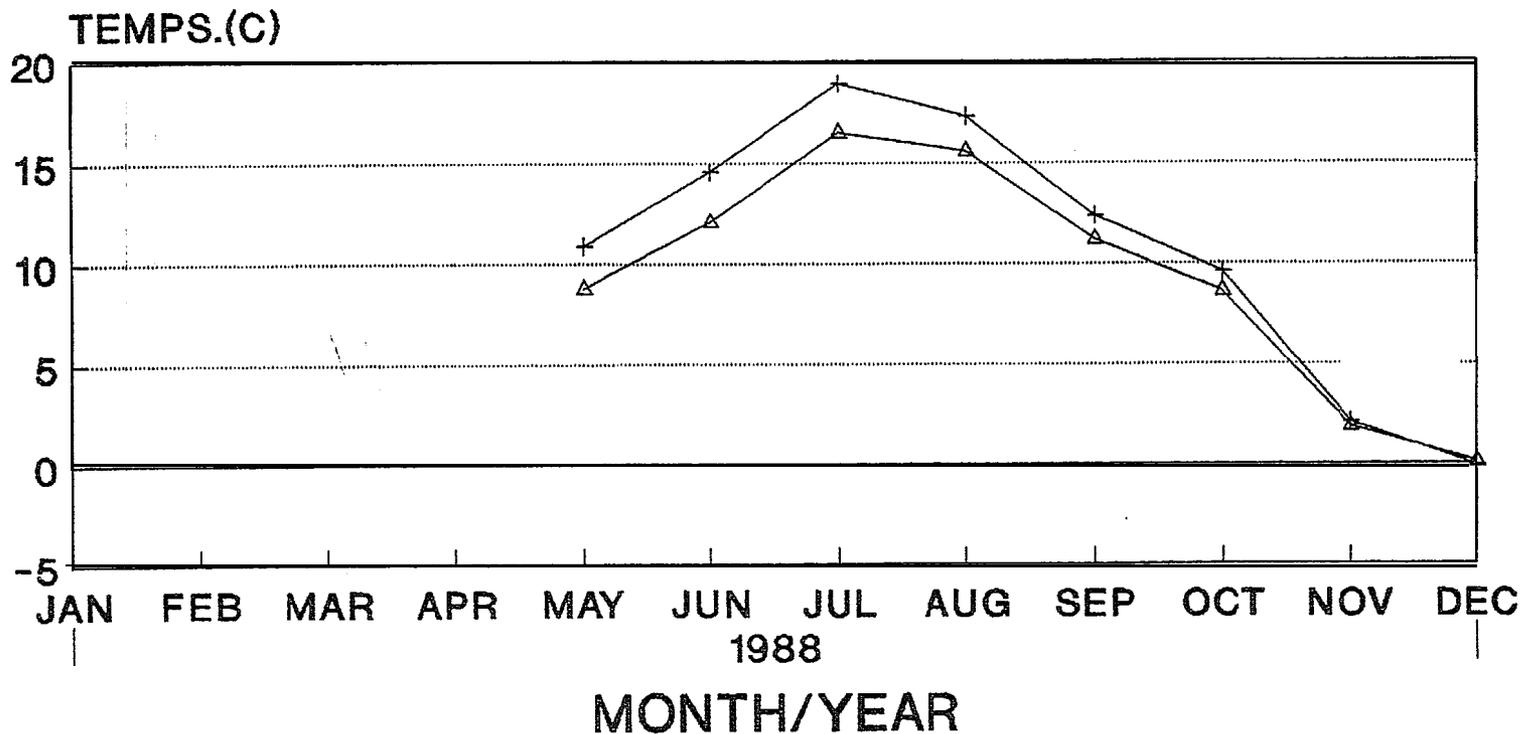
Deployment #001/2

SHEEP CK.- Upper & Lower RTM Monthly Mean Water Temperatures

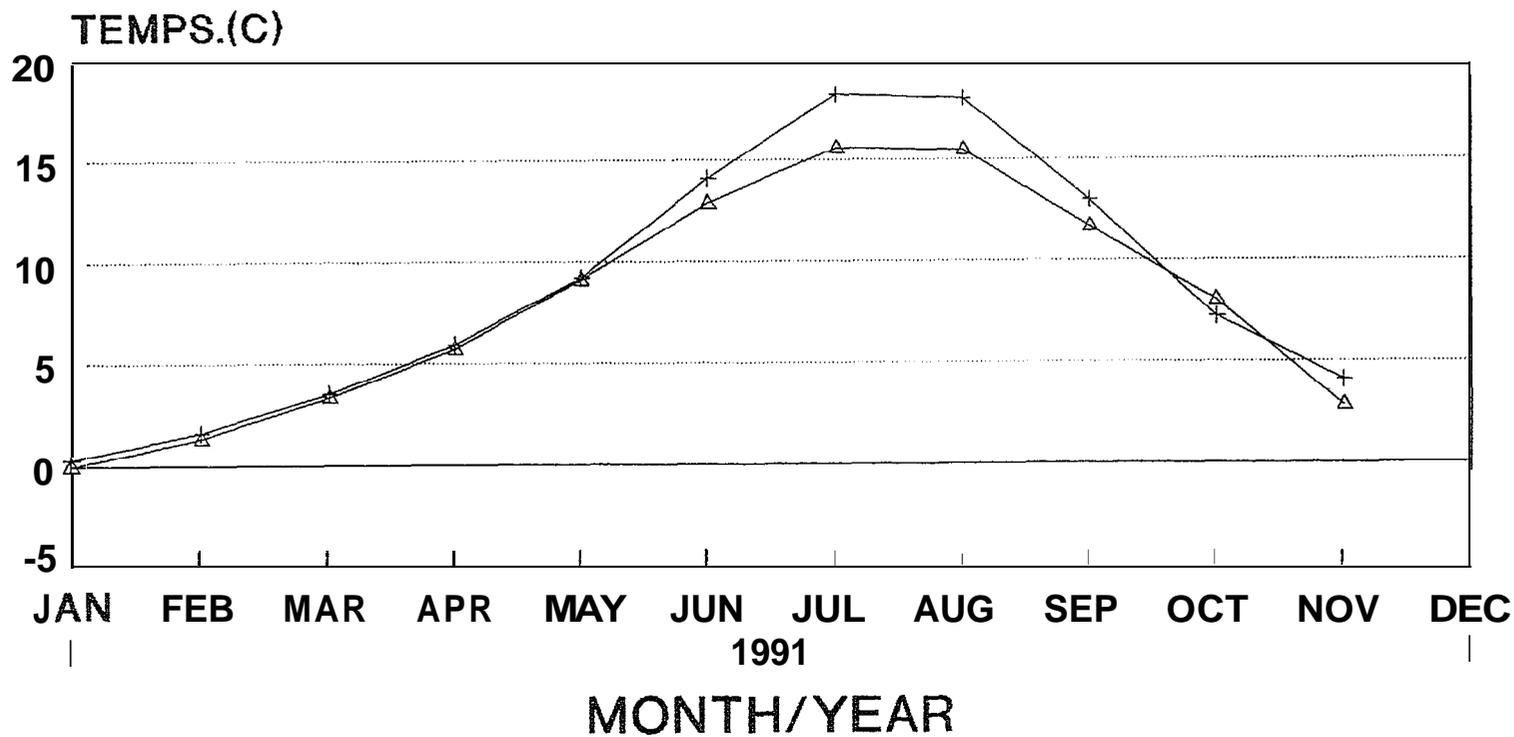
Deployment #004-8.

McCOY CK - Upper & Lower RTM Monthly Mean Water Temperatures

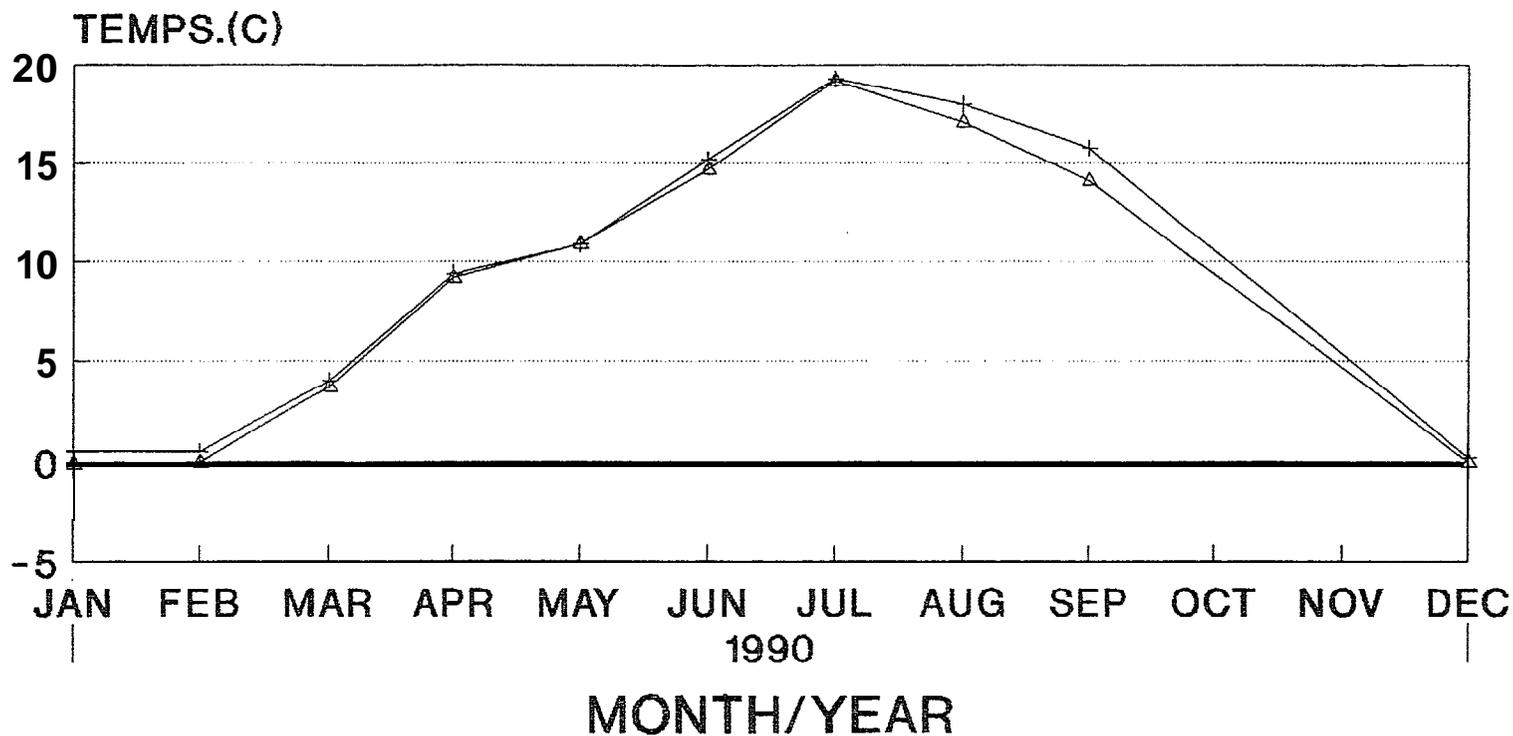
Deployment #004/6, no data 9/20 to 12/10

McCOY CK.- Upper & Lower RTM Monthly Mean Water Temperatures

—△— Mccoy-Upper(2) —+— McCoy- Lower(3)

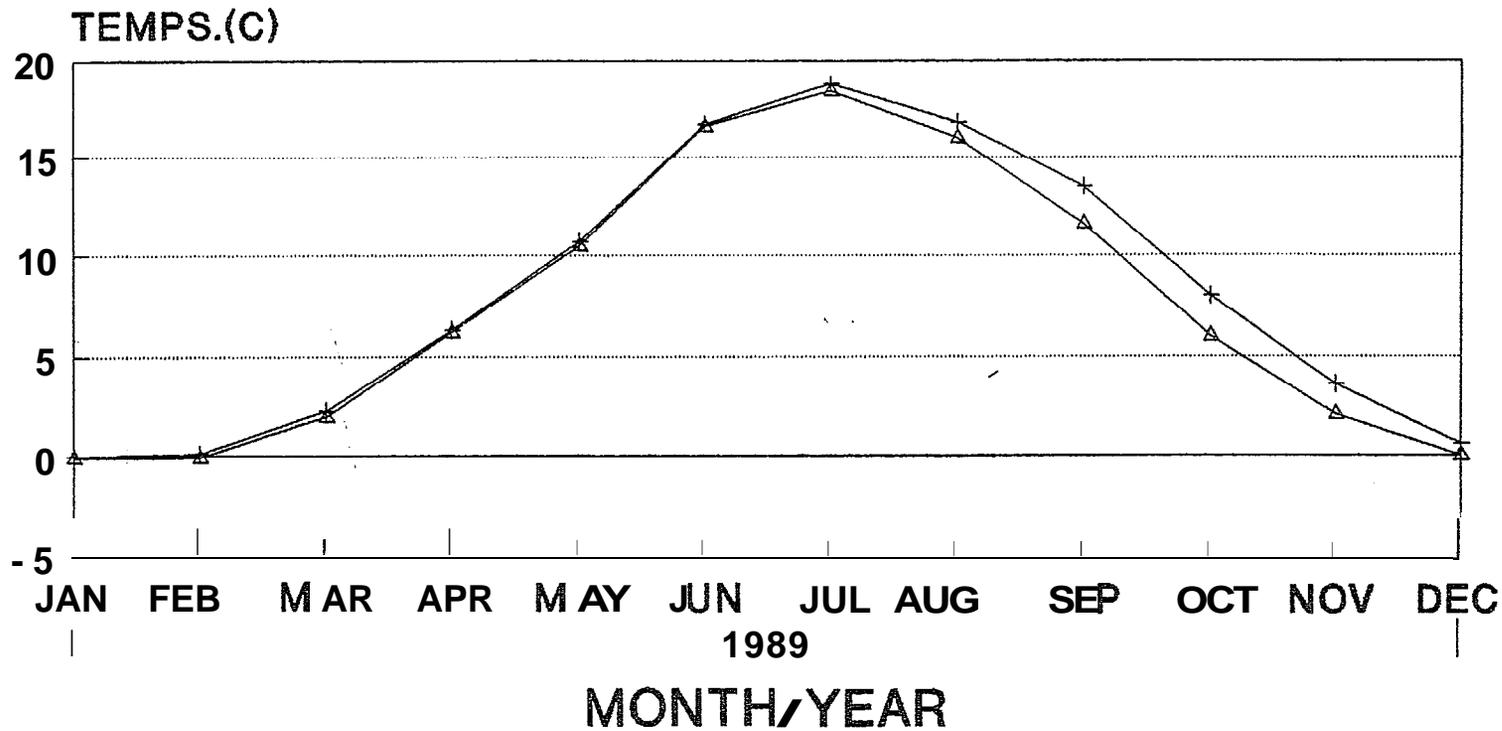
Deployment #002-4

McCOY CK.- Upper & Lower RTM Monthly Mean Water Temperatures

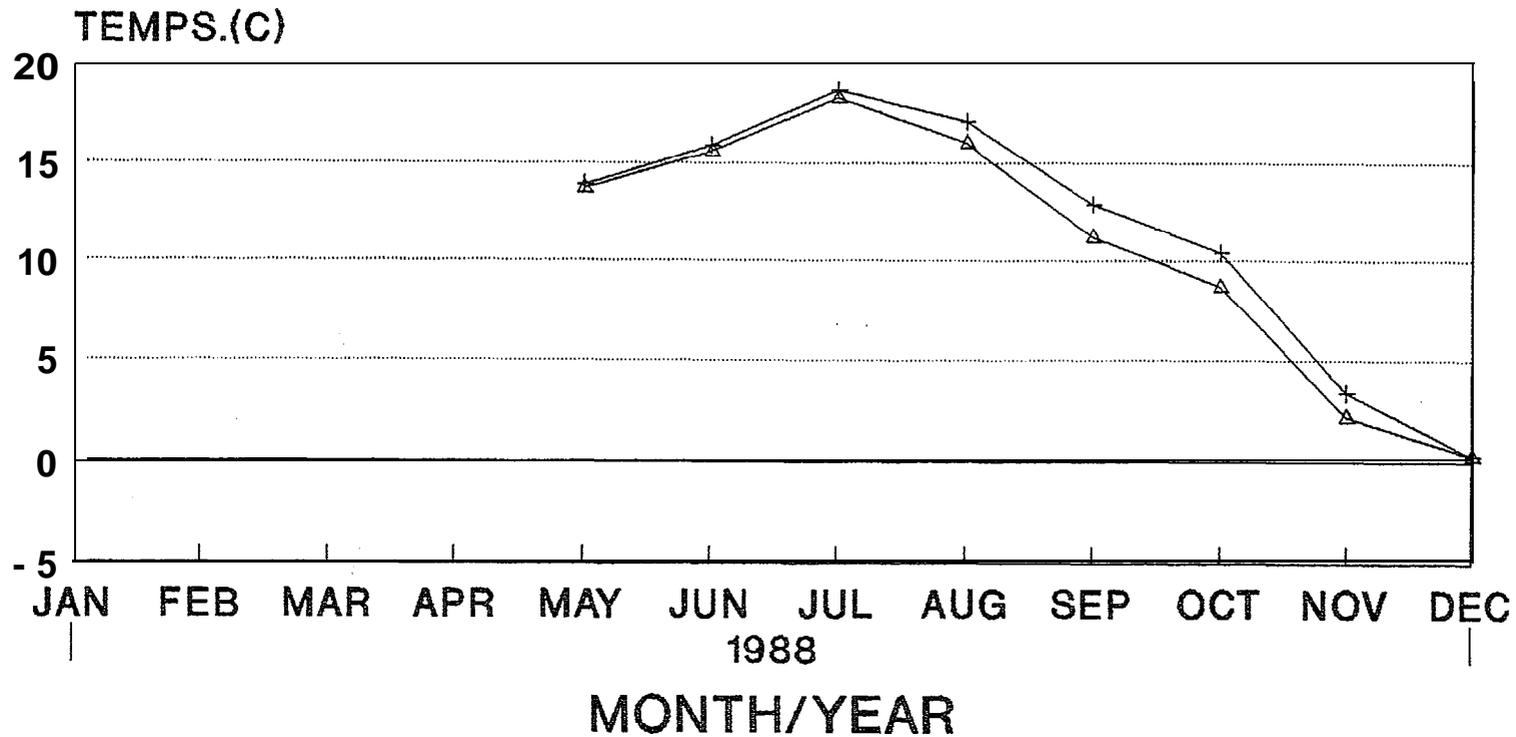
Deployment #001/2

McCOY CK.- Upper & Lower RTM Monthly Mean Water Temperatures

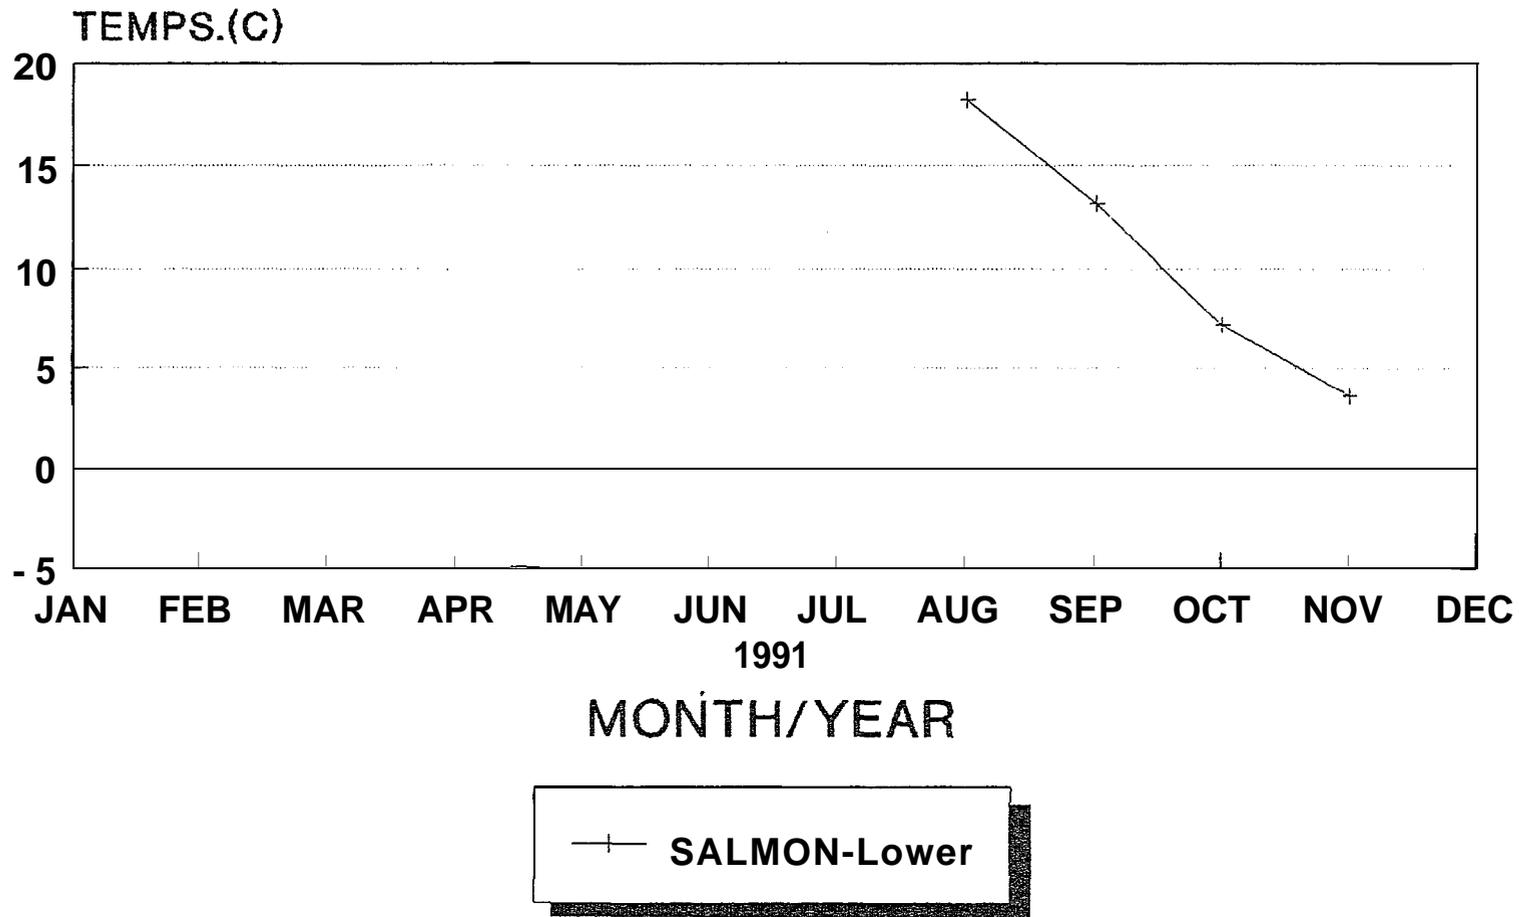
Deployment #001, no data for Upper

SALMON CK.- Upper & Lower RTM Monthly Mean Water Temperatures

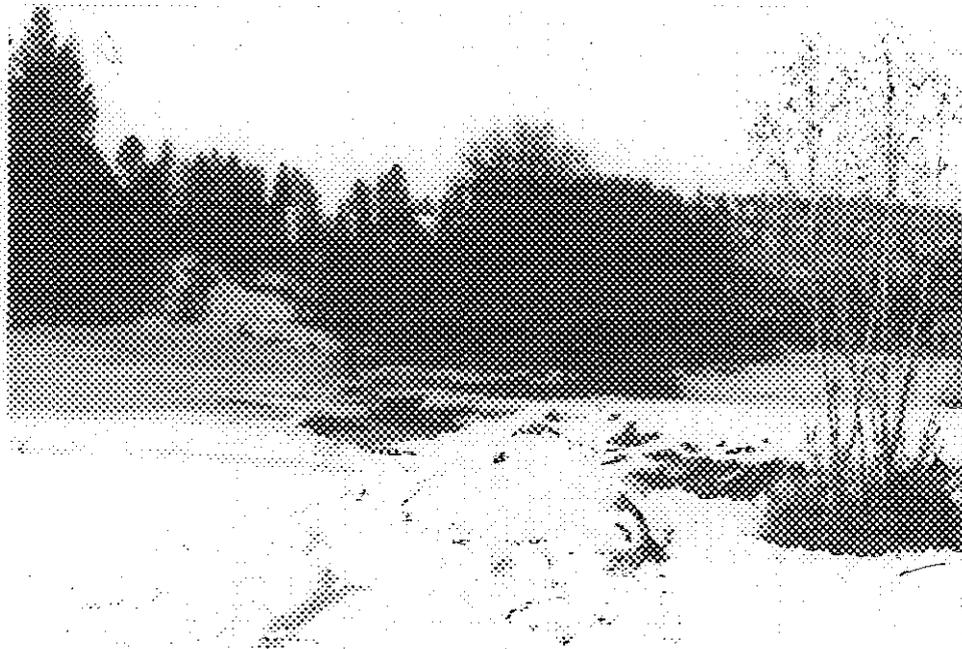
Photo 9. Upper Grande Ronde River, Bowman/Hoeft, January 1991. Refer to Photos 14, 15, and 16. Photopoint showing annual ice on the river.

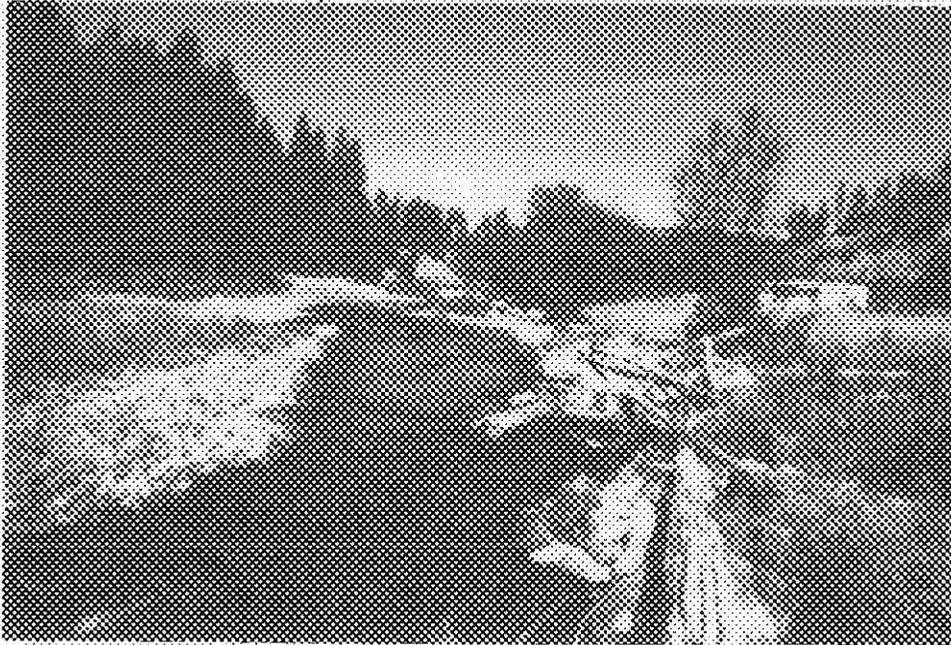
Photo 16. Upper Grande Ronde River, Bowman/Hoeft, August 1991. Same photo as 14 and 15. Notice large amount of woody debris that was collected during the May flood.

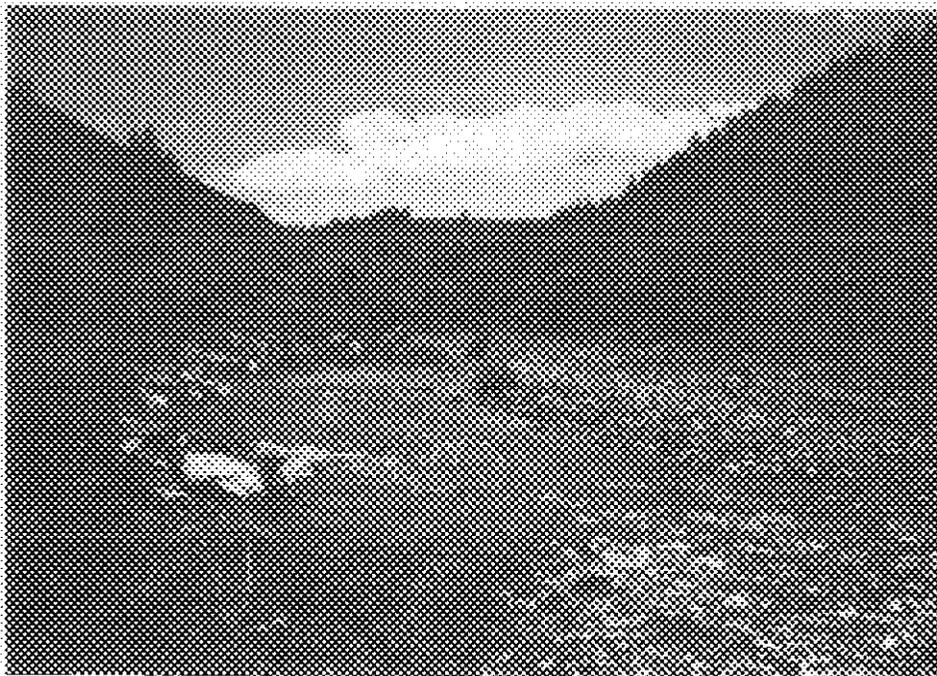
Photo 17. Lower Grande Ronde, Chesimous Creek, Yost, Summer 1987. Photopoint taken after implementation. Note gravel bar on right side of photo.

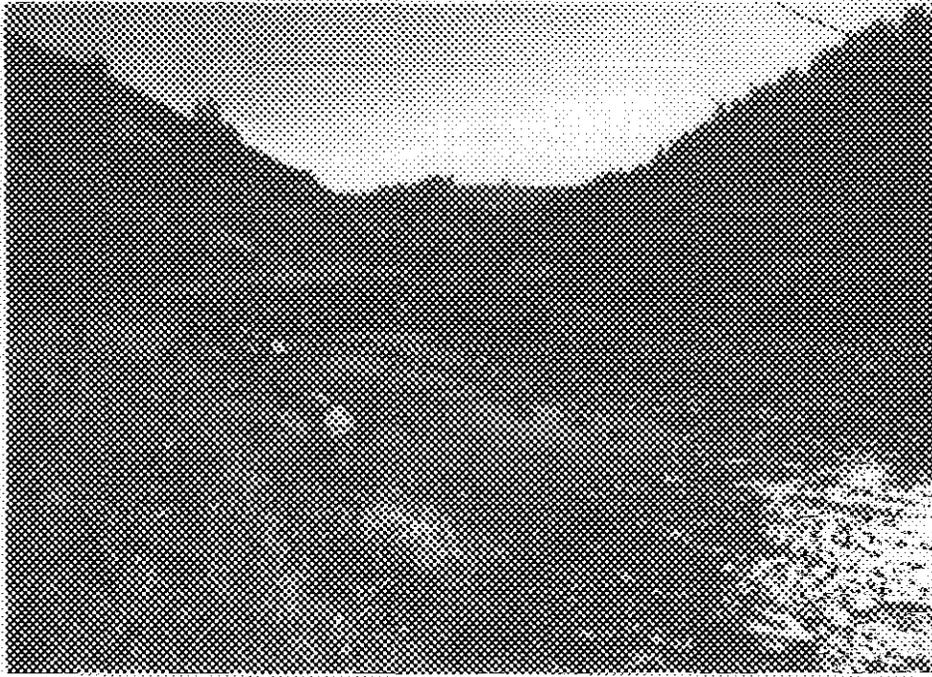
Photo 18. Lower Grande Ronde, Chesnimus Creek, Yost, Fall 1987. Same photo as 17.

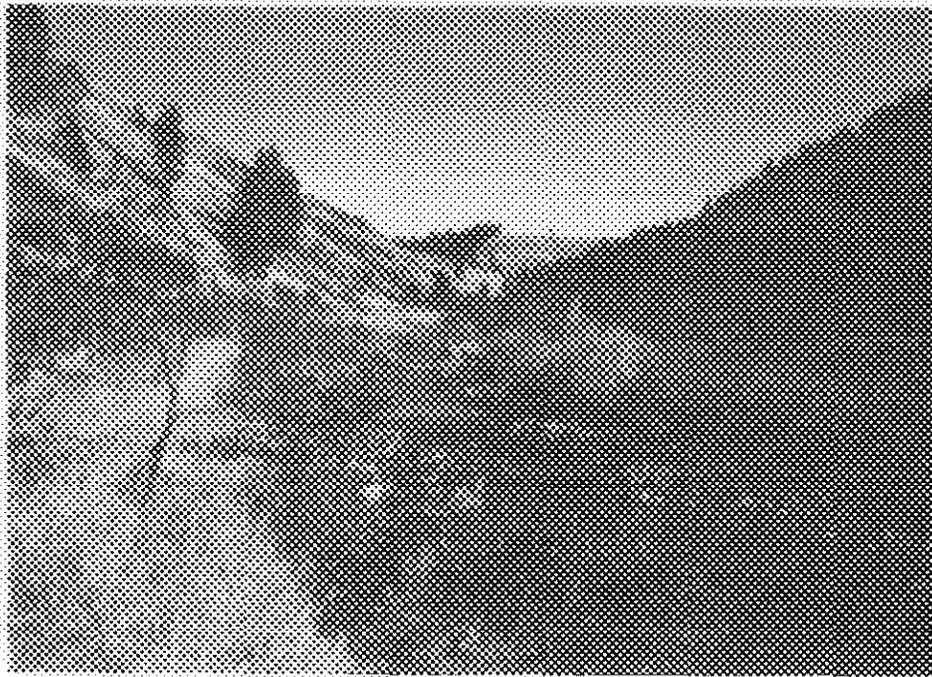
Photo 19. Lower Grande Ronde, Chesnimus Creek, Yost, Fall 1991. Same photo as 17 and 18. Note willow recruitment on the right bank.

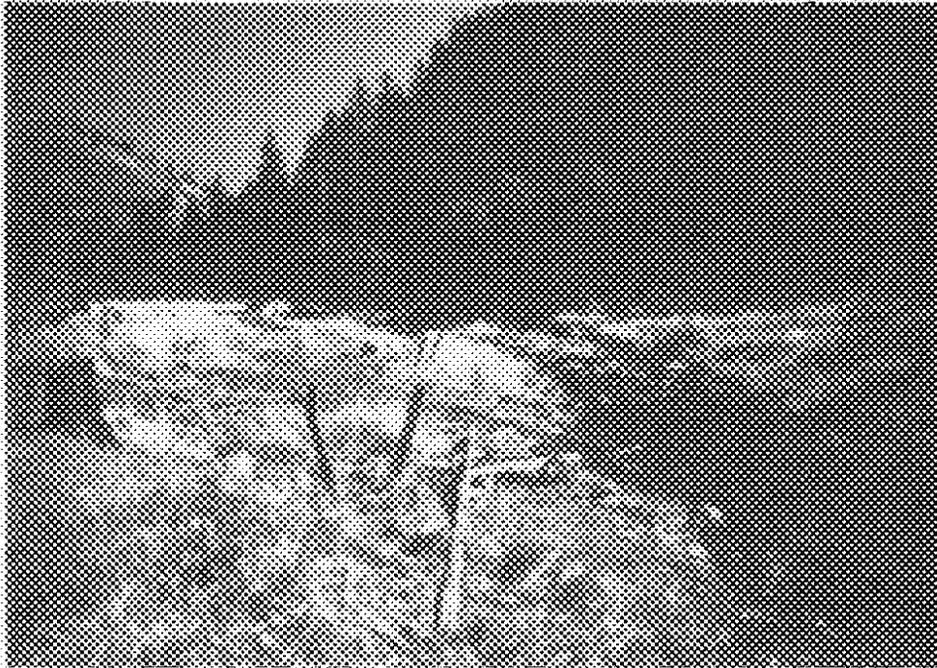
Photo 20. Lower Grande Ronde, Elk Creek, Birkmeier, Fall 1985. Photopoint showing willow stakes recently planted.

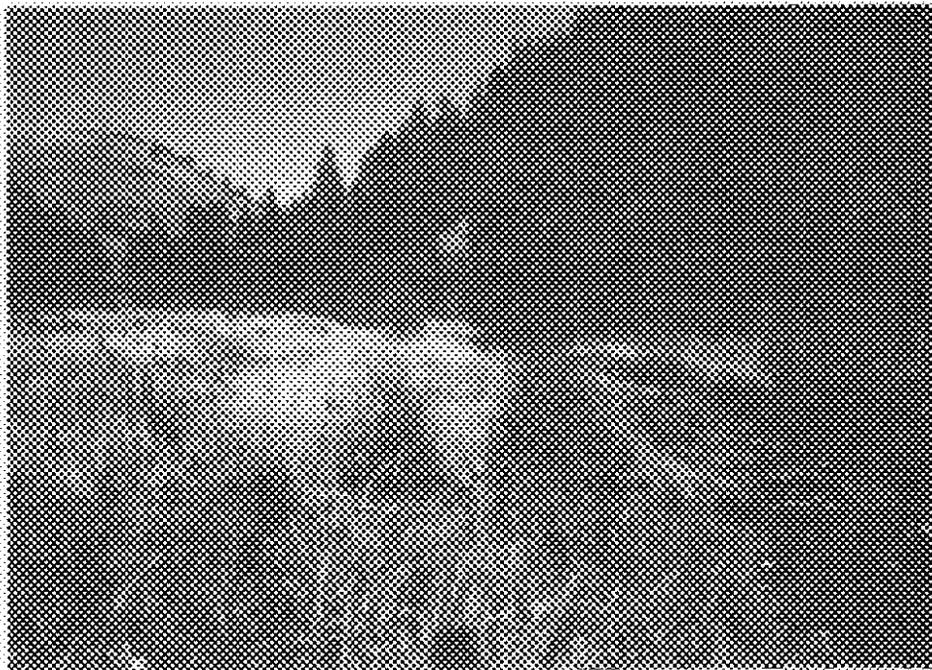
Photopoint 21. Lower Grande Ronde, Elk Creek, Birkmeier, Summer 1991. Same photopoint as Photo 20 showing the willows growing.

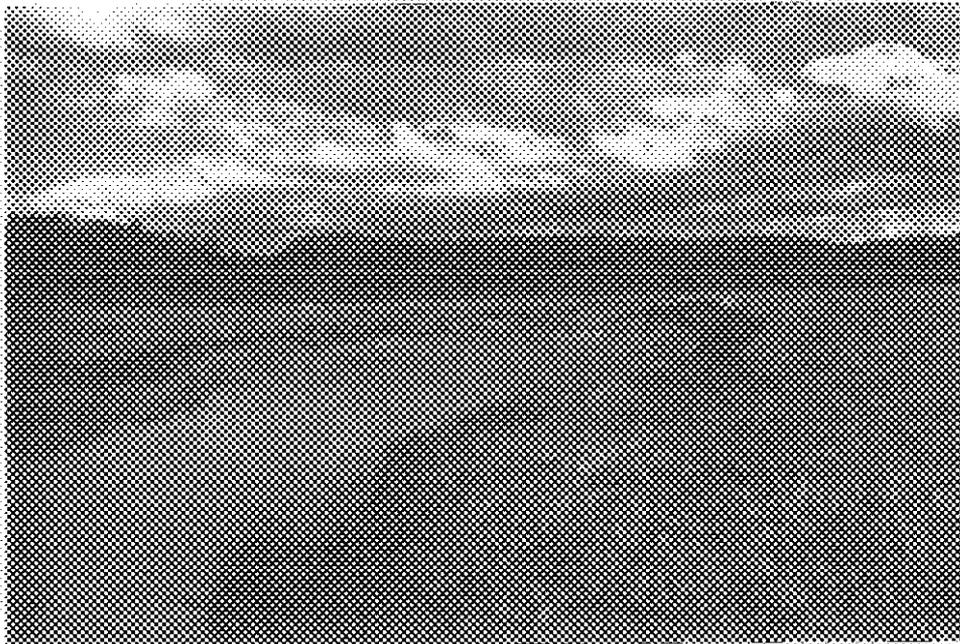
Photo 22. Upper Grande Ronde, Meadow Creek, Tipperman, Spring 1987. Pre-implementation photopoint. Note cut bank and wide shallow channel.

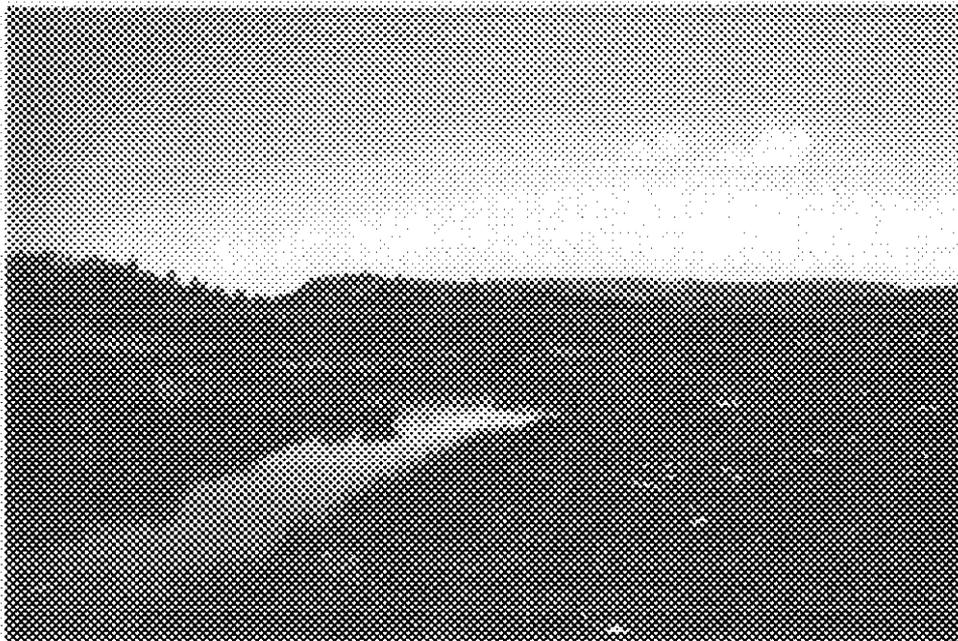
Photo 23. Upper Grande Ronde, Meadow Creek, Tipperman, Summer 1991. Same photopoint as Photo 22. Note grasses, sedges, and willows revegetating the cut bank. Also note narrowing and deepening of the channel.

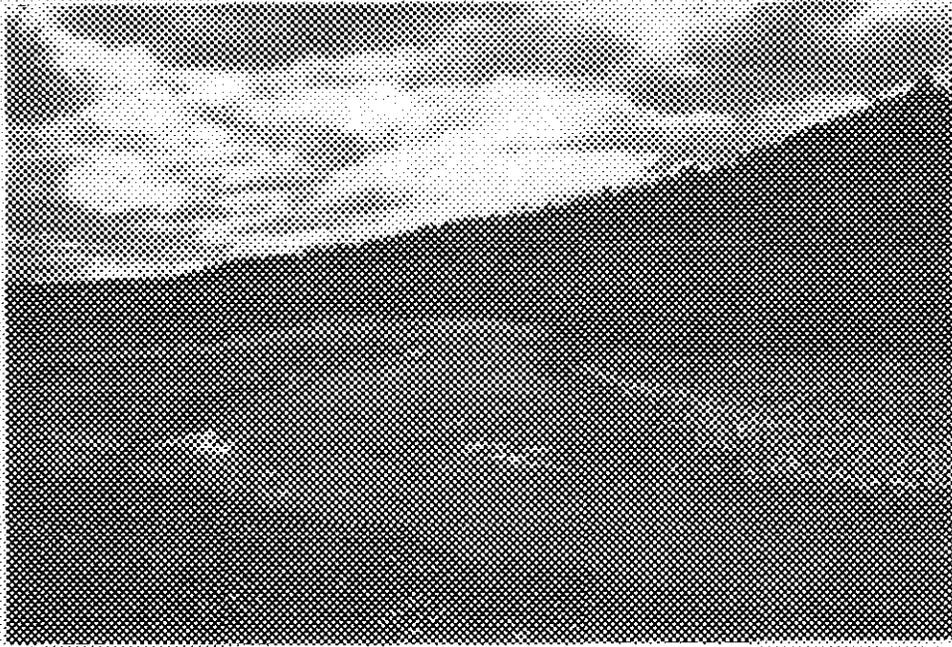
Photo 26. Upper Grande Ronde, Meadow Creek, Tipperman, Spring 1987. Note wide shallow channel and gravel island.
