1987 ANNUAL REPORT

CLACKAMAS/HOOD RIVER HABITAT ENHANCEMENT PROGRAM

Mt. Hood National Forest
2455 NW Division Street
Gresham, OR 97030

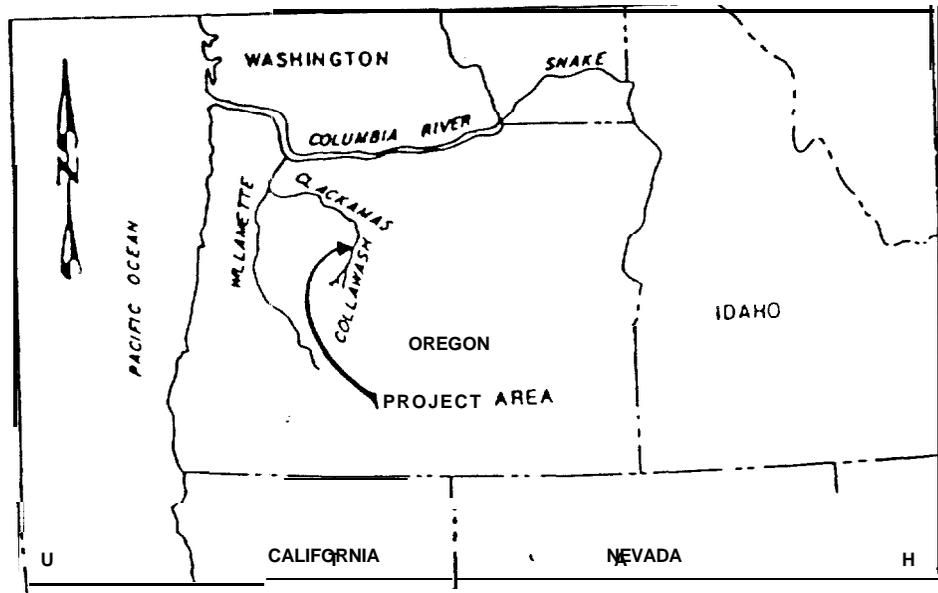
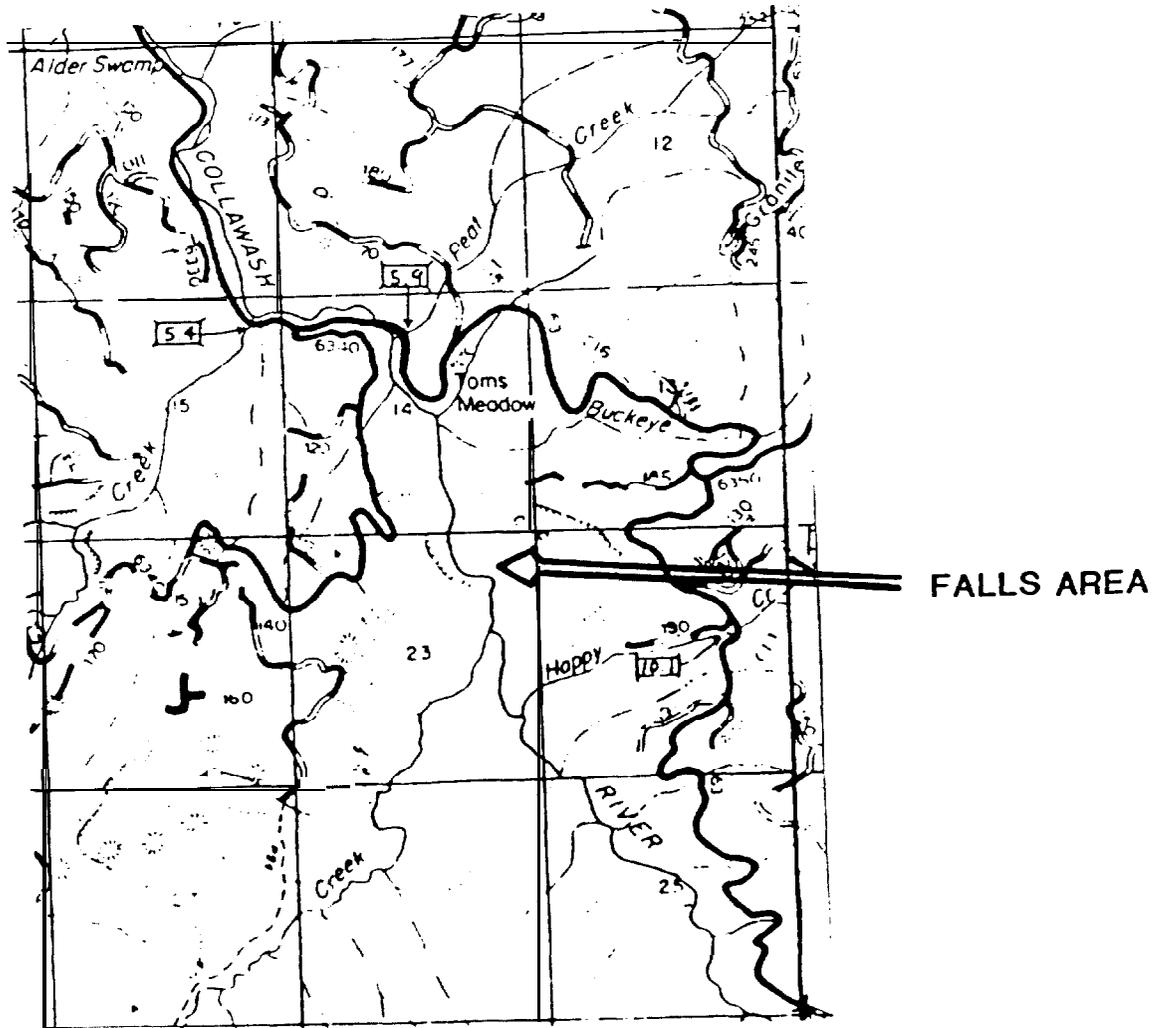
FIGURE 1. Project location map for Collawash Falls passage improvement

The falls are located in a deeply incised gorge (FIGURE 1). Access and working conditions at the site are difficult, and earlier work (1974) on the falls was terminated due to safety concerns over stability and condition of the steep headwall adjacent to the project area. The project feasibility report of January 1986 by Ott Water Engineering identified four passage alternatives that could safely be implemented to meet the project objective of improving fish passage.

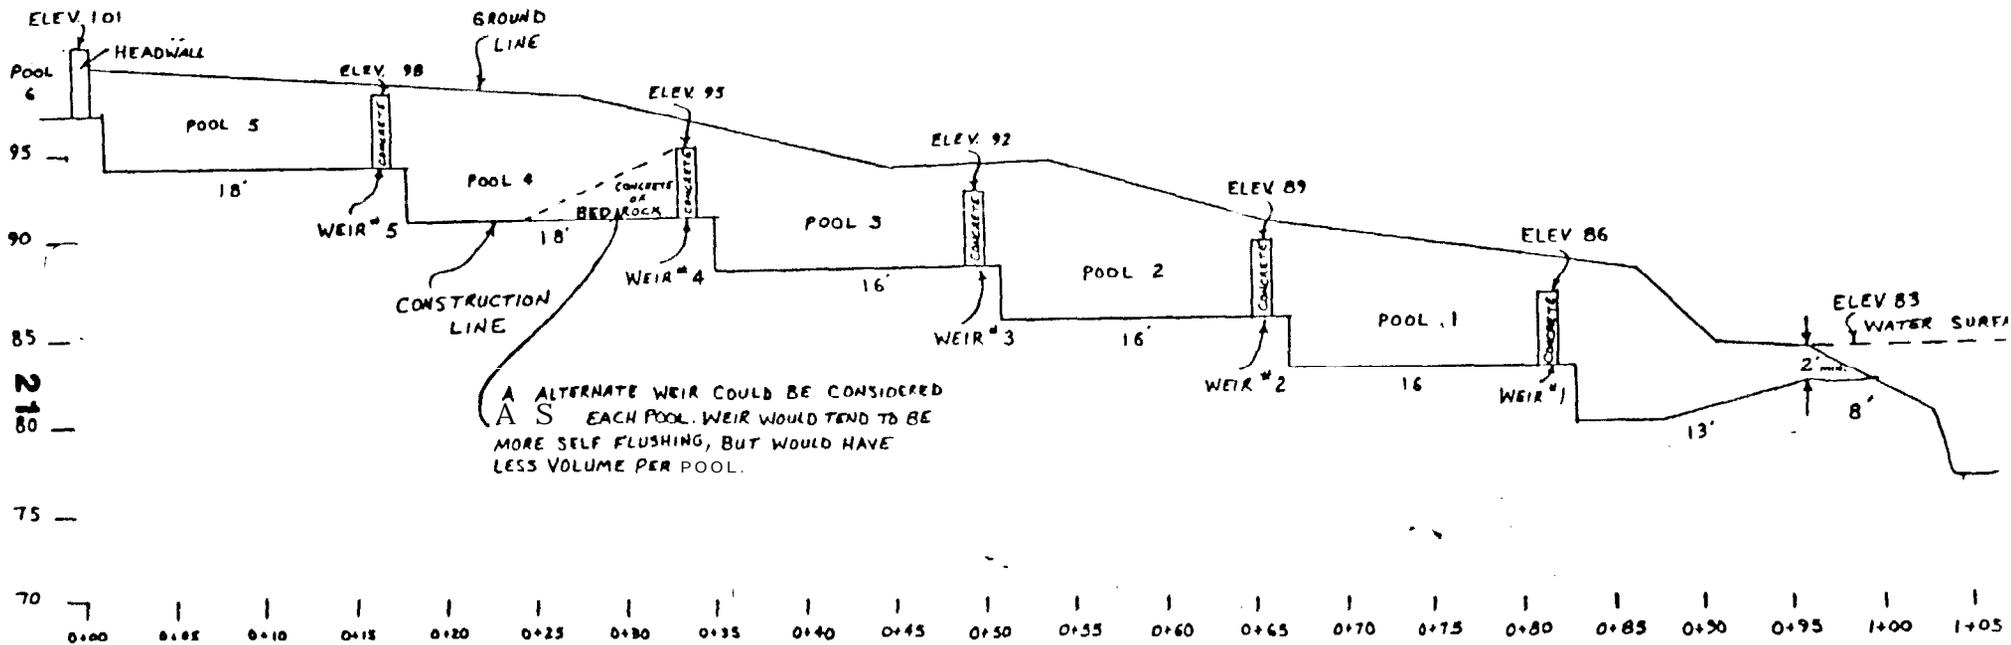
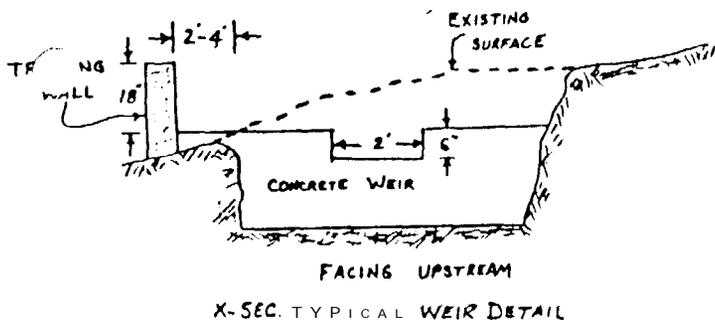
FIGURE 2. Collawash Falls fish passage facility schematic profile.

FISH PASSAGE SCHEMATIC
PROFILE

In June of 1986, a Forest Service fisheries engineer and passage facility specialist, Dale Kanen, was detailed to the Mt Hood NF from the Chatam Area of the Tongass NF (Region 10) to produce preliminary jump pool designs and construction recommendations based on selected action alternative. Mr. Kanen developed designs for a passage structure facility to be placed in a trench blasted in bedrock at the falls, with a training wall and six concrete weirs and pools (FIGURE 2). By October 1986, Forest Service engineers on the Mt. Hood N.F. had completed intensive site surveys at the falls and produced topographic blue line project site plan maps for use in development of the final design and construction contract package (FIGURE 3).

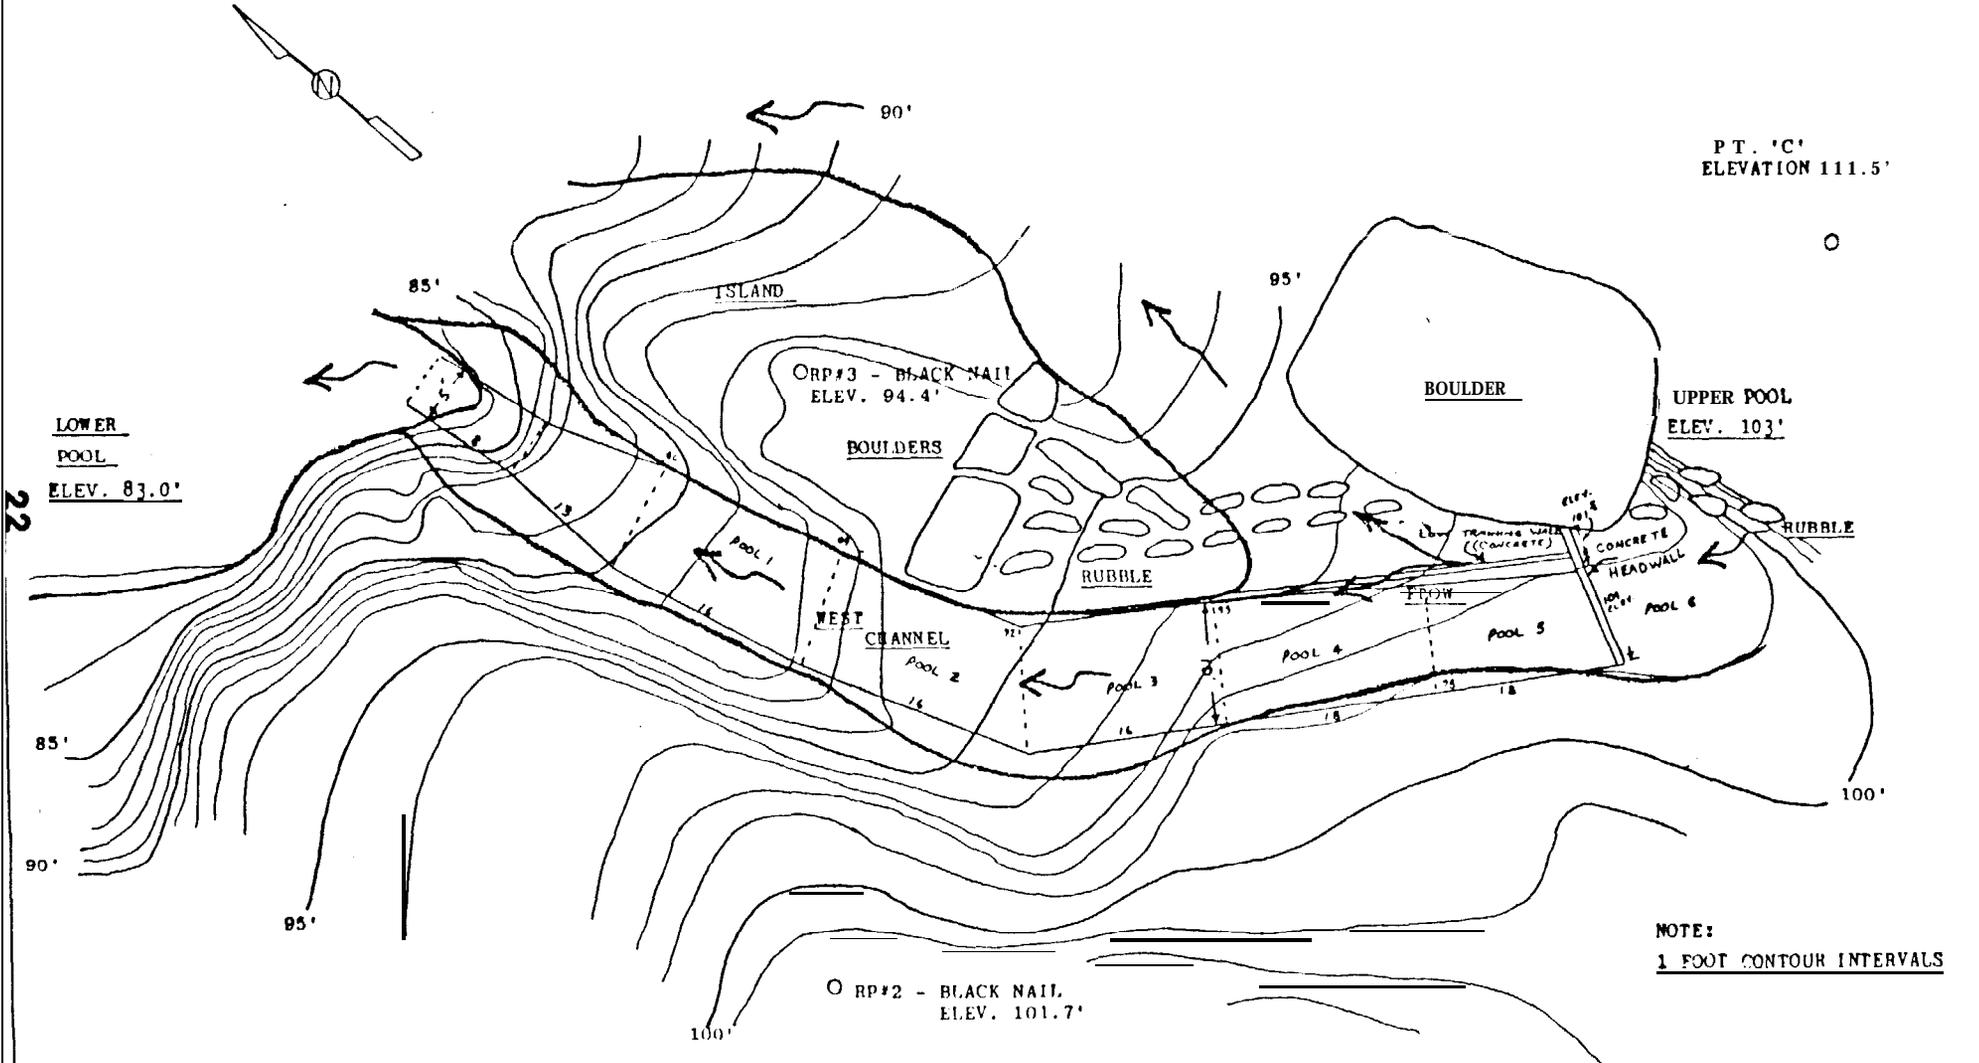
COLLAWASH FALL FISH PASSAGE PROJECT SITE PLAN

NOTE:
1 FOOT CONTOUR INTERVALS

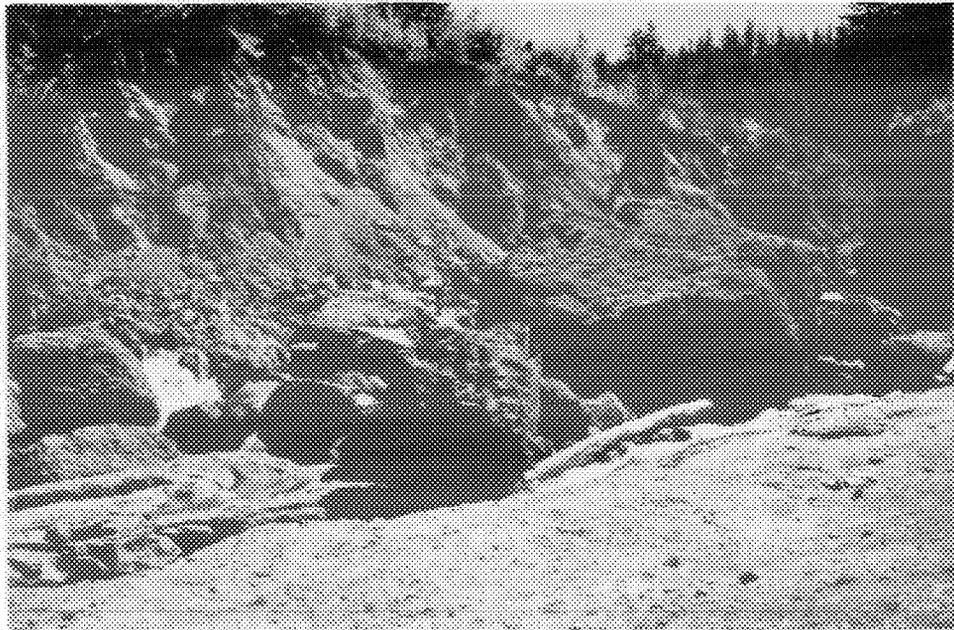
COLLAWASH FALLS PROJECT SITE, FROM THE NORTH BANK. NOTE BLUFF OVER-LOOKING SITE ON THE SOUTH BANK.

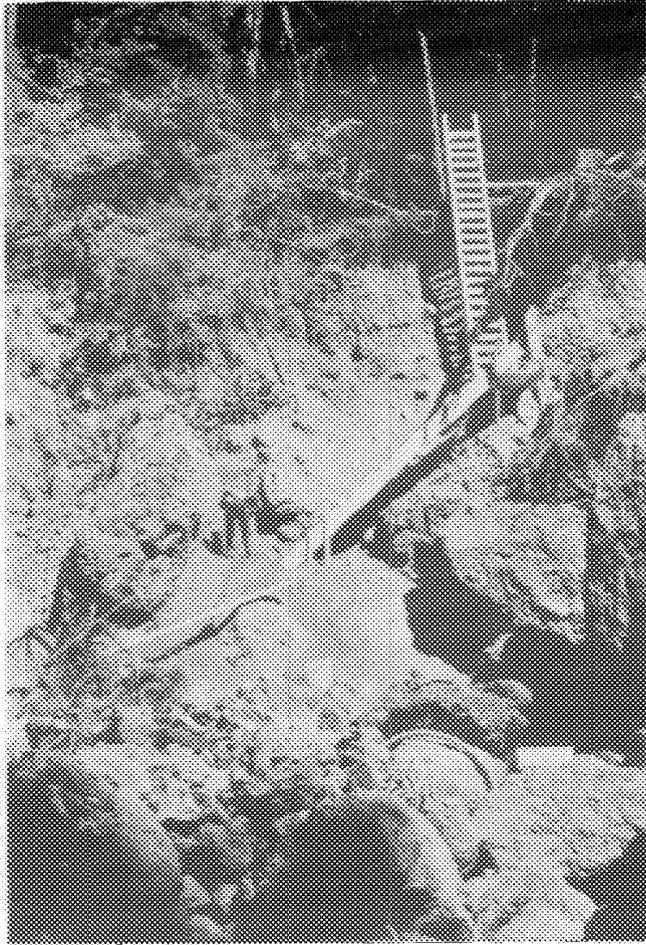
CONSTRUCTION OF THE PROJECT SITE ACCESS STAIRWELL.

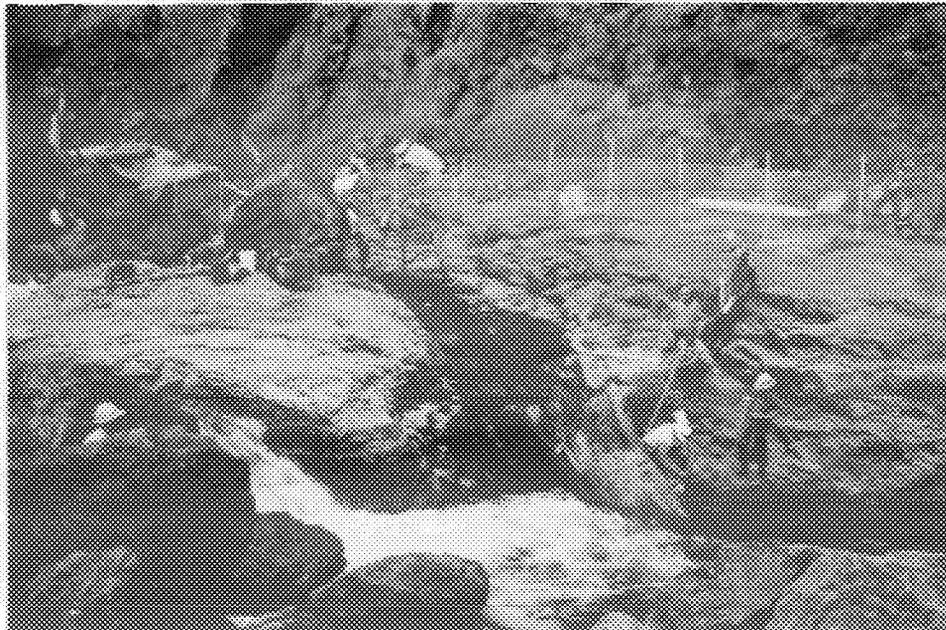
PRE-DRILLING PREPARATIONS INCLUDED REMOVAL OF A PORTION OF A LOG AT THE BASE OF THE PASSAGE FACILITY (FISHWAY). NOTE SAFETY FENCING IN BACKGROUND.

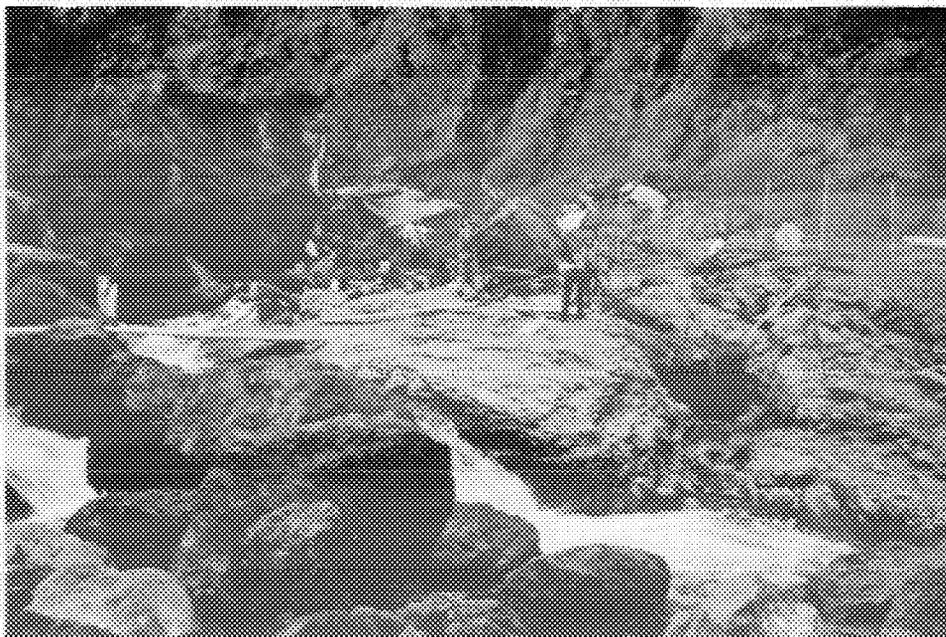
EXCAVATION OF THE FIRST OF THE SIX FISHWAY POOLS.

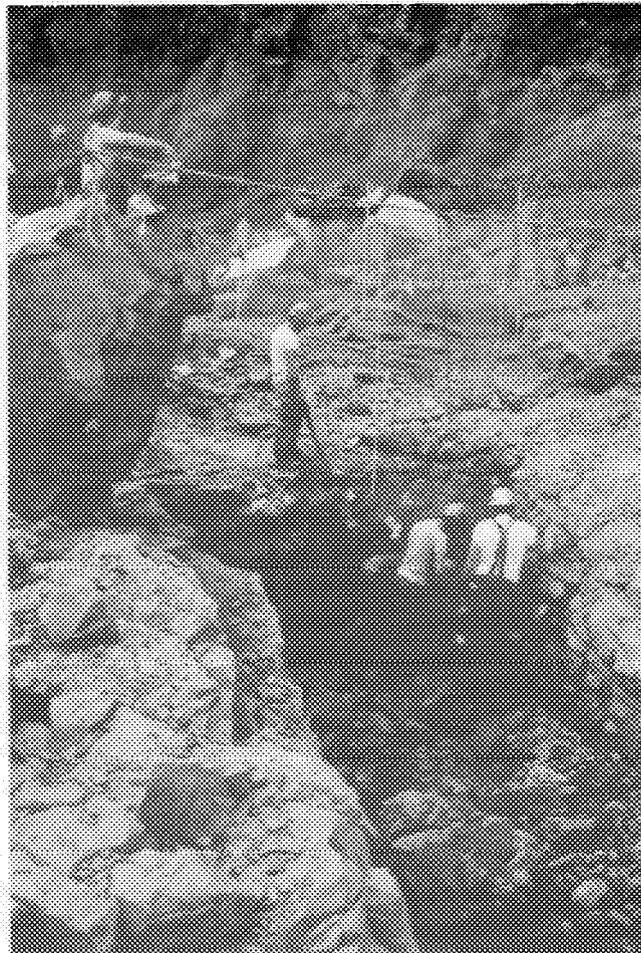
TRENCH AT THE HALFWAY POINT. NOTE WATCHMAN ON LARGE BOULDER.

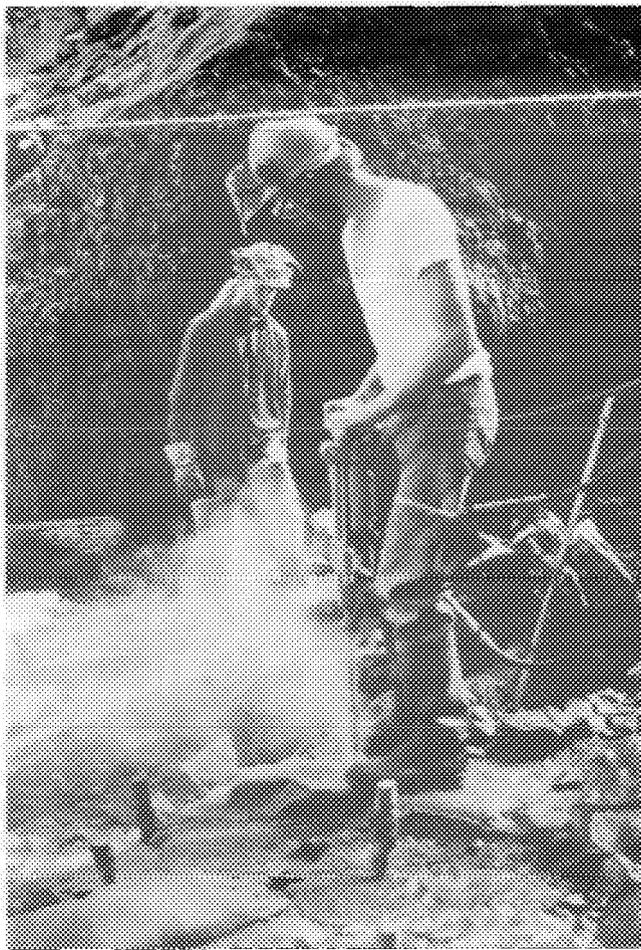
PRODUCTION BLAST HOLE DRILLING, CREW MEMBER IN BACKGROUND IS WATCHING FOR STRAIGHTNESS OF DRILL HOLE.

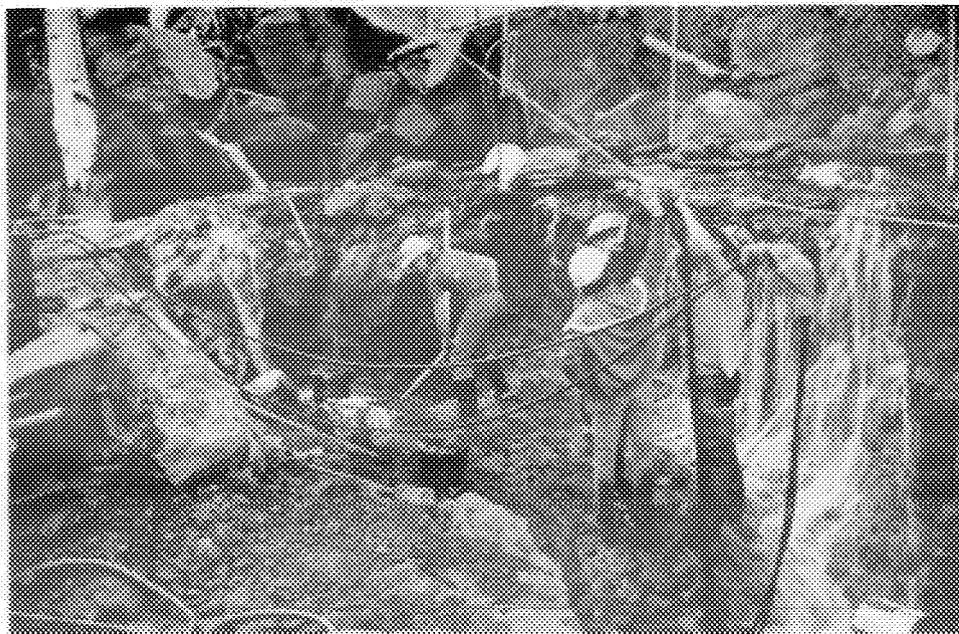
COMPRESSOR AND HYDRAULIC LINE ADJUSTMENT AT HEAD OF THE FISHWAY TRENCH.

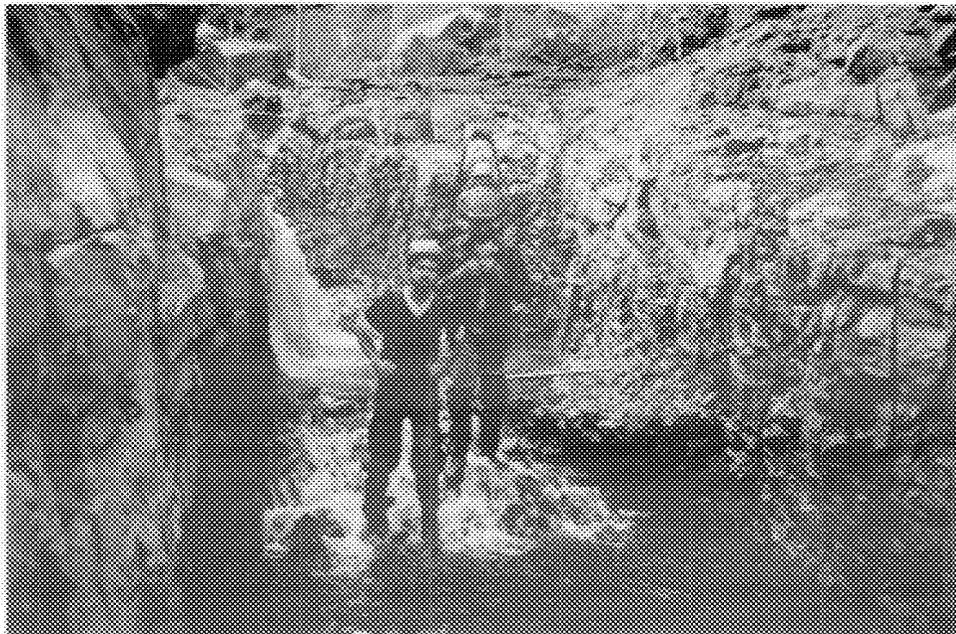
THE PROJECT'S PRIMARY DRILL OPERATORS, NICK BECKER (LEFT) AND JOHN SOBOLEWSKI (RIGHT), WALK THE COMPLETED TRENCH. KEVIN REED, ASSISTANT PROJECT WORK SUPERVISOR FROM R-10, IS IN BACKGROUND.

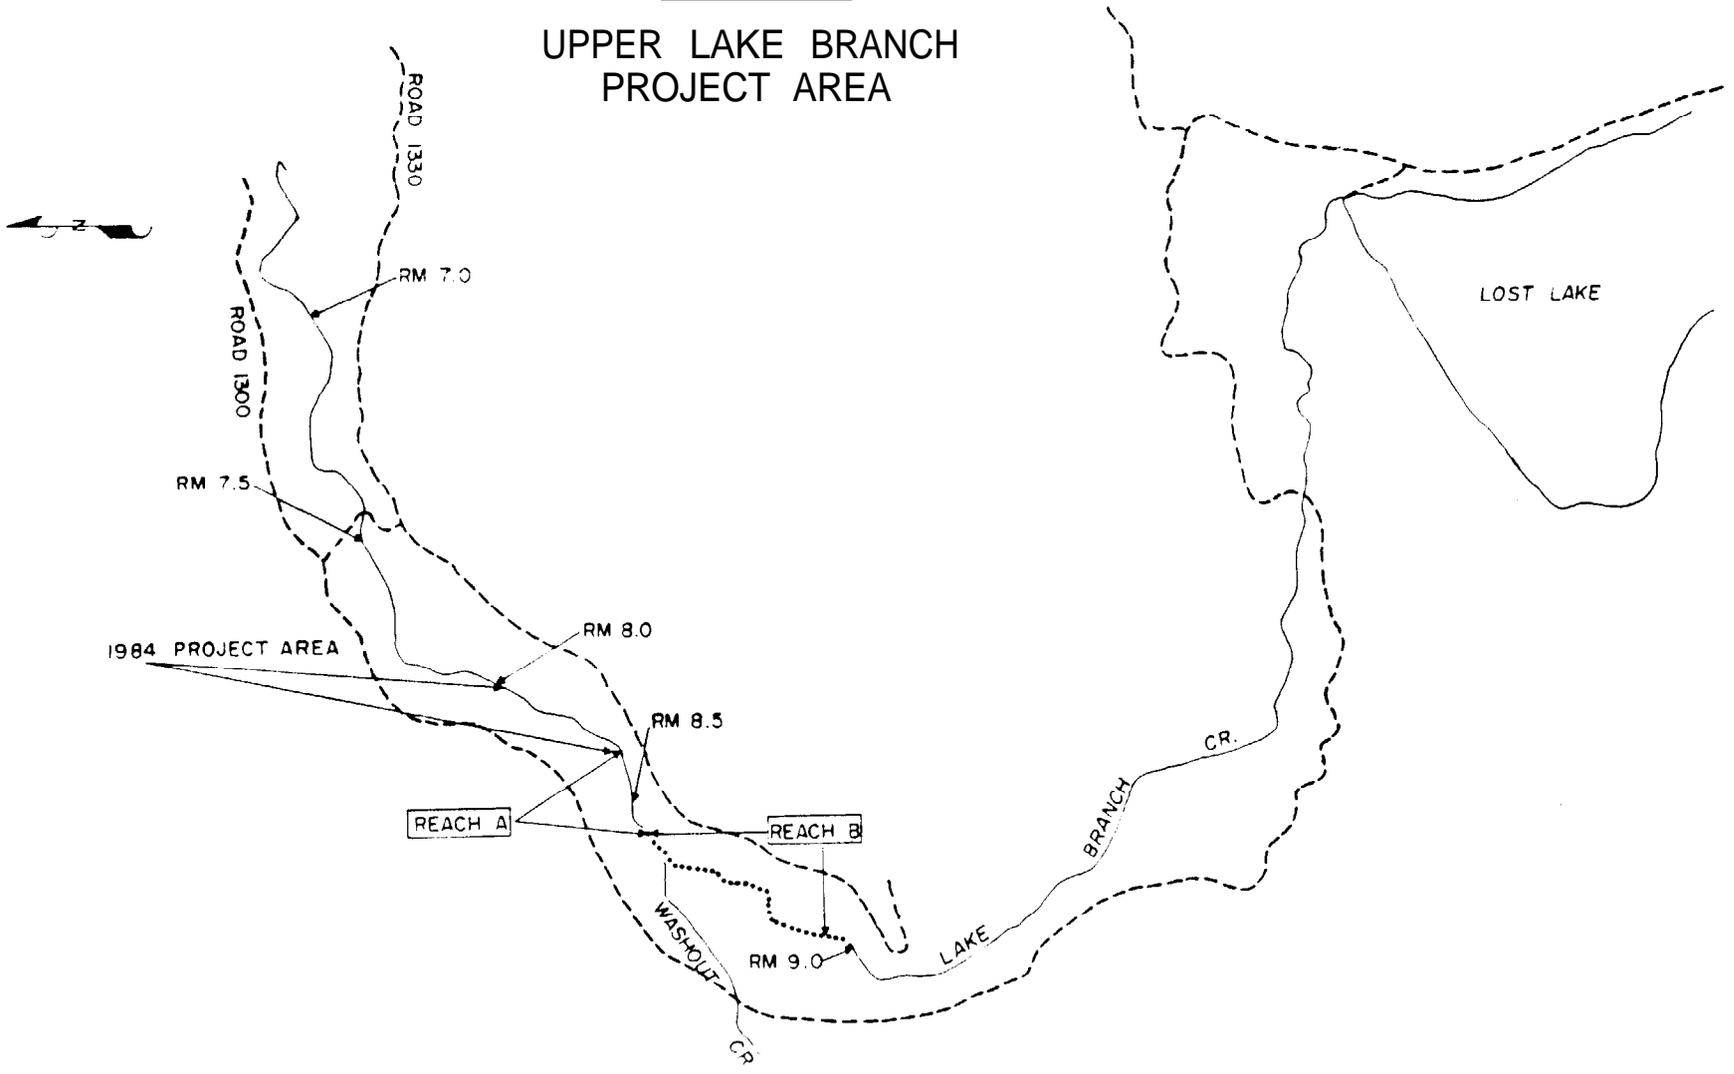
FIGURE 3
UPPER LAKE BRANCH
PROJECT AREA

The approach in the subterranean reach was to install wood structures to stabilize stream channels and banks. It also would increase channel roughness to dissipate high flow energies to allow fine material to settle and seal the channel, provide pool habitat, and collect gravel, and generally increase bed and bank stability. Structures included log sills, double, log wings, "K" and half "K" structures (Appendix A).

The upstream sides of the sills and "K" structures were lined with hog wire (actually dog fence) and filter cloth to prevent undercutting and seal the structure. Pools were excavated below the structures to hasten plunge pool development and the excavated material used to rip-rap each end of the structures. It was attempted to extend the sill logs ten feet into each bank. When it was not possible excavate the ten feet or bank material seemed to be too erodible, wings were placed for stability (Appendix A).

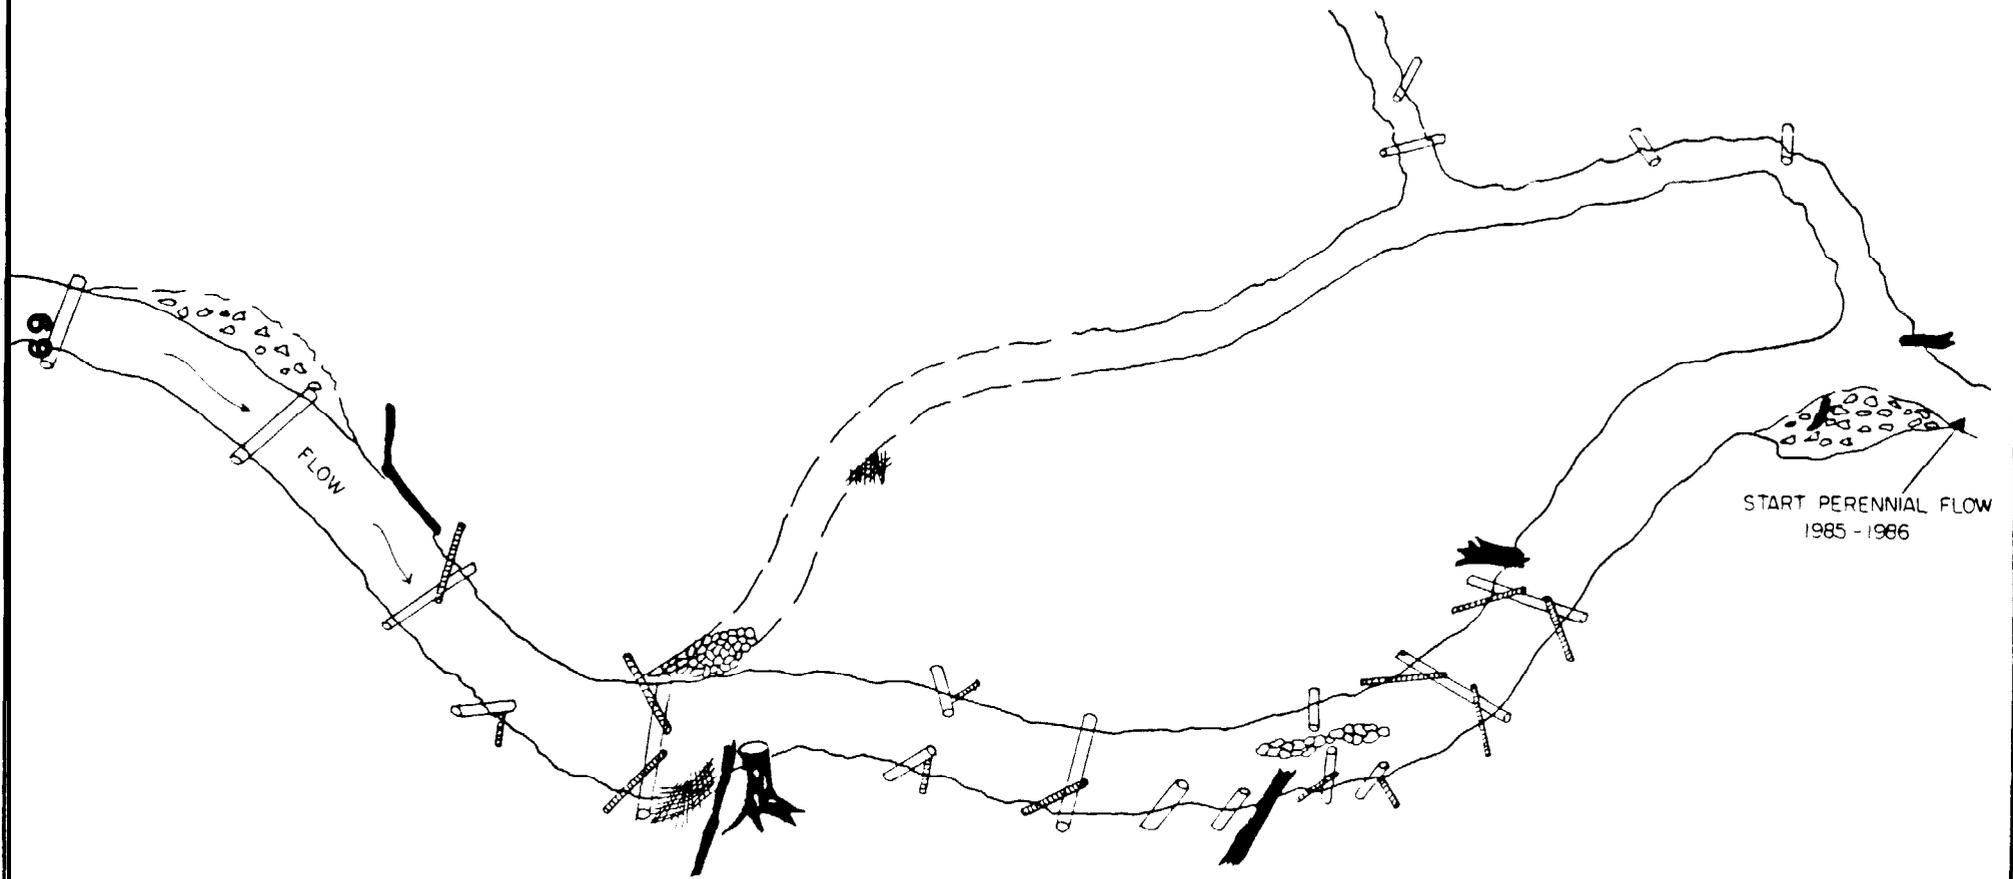
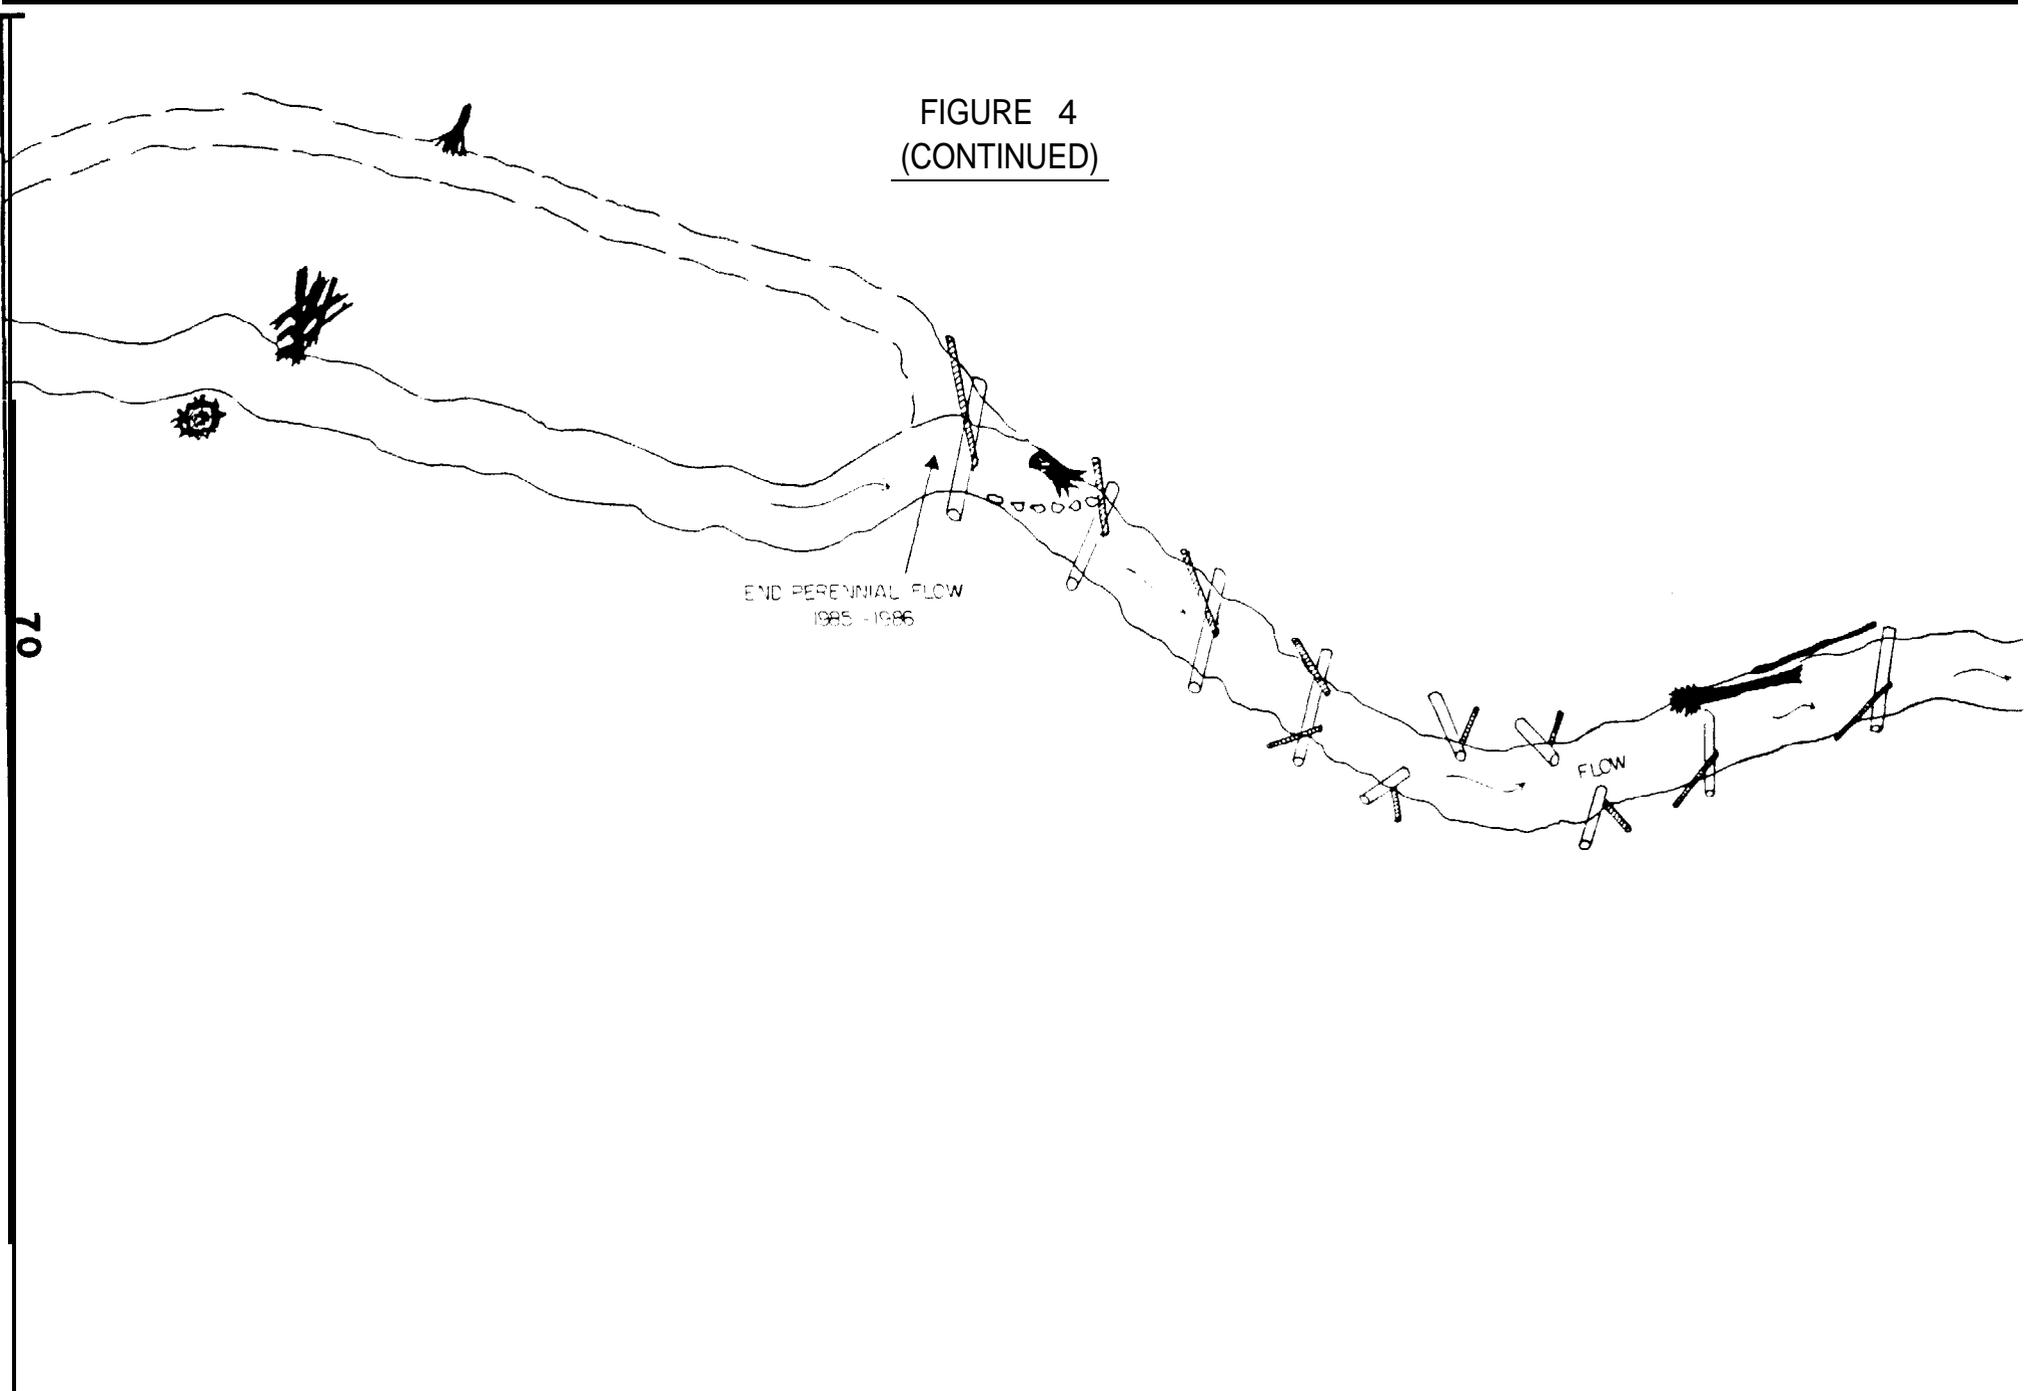
FIGURE 4

UPPER LAKE BRANCH - REACH B
STRUCTURE LOCATIONS

One log sill was added in 1987 as maintenance (improvement) of work completed during the 1984 Lake Branch Channel Rehabilitation Project. The sill was installed downstream of two accelerators to act as a downstream control to hasten scour pool development associated with the structures (MacDonald and Ragan, 1985).

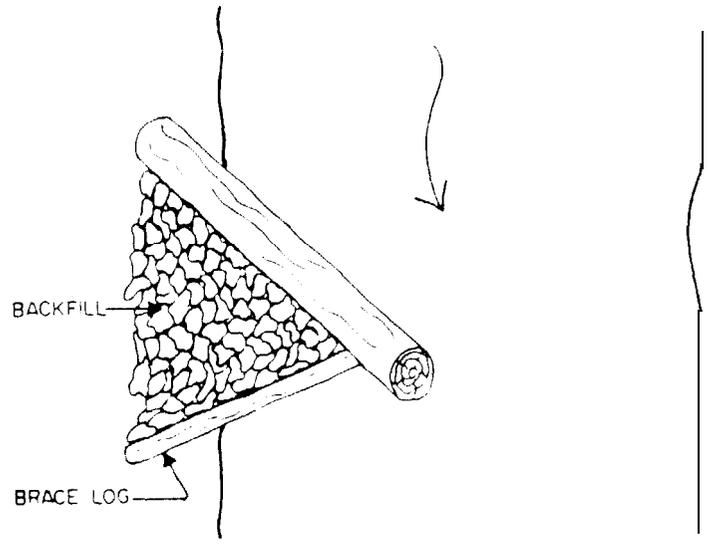
Double Log Wing

Wings, double log wings and accelerators were designed to narrow the channel, create a low flow channel and scour pools. Double log structures were used where it was felt added stability was needed and to help stabilize banks. Water flowing over a wing has a tendency to form a plunge pool on the downstream side of the log. The plunging action can cause bank cutting and jeopardize the structure. The double log structure will help dissipate energy over the structure while allowing acceleration at the tip, thus encouraging deposition of fine material. This fine material will provide an area for vegetation growth to become established, thus stabilizing the bank, but will not inhibit development of a scour pool.

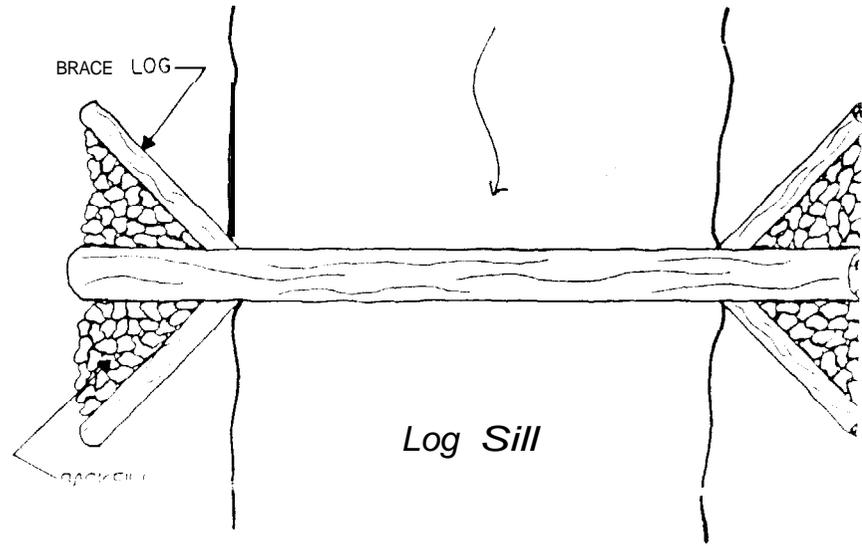
Log Sill

BRACE LOG

BACKFILL

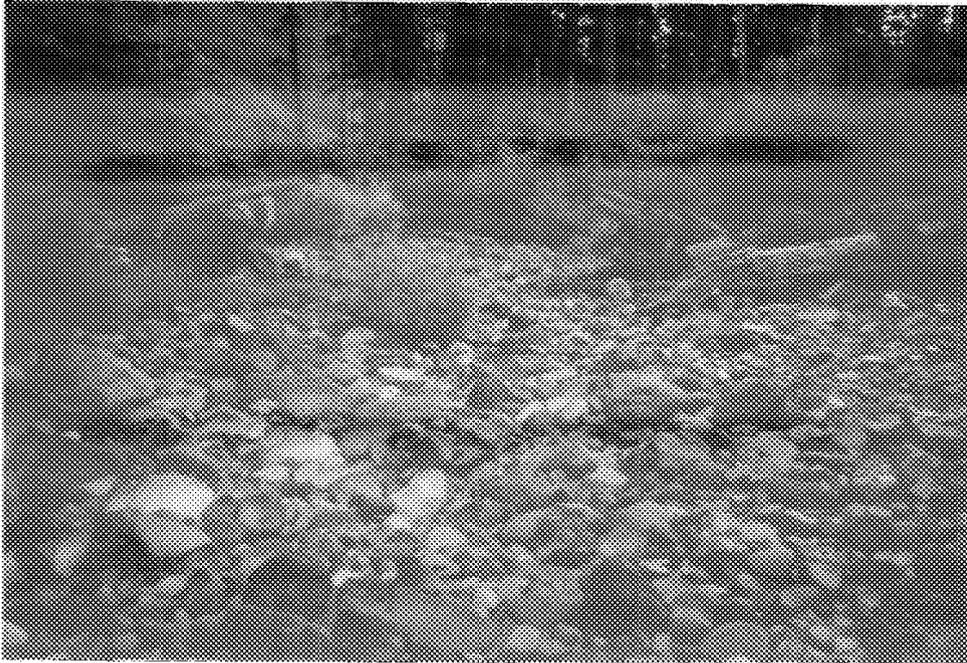
Before Work

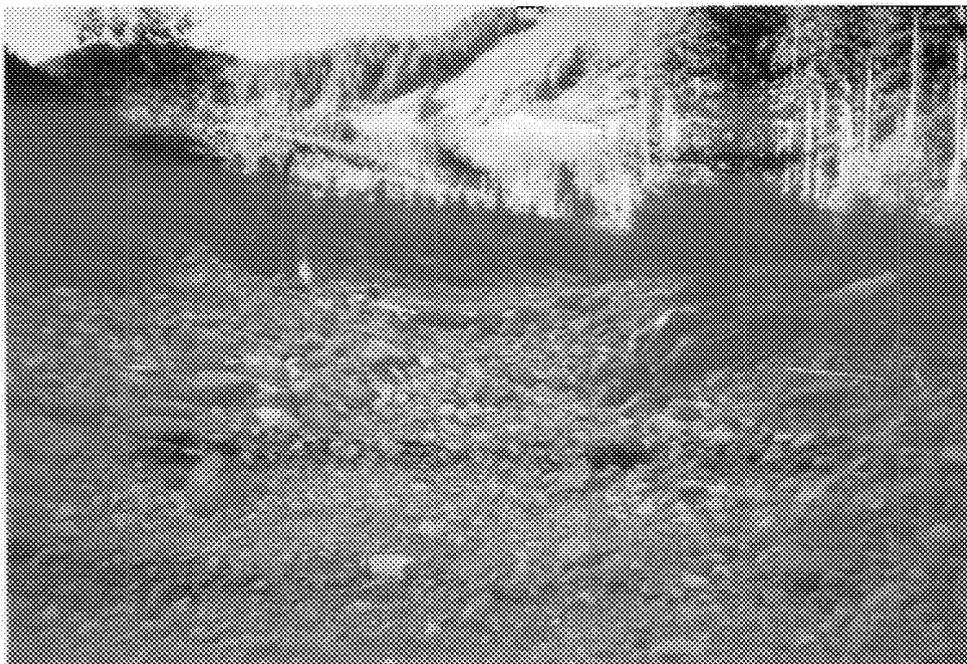
After Silt Construction

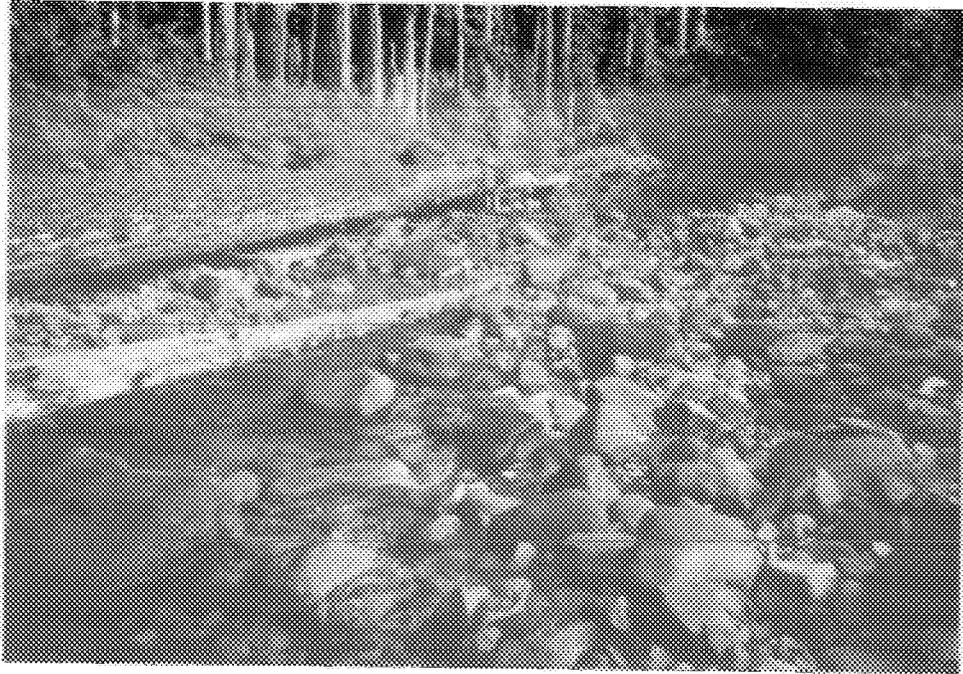
Site 1/2 K-4 Before Work

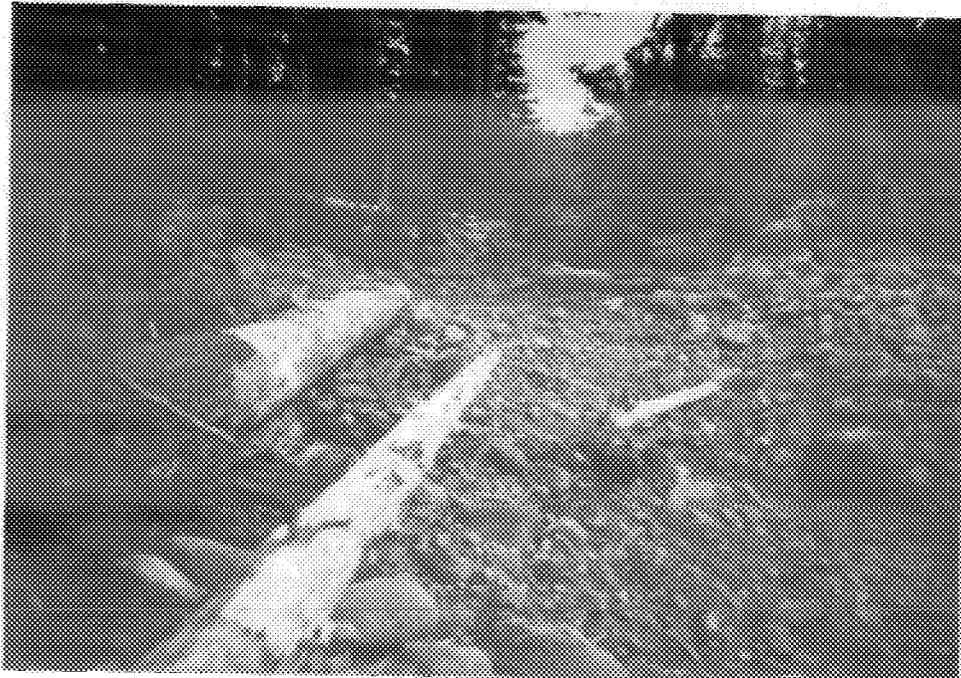
Site 1/2 K After Constuction

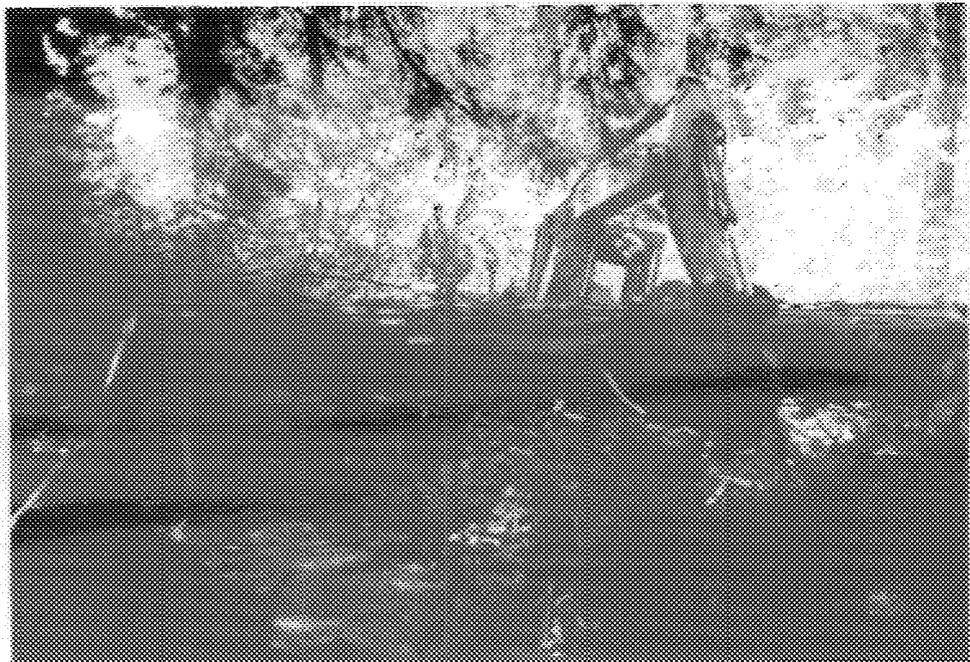
Kubota Backhoe Placing Structure Log

Project work was completed under a Forest Service administered equipment rental contract. The contract specified a small track-mounted backhoe/excavator equipped with an opposable thumb along with an operator. The machine retained by the contract, a Kabota KH-28L, was fully capable of moving the necessary logs and excavating the channel. The opposable thumb is very helpful in placing logs and boulders. Unlike many small backhoes in the size class of the KH-28L, the Kabota is capable of a 360 degree pivot which is very valuable and reduces damage to riparian vegetation compared to a machine without the pivot capacity. Forest Service personnel directed the operator during construction and performed necessary hand labor.

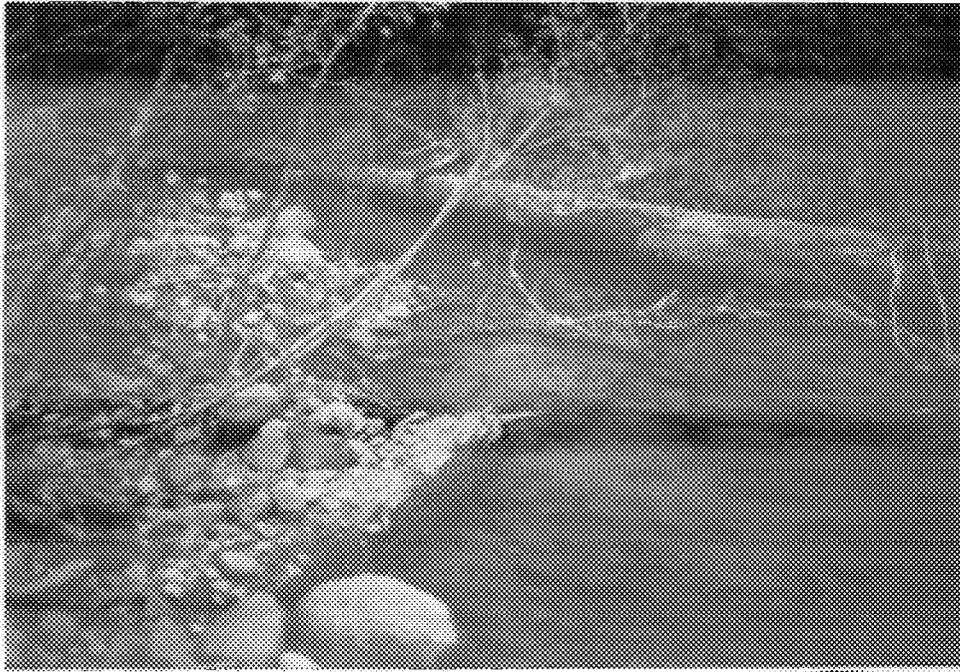
Two Deflector Wings and Cover Log
