1987 ANNUAL REPORT

CLACKAMAS/HOOD RIVER HABITAT ENHANCEMENT PROGRAM

Mt. Hood National Forest
2455 NW Division Street
Gresham, OR 97030

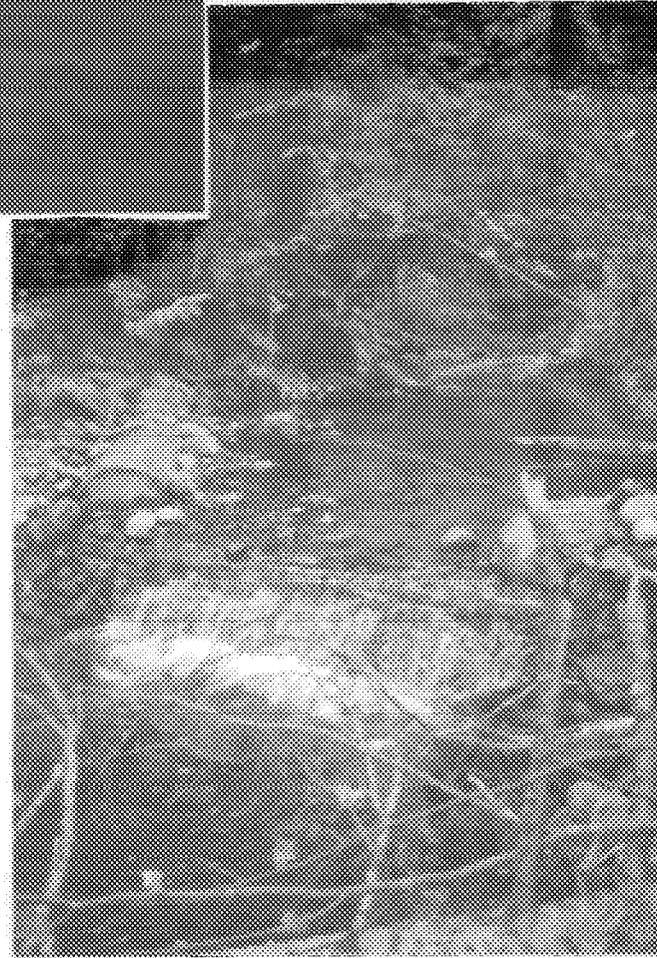
"K" Sill Structure

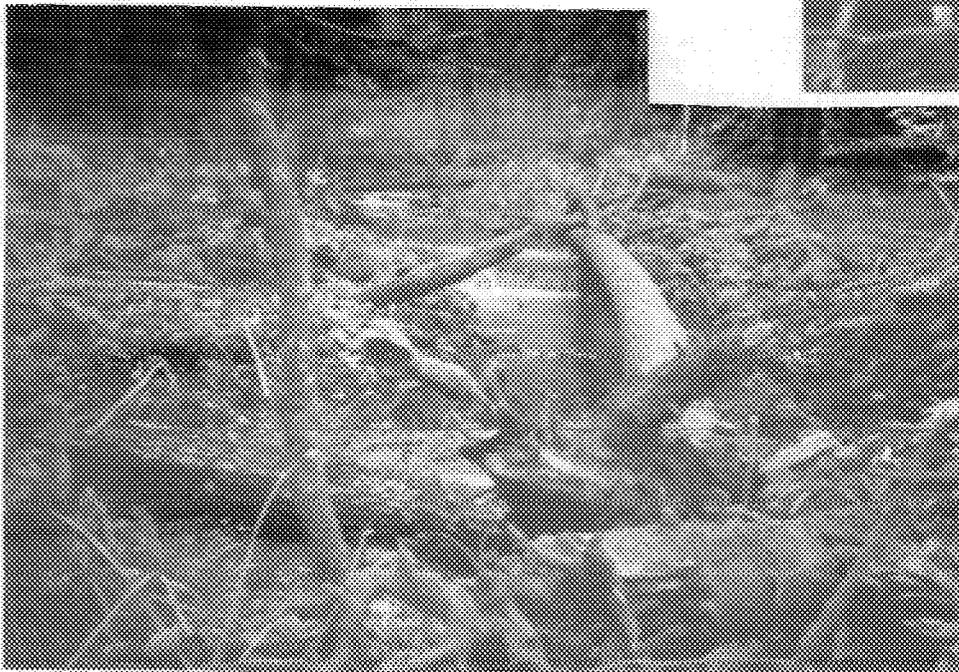
Sill, Digger & Cover Log Combo

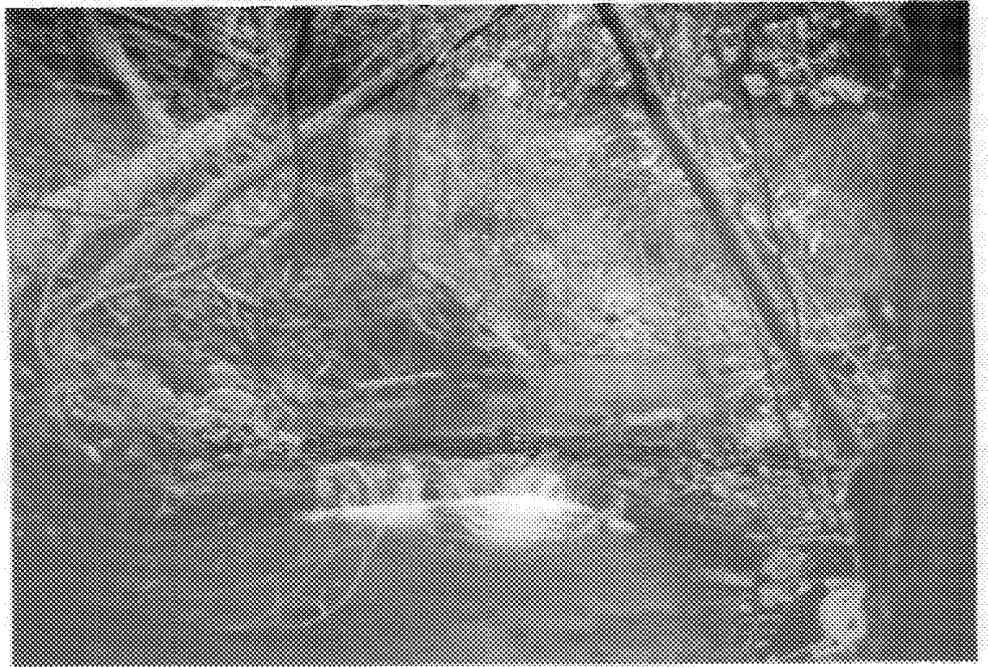
Upstream "Y"

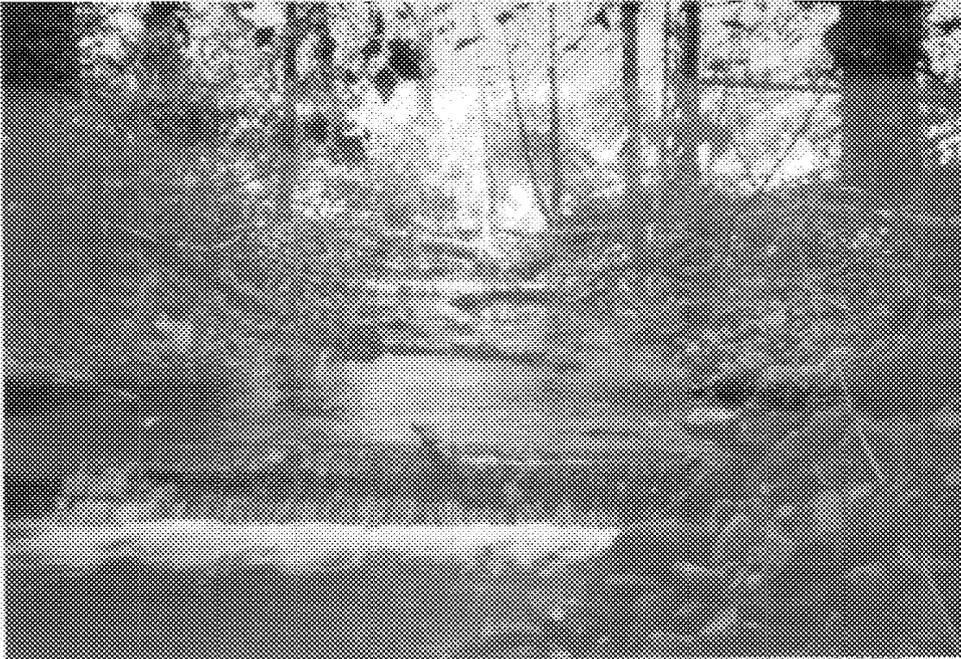
Digger and Sill Combo

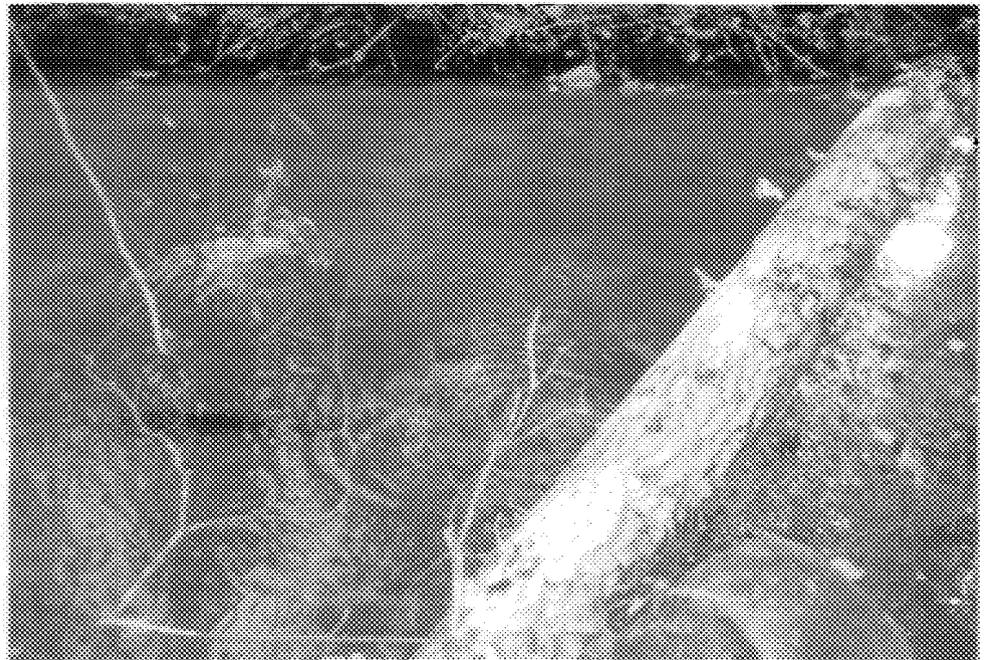
Digger Log With Boulders
