FIFTEENMILE BASIN
HABITAT IMPROVEMENT PROJECT

1990 ANNUAL REPORT

Gary M. Asbridge, Fisheries Biologist

Mt. Hood National Forest
Barlow Ranger District
Dufur, Oregon

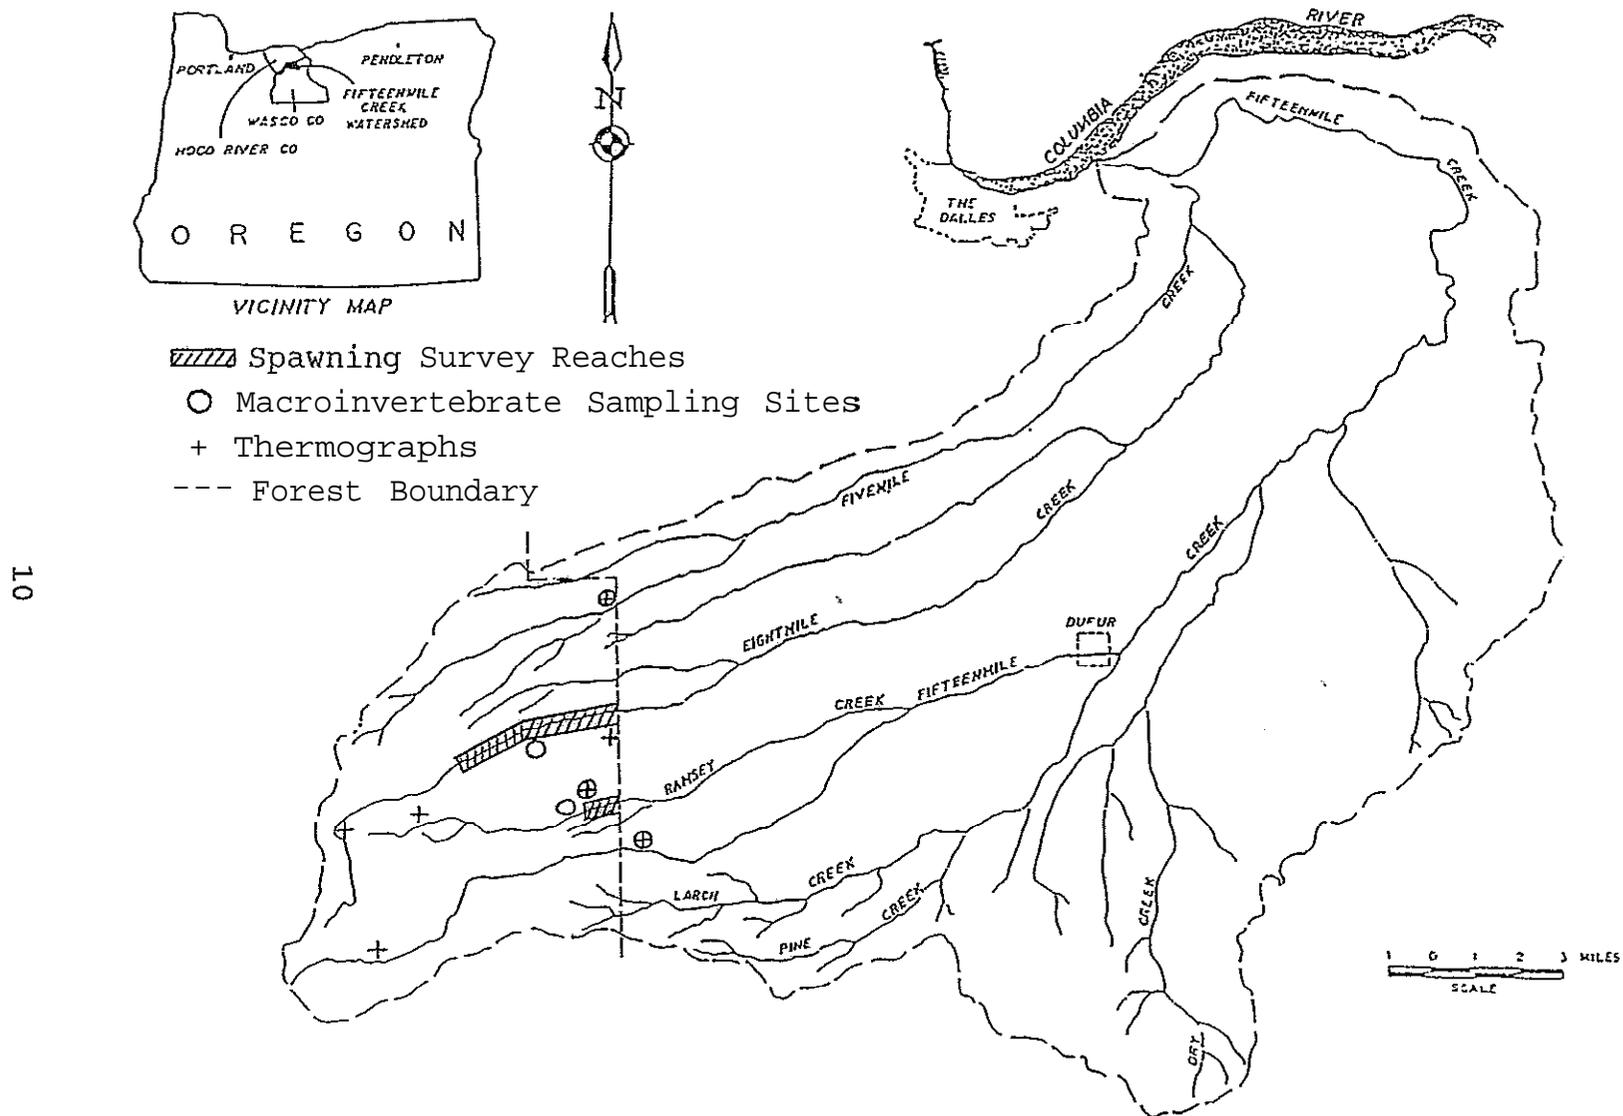
Figure 2. USFS spawning survey stream reaches, macroinvertebrate sampling sites, and thermograph locations in the Fifteenmile Creek basin, 1990.

Spawning surveys in the Fifteenmile Creek basin were conducted during April 1990 on Eightmile and Ramsey Creeks (Figure 2). Fifteenmile Creek was not surveyed on Forest, but USFS personnel assisted ODFW personnel below the Forest boundary. The number of redds and adult steelhead trout were tallied during each survey.

In 1986 the USFS and ODFW contracted with Dr. Fred Mangum (Aquatic Ecologist, USFS, Region 4), to establish a macroinvertebrate sampling program in the Fifteenmile Basin. Macroinvertebrates respond to changes in aquatic habitat, and analysis of macroinvertebrate community structure can reveal condition and trends in aquatic ecosystems (Mangum 1987). Monitoring changes of macroinvertebrate populations should be a good indicator of changes in aquatic habitat as a result of habitat improvement work. Three samples were taken at each of five sites three separate times in 1990 (spring, summer, and fall). Sampling procedures and site locations (Figure 2) are

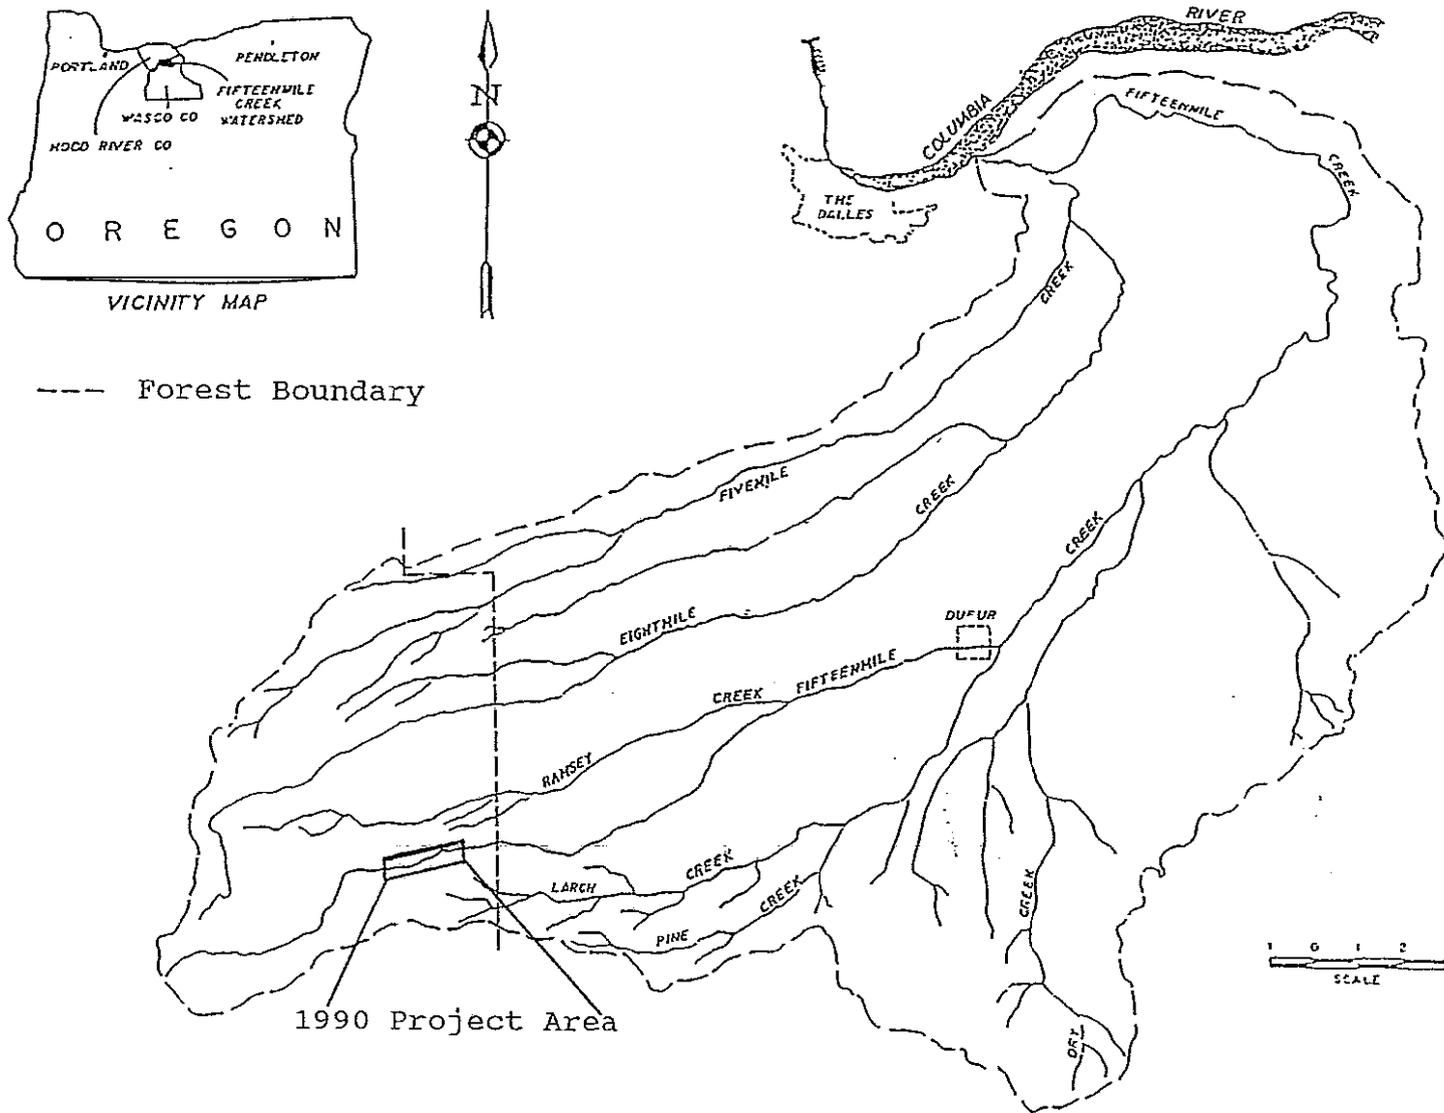
Figure 3. Location of 1990 fish habitat improvement work on Fifteenmile Creek.

The 1990 Fifteenmile Creek project objective was to increase rearing habitat capability by improving habitat diversity with instream structures within a two mile reach of stream (Figure 3). The focus was to increase low flow pool/glide volume and effective cover for age 1+ and older winter steelhead trout. The instream structures were designed to create scour and plunge pools, accumulate spawning gravels, and provide cover.

Structures were placed by one of three ways: falling whole trees into the creek from adjacent riparian areas, bucking existing downed trees into the channel, or winching fallen trees or bucked logs into the creek from the riparian zone. Trees for falling or bucking were pre-selected by USFS

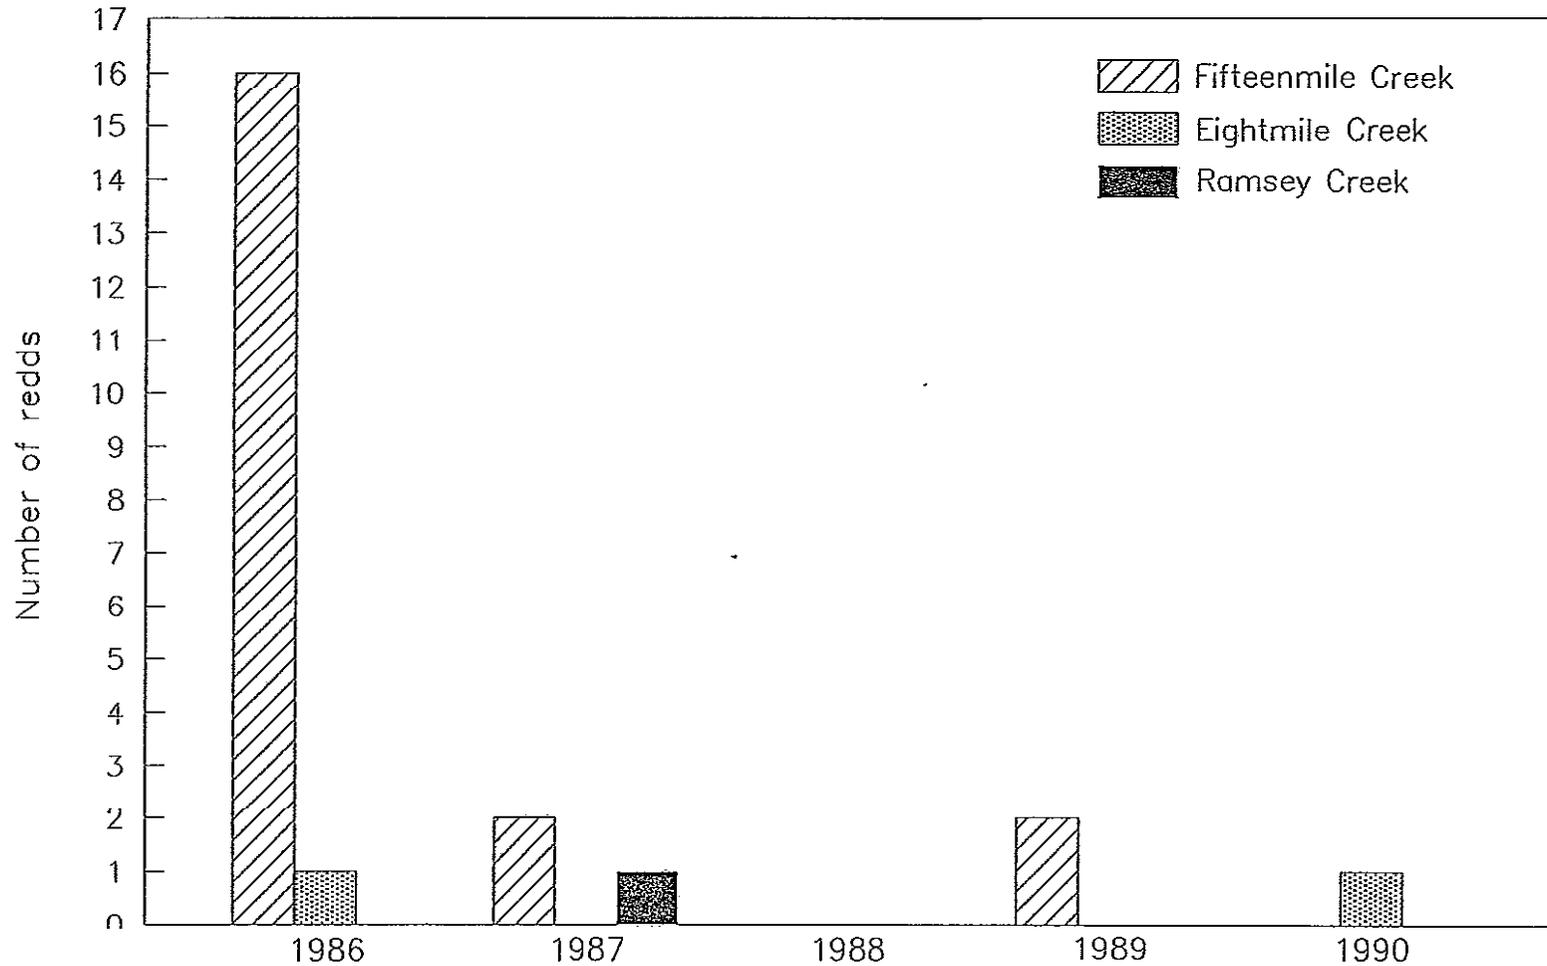
Figure 4. Number of steelhead trout spawning redds counted in Fifteenmile, Eightmile, and Ramsey Creeks during 1986 - 1990 upstream from the National Forest boundary. Fifteenmile Creek was not surveyed in 1990.

The number of redds counted within the Forest boundary since 1986 has varied slightly by stream and year, but, except for Fifteenmile Creek in 1986, the number of redds has been two or less for each stream surveyed (Figure 4). The large number of redds seen in Fifteenmile Creek in 1986 may be attributable to a large returning adult run that year (Tom Macy, USFS, Hood River Ranger District, personal communication). Based on past evidence, it is unlikely large numbers of steelhead trout will utilize spawning habitat on the National Forest until run sizes increase.

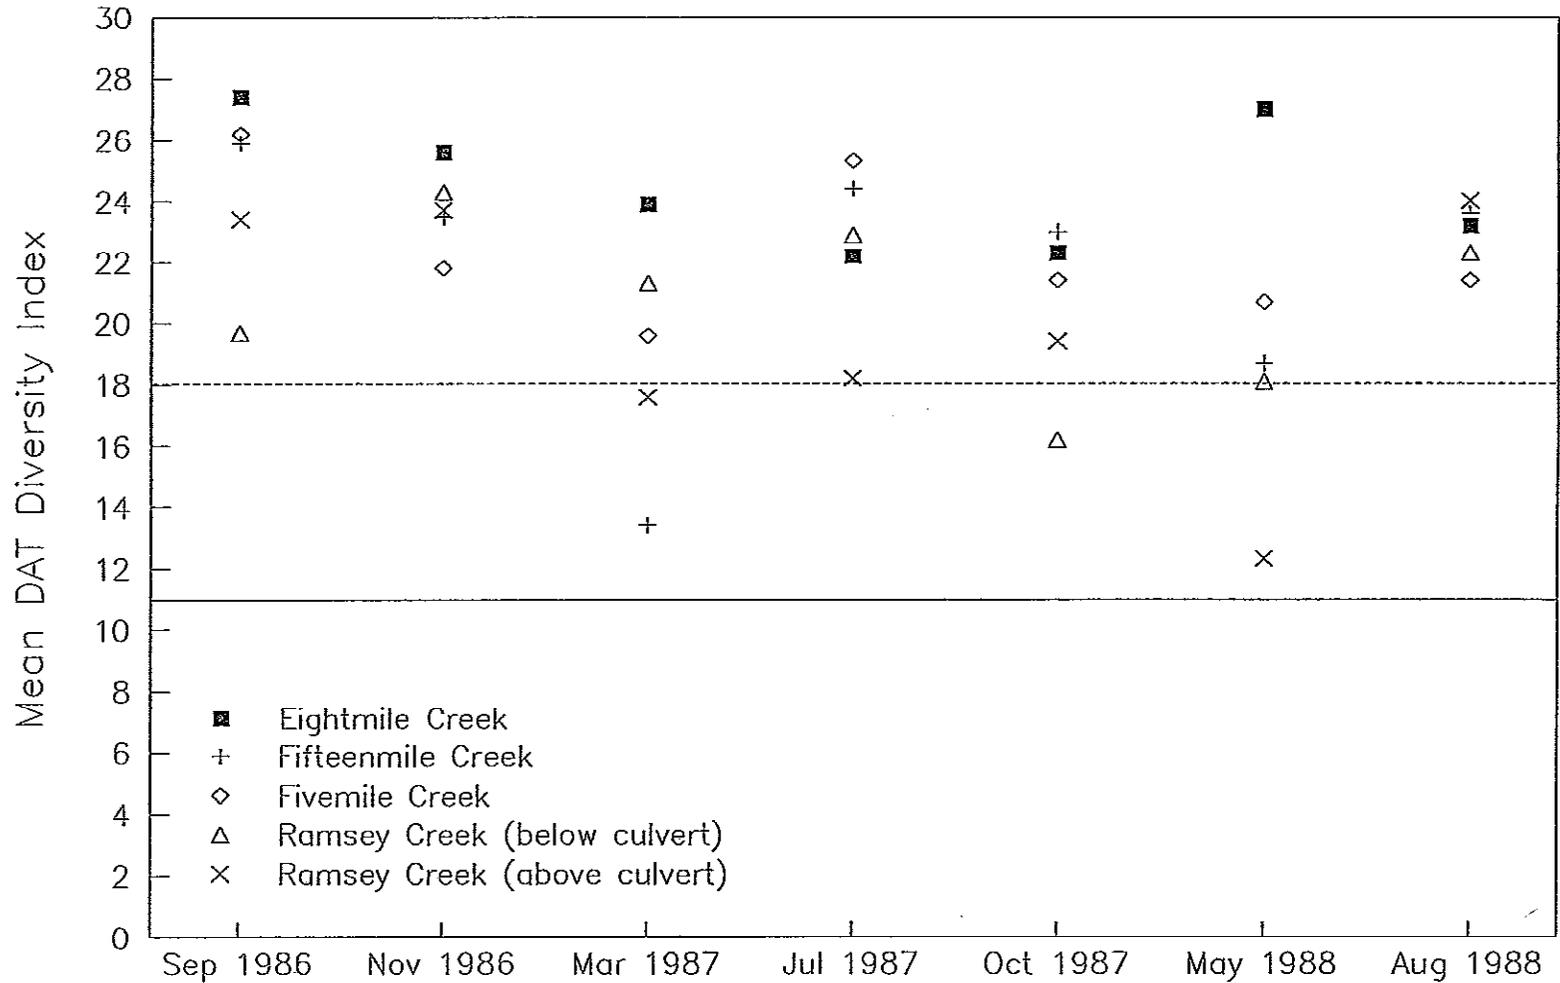
Figure 5. Mean DAT diversity index values for macroinvertebrates collected from five sites within the Fifteemile Creek basin during 1986 - 1988. Each point represents the mean from three samples taken at each site. Values above the dashed horizontal line are considered excellent, values between the dashed and solid horizontal lines are considered good.

Macroinvertebrate diversity indices are a measure of stress in the environment and assume that large numbers of species are present in an unpolluted, or unstressed, environment (Mason 1981). For the DAT diversity index used in this analysis (Mangum 1987), values between 11 and 17 indicate good environmental conditions while values greater than 18 indicate excellent conditions. From 1986 through 1988 none of the Fifteen-mile basin macroinvertebrate samples taken within the National Forest exhibited DAT diversity index values below those considered good, and most were in the excellent range (Figure 5). There was year to year and seasonal variation, but given the variable nature of aquatic ecosystems this was not unexpected.

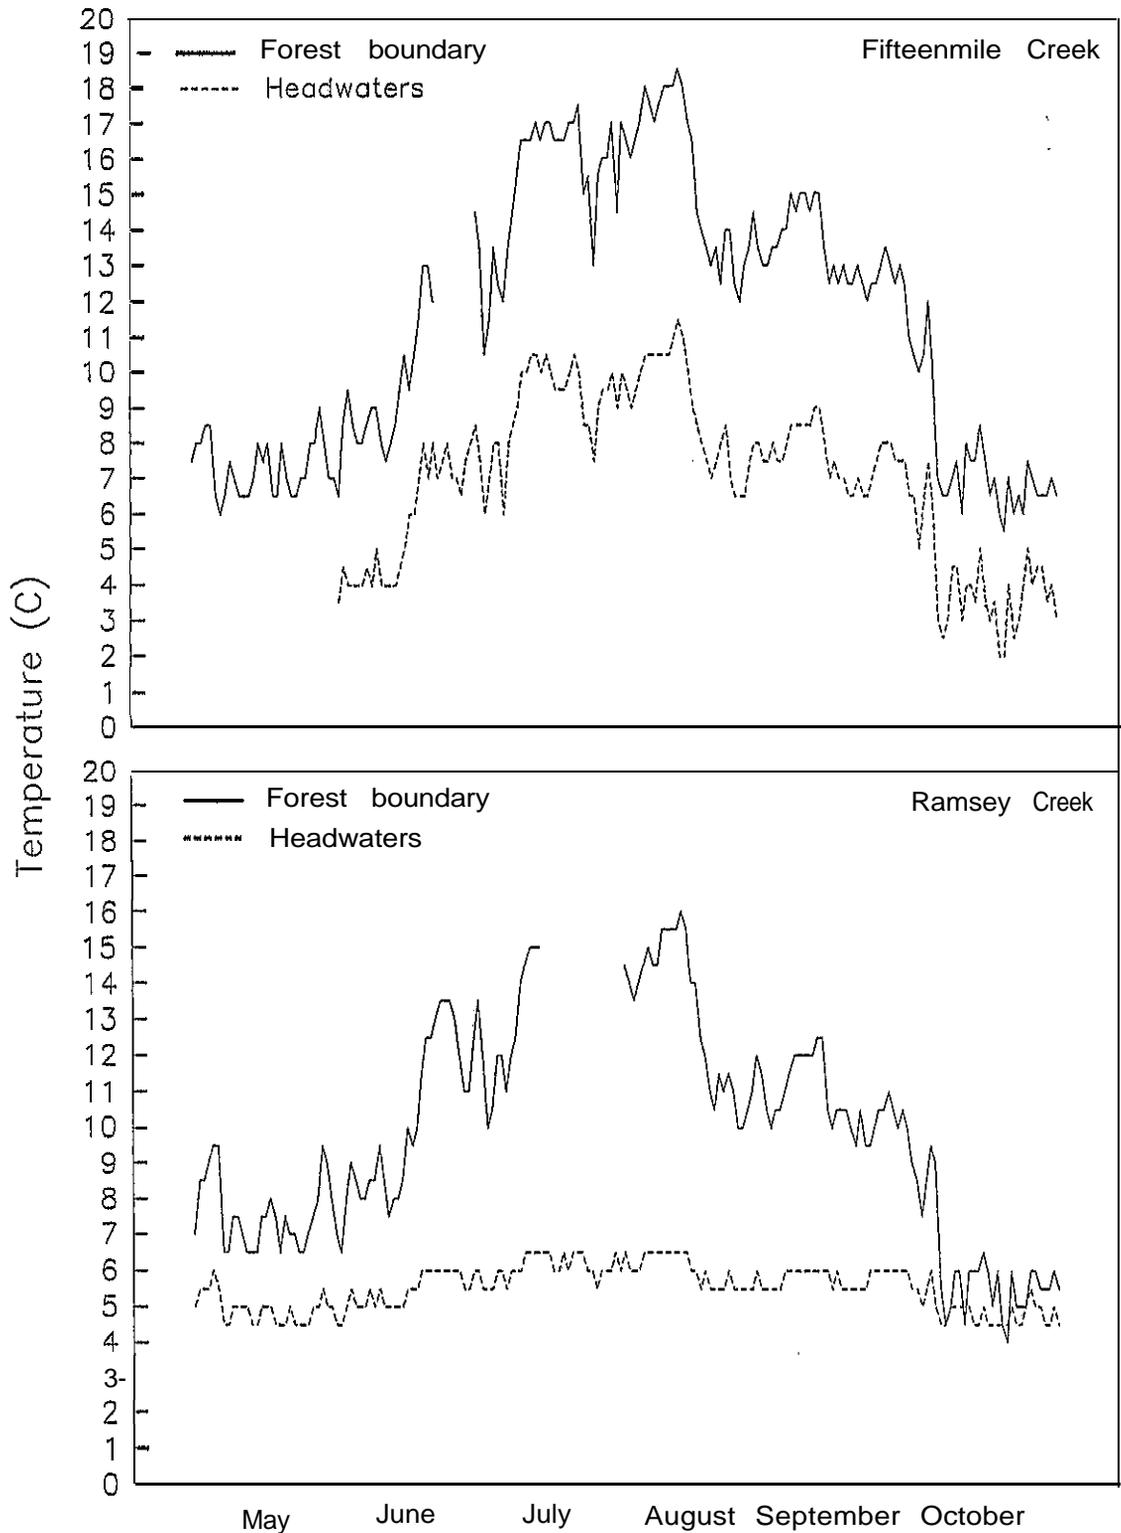
Figure 6. Daily maximum water temperatures ($^{\circ}\text{C}$) recorded at two sites (Forest boundary and headwaters) in Fifteenmile and Ramsey Creeks from 1 May to 31 October 1990. The head-water thermograph in Fifteenmile Creek was not installed until 1 June 1990.

Water temperatures in the Fifteenmile basin on the National Forest are well below upper lethal limits for salmonids. Daily maximum water temperatures of 18.5, 18.0, 17.0, and 16.0 °C were recorded during August in Fifteenmile, Fivemile, Eight-mile, and Ramsey Creeks, respectively (Figures 6 and 7).

Generally, Fifteenmile and Fivemile Creeks had the highest daily maximum temperatures, but the temperature regimes were similar for the four creeks. One exception was the upper Ramsey Creek site which maintained low temperatures with little diurnal fluctuation during the six month period.

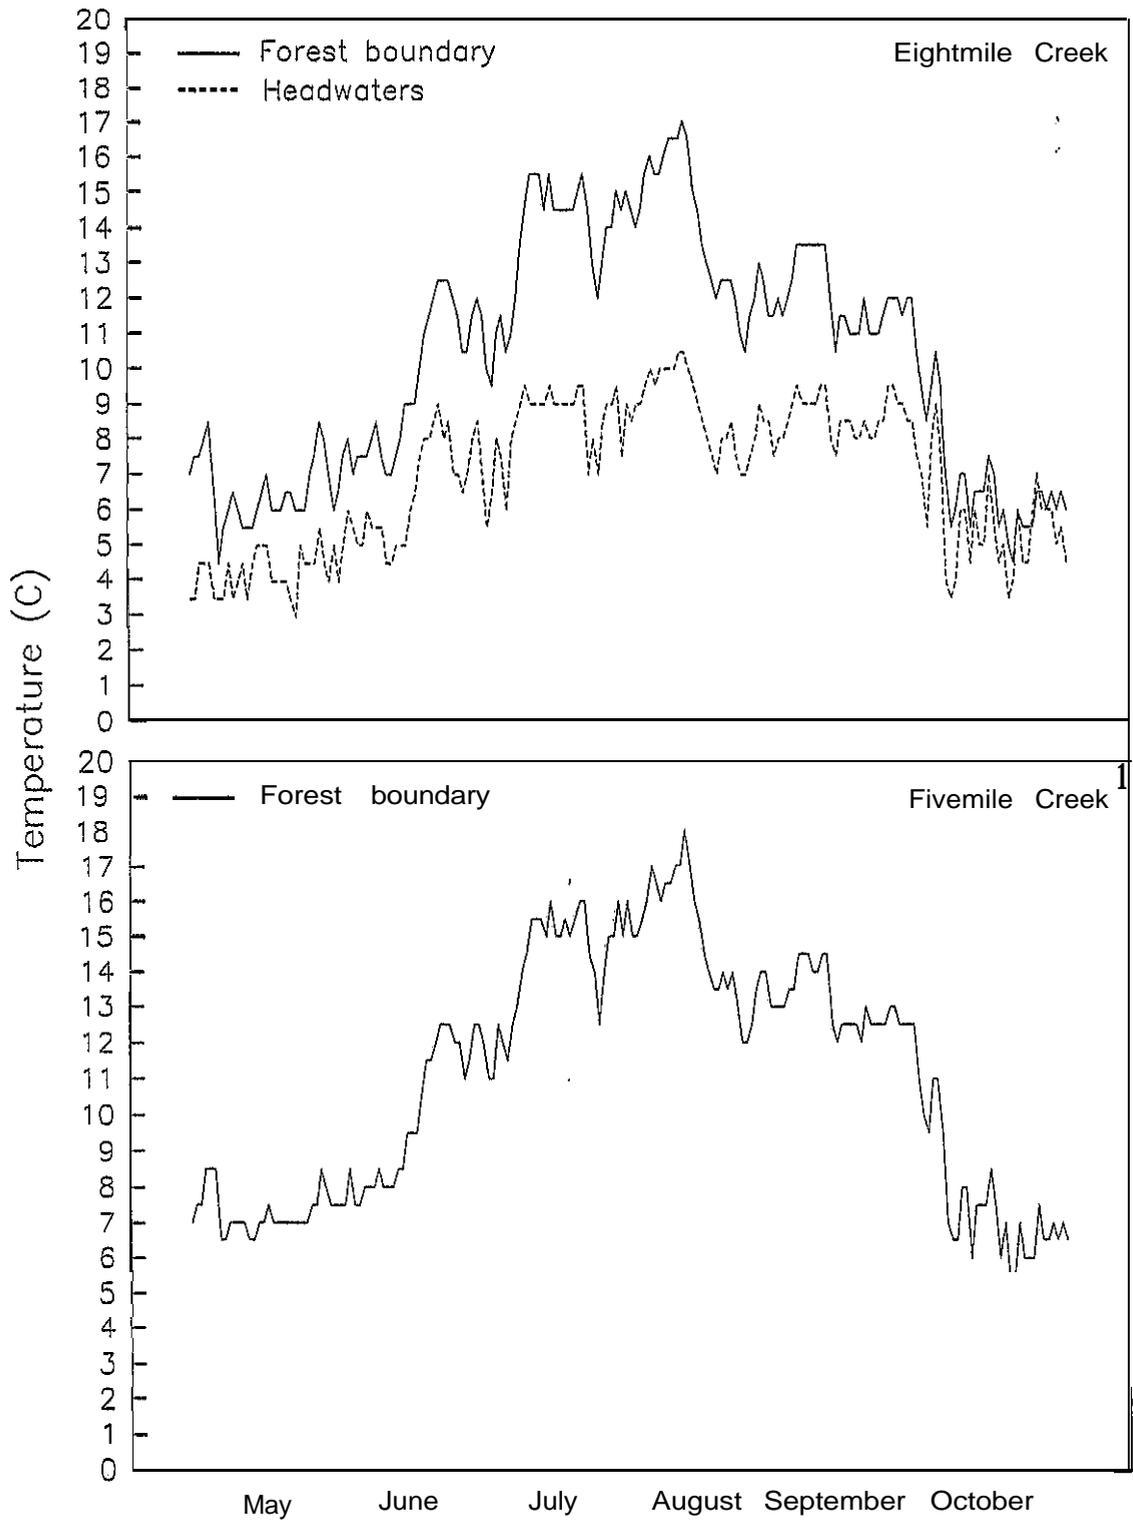
Figure 7. Daily maximum water temperatures ("C) recorded at two sites (Forest boundary and headwaters) in Eightmile Creek and one site (Forest boundary) in Fivemile Creek from 1 May to 31 October 1990.

Based on spot checks conducted by USFS personnel none of the thermographs appeared to be recording abnormal water temperatures, with the possible exception of the lower Eight-mile Creek thermograph in late October. On 1 November we recorded a water temperature of 0.0°C with the hand held thermometer whereas the thermograph read 2.5°C. Missing data during June for the lower Fifteenmile Creek site and July for the lower Ramsey Creek site may have been attributable to weak batteries or moisture in the unit. When the Fifteenmile Creek thermograph was checked on 29 June it was not recording data, the Ramsey Creek thermograph was recording when checked on 30 July but did read one error.

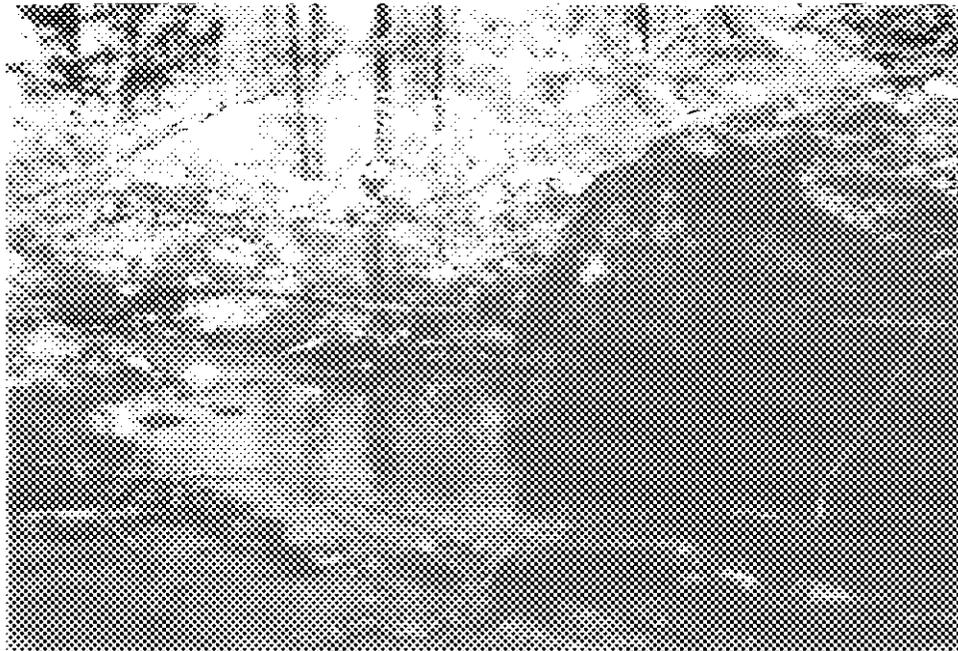
Lower middle project area site,, before failing.

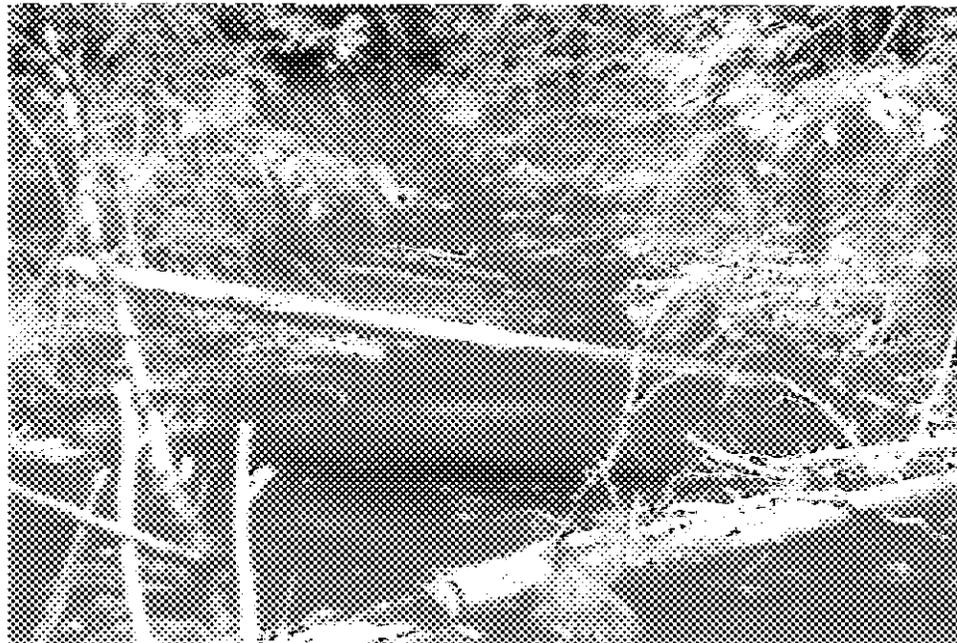
Middle project area site, before falling.

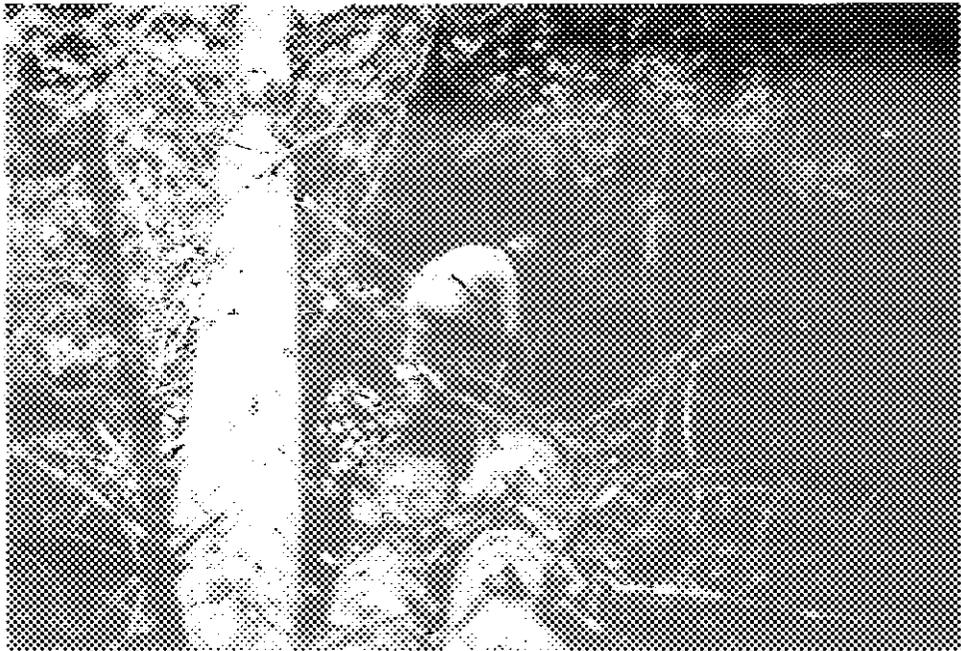
Upper project area site after two logs had been winched in.
