John Day River Subbasin Fish Habitat Enhancement Project

1992 ANNUAL REPORT

Oregon Department of Fish and Wildlife
P.O. Box 9
John Day, Oregon 97845

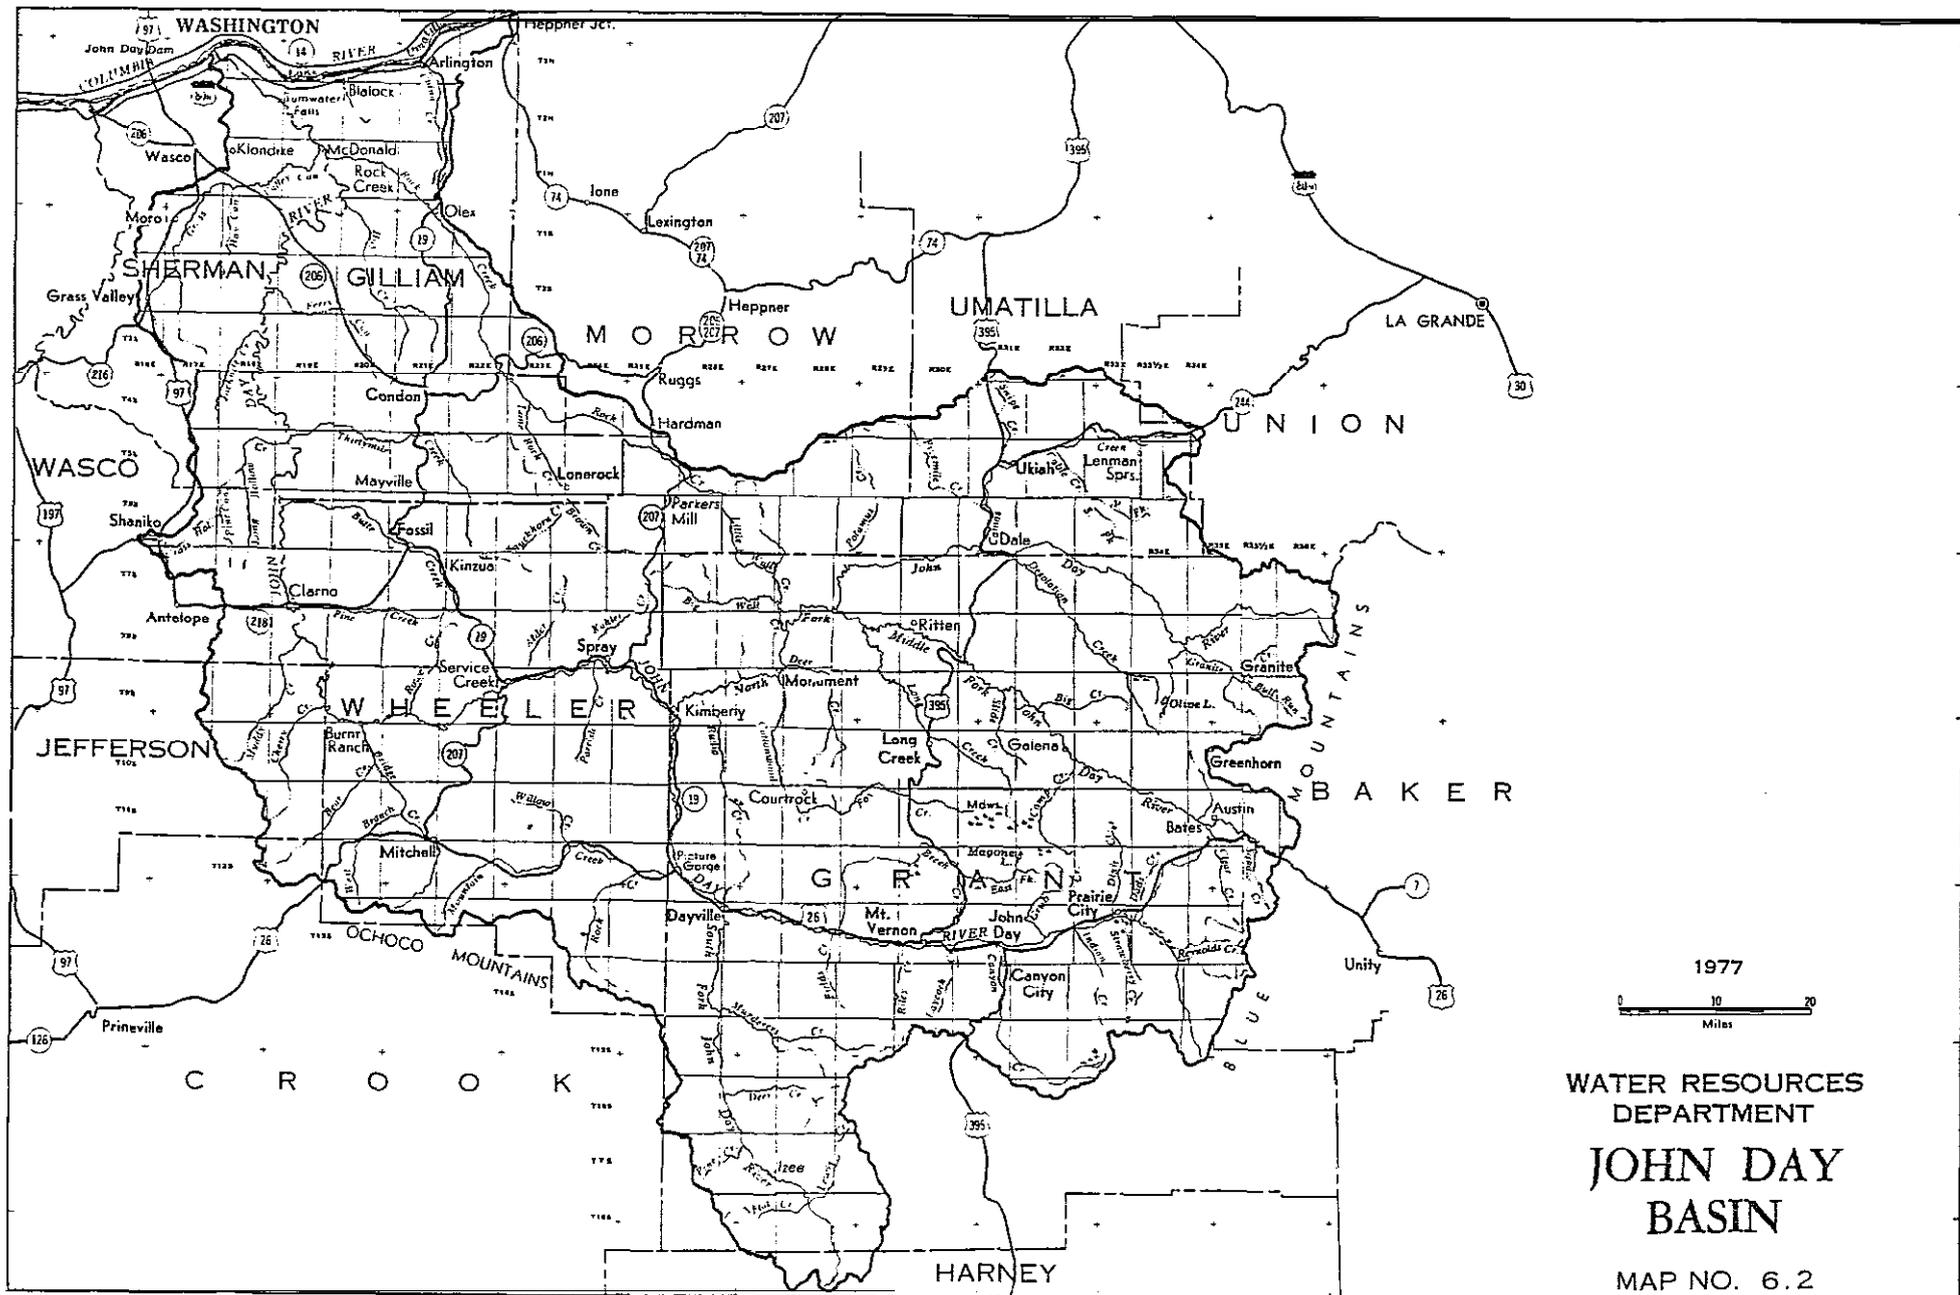
Figure 1

The John Day River drains 8,010 square miles of land in east central Oregon and is the third largest drainage in the state (Figure 1). The subbasin includes a major part of Gilliam, Grant, and Wheeler counties and portions of Crook, Harney, Jefferson, Morrow, Sherman, Umatilla, Union, and Wasco counties.

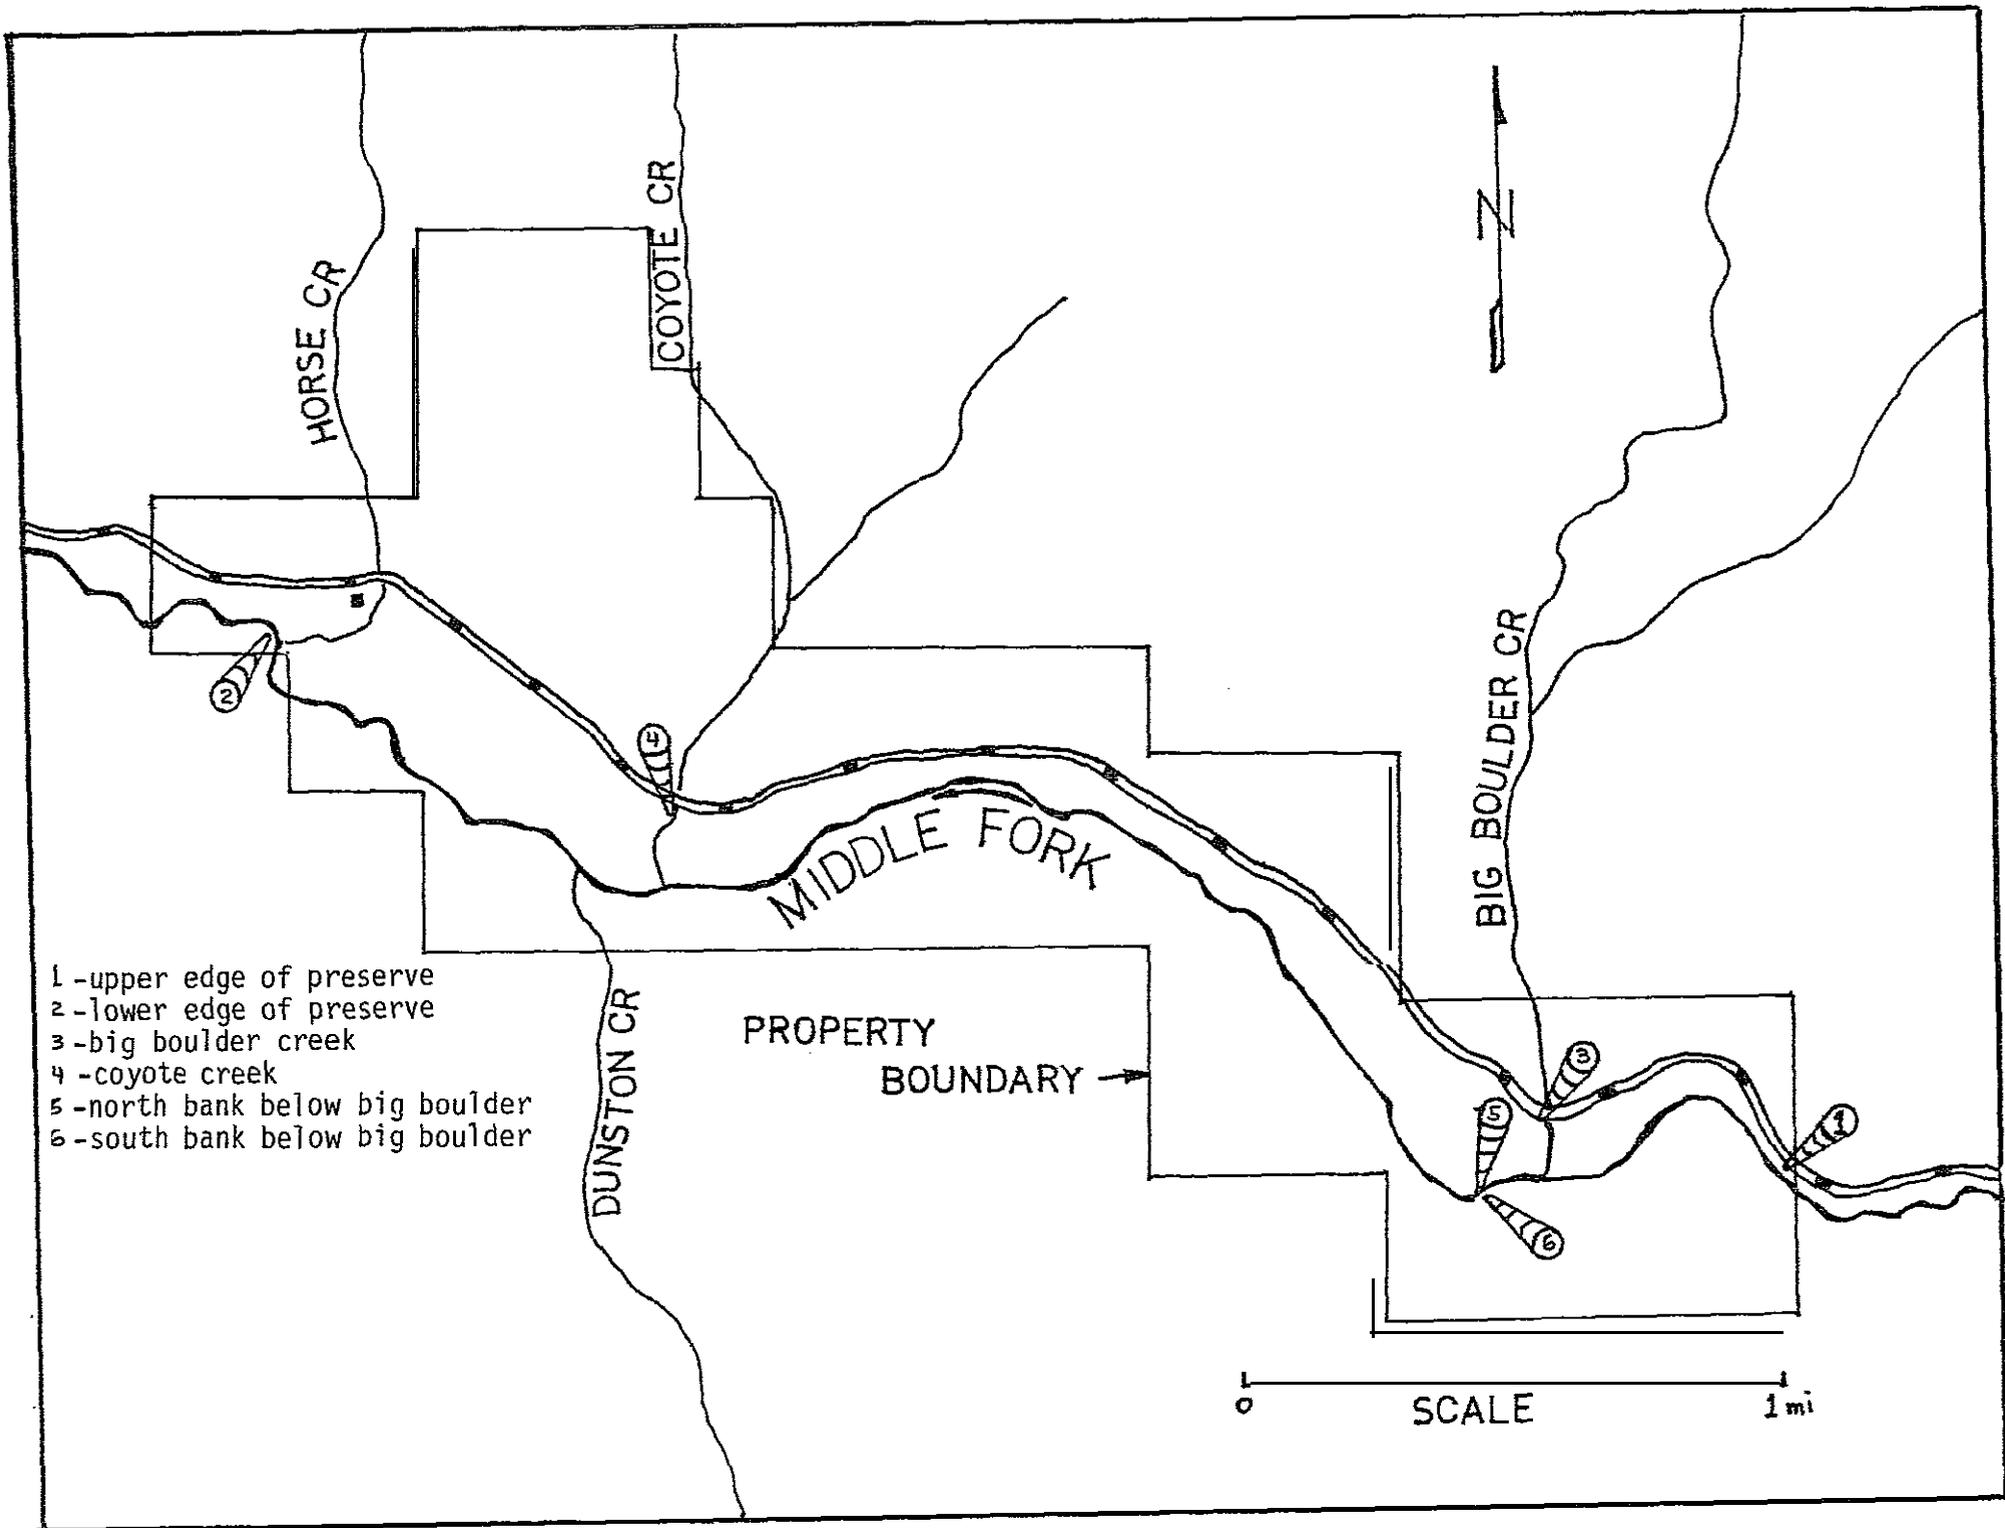
Figure 2

- 1 - upper edge of preserve
- 2 - lower edge of preserve
- 3 - big boulder creek
- 4 - coyote creek
- 5 - north bank below big boulder
- 6 - south bank below big boulder

Six thermographs were deployed for the first time in June on the Nature Conservancy property on the Middle Fork. One was placed at the upper end and one was placed at the lower end, 4 miles away. One was placed in Coyote Creek and one in Big Boulder Creek. The last two were placed on opposite sides of the river at a point 300 yards below the mouth of Big Boulder Creek (Fig. 2). Results showed the Middle Fork's average maximum temperature coming into the property was 73° during July and 77° during August. Big Boulder Creek cools the Middle Fork by 4° at 300 yards below their confluence. The Middle Fork warms back up to within 1° of its former temperature by the time it reaches the bottom of the property (see Appendix B for data). These thermographs will be monitored for the life of the lease to document temperature changes as this area recovers its riparian canopy.

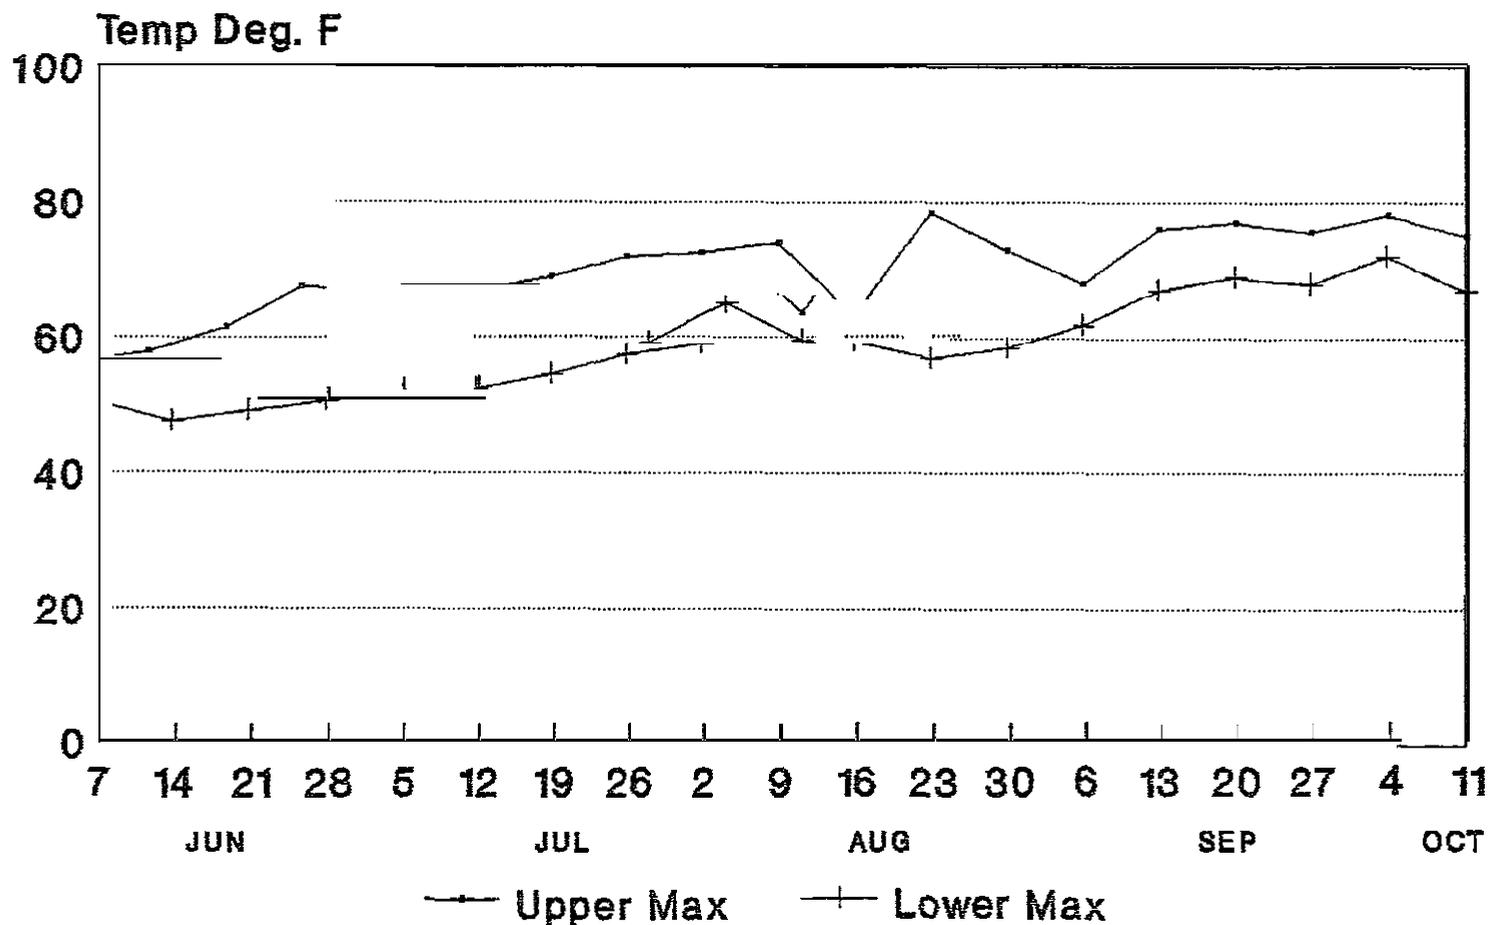
Mean Weekly Maximum Temperatures

COTTONWOOD CREEK

Two thermographs were monitored on Cottonwood Creek this year from April through September, one is stationed above and one is stationed at the lower end of our $\frac{1}{2}$ mile long project area. This allows us to record temperature changes as a result of the stream flowing through our project. Weekly maximum water temperatures were found to be 8.4°F cooler in the summer after flowing through our riparian corridor. This means the stream cooled down 8.4°F in only $\frac{1}{2}$ mile of recovered riparian canopy. We also found that the stream was warmer at night by an average of 2.5°F . This means the stream at the lower end of our treatment area goes through less of a daily temperature fluctuation. We recorded these temperatures during a severe drought year so the low water levels may have affected the stream's temperature pattern. Temperatures averaged 10° warmer than last year's data. (see Appendix A).

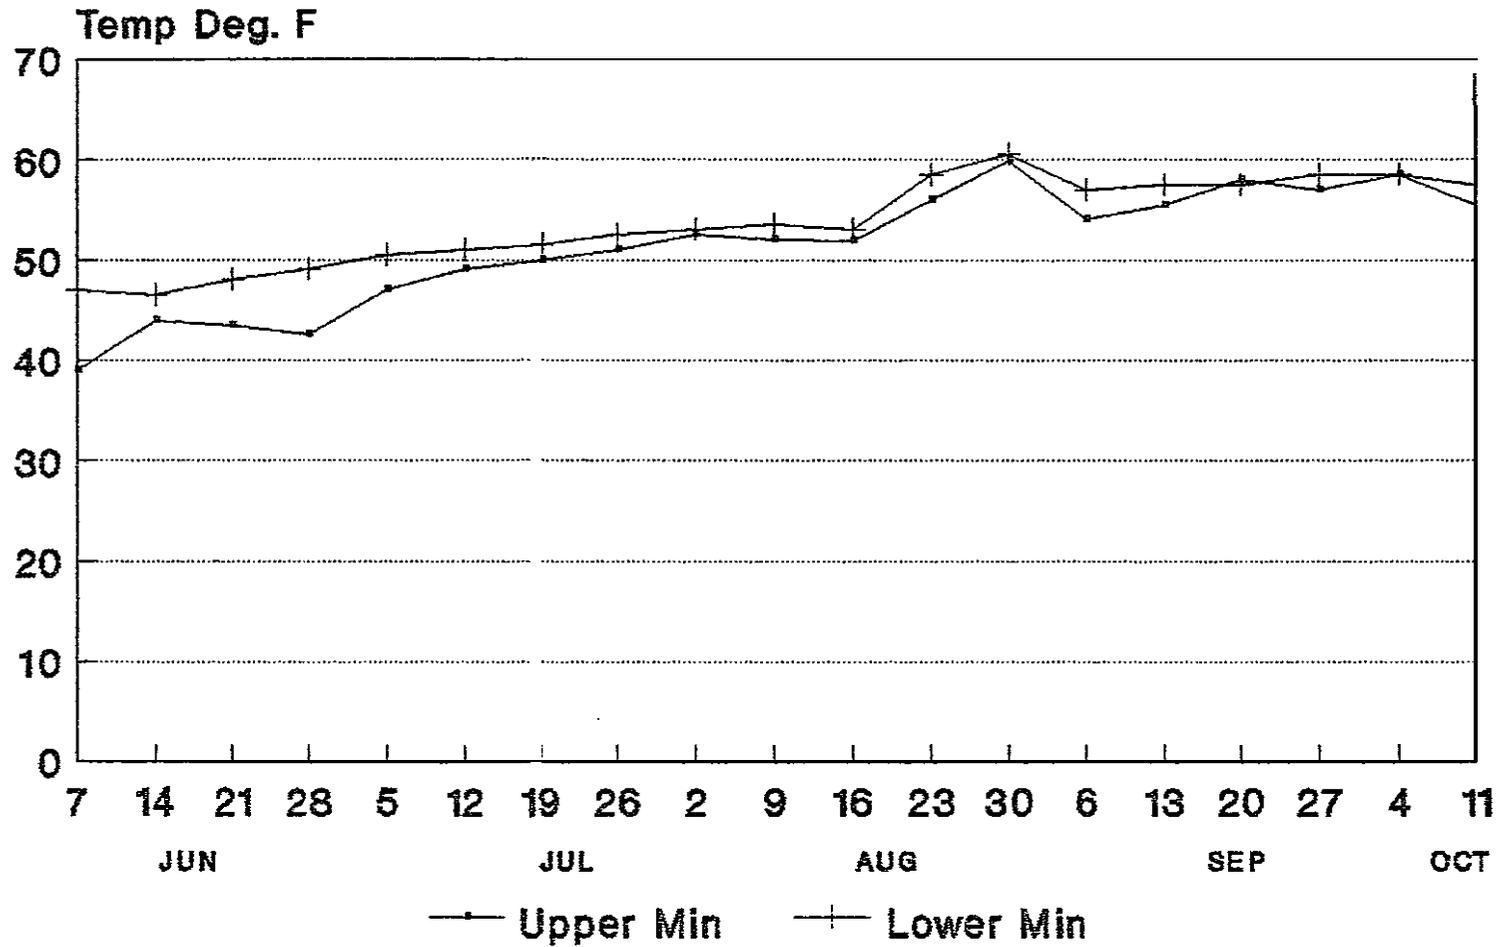
Mean Weekly Minimum Temperatures

COTTONWOOD CREEK

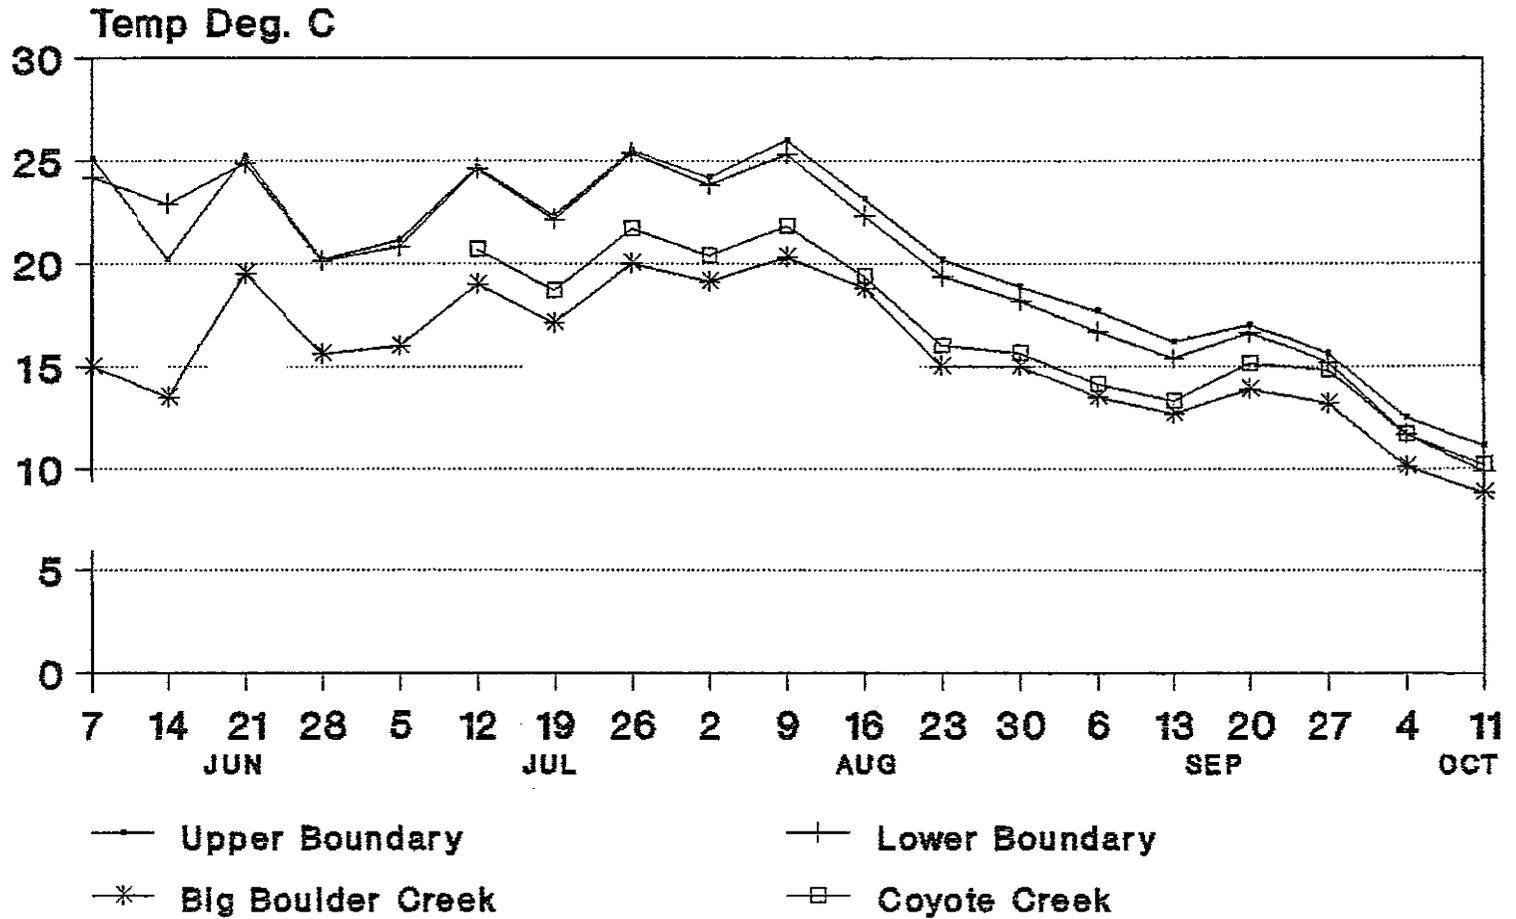
Mean Weekly Maximum Temperatures

MIDDLE FORK JOHN DAY RIVER - TNC PROPERTY

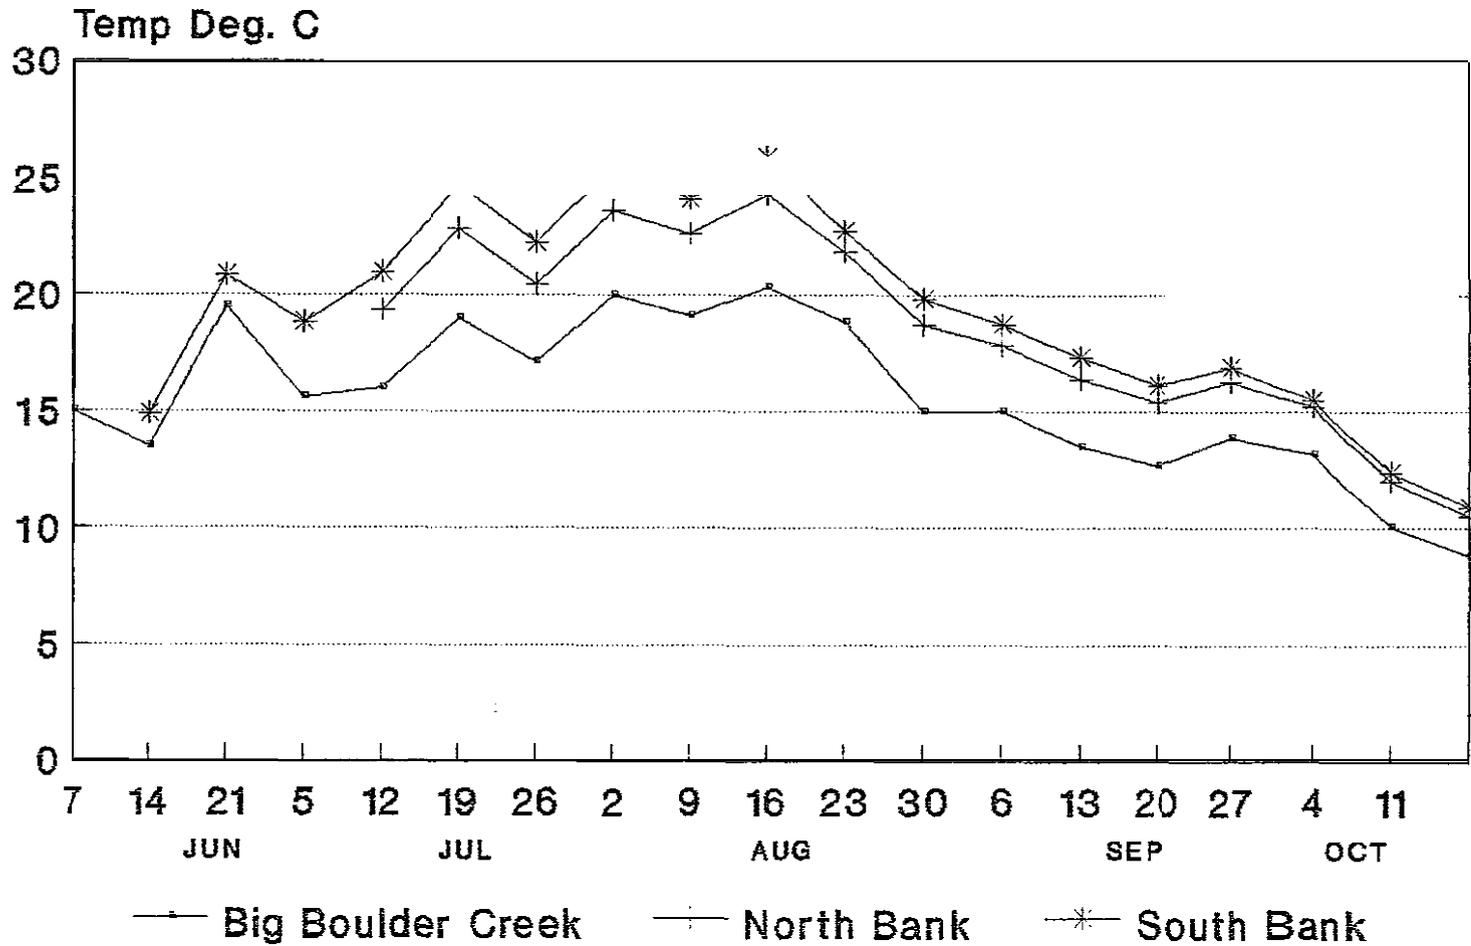
Mean Weekly Maximum Temperatures

MIDDLE FORK JOHN DAY RIVER - TNC PROPERTY
