FIFTEENMILE BASIN HABITAT IMPROVEMENT PROJECT

Annual Report FY 1990

Project Number 86-79
Contract Number DE-AI79-87BP37379

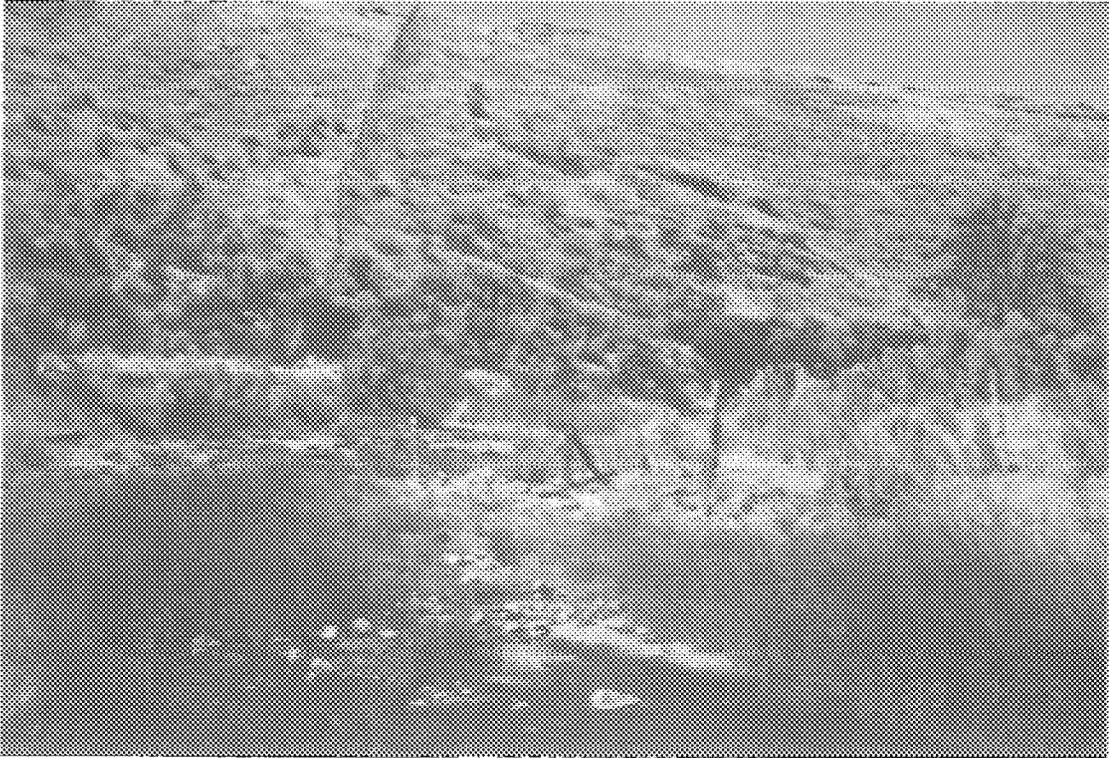
Appendix D-2

Bolton property after one year of protection

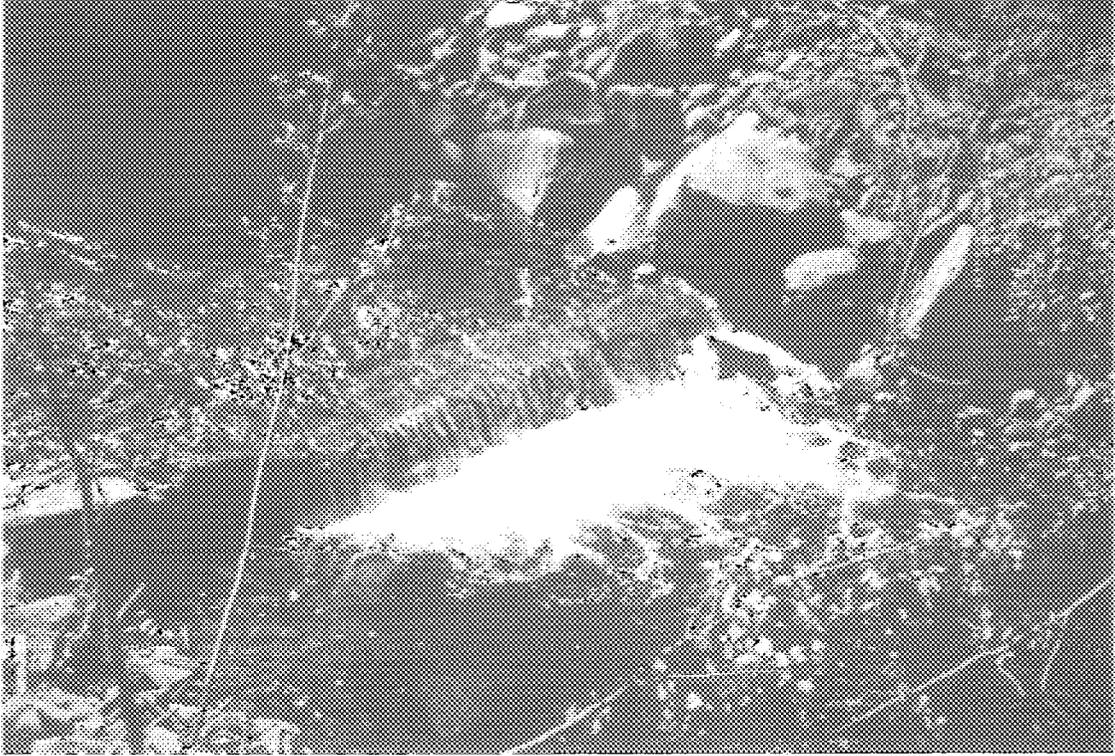
Appendix D-6

Rock weir designed to create a pool downstream and recruit gravel upstream

Installation of rock structures was similar to that of log structures except that rock in the proper gradation was used to fill the toe trench. A toe trench was dug into the stream bed and into the stream bank. The depth of the trench was approximately two feet and was keyed into the stream bank, a length equivalent to one third of the stream width. The toe trench was filled with 50 to 100 yd³ of rock, and then covered with soil and gravel removed from the toe trench. The bank directly upstream and downstream of the structure was rip-rapped with approximately 10-20 cubic yards of rock to prevent the stream from cutting behind the structure. The rip-rap installed around the weir provides the added benefit of providing winter habitat for rearing juveniles (Gebhart Pers. Comm. 1988).

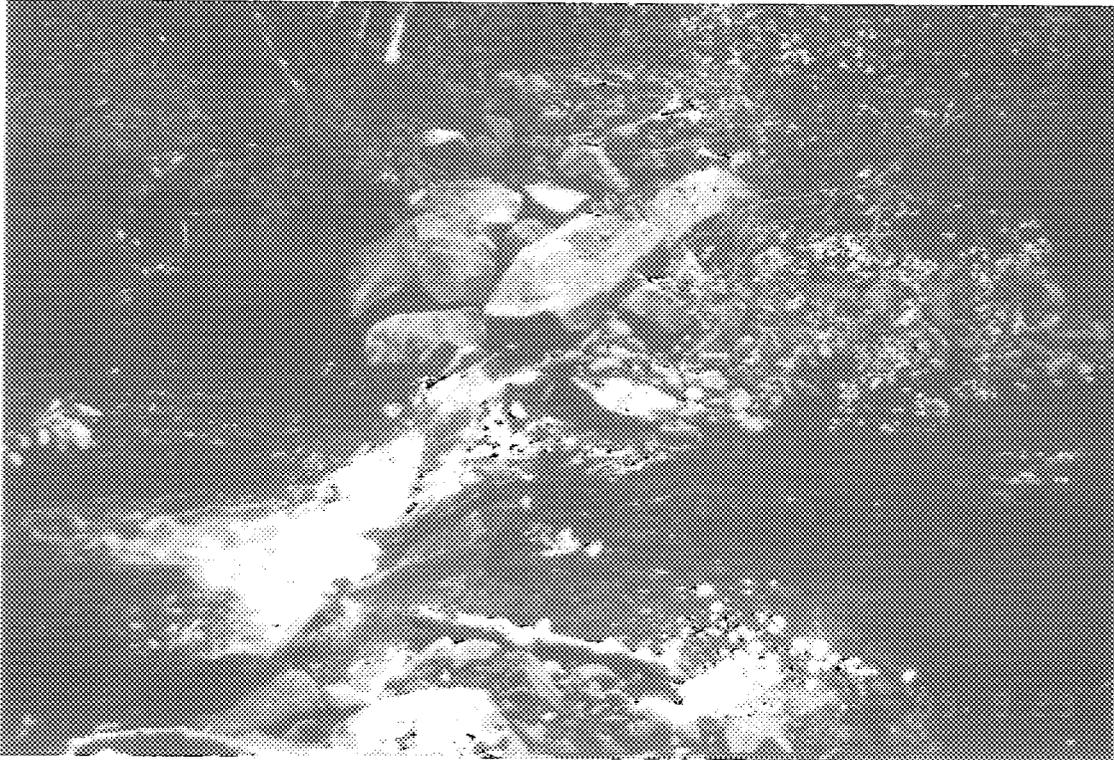
Appendix D-7

Rock weir demonstrating size and type of aggregate
Columnar basalt acquired within Dufur Valley was primary rock type

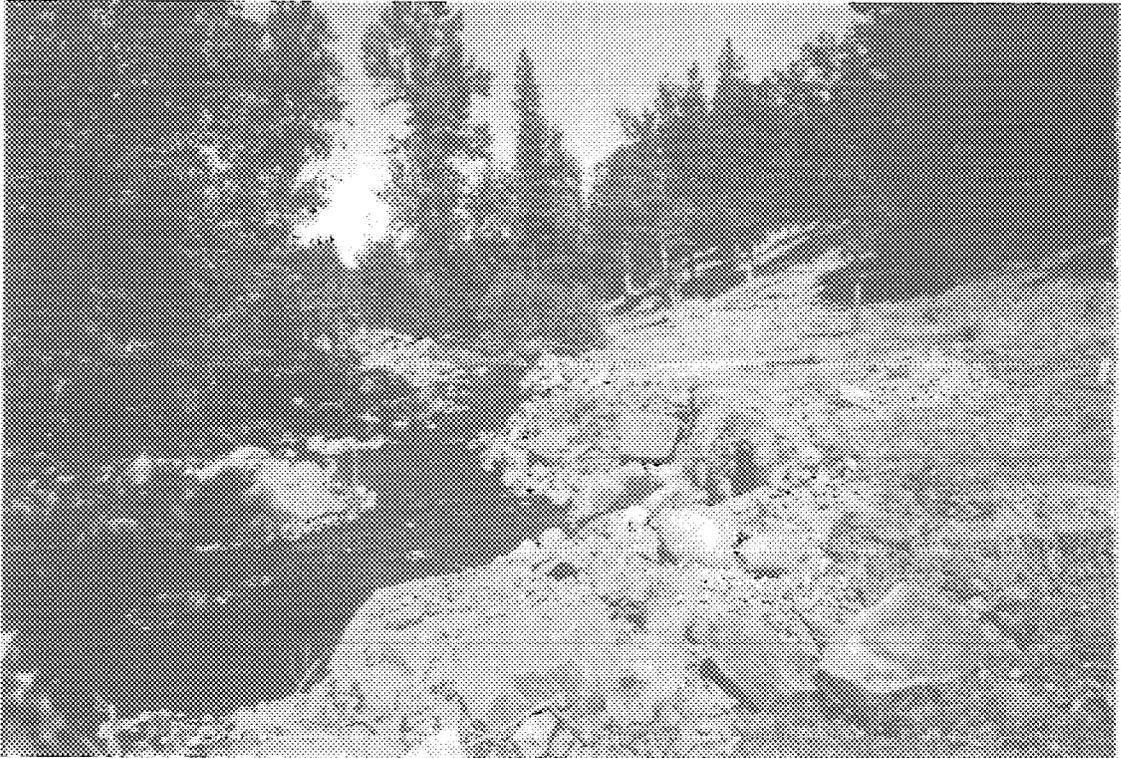
Appendix D-9

Rock jetty designed to create pools as well as protect stream bank.
