Kalispel Resident Fish Project

Annual Report
2002

KALISPEL RESIDENT FISH PROJECT

ANNUAL REPORT

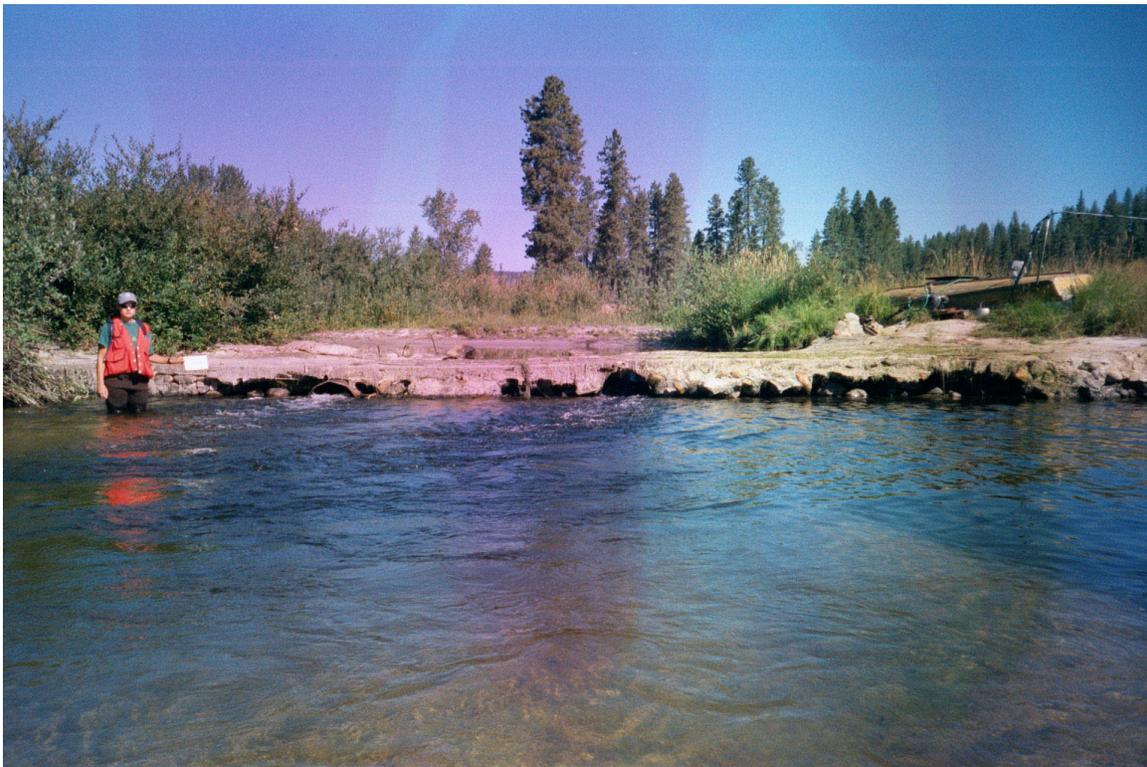
Figure 4. Concrete road crossing with 2 culverts in reach 2 of Tacoma Creek.

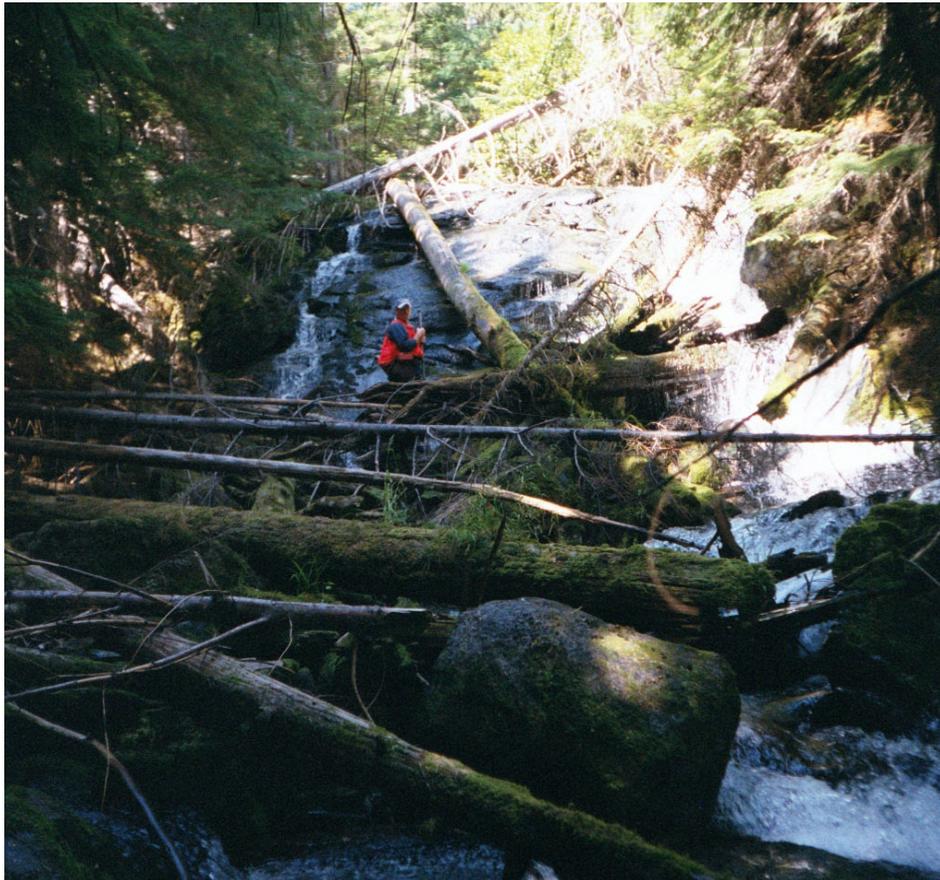
Figure 6. Fish passage barrier located in reach 16 of Tacoma Creek. Barrier isolates native cutthroat trout above.

Reach 16 was a B3 type channel and was 1500 m in length. A fish passage barrier was observed which precluded upstream passage of non-native fish (Figure 6). The LWD density (51.5 pieces/100 m) and primary pool frequency (6.0 pools/Km) were relatively high. However, substrate embeddedness was high for a channel with 3.3% gradient. Spawning gravel was abundant in reach 16; 31.0 m² of gravel was classified as spawning habitat. The population of cutthroat trout upstream of the barrier is isolated from downstream populations of fish. Therefore, cutthroat trout were the only fish species observed; density was 6.0 fish/100 m².

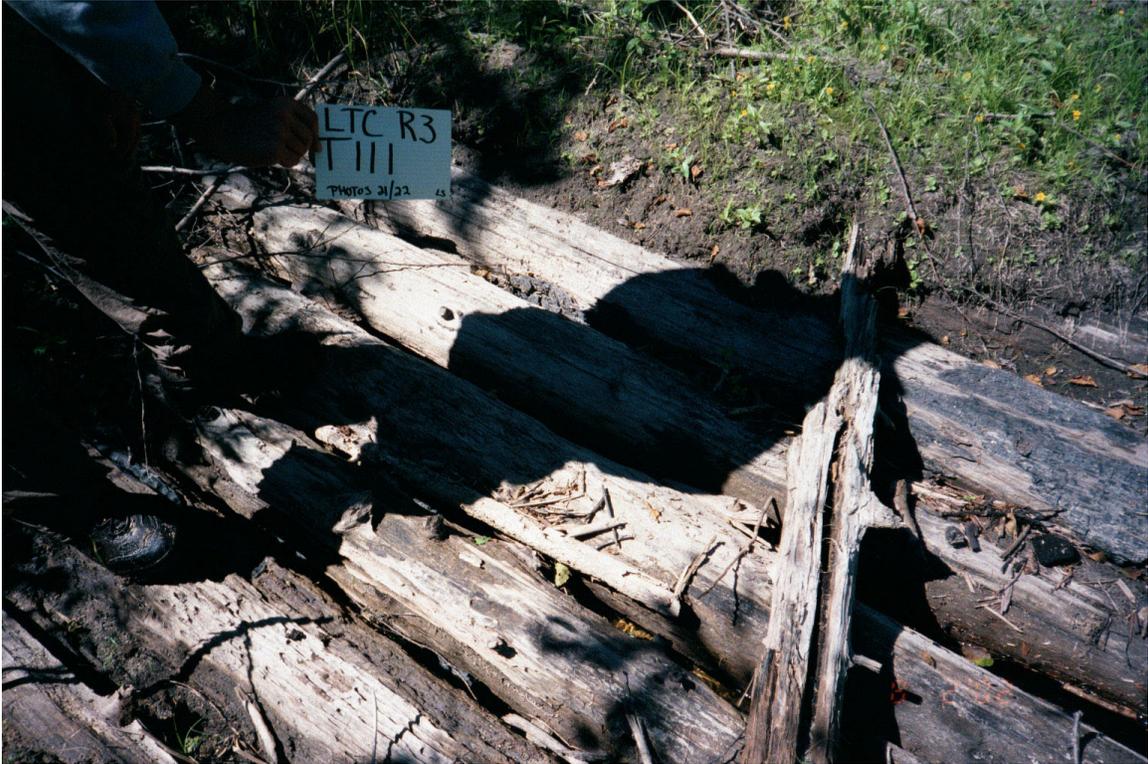
Figure 21. Old corduroy road that existed over the channel through much of Little Tacoma Creek.

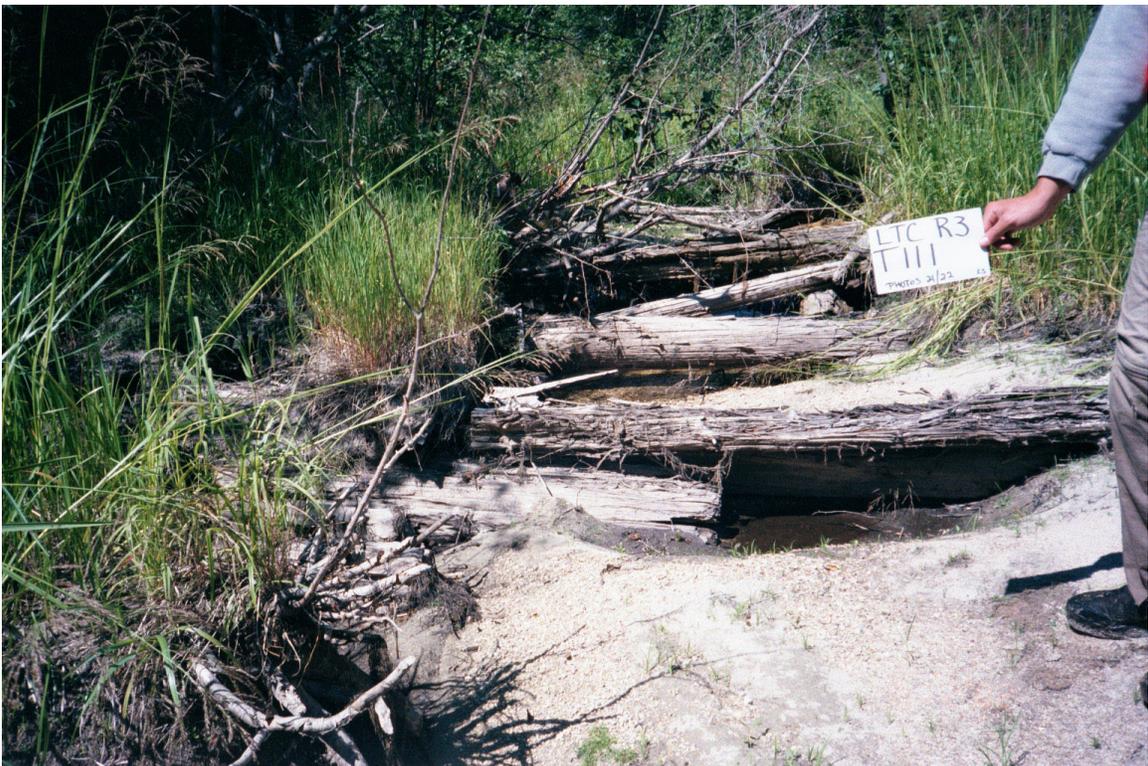
Figure 22. Remnants of the old corduroy road running over the channel.

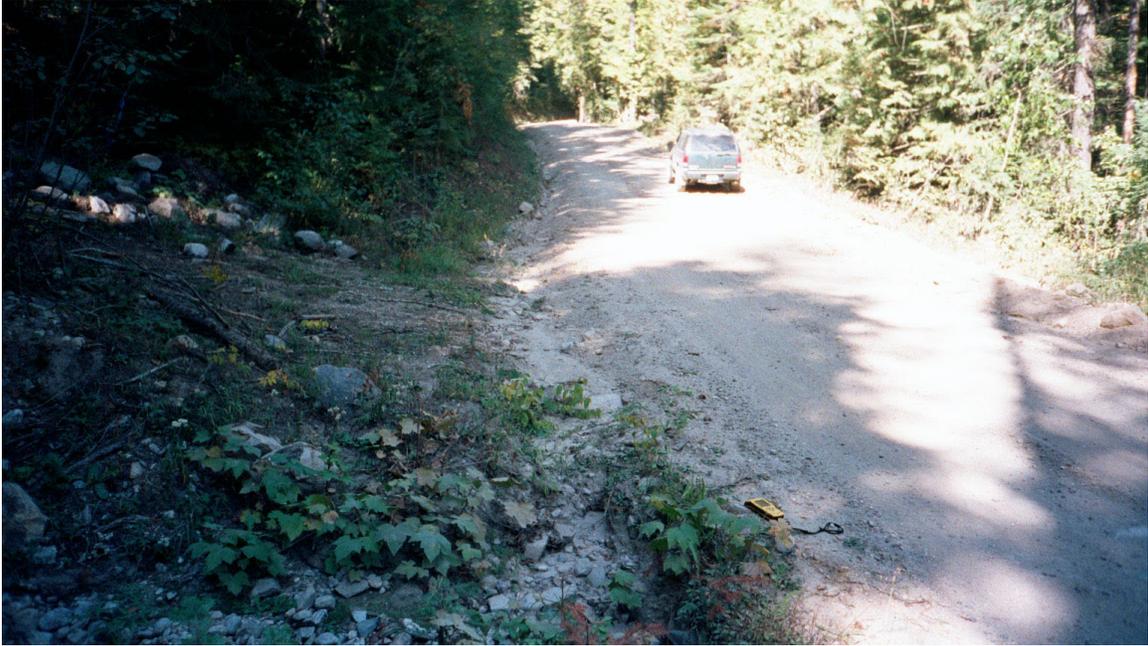
Figure 24. Sediment laden runoff diverted to an intermittent gully.

Habitat restoration in Tacoma Creek and its tributaries should be focused on a reduction of in-channel fine sediment. Over-winter habitat (i.e. primary pools) and spawning habitat appeared to be the primary limiting factors. The components for these types of habitats were present (e.g. high density of LWD, gravels); however, they were rendered functionless due to the high levels of sediment.

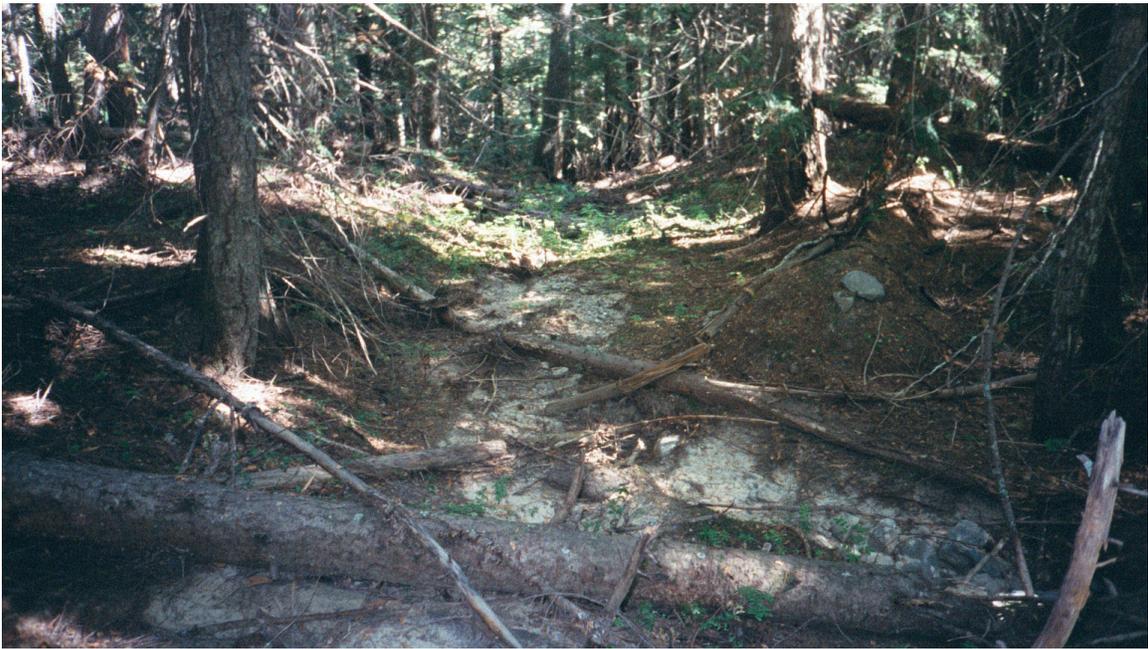
Figure 26. Sediment was transported through gullies and deposited behind LWD.

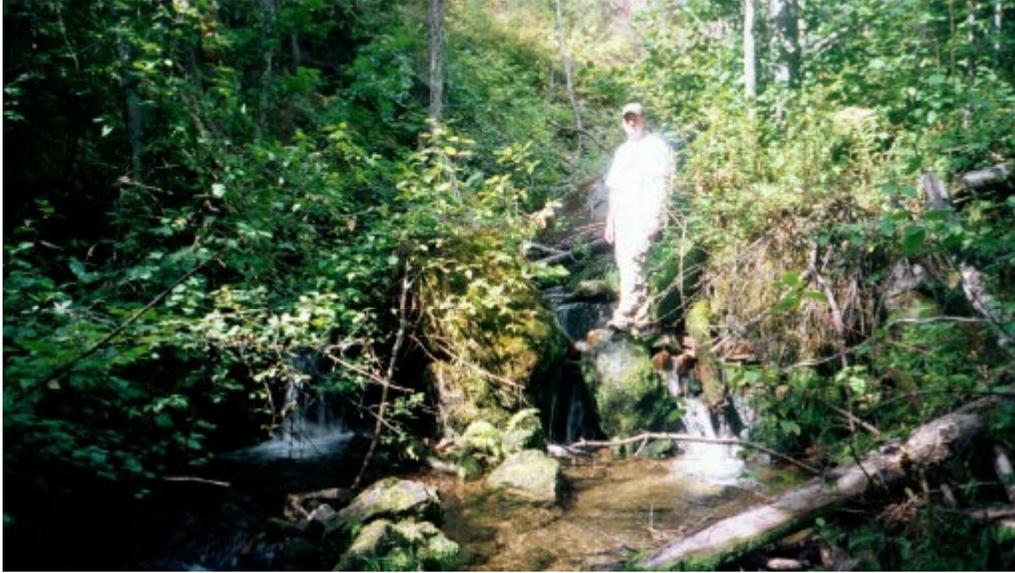
Figure 57. Fish passage barrier where brook trout removal started.

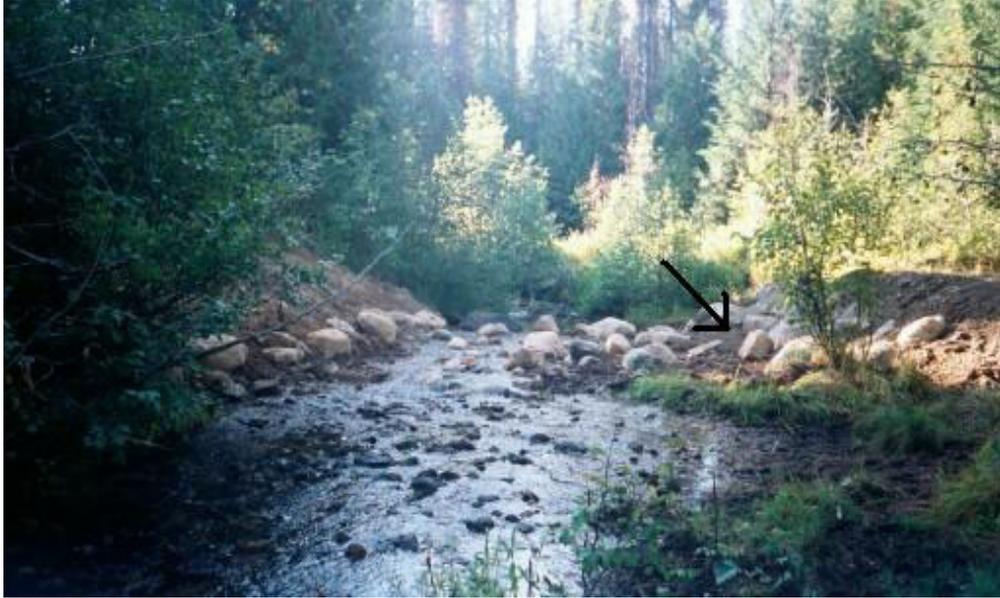
Figure 58. Downstream view of culvert removal project. Arrow indicates likely bankfull point if boulders were not relocated.

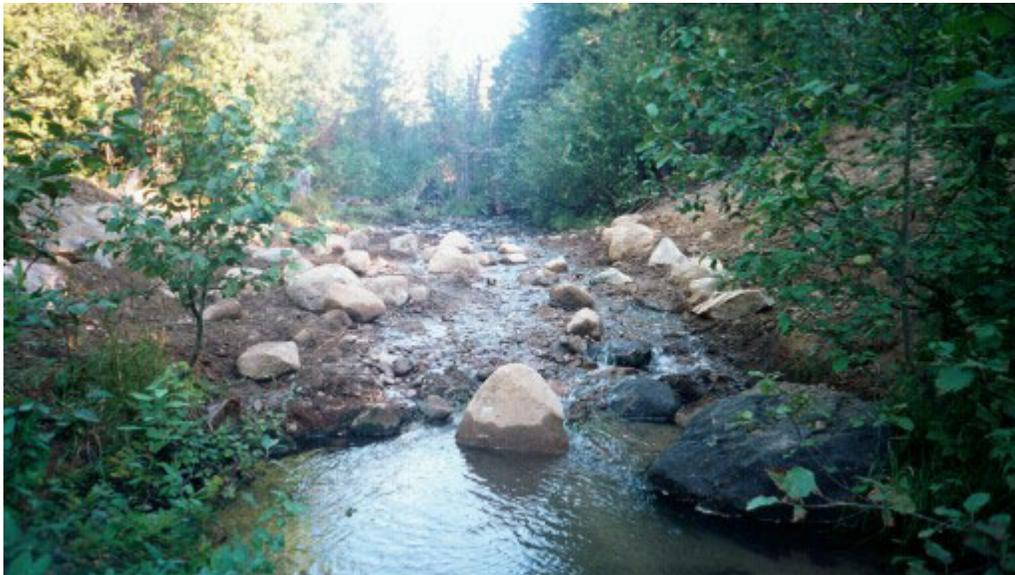
Figure 59. Upstream view of culvert removal site.

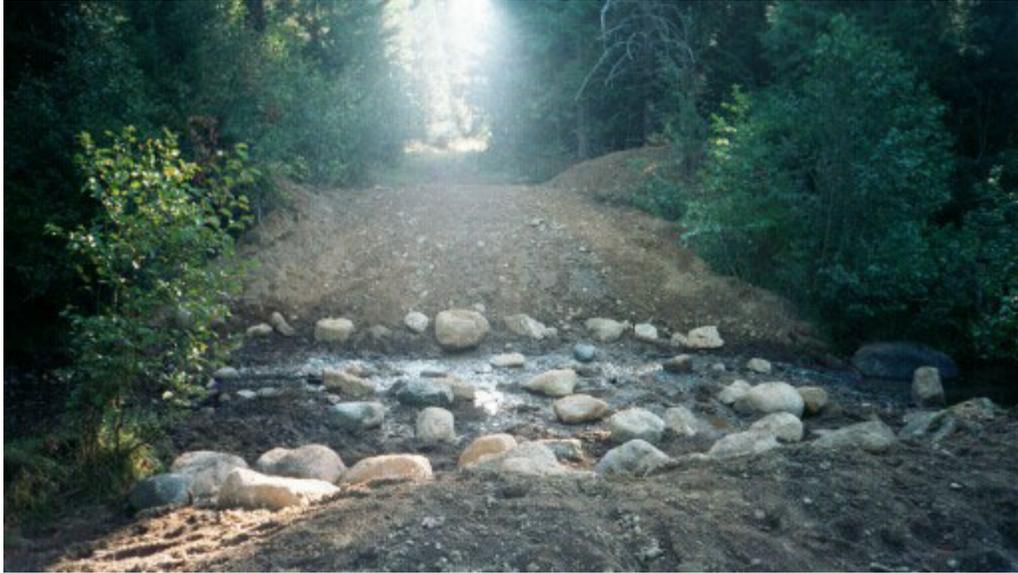
Figure 60. Banks prior to placement of debris fence and alder plantings.
