New Concepts in Fish Ladder Design: Analysis of Barriers to Upstream Fish Migration, Volume IV of IV

Investigation of the Physical and Biological Conditions Affecting Fish Passage Success at Culverts and Waterfalls

DOE/BP-36523-1

August 1985

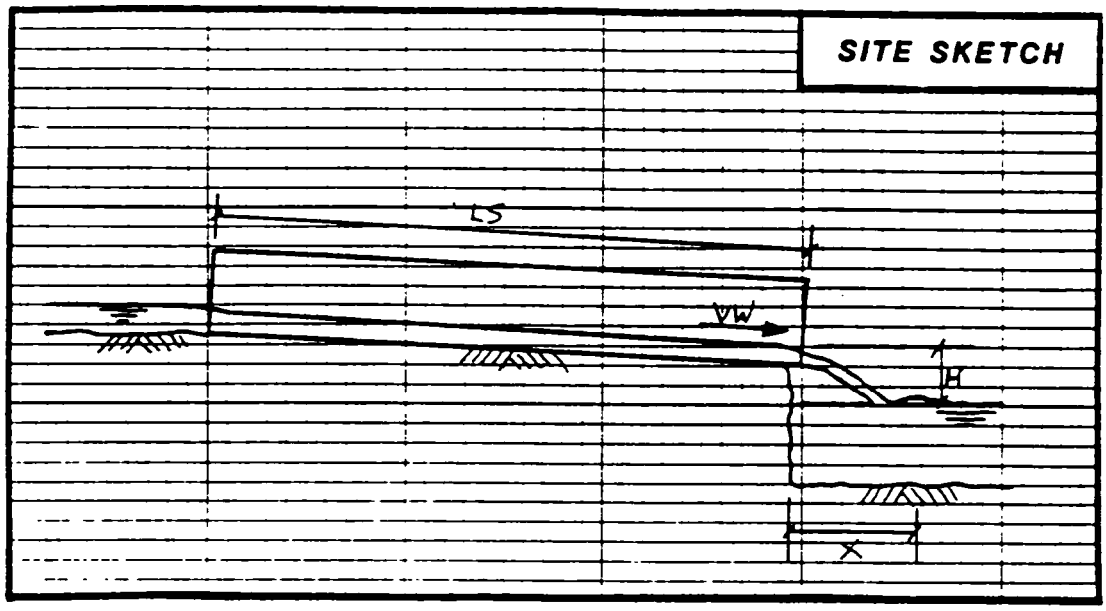
SITE: Red Cabin Creek Culvert DATE: 12/8/84

CLASS: Compound (chute/fall)

TYPE: II C 1
