March 1994

EVALUATION OF JUVENILE FISH BYPASS AND ADULT FISH PASSAGE FACILITIES AT WATER DIVERSIONS IN THE UMATILLA RIVER

Annual Report 1993

Project No. 89-024-01
Contract No. 89-BI-01385

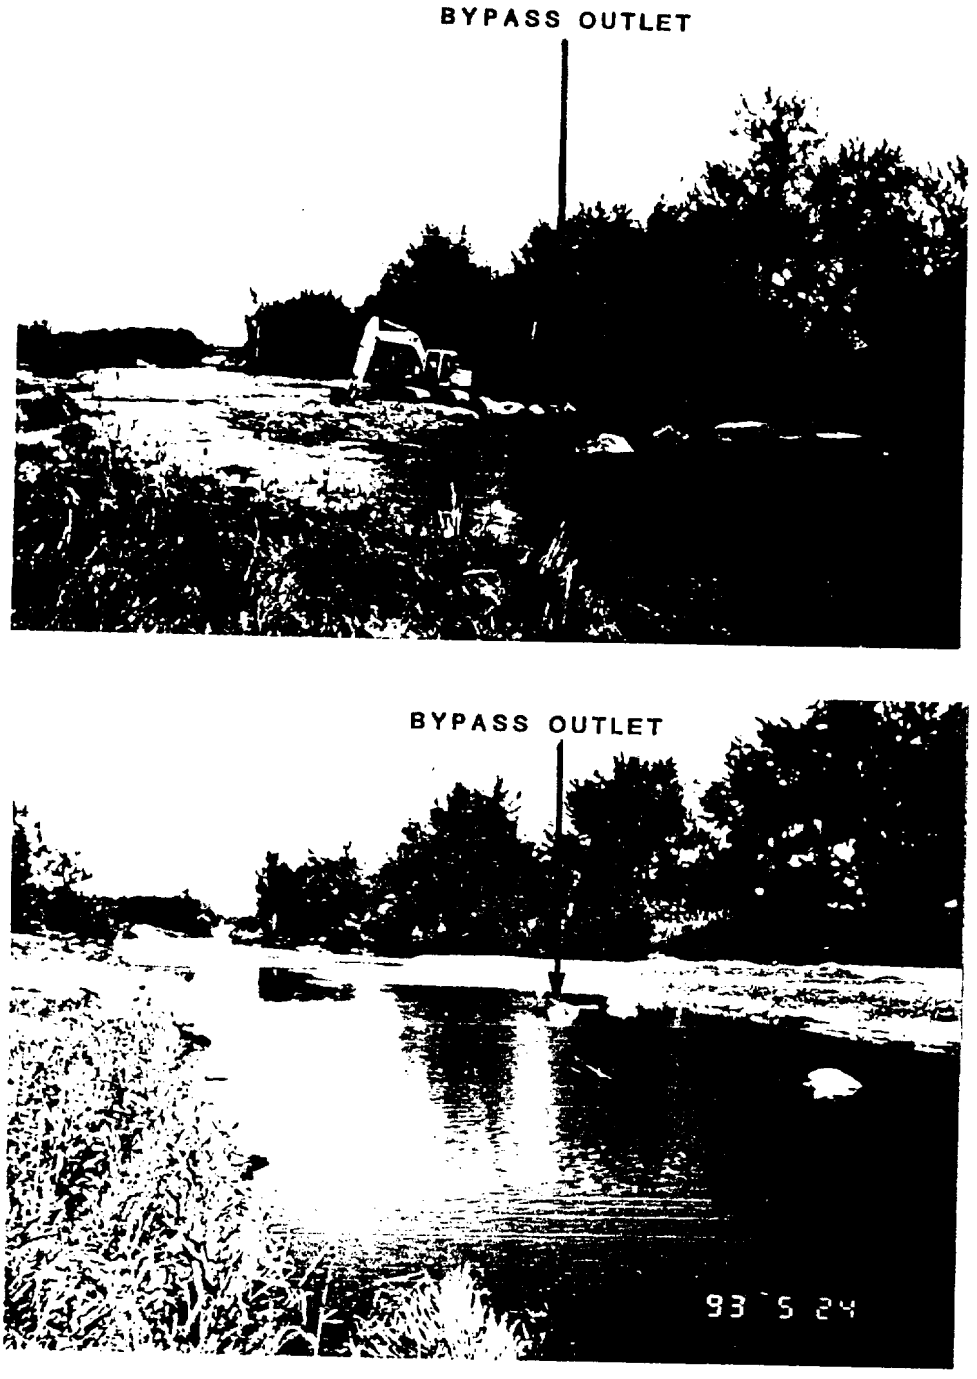
Several attempts were made to keep the bypass clear of gravel. Instream structures were installed on 20 April 1993 in an attempt to make the bypass outlet self-scouring. The structures consisted of two rows of boulders (approximately 1 cubic yard each) placed at an approximately 45 degree angle to river flow in front of the bypass outlet (Figure 9). The boulder configuration failed when a major flood in early May caused substantial bedload movement, channel changes (Figures 9 and lo), and the disappearance of some of the boulders. The main river channel shifted from the right to left bank as a result of. the flood event.

Figure 9. River channel characteristics near the bypass outlet at the Westland Canal juvenile fish bypass facility before (top: 4/20/93) and after (bottom: 5/24/93) a major flood event in early May, Westland Dam, Umatilla River, spring 1993. Photos were taken approximately 50 yards south of the bypass outlet.

Revision of facility operating criteria was another measure taken this year to deter gravel deposition at the bypass outlet. Revising normal operating criteria from a bypass flow of 10 cfs to maximum bypass flow (approximately 26 cfs).was not effective at preventing gravel deposition at the outlet. The decision to shorten the bypass pipe to the current shoreline will improve access to the outlet for gravel removal operations.

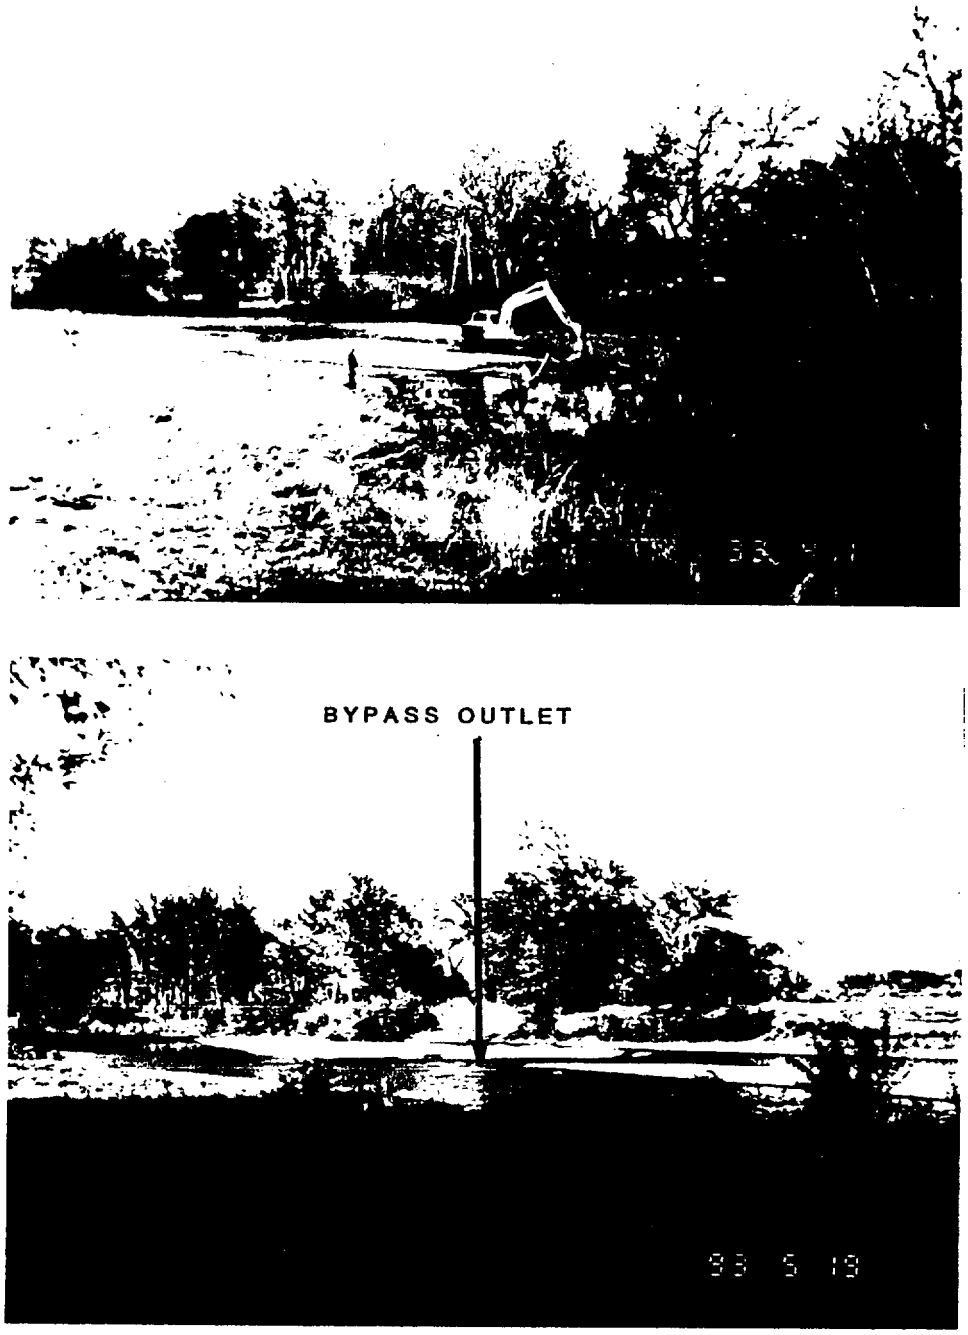
Figure 10. River channel characteristics near the bypass outlet at the Westland Canal juvenile fish bypass facility before (top: 4/14/93) and after (bottom: 5/19/93) a major flood event in early May, Westland Dam, Umatilla River, spring 1993. Photos were taken approximately 30 yards south-west of the bypass outlet (located directed under the backhoe's lifting bucket).
