**WASHINGTON PHASE II FISH  
DIVERSION SCREEN EVALUATIONS IN  
THE YAKIMA RIVER BASIN, 1998**

Annual Report 1998

DOE/BP-62611-15

# **Washington Phase II Fish Diversion Screen Evaluations in the Yakima River Basin, 1998**

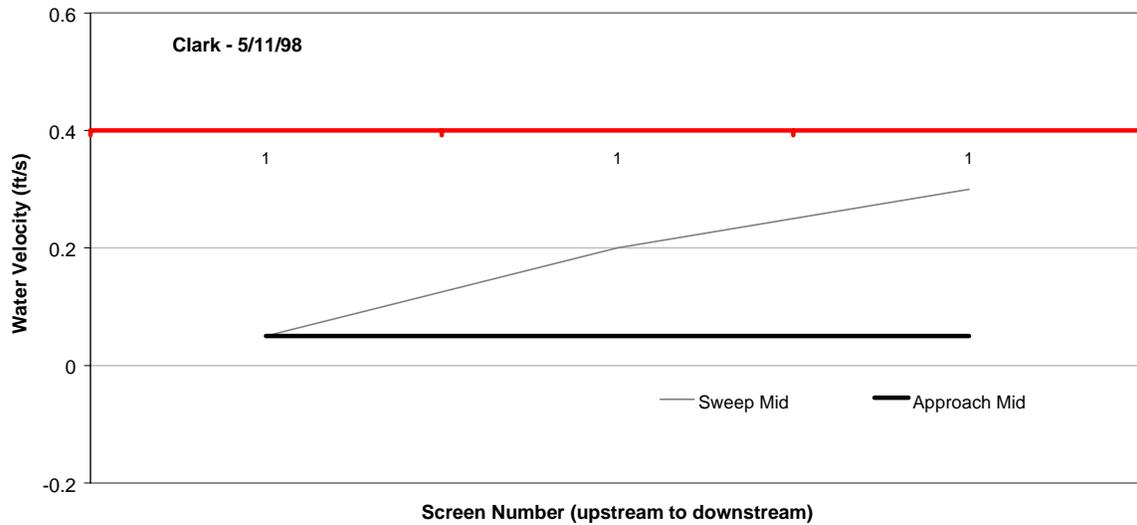
Figure 9. Water velocities at Clark, 5/11/98.

Half of all approach velocity measurements recorded in 1998 were between 0 and 0.4 fps. The remaining 50% of the recorded approach velocities were negative values. Sweep velocities were extremely slow, but were consistently greater than approach velocities and increased toward the bypass (Figure 9 and Figure 10). Approach velocities were all negative in June (Figure 10).

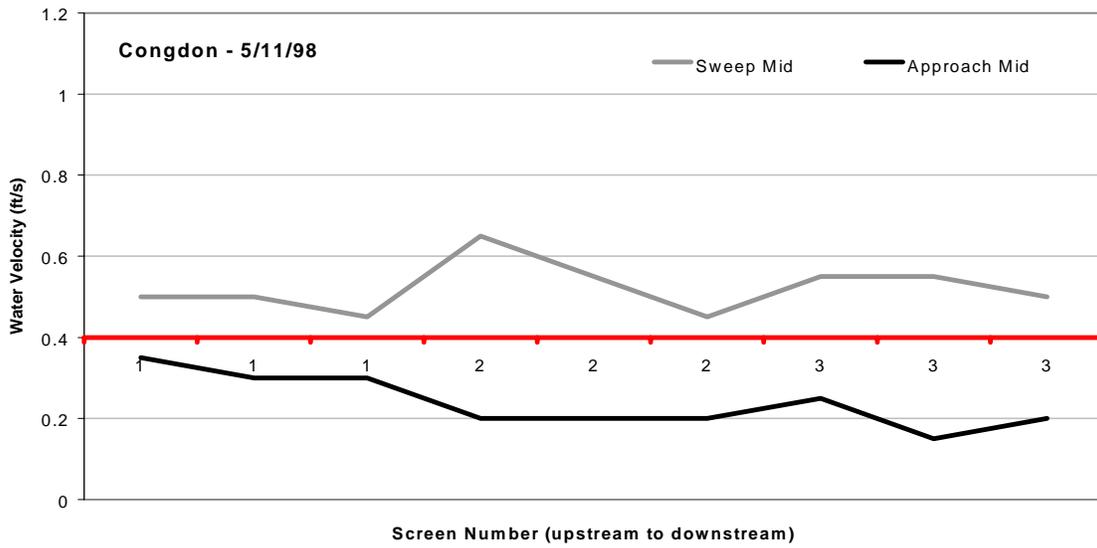
Figure 11. Water velocities at Congdon, 5/11/98.

Ninety-six percent of the recorded approach velocities met NMFS criteria at the Congdon site. The remaining 4% of the recorded velocities were greater than 0.4 fps. In general, sweep velocities were greater than approach velocities and increased near the bypass (Figure 11, Figure 12, and Figure 13). The only places sweep velocities were less than approach velocities or where approach velocities exceeded criteria were in front of Screen 1 (furthest upstream) in July and September.

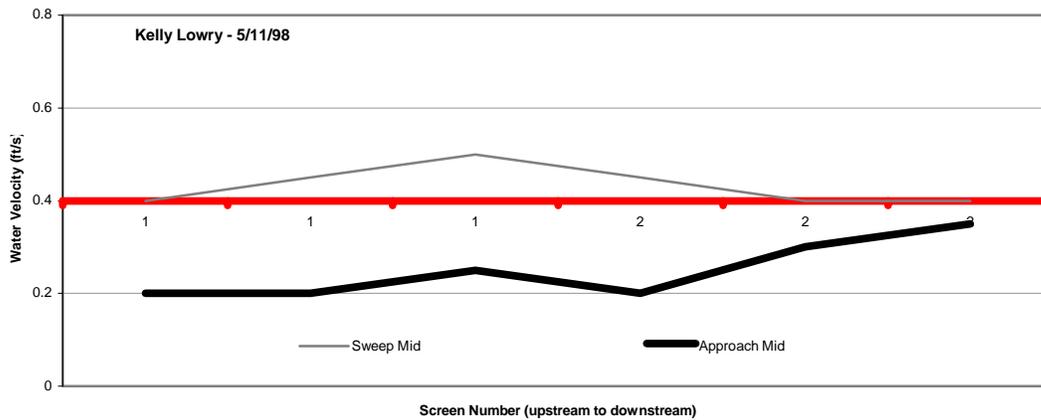
Figure 14. Water velocities at Kelly Lowry, 5/11/98.

Fully 100% of the approach velocities recorded at this site met NMFS criteria (Figure 14, Figure 15, and Figure 16). Sweep velocities always exceeded approach velocities, but sometimes decreased near the bypass instead of increasing. Bypass flows were generally within criteria (i.e., they exceeded sweep velocities), but in May, bypass flow was slightly lower than the average sweep velocity (0.35 fps compared to 0.45 fps). Screen submergence levels met NMFS criteria at 65, 80, and 77%.

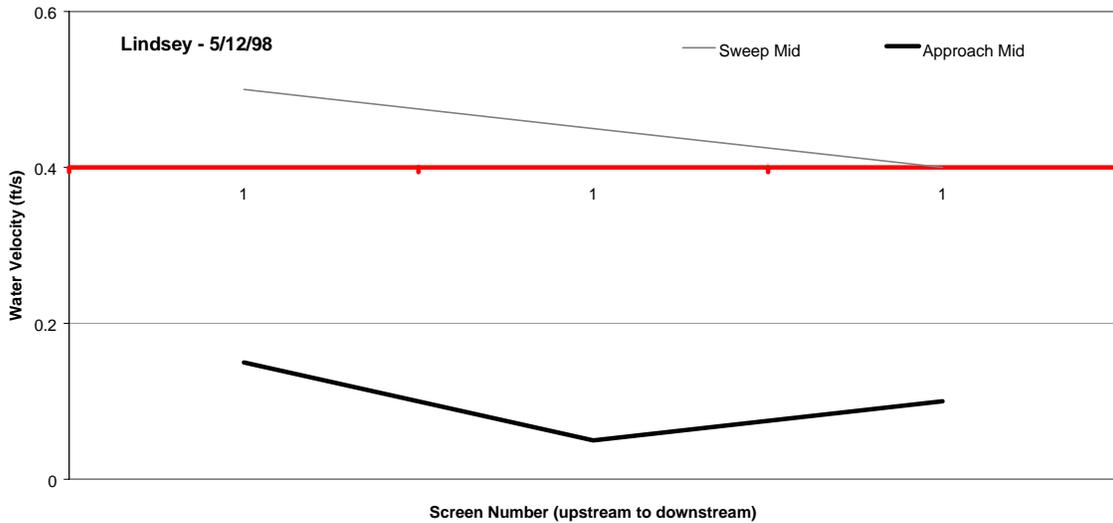
Figure 18. Water velocities at Lindsey, 5/12/98.

All recorded approach velocities at this site met NMFS criteria. Sweep velocities were consistently greater than approach velocities, but did not always increase near the bypass (Figure 18, Figure 19, and Figure 20). Screen submergence levels were always slightly high at 88, 90, and 86.1%.

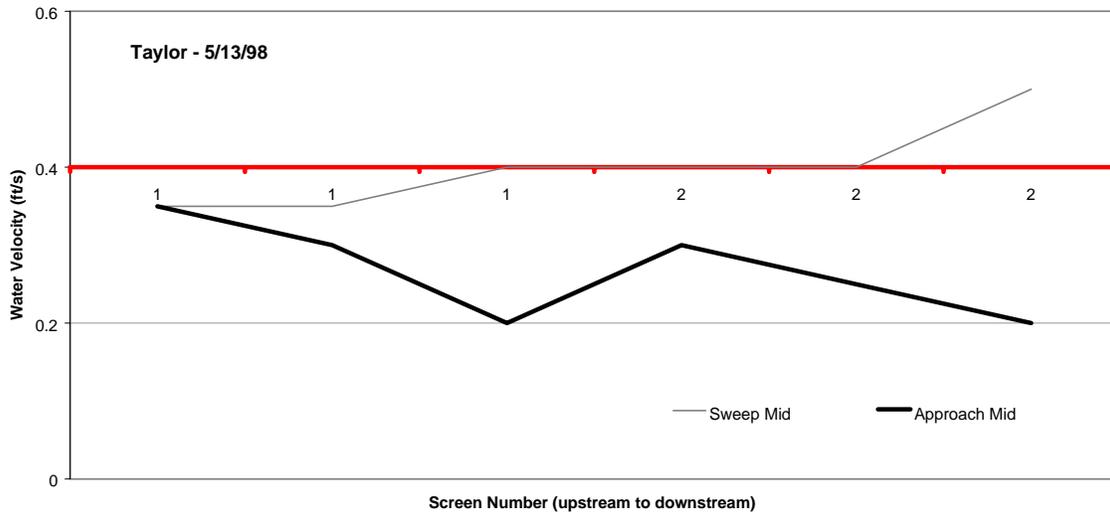
Figure 30. Water velocity at Taylor, 5/13/98.

All approach velocities recorded in May met NMFS criteria. Sweep velocities were greater than the corresponding approach velocities and sweep velocities, increased toward the

bypass (Figure 30). Screen submergence was very high (95%) in May but was only 45% in September.

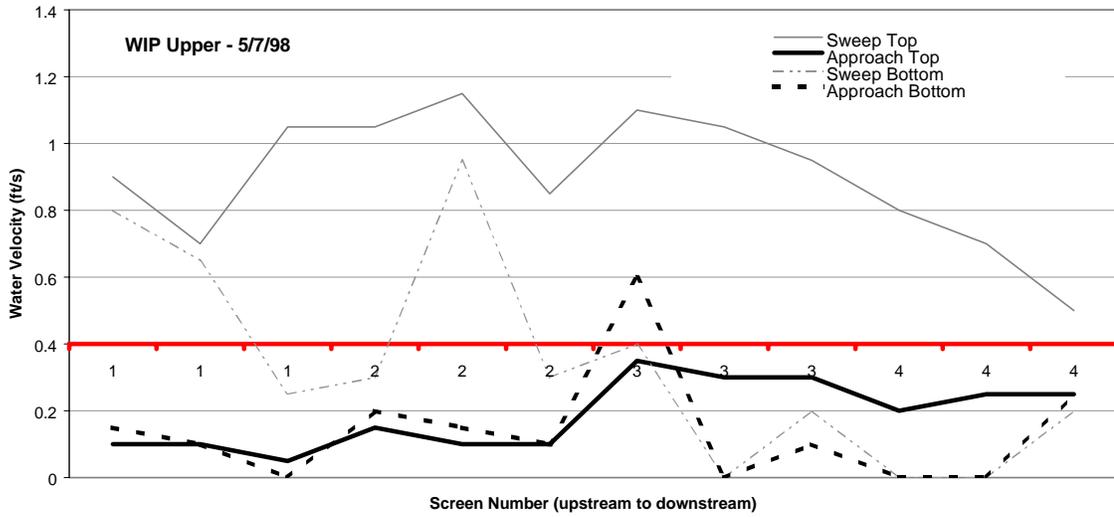
Figure 33. Water velocities at the WIP upper site, 5/7/98.

Eighty-five percent of the recorded approach velocities met NMFS criteria. Six percent were zero velocities, and the remaining 9% were greater than 0.4 fps (Figure 33, Figure 34, and Figure 35). Approach velocities exceeded bottom sweep velocities measured in May in front of

Screens 3 and 4 (those closest to the bypass). In all other cases, sweep velocities were greater than approach velocities, though they did not generally increase near the bypass in May and September. Screen submergence levels were 84, 81.3, and 88.5%.

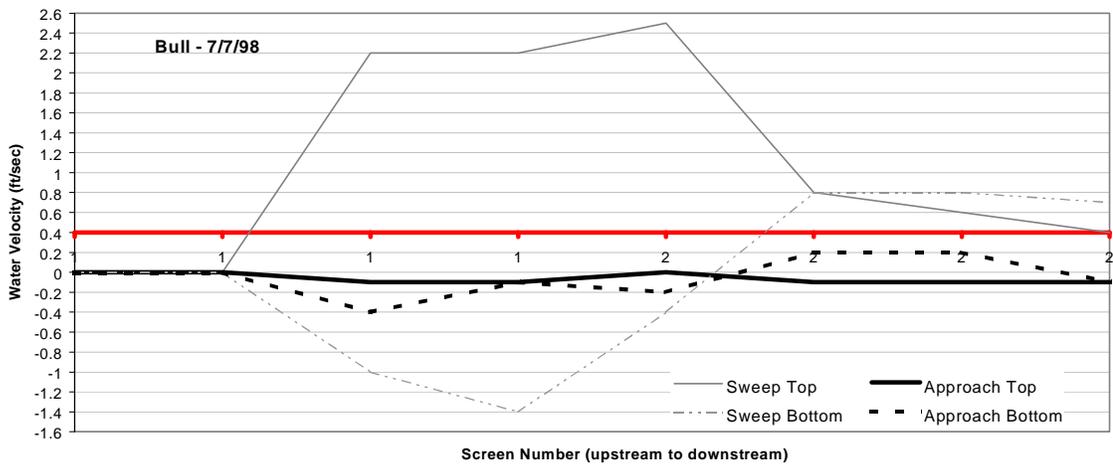
Figure 37. Water velocities at Bull, 7/7/98.

On 7/7/98, 3% of the recorded approach velocities exceeded 0.4 fps. Forty-four percent were between 0 and 0.4 fps, 15% were 0 fps, and 38% were negative values (Figure 37 and Figure 38). Surface sweep velocities were consistently greater than bottom sweep velocities.

Overall, sweep was slow and bottom sweep values were often less than corresponding approach velocities. Water in front of the screens was always high and submergence values for the flat plate screen were approximately 100, 100, and 91.7%.

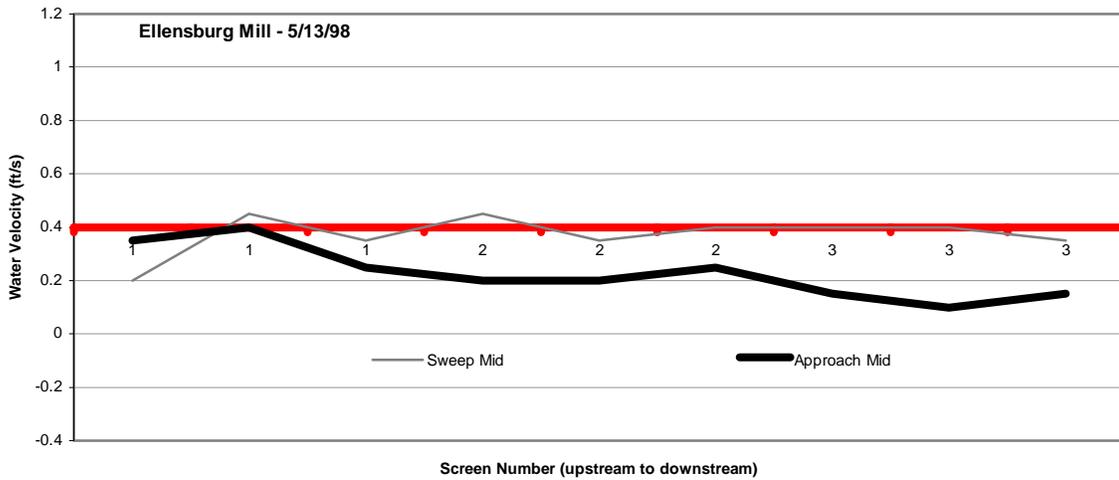
Figure 40. Water velocities at Ellensburg Mill, 5/13/98.

In May, approach velocities exceeded sweep at the very upstream end of the screen (Figure 40). The louvers behind the screen were wide open at that position, so closing them slightly would probably have alleviated the effect.

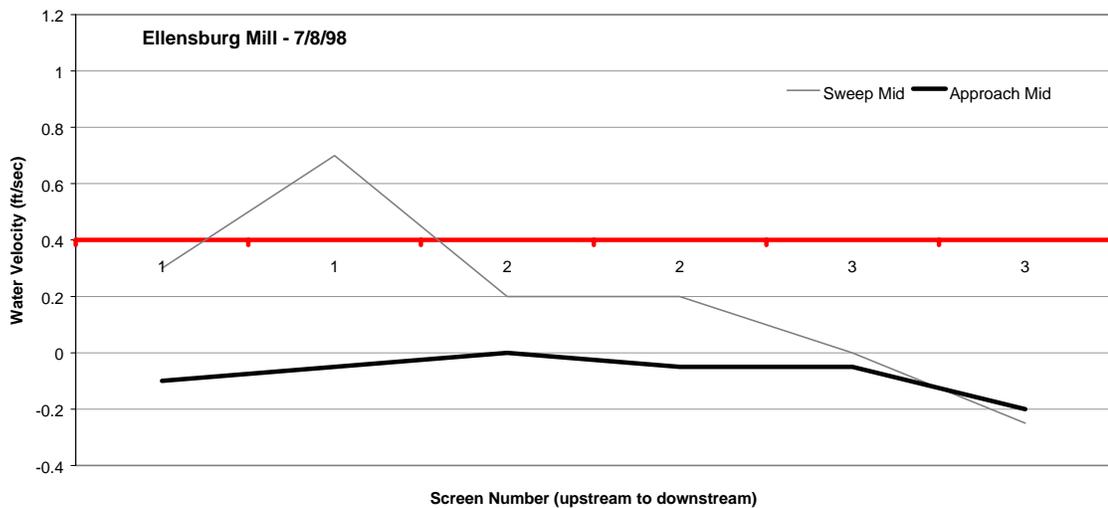
Figure 41. Water velocities at Ellensburg Mill, 7/8/98.

In most other cases, sweep velocities exceeded their corresponding approach velocities (Figure 41 and Figure 42). However, sweep did not generally increase near the bypass. Seventy-five percent of the recorded approach velocities were between 0 and 0.4 fps. Four percent were zero velocities and 21% were negative approach velocities. All the negative approaches were recorded in July. This flat plate screen does not appear to have any submergence problems as measured submergence values were only 68.1, 56.9, and 61.1% during the 1998 season.

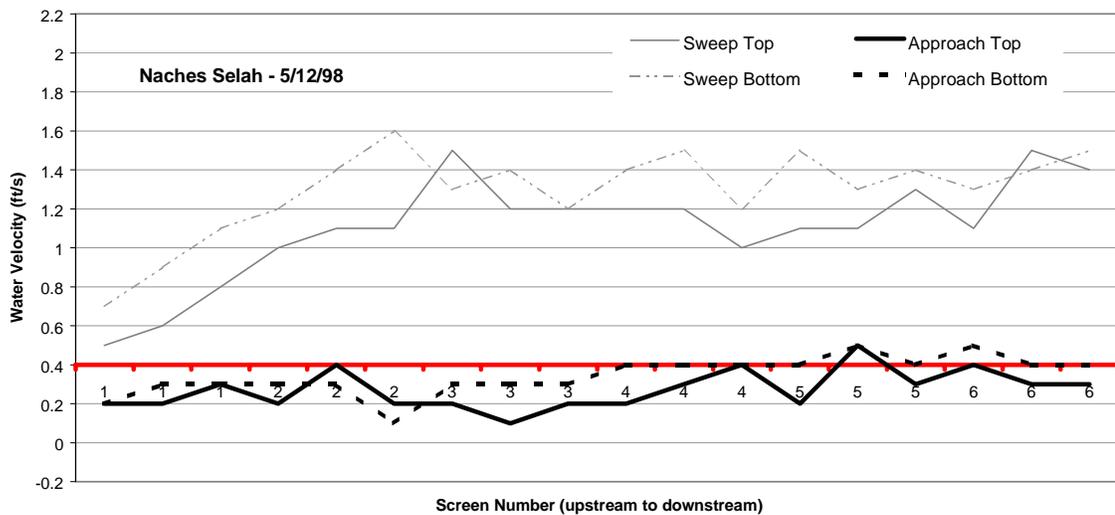
Figure 47. Water velocities at Naches Selah, 5/12/98.

Flows at Naches Selah were very good. Bypass velocities were always higher than the average sweep velocities (Figure 47, Figure 48, and Figure 49). Also, sweep velocities were always much greater than their corresponding approach velocities. Eighty-two percent of the approach velocities recorded at Naches Selah were between 0 and 0.4 fps. Only 3% exceeded 0.4 fps. Thirteen percent were zero velocities, and 2% were negative velocity values. Screen submergence values for this flat plate screen were approximately 86.8, 94.4, and 84.7%.

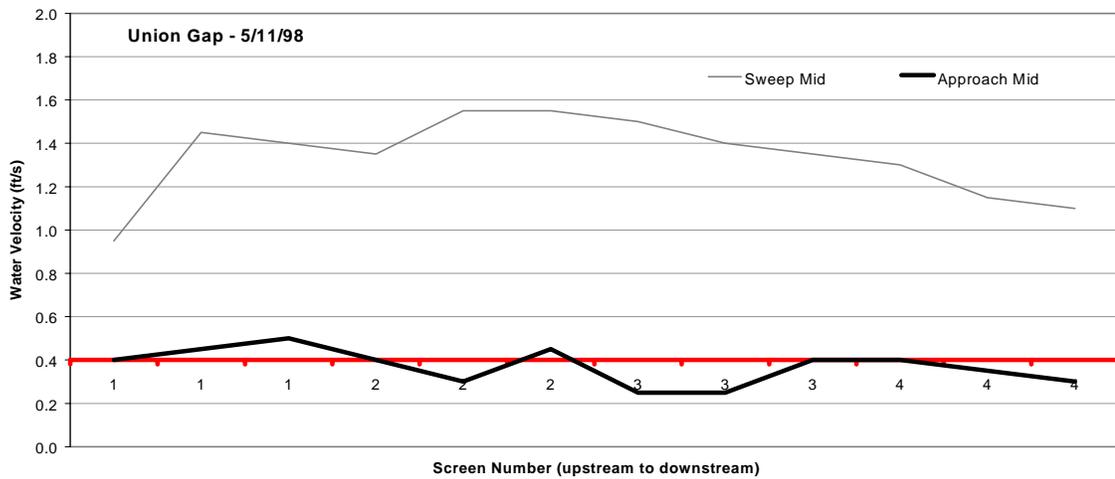
Figure 51. Water velocities at Union Gap, 5/11/98.

Eighty-seven percent of the recorded approach velocities were between 0 and 0.4 fps (Figure 51, Figure 52, and Figure 53). Eight percent of the approach velocity records were zero values, but only 5% were outside NMFS criteria and greater than 0.4 fps. Sweep velocities, while always greater than corresponding approach velocities, generally decreased toward the bypass and were much faster than the bypass velocities. Screen submergences at this flat plate site were 93.3, 93.3, and 90%.

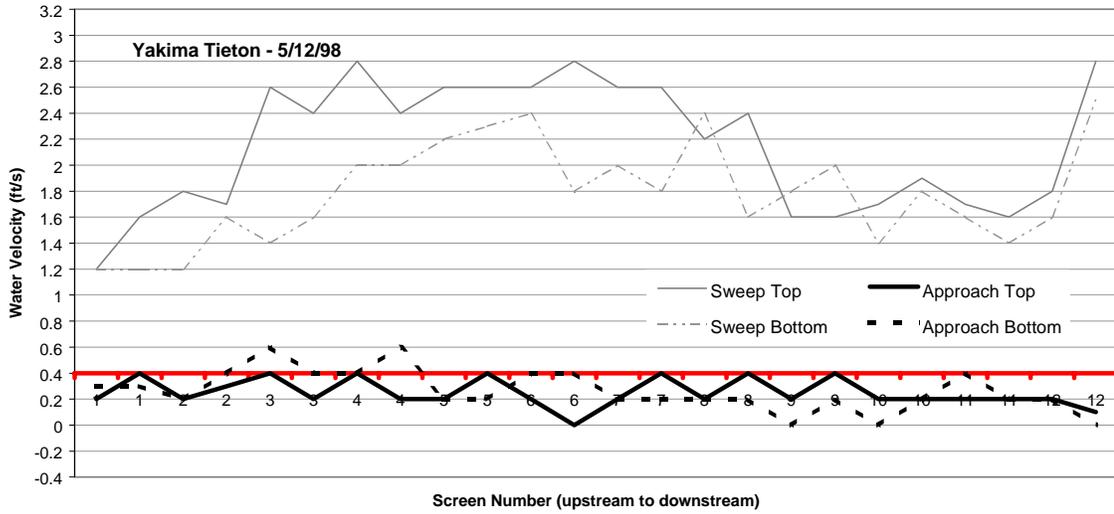
Figure 54. Water velocities at Yakima Tieton, 5/12/98.

Seventy percent of the recorded approach velocities were between 0 and 0.4 fps (Figure 54, Figure 55, and Figure 56). Twelve percent of the recorded velocities were zero, and 13% were negative values. Only 5% exceeded the NMFS limit of 0.4 fps. Most of the high approach velocities were recorded along the upstream half of the screen. There is a fast flow at this site, and sweep velocities were always much higher than their corresponding approach velocities. Sweep velocities did not increase toward the bypass, but sweep velocities were generally high

enough to mitigate this condition. Screen submergence at Yakima Tieton was approximately 83.3, 95.2, and 92.9%.
