1991 Annual Report

North Fork John Day Anadmmamus Fish Habitat Enhancement

Funded By:  
Bonneville Power Administration  
Division of Fish and Wildlife  
Contract No. DE-A179-84BP16725  
Project Number 84-8

January 1992

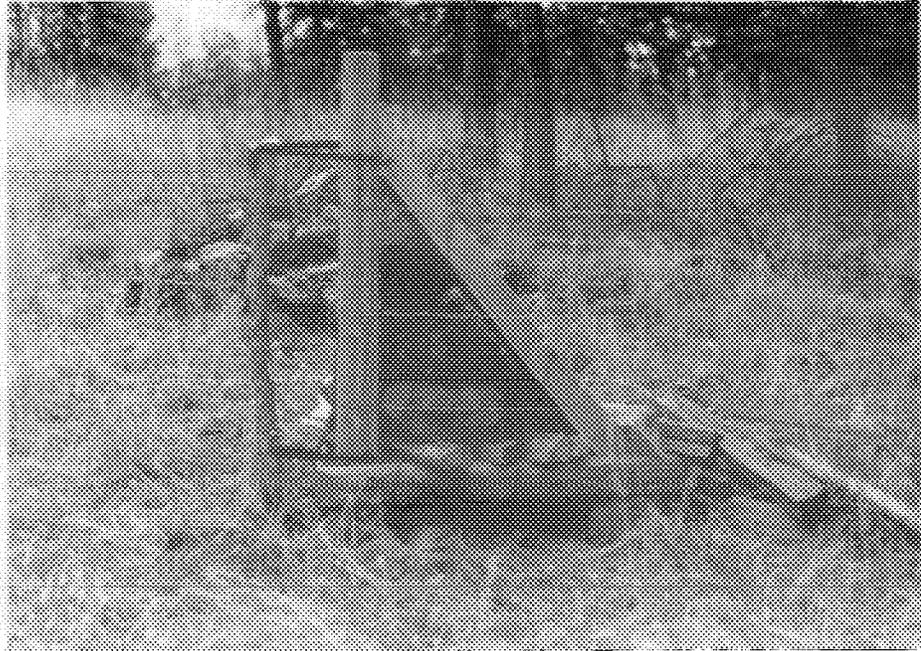
Riparian fence segment along Wilson Creek. This is an access gate and its corresponding rock anchor points.

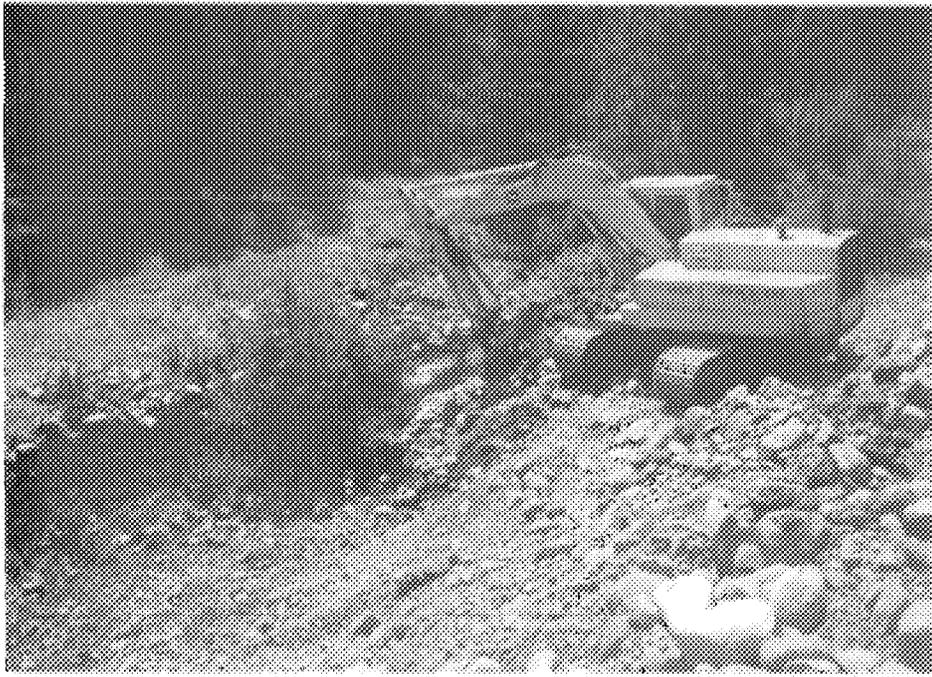
Completed weir with wings built onto it to keep pools dug during high flow. Woody material was added to the pool to provide hiding cover for salmon and steelhead.

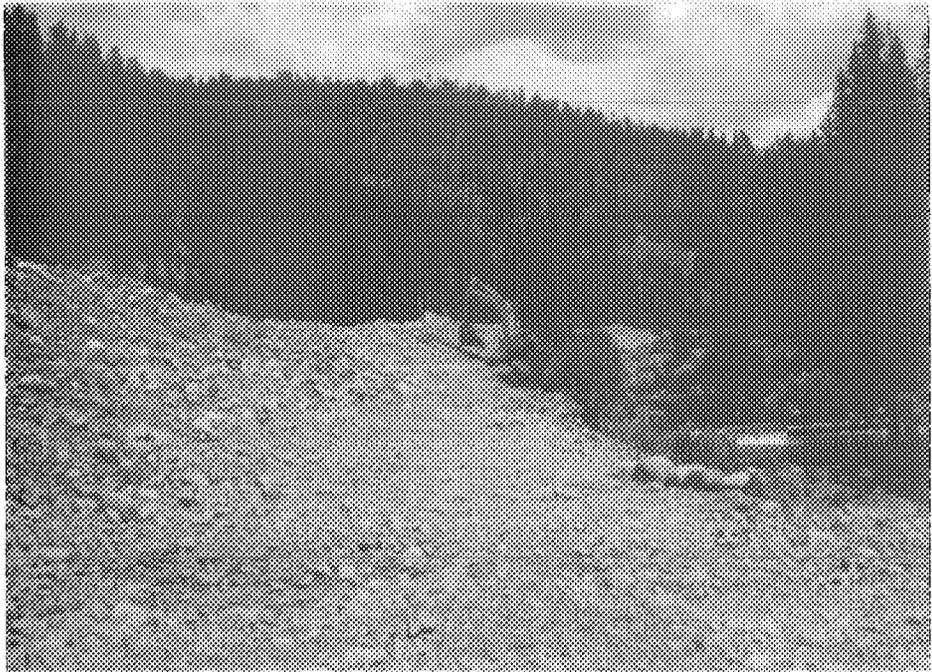
Excavator pulling back dredge pilings, created by previous mining activity, to create additional floodplain for Clear Creek. The additional floodplain will collect silt and grow vegetation. This will help shade the creek and provide nutrients to the stream system.
