EVALUATION OF JUVENILE SALMONID BYPASS FACILITIES  
AND PASSAGE AT WATER DIVERSIONS ON THE LOWER  
UMATILLA RIVER

**Oregon Department of Fish and Wildlife**

**Project Number 89-24-01**  
**Contract Number DE-BI79-89BPO 1385**

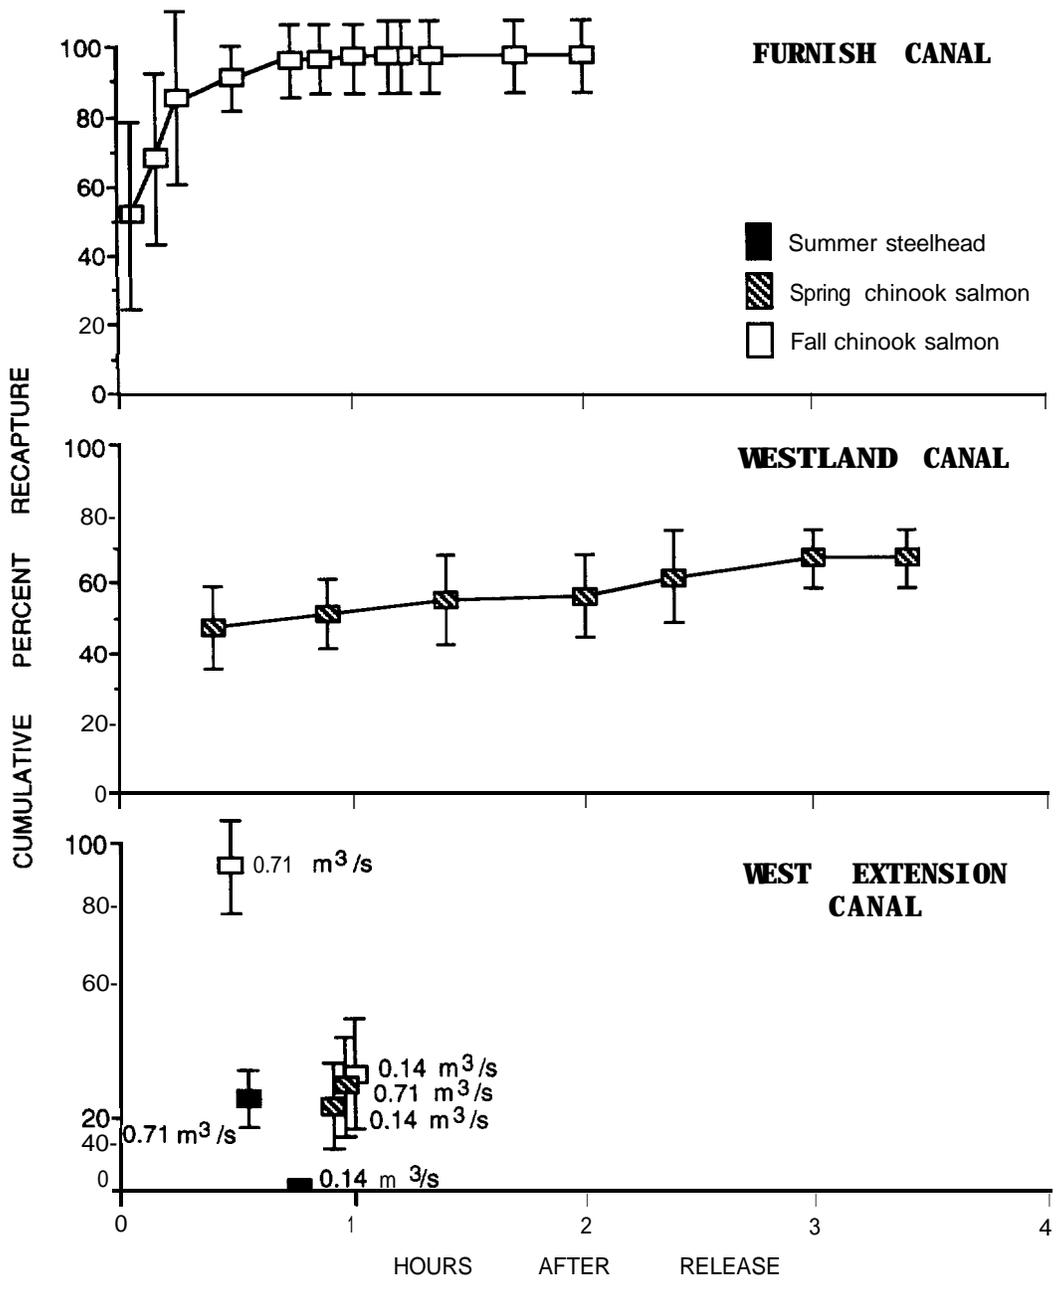
The single bypass pipe design of the lower bypass at Furnish Canal passed subyearling fall chinook salmon quickly (0.57-m<sup>3</sup>/s bypass flow; Figure 10). Fifty-two percent of the fish released at the bypass weir were recaptured at the outlet within 0.05 hours; 97% were recaptured within 1.2 hours, afterwards no additional fish were recaptured. Median travel speed through the lower bypass at Furnish Canal (2,800 m/h) was more than three times faster than travel rates through headworks canals at Furnish (485 m/h) and Maxwell (831 m/h) canals.

The coupled bypass-drain pipe design of the lower bypass at Westland Canal appeared to delay movement of yearling spring chinook salmon even though bypass flow was 0.74 m<sup>3</sup>/s. Approximately half (47%) of the test fish traveled through the lower bypass at a speed of 533 m/h and were recaptured within 0.4 hours (Figure 10). Further collection of fish was protracted and continued for more than three hours after release. Only 76% of the test fish were recaptured at the conclusion of testing.

At West Extension Canal, the bypass pipe and energy-dissipating design of the lower bypass channel quickly passed only subyearling fall chinook salmon when bypass flow was 0.71 m<sup>3</sup>/s (Figure 10). Ninety-two percent were recaptured in 0.5 hours. This was similar to the rapid travel of fall chinook salmon through the lower bypass at Furnish Canal. Recapture decreased for larger-sized fish and at lower bypass flows. Recapture for fall chinook salmon, spring chinook salmon, and summer steelhead after 0.5 hours was 92%, 16%, and 14% at a 0.71-m<sup>3</sup>/s bypass flow and 17%, 13%, and 0.5% at a 0.14-m<sup>3</sup>/s bypass flow, respectively.

**Figure 10. Cumulative percent recapture (mean and SD) of treatment fish released during injury tests conducted in the lower portion of fish bypass facilities at Furnish, Westland, and West Extension canals, Umatilla River, Oregon. Bypass flow (m<sup>3</sup>/s) is shown for tests conducted at West Extension Canal.**

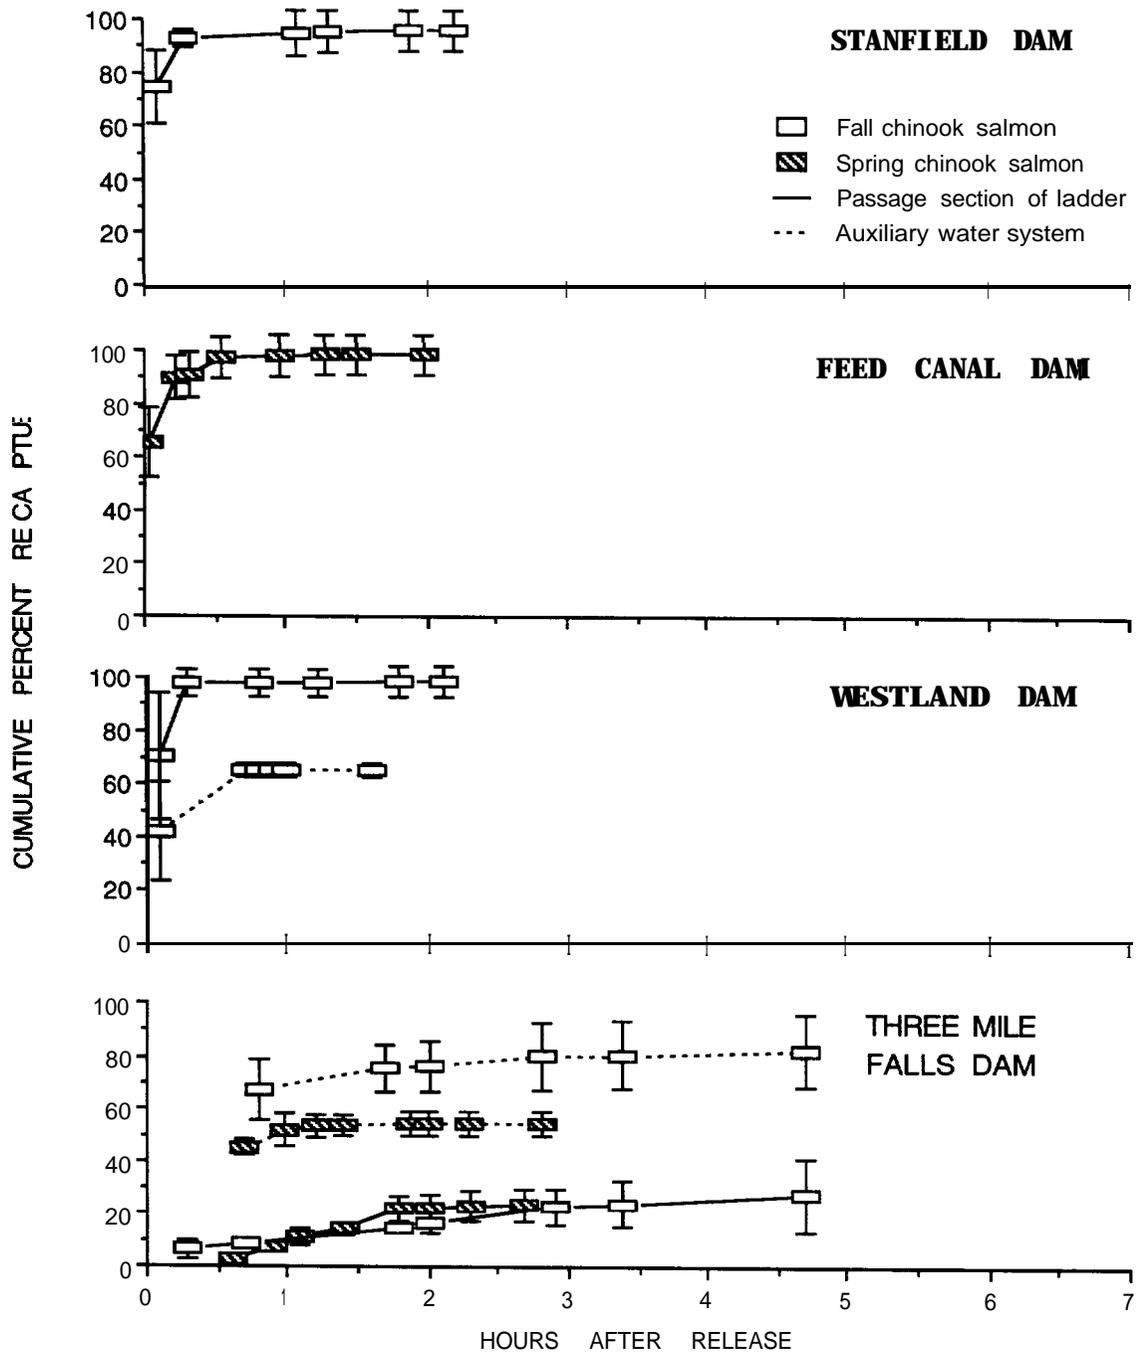
Test fish traveled quickly through the fish ladders at Stanfield and Feed Canal dams and the passage section of the fish ladder at Westland Dam. At these locations, greater than 90% recapture was reached in less than one hour; additional recaptures were not recorded after 1.5 hours (Figure 11). Travel was slower through the auxiliary water section of the fish ladders at Three Mile Falls and Westland dams. Approximately 50-65% of the fish released in the auxiliary water systems were recaptured after one hour; additional recapture was protracted (Figure 11). Final cumulative recapture of treatment fish passing through auxiliary water systems at the conclusion of testing was 82% for subyearling fall chinook salmon and 54% for spring chinook salmon at Three Mile Falls Dam, and 66% for fall chinook salmon at Westland Dam. Recapture was protracted for fish released upstream of Diffuser 1 in the passage section of the fish ladder at Three Mile Falls Dam. Recapture of spring chinook and fall chinook salmon released upstream of Diffuser 1 was 18% and 25% at the end of the testing.

Figure 11. Cumulative percent recapture (mean and SD) of treatment fish released during injury tests conducted in the passage and auxiliary water sections of fish ladders at Stanfield, Feed Canal, Westland, and Three Mile Falls dams, Umatilla River, Oregon.
