## **1. EXECUTIVE SUMMARY**

1.1. The Colville Tribes and Bonneville Power Administration (BPA) requested the services of the Corps to perform a limited reconnaissance study to evaluate and recommend potential water sources for a planned fish hatchery (BPA Intergovernmental Contract No. 16123). This reconnaissance study was conducted to determine if there are water sources that can be developed and conveyed to the Colville Tribes fish hatchery, provide sufficient quantity and quality of water in a secure manner that does not pose a risk to dam safety and at minimal cost to the Government.

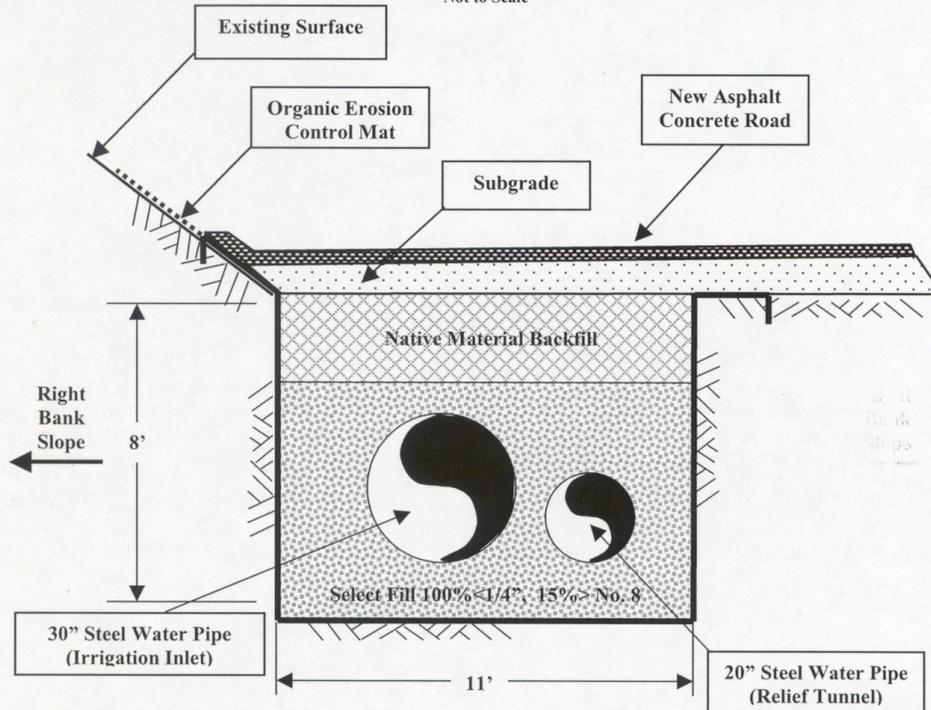
**Typical Cross Section of Lined Pipeline Trench – Paved Road Alignment**

Not to Scale

1. Trenches shall be lined with 40-mil LLDPE liner that shall extend fully across the trench bottom and sidewalls. All seams shall be welded per specifications. The liner shall be free of wrinkles and folds.

6. Riprap slope shall be repaired to existing conditions after the installation of pipes. Length of trench in riprap estimated at 300 feet.
7. Organic erosion control mat shall be placed to at least three feet up slope from the ditches and seeded.

1.4. Conveyance of the relief tunnel water to the hatchery site will require a 20-inch diameter metal pipe and conveyance of the reservoir water will require a 30-inch diameter metal pipe. The pipes must be buried for seismic and security considerations and would run approximately 300 feet through the riprap on the embankment and 2,400 feet under the existing road. This will require demolition and repaving the road and excavating pipe trench 8-feet deep by 11-feet wide.
