Protect and Restore Mill Creek Watershed

Annual Report
2002 - 2003

Nez Perce Tribe Fisheries/Watershed Program
P.O. Box 365
Lapwai, Idaho 83540

Project Number 2000-036-00

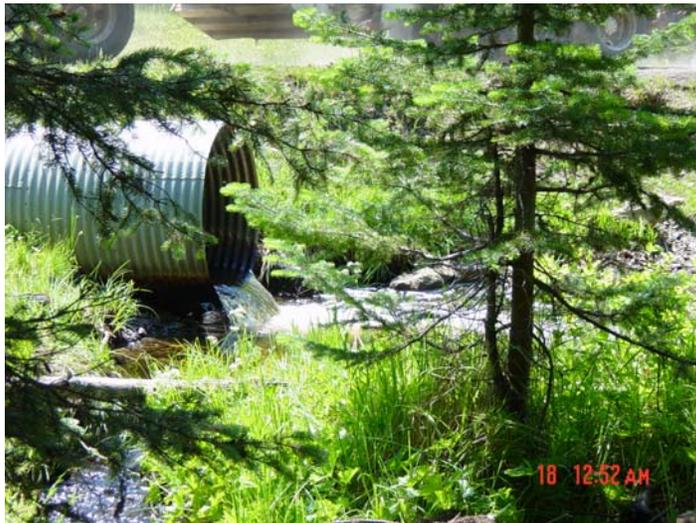
Inventory of all culverts at road/stream crossing sites was completed during the 2002 field season. 26 culverts were surveyed using the National Inventory and Assessment Procedure for Identifying Barriers to Aquatic Organism Movement at Road-Stream Crossings. Data was inputted into the FishXing database to determine whether crossing structures were passable by aquatic species. From the results six culverts were prioritized for replacement. These culverts include Merton Creek, Black George Creek, Hunt Creek, Corral Creek, Camp Creek, and Heppner Creek.

Figure 1. Drop at outlet of culvert within Mill Creek watershed. Passage barriers exist at culverts when outlets are not in contact with the stream bottom.

Additional restoration work remains to be completed in this watershed. During the FY2002, culvert inventories were completed and a prioritization of culverts to be replaced. Implementation of culvert replacement is scheduled to begin during field season 2004; contracts will be prepared in FY 2003. Culverts are expensive to replace, so the six priority culverts will likely take several years to complete.
