Natural Propagation and Habitat Improvement

Volume II - Idaho

Annual and Final Reports, 1985

LOCHSA RIVER TRIBUTARIES ENHANCEMENT PROPOSAL

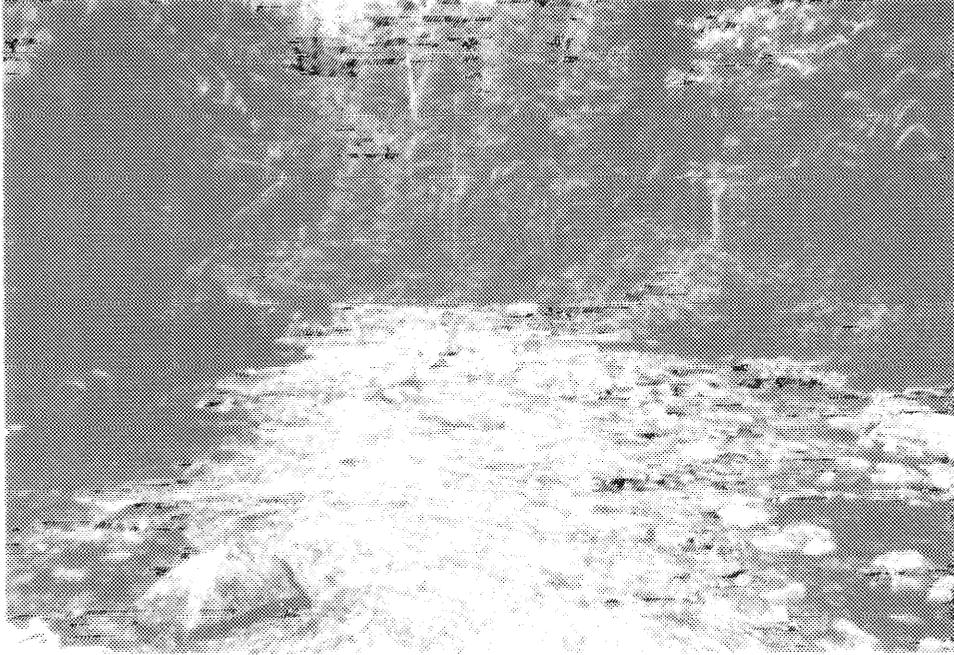
Figure 5. An example of a Squaw Creek reach.

The majority of the stream, as demonstrated by an overall pool-riffle ratio of 25:75, consists primarily of monotypic reaches of shallow, riffled water with low quality pools. Overall pool quality is fair, with an average value of 5.2 (Table 1). Occasional higher quality pools do occur, especially in reaches F-O where the water cascades over larger substrate material.

Road encroachment is more continuous on Squaw Creek above Doe Creek and only diverges from the stream in Reach J, where riparian vegetation on the right bank is composed of mixed hardwoods. Elsewhere along these reaches of Squaw Creek, riparian vegetation is reduced to mostly grass, occasional brush and infrequent trees on the bank that is experiencing the road encroachment.

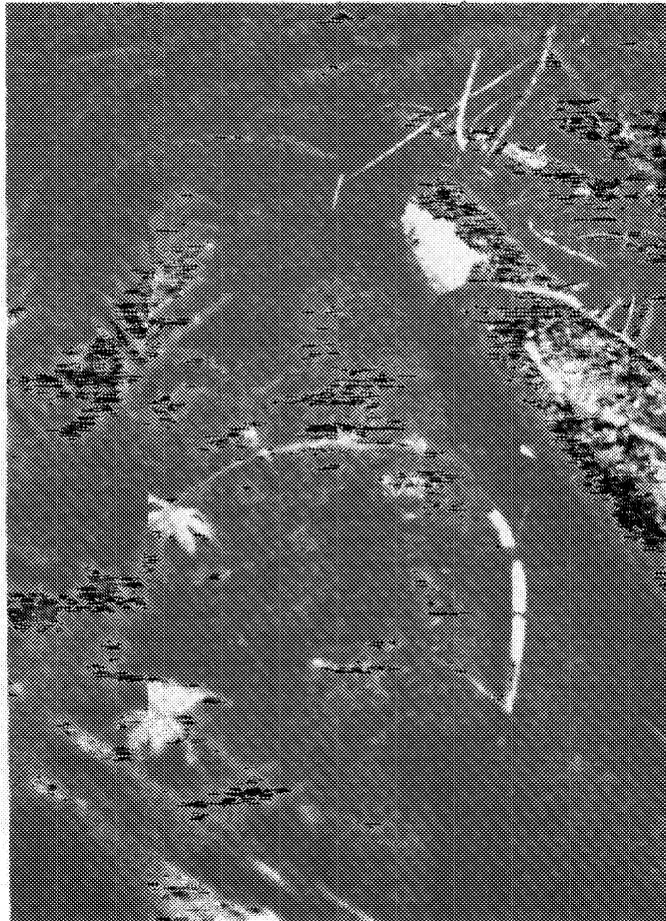
Figures 10 and 11. Upper and lower photos show accumulating sediments and debris in Fan Creek.

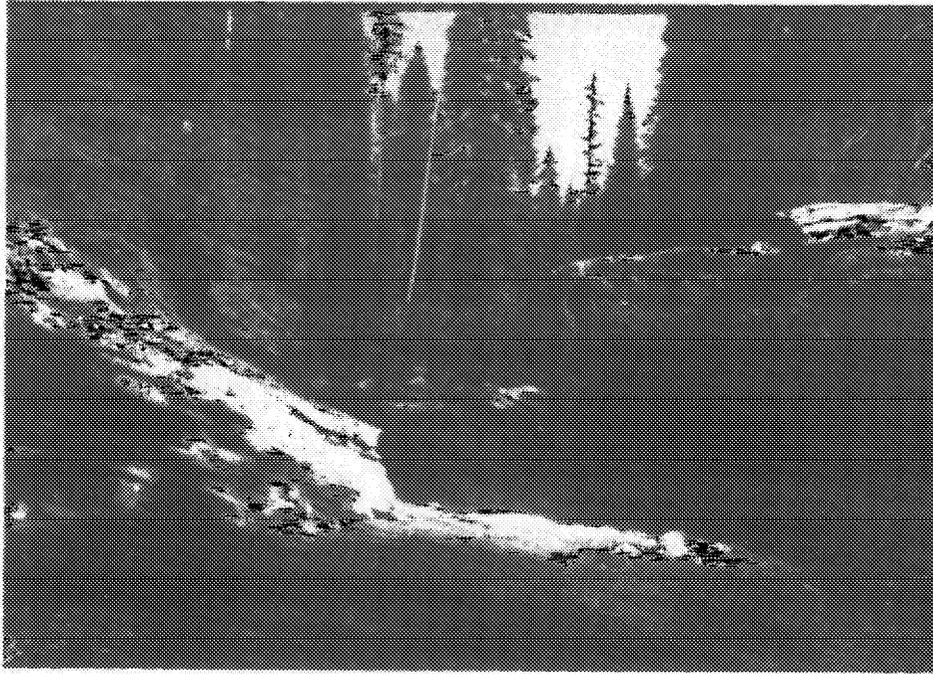
In 1984, two jump pools were created at this barrier (Figs. 21 & 22). Upon review it was determined that the channel needed to be made deeper and wider to improve fish passage. Ten holes, a total of 23 feet were drilled and one shot made. The site presently consists of a 55 cm deep pool (Fig. 23, point A) and a 30 cm deep run (Fig. 23, point B) below a 25 cm jump (Fig. 23, point C). The resting pool above the jump was deepened to 40 cm (Fig. 24, & Fig. 23, point D).

Figure 24. Site # 3, post-blast 1985, upstream view.

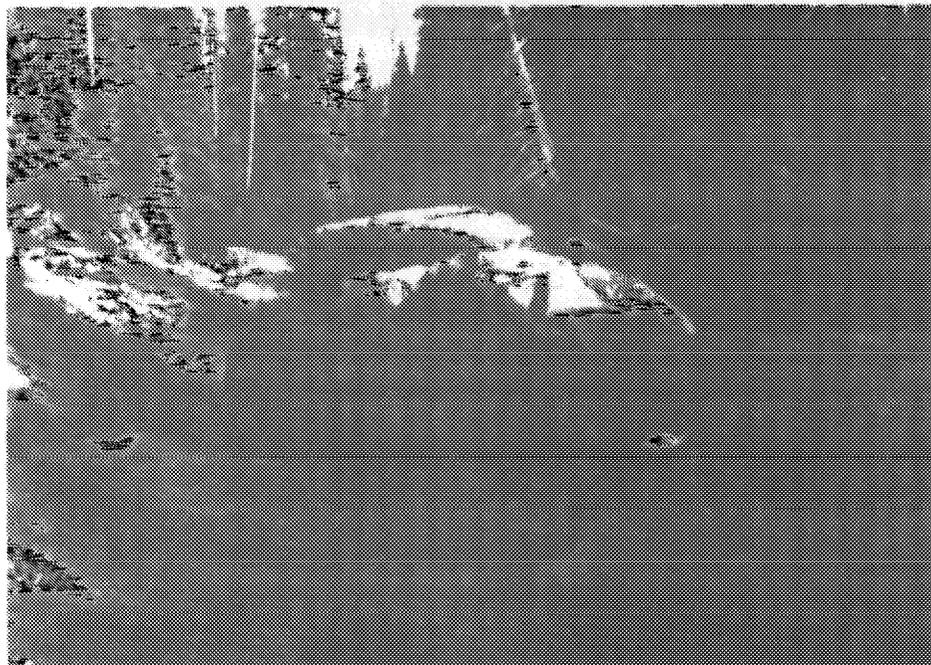
Efforts were made in 1984 to create two pools on the left side of the stream to help deepen the channel and slow the velocity (Figs. 25 & 26). The appraisal in 1985 concluded that the velocity was still too high and the pools too shallow. Thirty one feet of bedrock were drilled and four blasts made (Figs. 27 & 28). The pool at the base of the run is currently 40 cm in depth (Fig. 29, point A). into which flows a 30 cm deep channel (Fig. 29, point B). A 35 cm deep pool (Fig. 29, point C) was created in this run when the point of a boulder was removed. A 30 cm jump (Fig. 29, point D) into a 30 cm deep pool (Fig. 29, point E) complete the run. A secondary channel on the right side of the stream would have sufficient flows for steelhead passage in the spring but is too shallow for summer passage of chinook salmon.

Figure 27. Site # 4, post-blast 1985, upstream view. Site # 3 is in the background.
